## **TAMU Project**

**Energy Consumption Data Quality Assurance/Quality  
Control Assessment Report for the  
Month of January 2017**

**Utility & Energy Services  
Division of Administration  
Texas A&M University**

**February 2017**

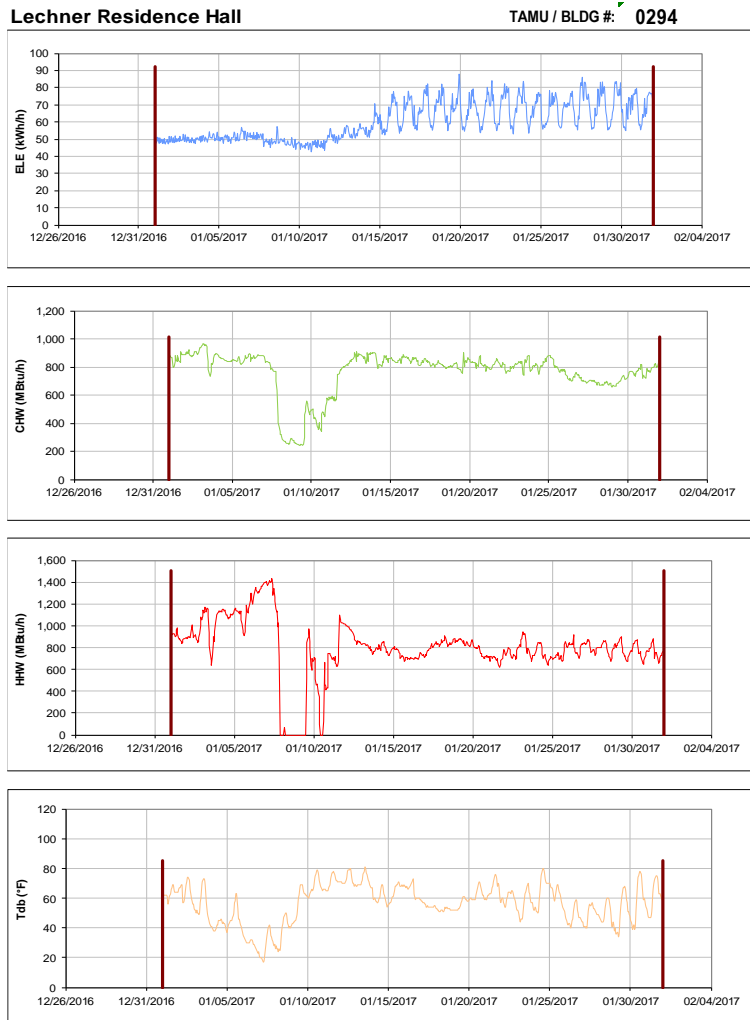
Figure III-7 Hourly Whole Building Electricity, Chilled Water, and Hot Water Consumption for Lechner Residence Hall during the Month of January 2017 and the Corresponding Hourly Outdoor Dry Bulb Temperature for College Station, TX

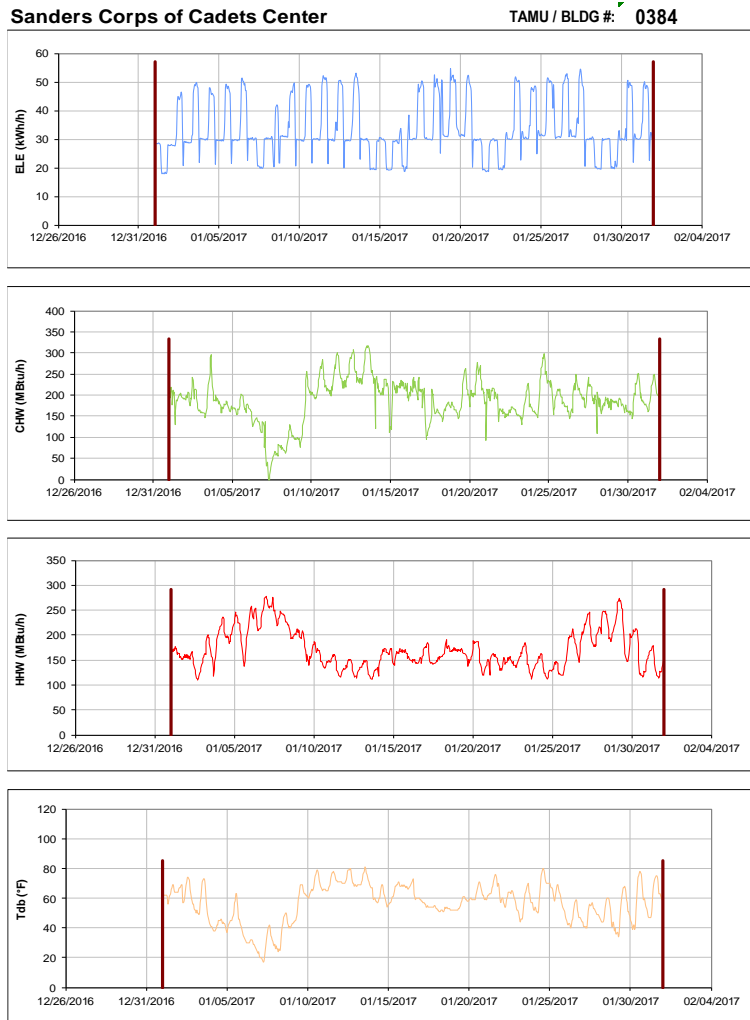
Figure III-19 Hourly Whole Building Electricity, Chilled Water, and Hot Water Consumption for Sanders Corps of Cadets Center during the Month of January 2017 and the Corresponding Hourly Outdoor Dry Bulb Temperature for College Station, TX

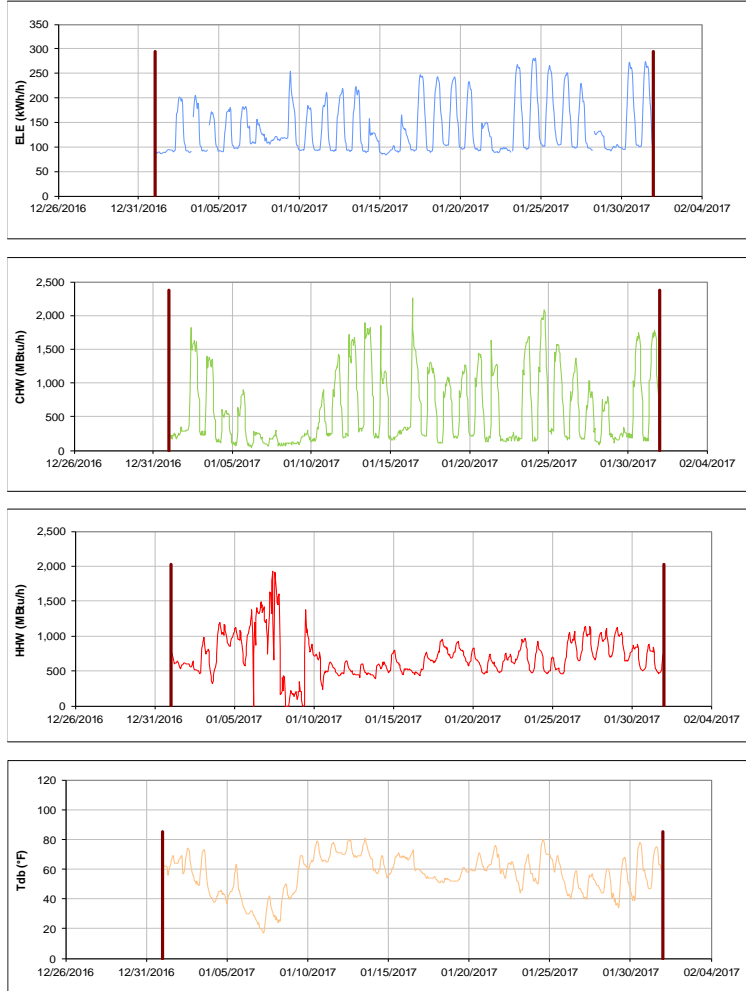
**Harrington Education Center Office Tower TAMU / BLDG #: 0435**

Figure III-57 Hourly Whole Building Electricity, Chilled Water, and Hot Water Consumption for Harrington Education Center Office Tower during the Month of January 2017 and the Corresponding Hourly Outdoor Dry Bulb Temperature for College Station, TX

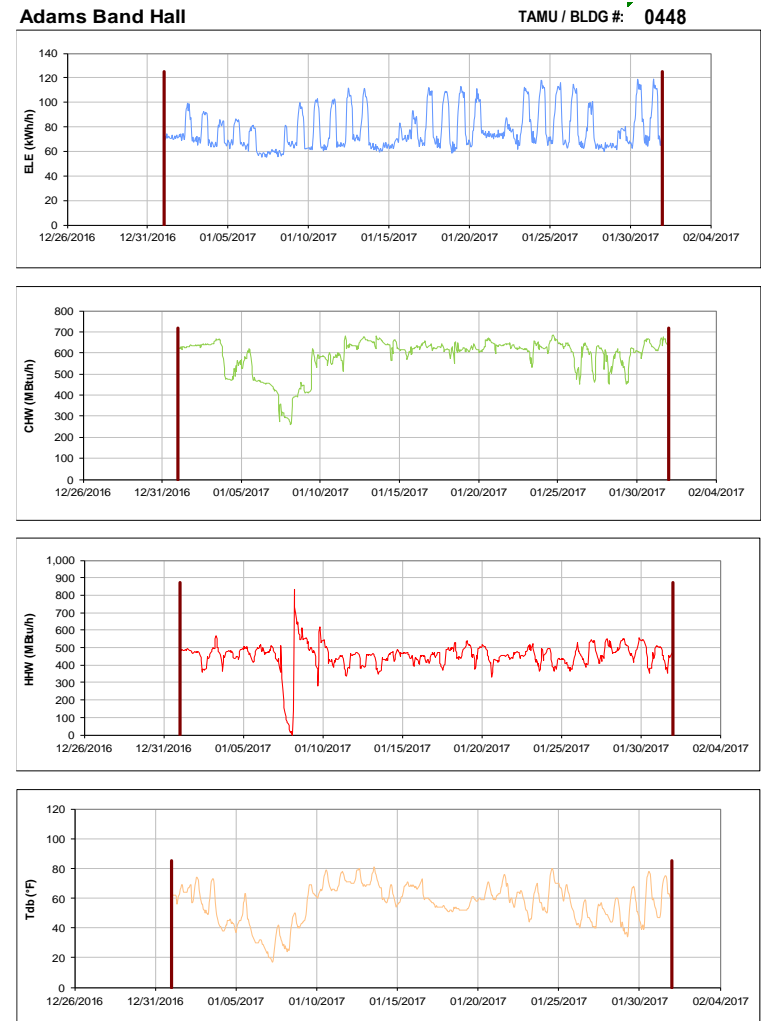
Figure III-70 Hourly Whole Building Electricity, Chilled Water, and Hot Water Consumption for Adams Band Hall during the Month of January 2017 and the Corresponding Hourly Outdoor Dry Bulb Temperature for College Station, TX

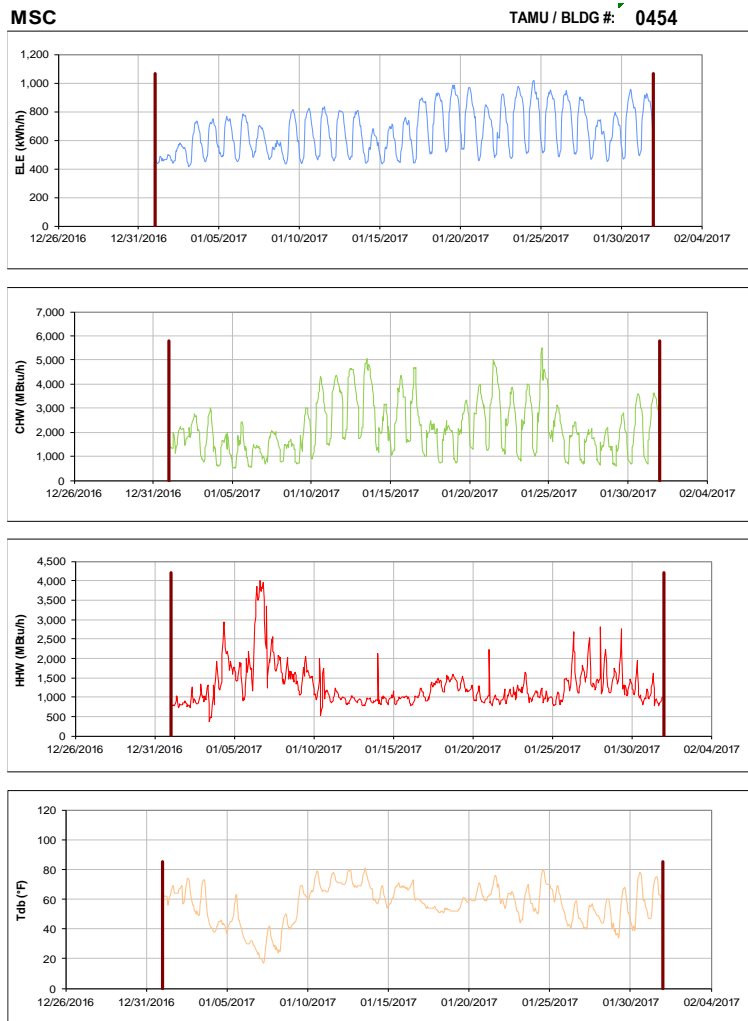
Figure III-73 Hourly Whole Building Electricity, Chilled Water, and Hot Water Consumption for MSC during the Month of January 2017 and the Corresponding Hourly Outdoor Dry Bulb Temperature for College Station, TX

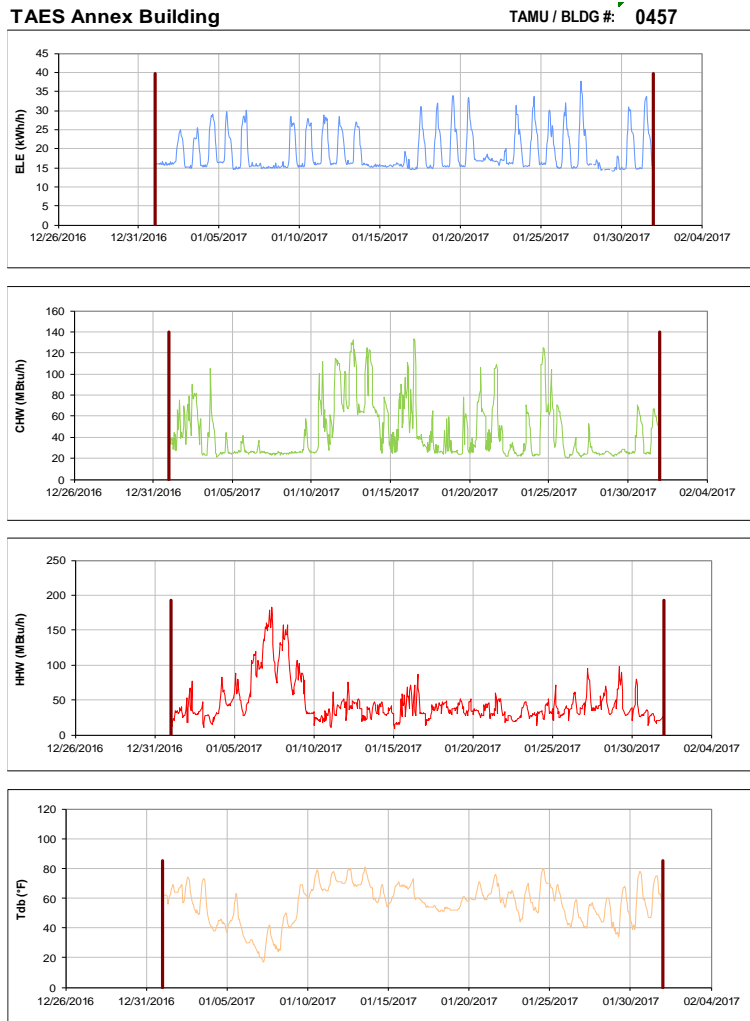
Figure III-75 Hourly Whole Building Electricity, Chilled Water, and Hot Water Consumption for TAES Annex Building during the Month of January 2017 and the Corresponding Hourly Outdoor Dry Bulb Temperature for College Station, TX

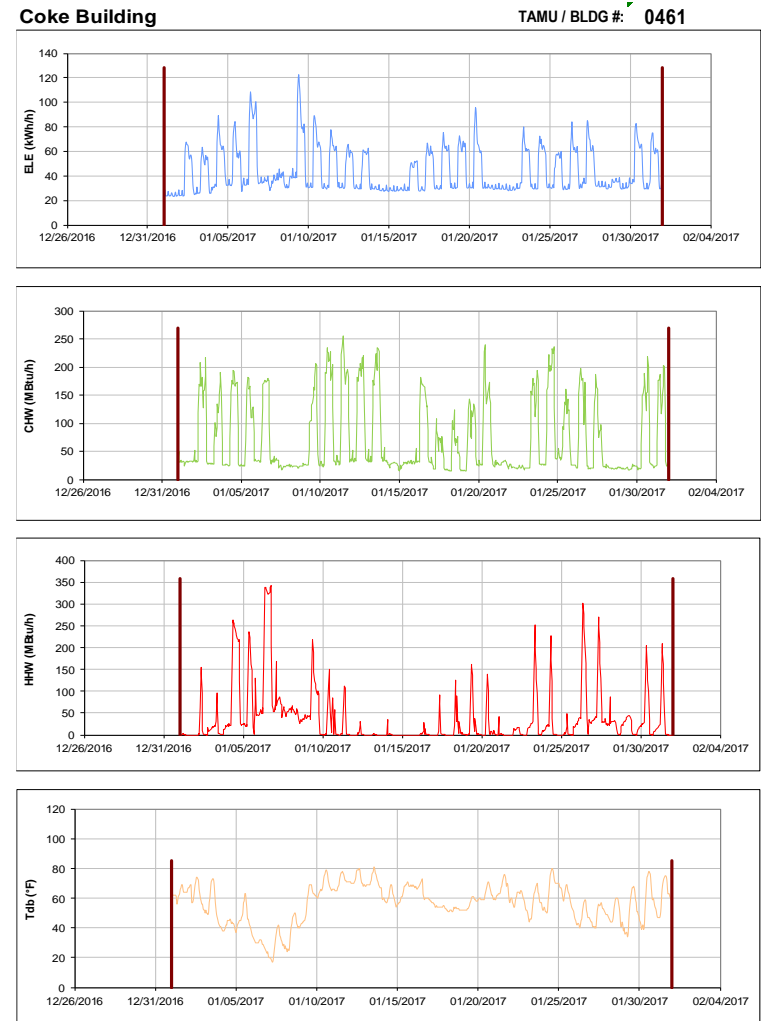
Figure III-76 Hourly Whole Building Electricity, Chilled Water, and Hot Water Consumption for Coke Building during the Month of January 2017 and the Corresponding Hourly Outdoor Dry Bulb Temperature for College Station, TX

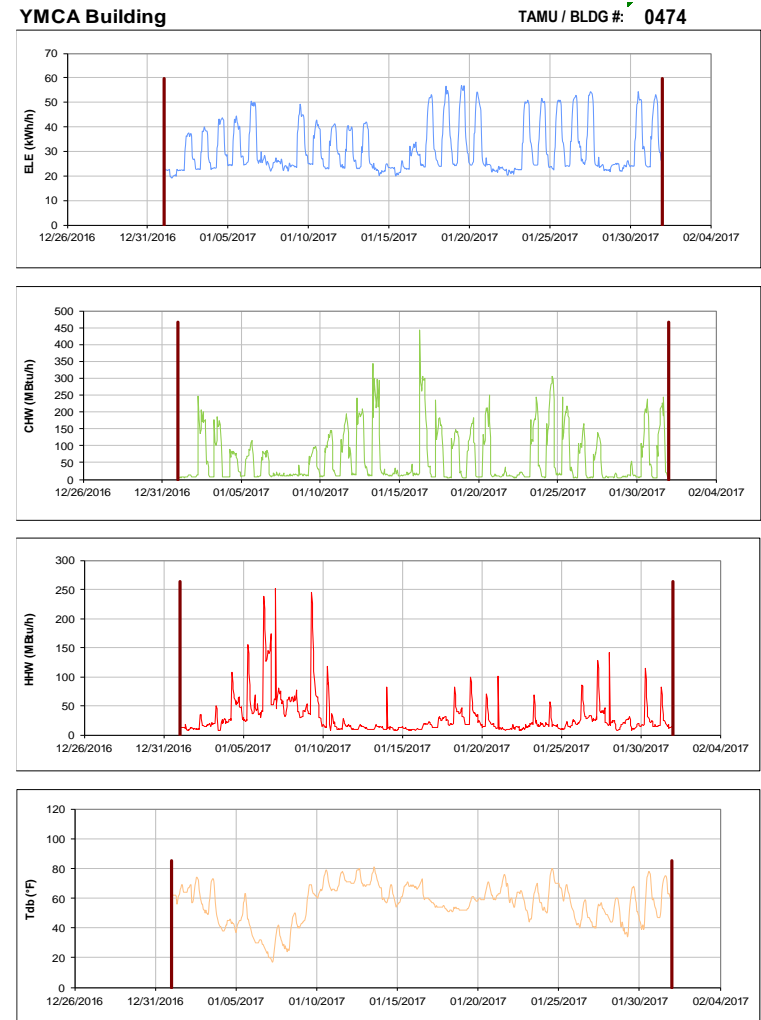
Figure III-88 Hourly Whole Building Electricity, Chilled Water, and Hot Water Consumption for YMCA Building during the Month of January 2017 and the Corresponding Hourly Outdoor Dry Bulb Temperature for College Station, TX

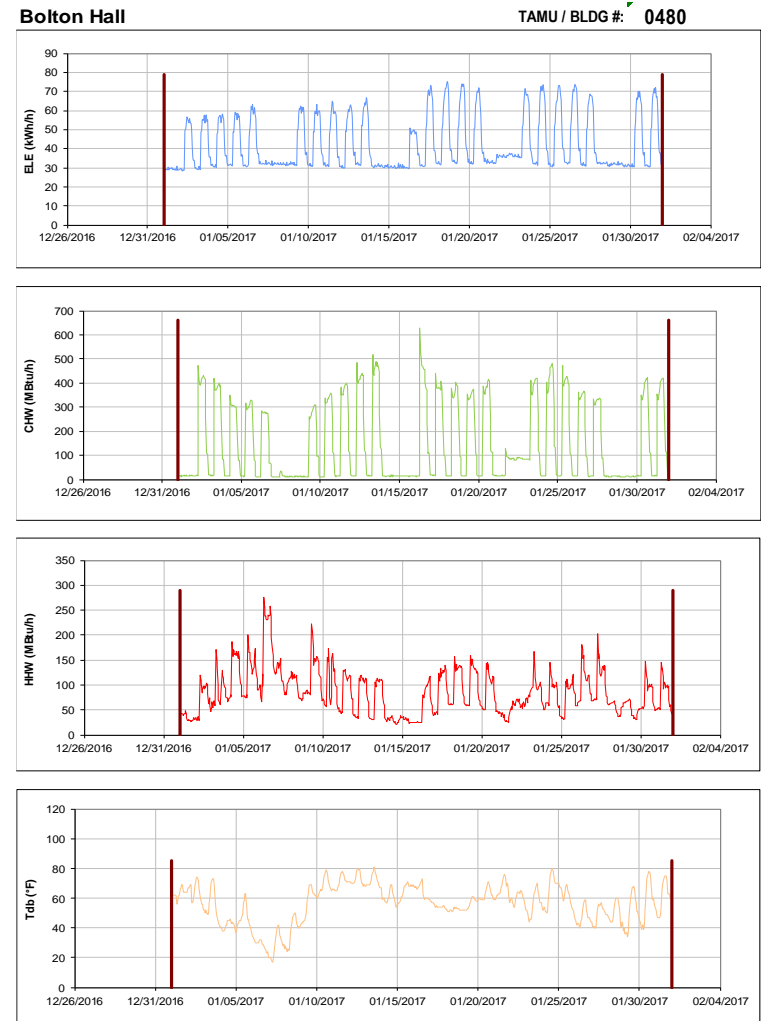
Figure III-92 Hourly Whole Building Electricity, Chilled Water, and Hot Water Consumption for Bolton Hall during the Month of January 2017 and the Corresponding Hourly Outdoor Dry Bulb Temperature for College Station, TX

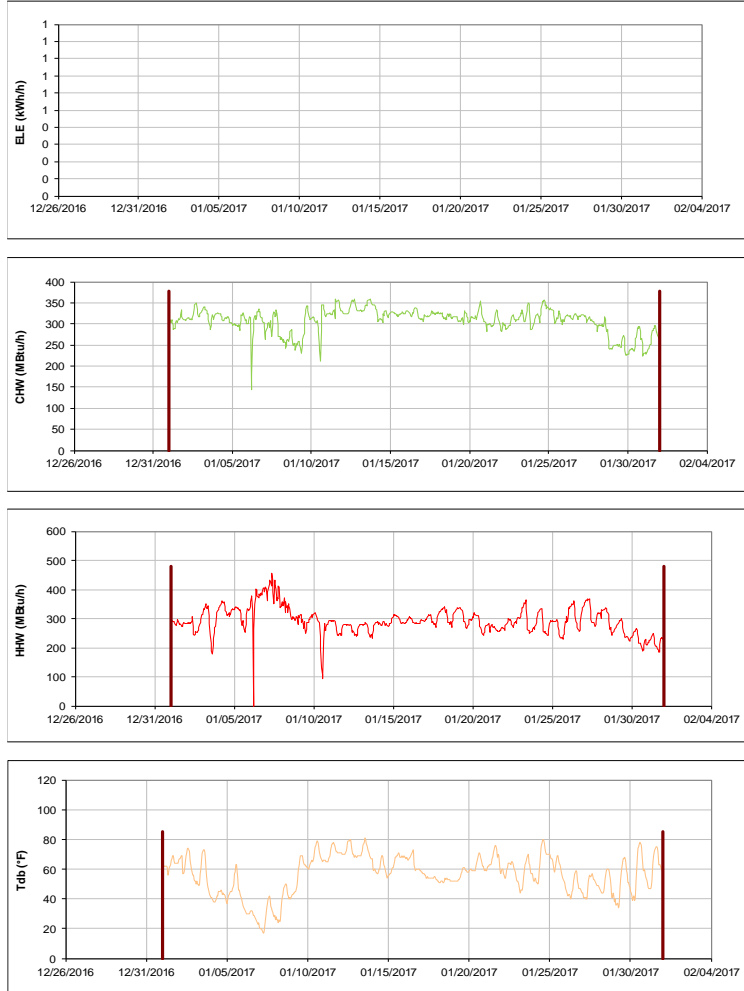
TAMU / BLDG #: 0481

Figure III-93 Hourly Whole Building Electricity, Chilled Water, and Hot Water Consumption for Heaton Hall during the Month of January 2017 and the Corresponding Hourly Outdoor Dry Bulb Temperature for College Station, TX

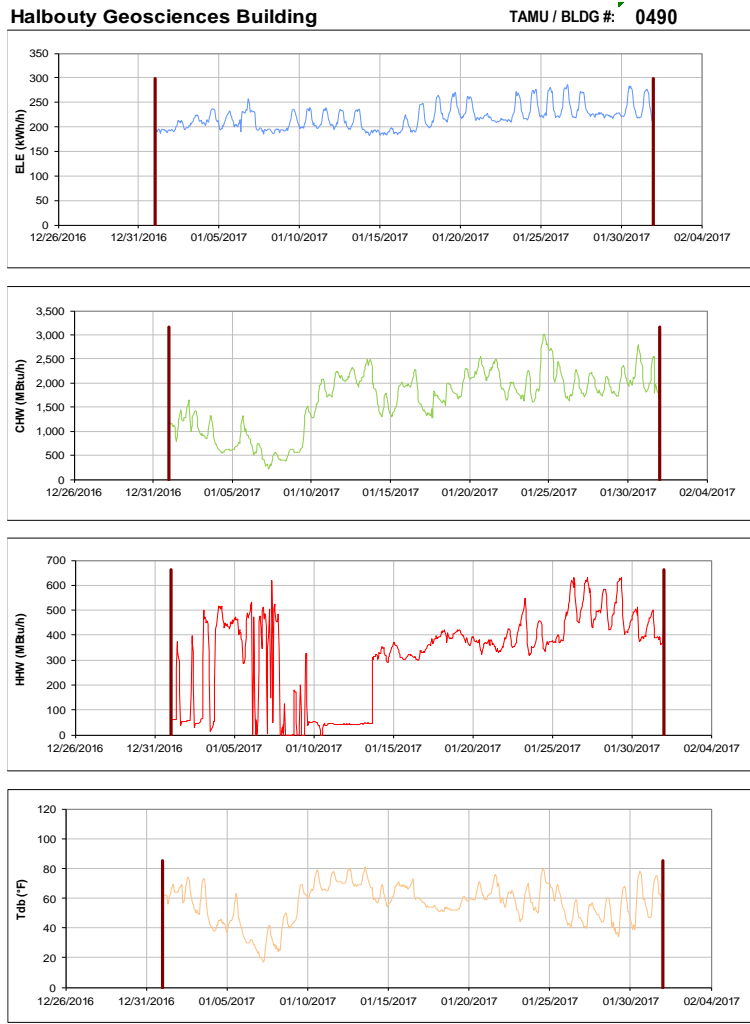
Figure III-97 Hourly Whole Building Electricity, Chilled Water, and Hot Water Consumption for Halbouty Geosciences Building during the Month of January 2017 and the Corresponding Hourly Outdoor Dry Bulb Temperature for College Station, TX

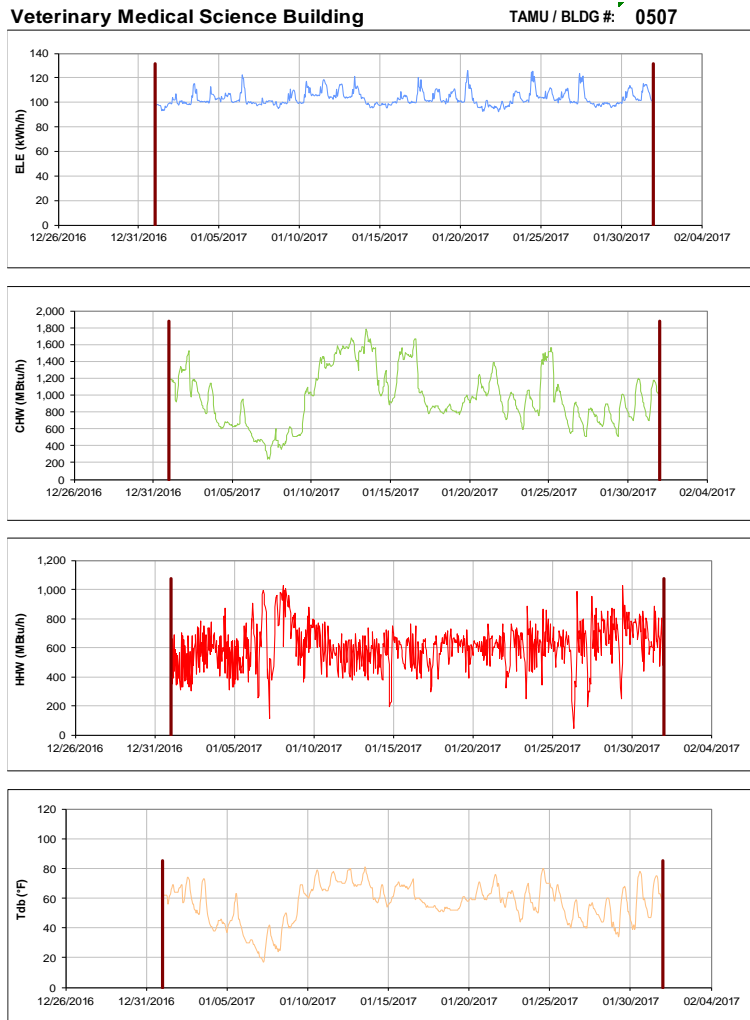
Figure III-103 Hourly Whole Building Electricity, Chilled Water, and Hot Water Consumption for Veterinary Medical Science Building during the Month of January 2017 and the Corresponding Hourly Outdoor Dry Bulb Temperature for College Station, TX

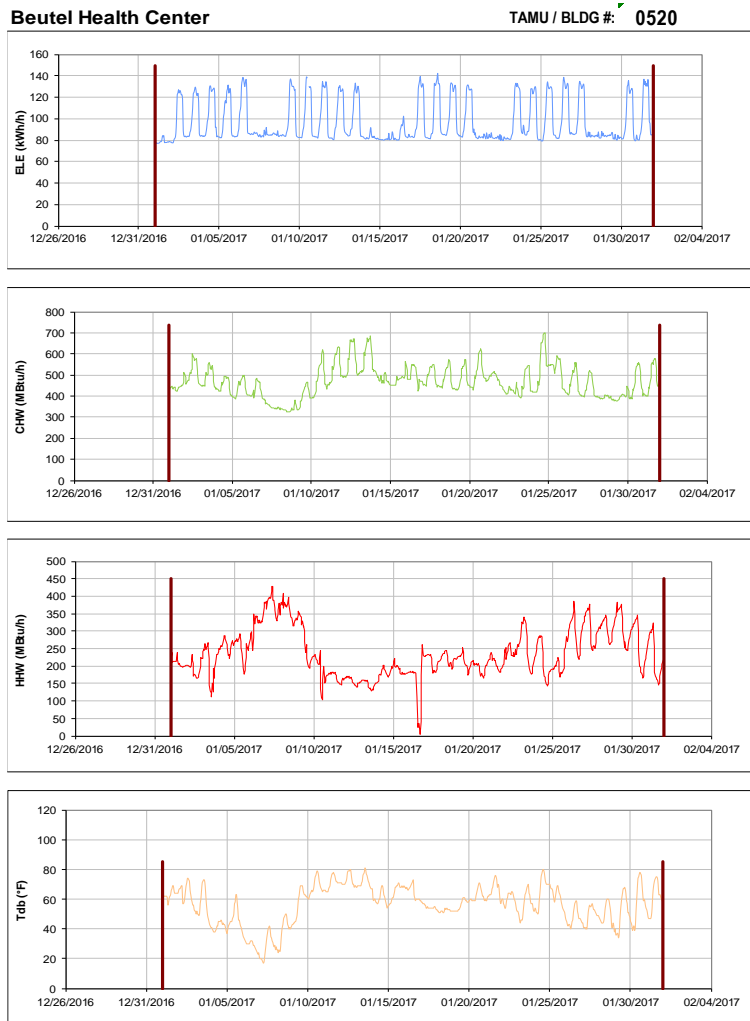
Figure III-111 Hourly Whole Building Electricity, Chilled Water, and Hot Water Consumption for Beutel Health Center during the Month of January 2017 and the Corresponding Hourly Outdoor Dry Bulb Temperature for College Station, TX

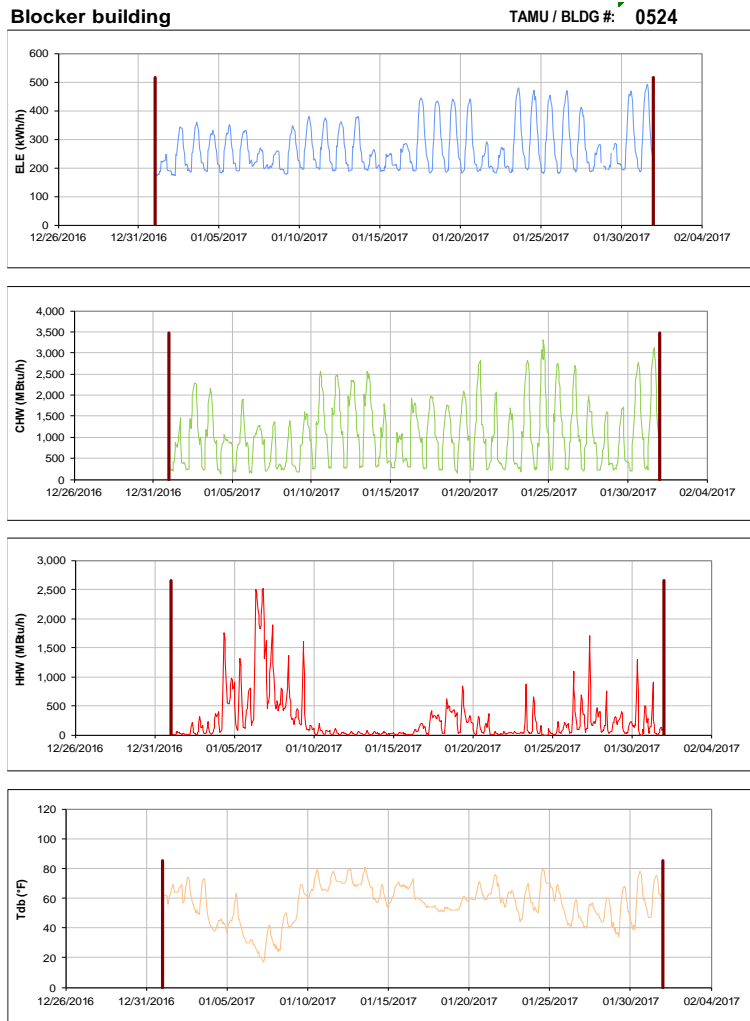
Figure III-113 Hourly Whole Building Electricity, Chilled Water, and Hot Water Consumption for Blocker building during the Month of January 2017 and the Corresponding Hourly Outdoor Dry Bulb Temperature for College Station, TX

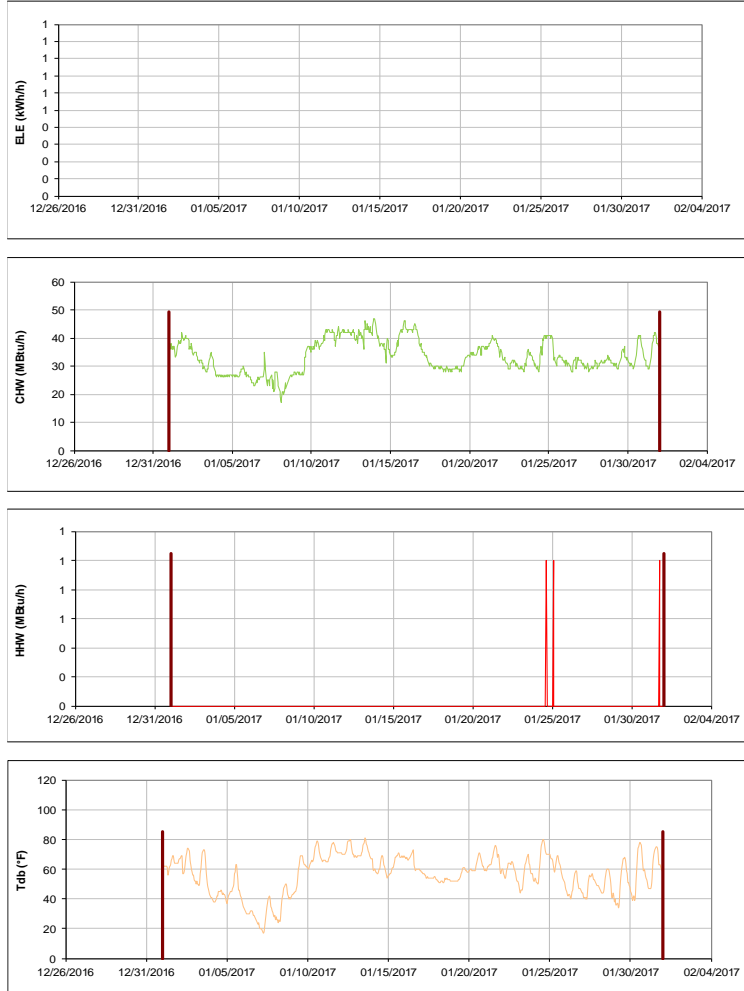
TAMU / BLDG #: 0880

Figure III-123 Hourly Whole Building Electricity, Chilled Water, and Hot Water Consumption for TVMC-Small Animal Building during the Month of January 2017 and the Corresponding Hourly Outdoor Dry Bulb Temperature for College Station, TX

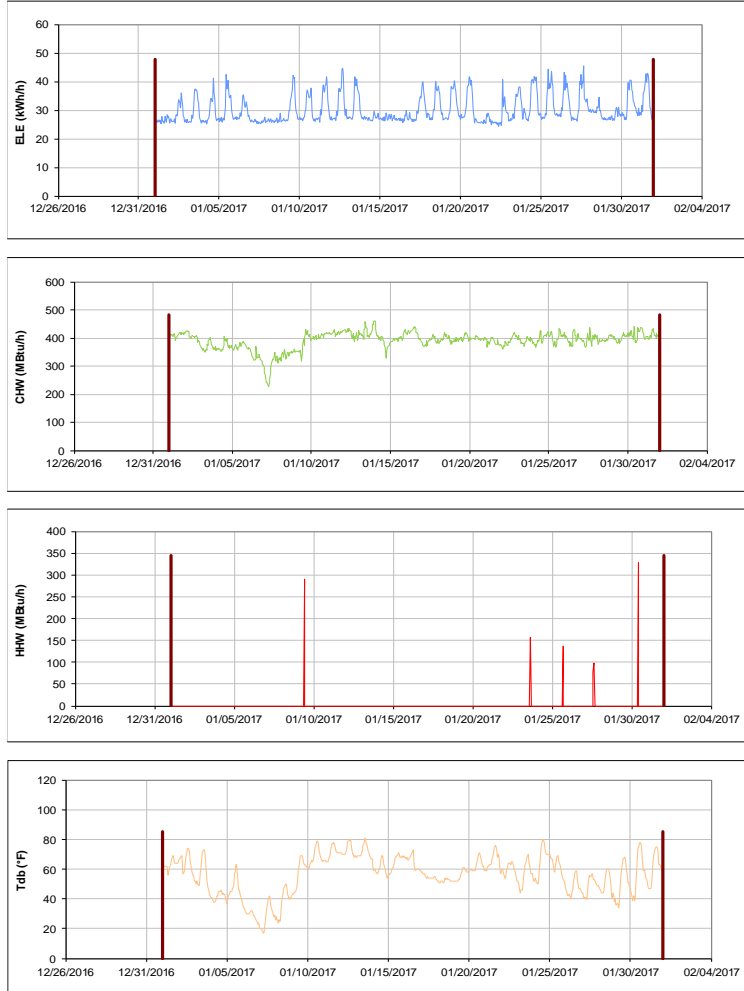
TAMU / BLDG #: 1020

Figure III-125 Hourly Whole Building Electricity, Chilled Water, and Hot Water Consumption for Vivarium III during the Month of January 2017 and the Corresponding Hourly Outdoor Dry Bulb Temperature for College Station, TX

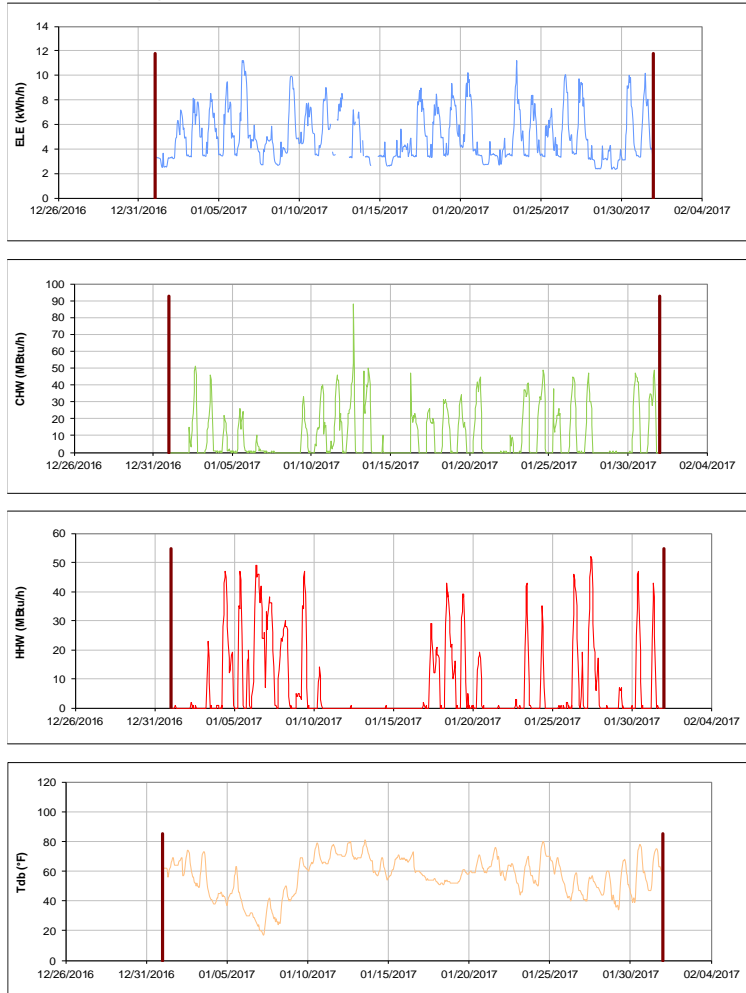
Utilities & Energy Services Business Office TAMU / BLDG #: 1497

Figure III-147 Hourly Whole Building Electricity, Chilled Water, and Hot Water Consumption for Utilities & Energy Services Business Office during the Month of January 2017 and the Corresponding Hourly Outdoor Dry Bulb Temperature for College Station, TX

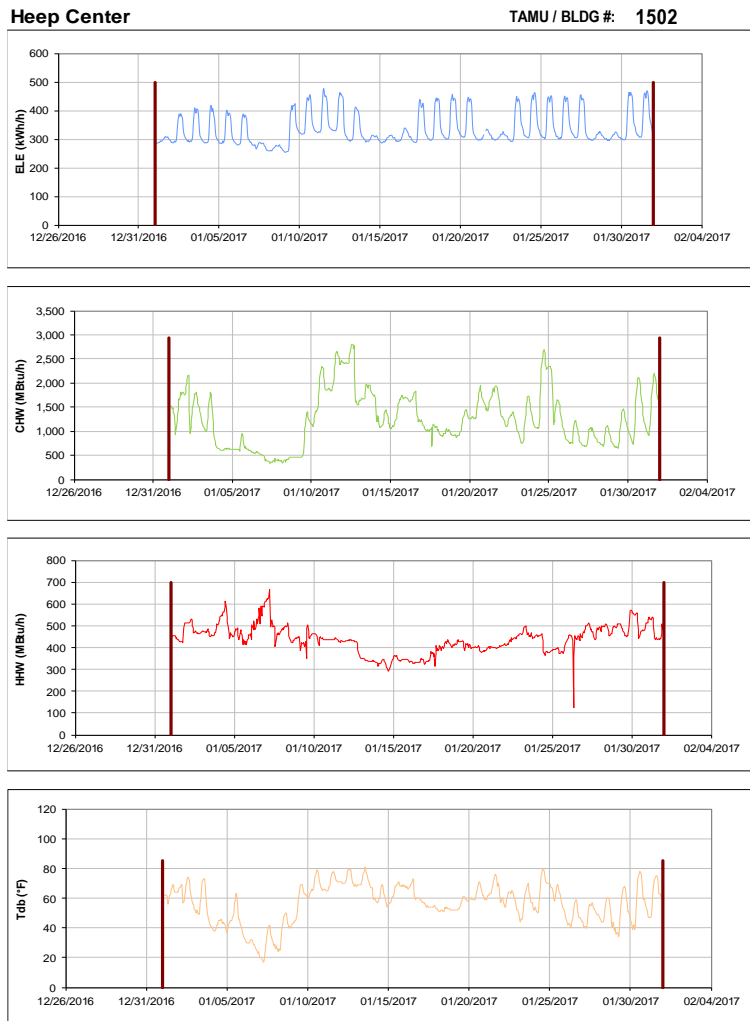
Figure III-149 Hourly Whole Building Electricity, Chilled Water, and Hot Water Consumption for Heep Center during the Month of January 2017 and the Corresponding Hourly Outdoor Dry Bulb Temperature for College Station, TX

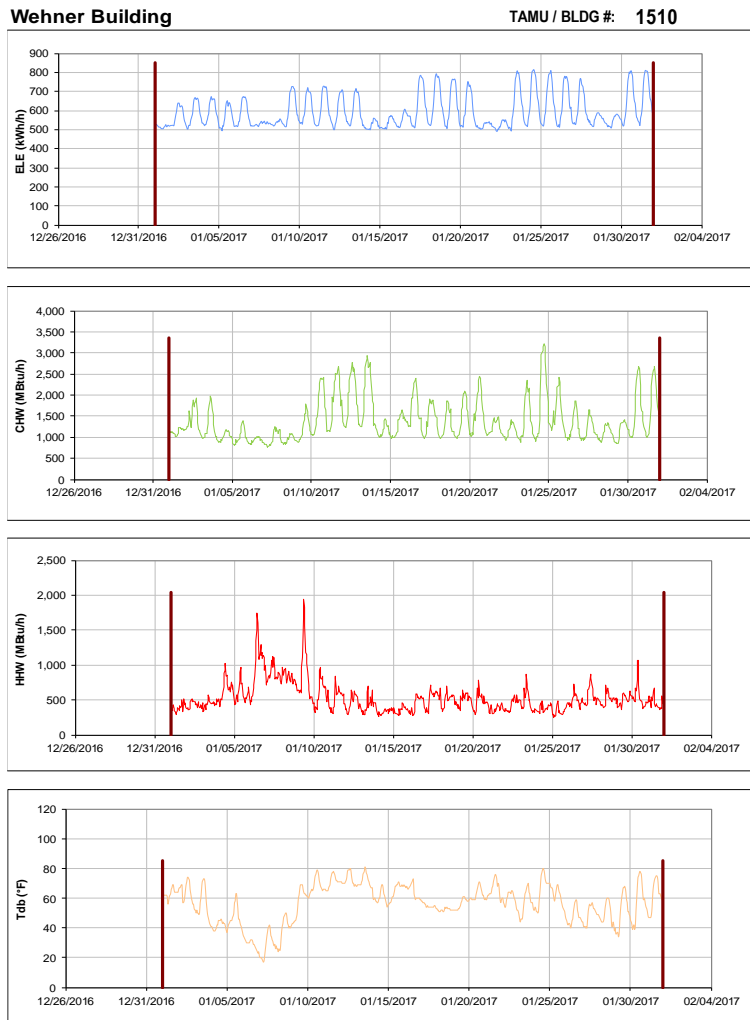
Figure III-157 Hourly Whole Building Electricity, Chilled Water, and Hot Water Consumption for Wehner Building during the Month of January 2017 and the Corresponding Hourly Outdoor Dry Bulb Temperature for College Station, TX

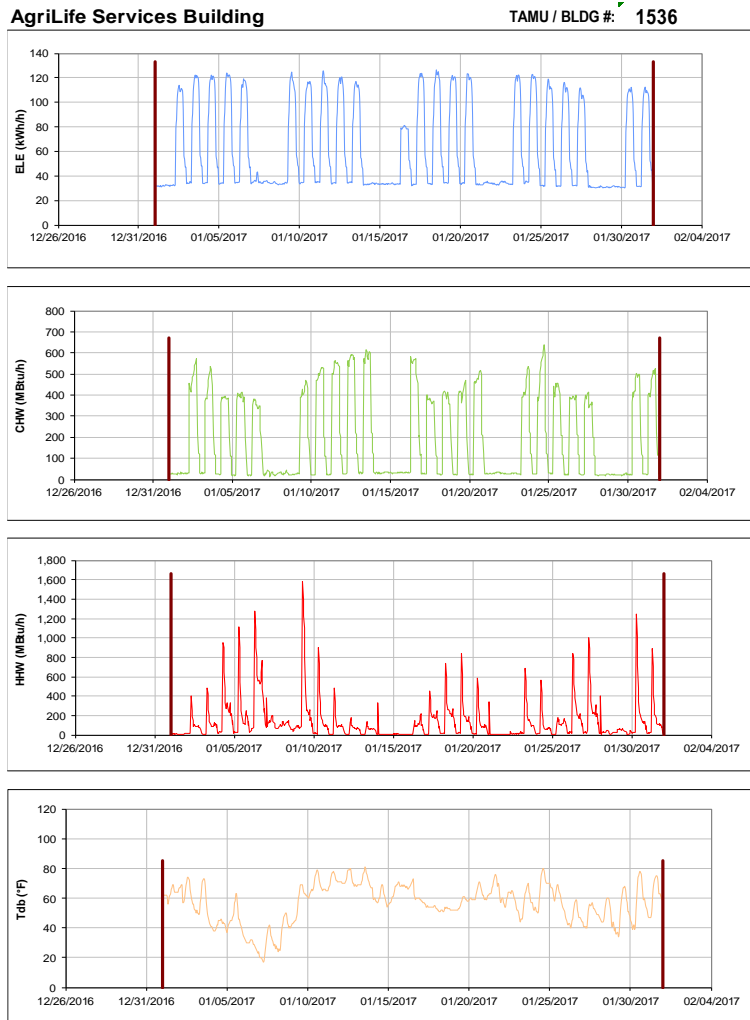
Figure III-165 Hourly Whole Building Electricity, Chilled Water, and Hot Water Consumption for AgriLife Services Building during the Month of January 2017 and the Corresponding Hourly Outdoor Dry Bulb Temperature for College Station, TX

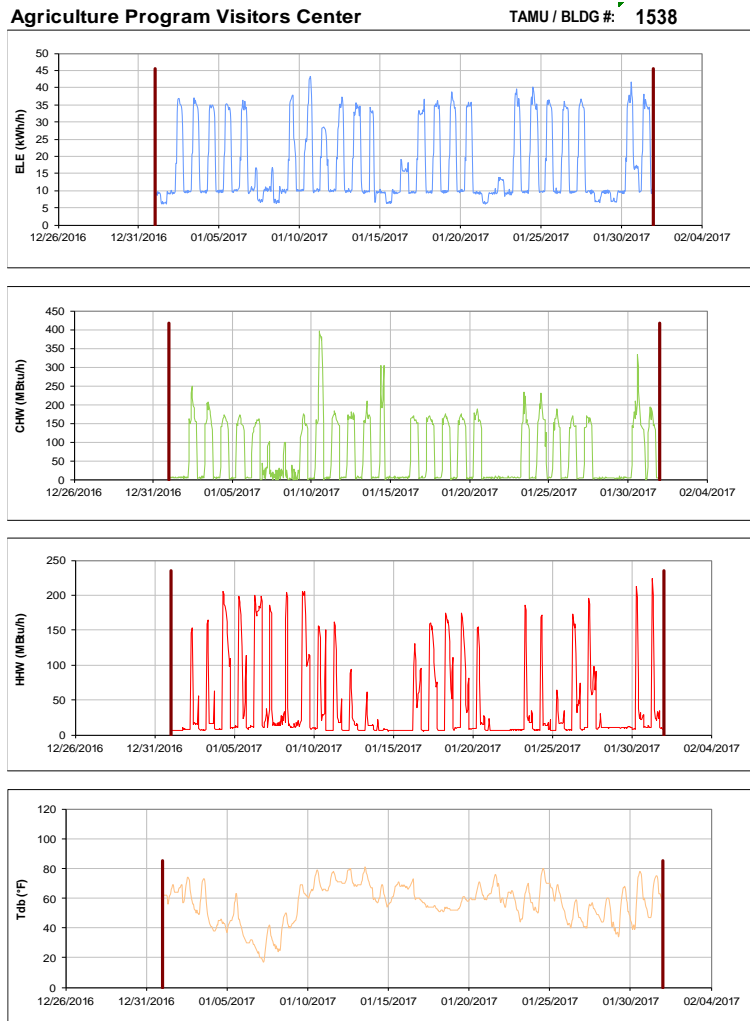
Figure III-167 Hourly Whole Building Electricity, Chilled Water, and Hot Water Consumption for Agriculture Program Visitors Center during the Month of January 2017 and the Corresponding Hourly Outdoor Dry Bulb Temperature for College Station, TX

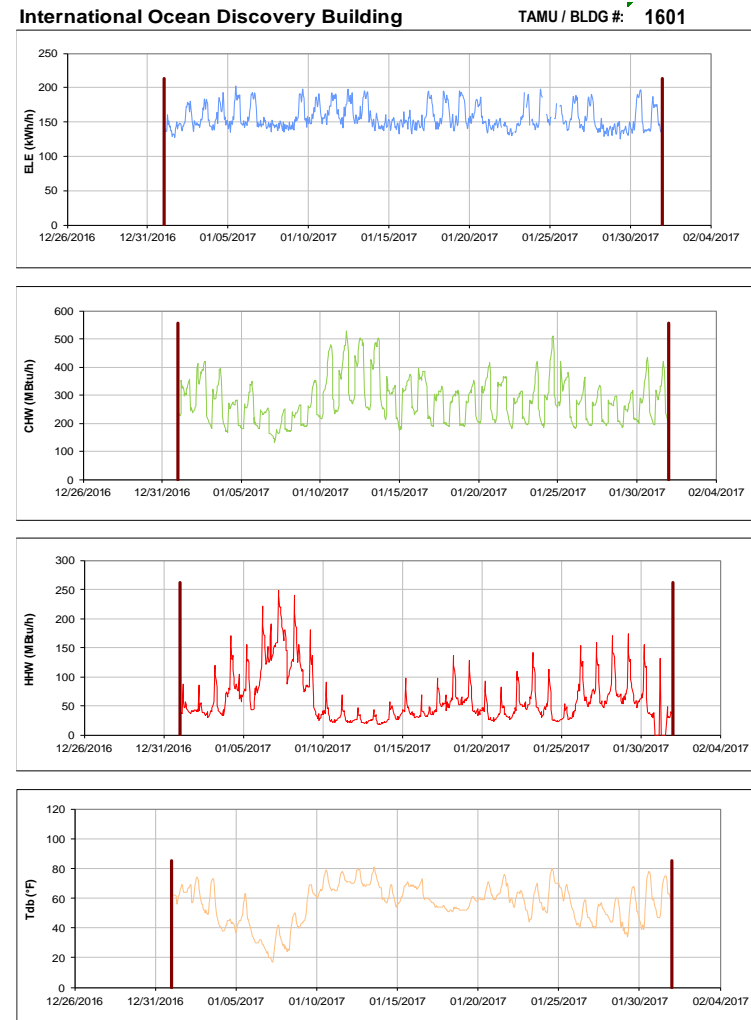
Figure III-180 Hourly Whole Building Electricity, Chilled Water, and Hot Water Consumption for International Ocean Discovery Building during the Month of January 2017 and the Corresponding Hourly Outdoor Dry Bulb Temperature for College Station, TX

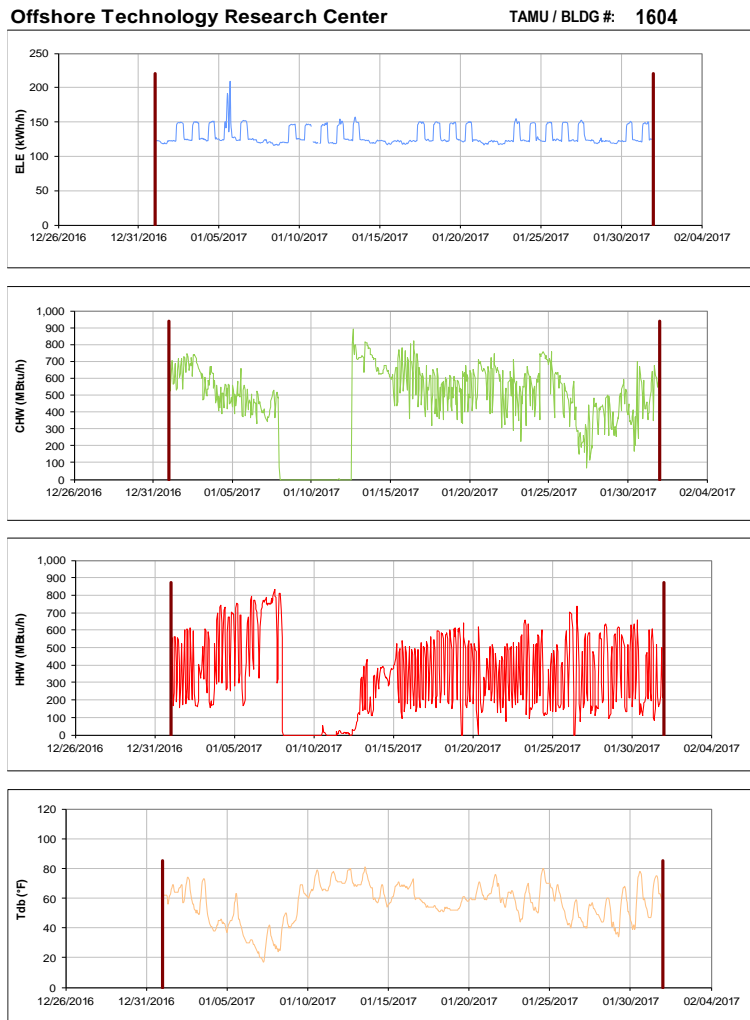
Figure III-181 Hourly Whole Building Electricity, Chilled Water, and Hot Water Consumption for Offshore Technology Research Center during the Month of January 2017 and the Corresponding Hourly Outdoor Dry Bulb Temperature for College Station, TX

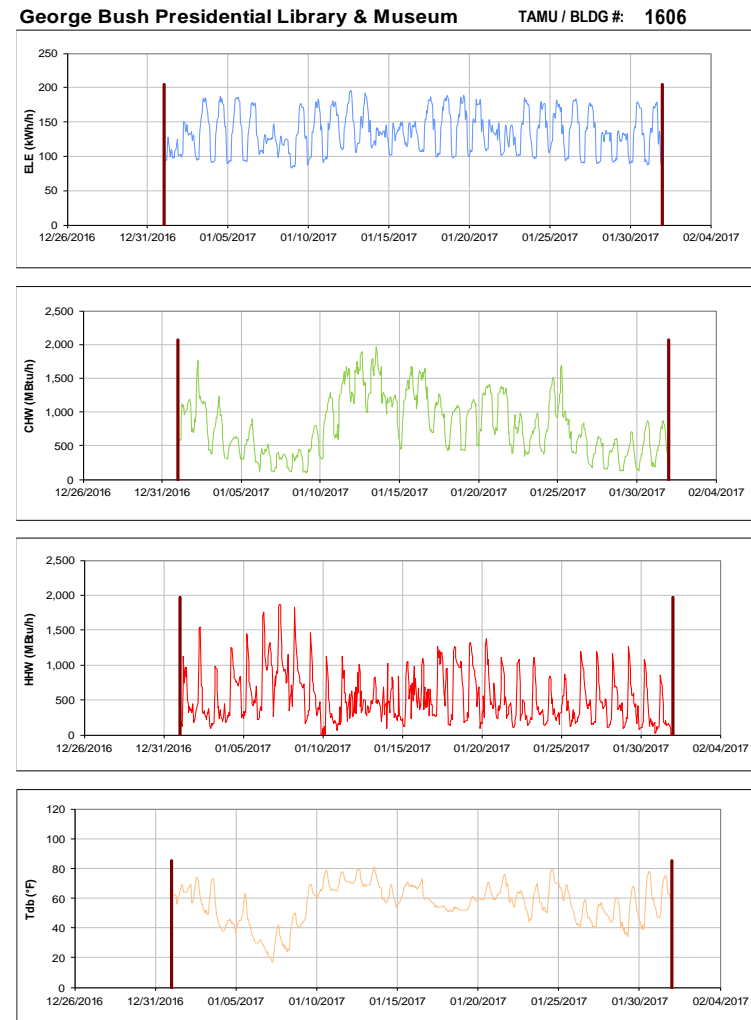
Figure III-182 Hourly Whole Building Electricity, Chilled Water, and Hot Water Consumption for George Bush Presidential Library & Museum during the Month of January 2017 and the Corresponding Hourly Outdoor Dry Bulb Temperature for College Station, TX

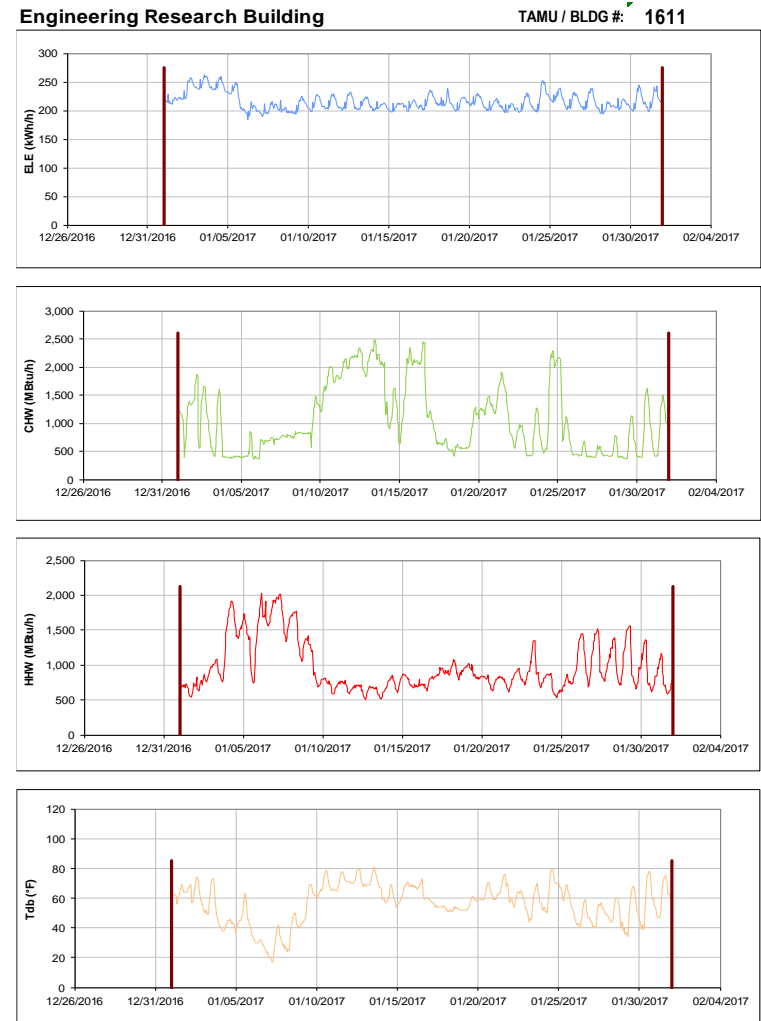
Figure III-186 Hourly Whole Building Electricity, Chilled Water, and Hot Water Consumption for Engineering Research Building during the Month of January 2017 and the Corresponding Hourly Outdoor Dry Bulb Temperature for College Station, TX
