Mesh expansion as the cause of bulging after abdominal wall hernia repair

CASE SUMMARY: In this report, we present bulging of a polyester mesh due to central pore expansion.

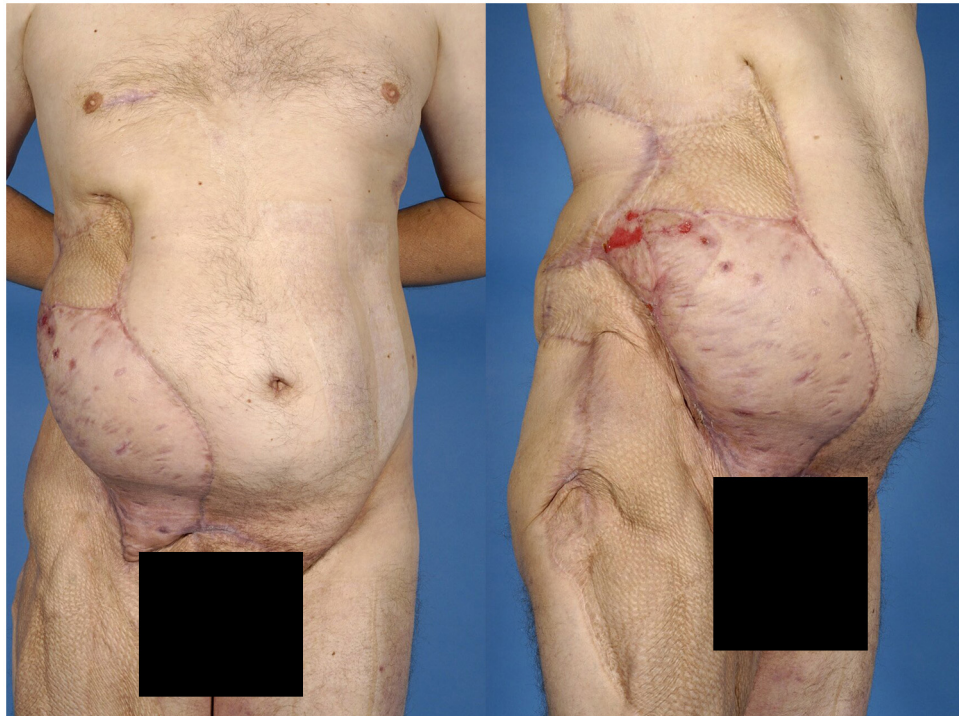
Fig. 1. Abdominal wall after four-staged repair with Parietex Composite® mesh and latissimus dorsi flap (2008).

The soft tissue defect was repaired at the sides of the hernia with skin obtained by using multiple tissue expanders. The soft tissue defect was covered with a free vascularized latissimus dorsi flap with large full thickness skin graft (Fig. 1). Four years after the final repair the patient returned to the outpatient department with progressive swelling of the right lower abdomen (Fig. 2). He suffered from abdominal pain and protrusion that interfered with his work.

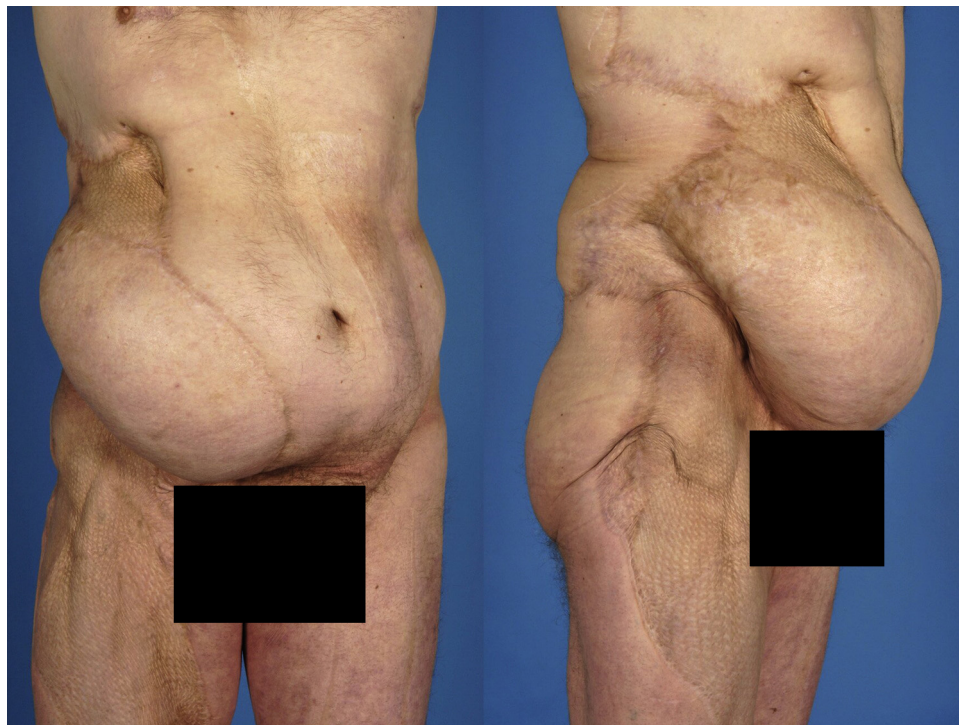
Fig. 2. Increased bulging of the abdominal wall four years after reconstruction (2012).

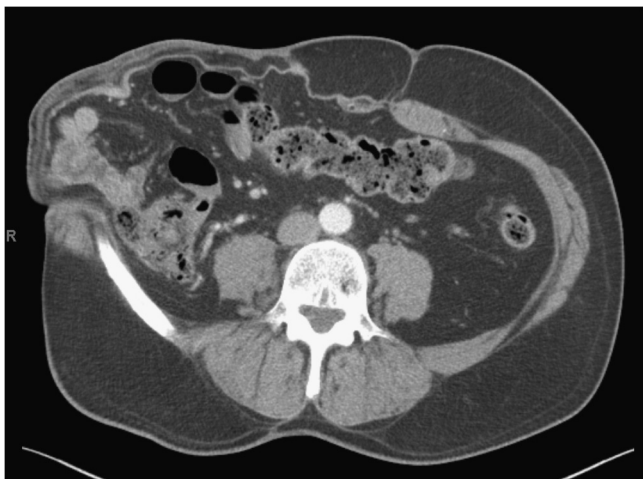
Fig. 3. CT-scan of bulging mesh four years after reconstruction (2012).

A CT-scan was performed, showing an intact repair, but enlargement of the mesh (Fig. 3). A surgical procedure was planned to repair the bulging abdominal wall. During surgery the bulging was found to be caused by expansion of an intact mesh. The elongation was caused by a striking central pore expansion from 1.5 to 2.5 mm (Fig. 4). Surgical excision of the central part of the mesh was performed to tighten the mesh and reduce the bulging. 30
