Tribological behaviour of microalloyed rail steels and conventional C-Mn in pure sliding condition

Journal:	Part F: Journal of Rail and Rapid Transit
Manuscript ID	JRRT-17-0128.R1
Manuscript Type:	Article
Date Submitted by the Author:	29-Dec-2017
Complete List of Authors:	Viesca, J; University of Oviedo, González-Cachón, Sergio; Universidad de Oviedo, Department of Construction and Manufacturing Engineering García, Alberto; Universidad de Oviedo, Department of Construction and Manufacturing Engineering González, Rubén; Universidad de Oviedo, Department of Marine Science and Technology Hernandez Battez, Antolin; University of Oviedo
Keywords:	wear, pin-on-disc, microalloyed steel, rail steels, fine pearlitic microstructure
Abstract:	This paper compares the tribological behaviour of microalloyed rail steel with conventional C-Mn rail steel under different test conditions (load, temperature and humidity). Pin-on-disc tribological tests were performed inside a climate chamber under different loads (20, 30 and 40 N), relative humidity (15, 55 and 70% RH) and temperatures (20 °C and 40 °C). After friction and wear tests, worn surfaces were analysed using both confocal and scanning elect

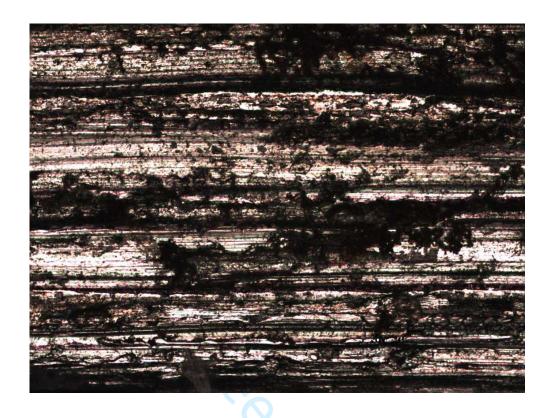
Fig. 9. R260-20 N steel pin worn surface, 200X.

Fig. 7 and Fig. 8 show the wear surfaces of the steel pins after tribological tests. The appearance of adhesion joints was observed on the wear surfaces of both tested steels. The adhesion joints are marked with a red circle, which had already been observed in the research carried out by Viáfara [29]. The increase in load leads to an increase in the severity of wear (more plastic deformation and formation of cracks on the surface). Adhesive wear was the wear mechanism observed in both cases, being more severe in the R260 steel. The results obtained demonstrate that the microalloyed steel has higher wear resistance than the R260 steel. Fig. 9 and Fig. 10 show the worn surfaces of the pins of the R260 and microalloyed steels at 20 N captured with optical microscope.
