3D patient imaging and retrieval analysis help understand the clinical importance of rotation in knee replacements

Purpose The purpose of the present study was to correlate highly accurate CT measurements of pre-revision total knee arthroplasty (TKA) implant position with findings of retrieval analysis post-revision, to understand the clinical relevance of TKA orientation.

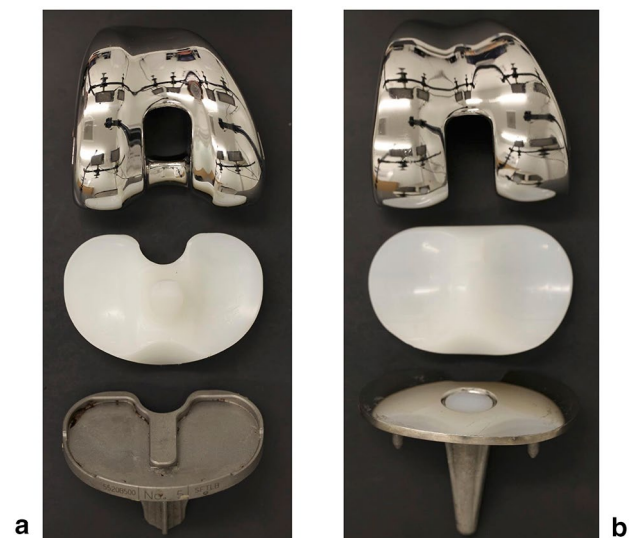
Fig. 1 Examples of contemporary retrieved knee implants. **a** Posterior stabilized (PS) TKA with fix bearing, **b** cruciate retaining (CR) TKA with rotating bearing

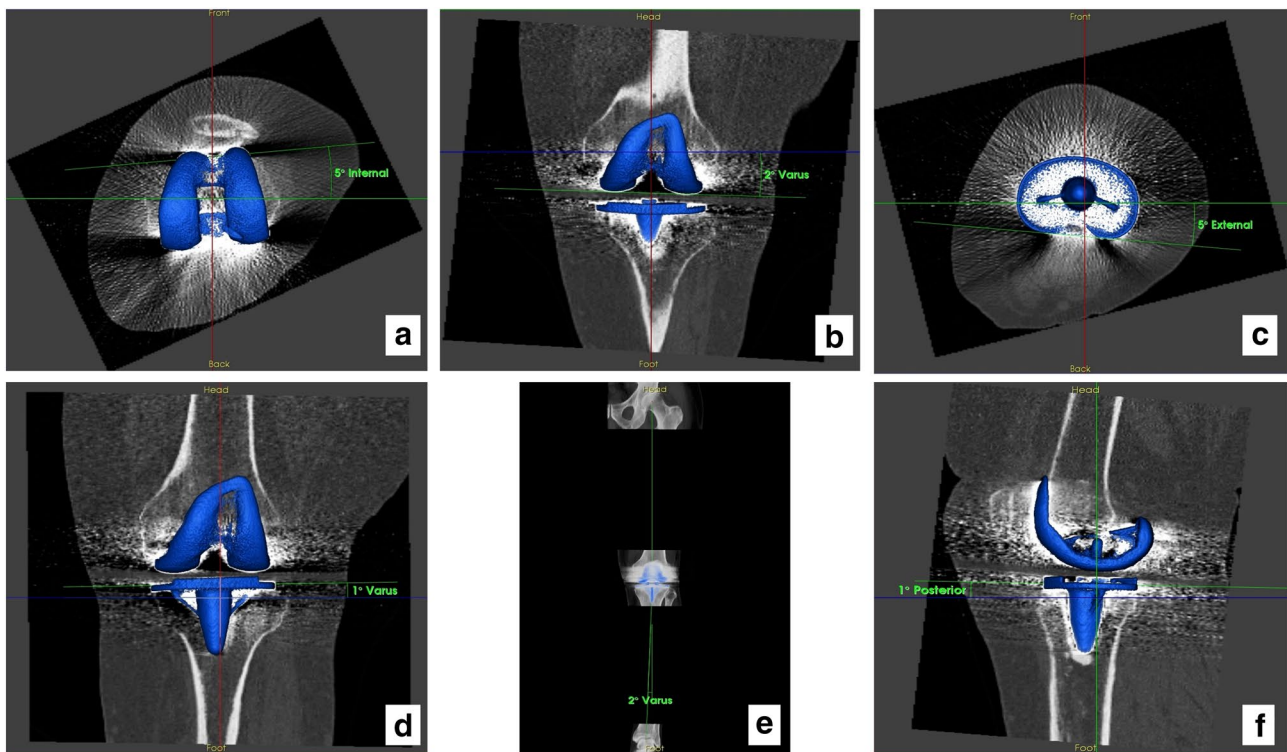
Fig. 2 A 3D CT image from a patient illustrating components' positions. **a** View from the transverse plane showing internal rotation of the femoral component; **b** view from the coronal plane showing varus angle on the femoral component; **c** view from the transverse plane

showing external rotation of the tibial component; **d** view from the coronal plane showing varus angle of the tibial component; **e** view from the transverse plane showing tibiofemoral angle; **f** view from the sagittal plane showing posterior slope of the tibial component

transverse plane of both the femoral and tibial components, with reference to the transepicondylar and anteroposterior axes, respectively, (2) the degree of varus/valgus of single components and the tibiofemoral angle in the coronal plane and (3) the tibial component slope in the sagittal plane, Fig. 2.

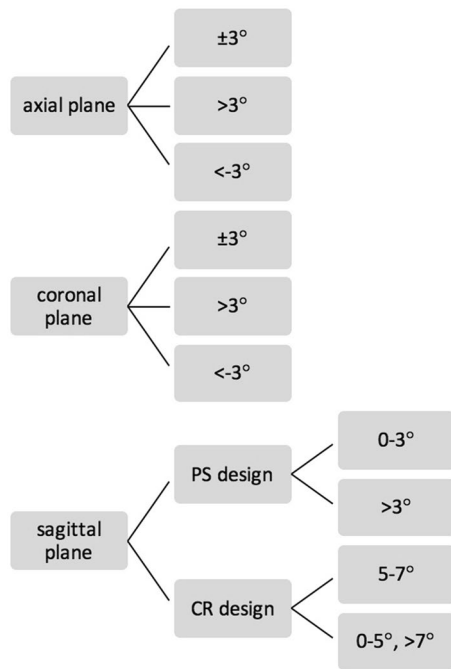
Fig. 3 Classification of the orientations in the three planes (axial, coronal and sagittal orientations)

The measured values were classified into three ranges (Fig. 3), in agreement with surgical standard aims [28, 29].

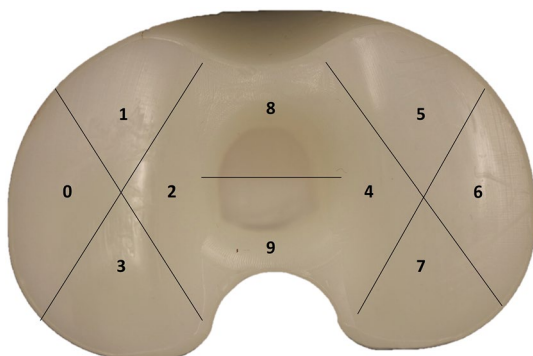
Fig. 4 Surface divisions on the articular surface of the tibial insert, showing 10 sections (from 0 to 9) defined by Hood [30]

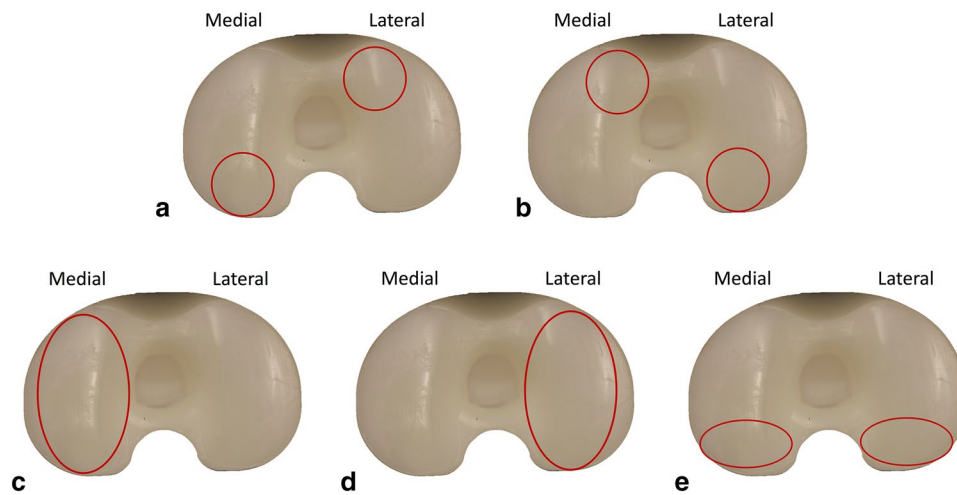
Fig. 5 Localisation of expected wear (on a right knee) according to implant orientations. **a** An internal relative rotational mismatch is expected to increase the damage on the posterior compartment in the medial side and on the anterior compartment in the lateral side; **b** an external relative rotational mismatch is expected to increase the damage on the posterior compartment in the lateral side and on the

anterior compartment in the medial side; **c** a varus tibiofemoral angle is expected to increase the damage on the medial compartment; **d** a valgus tibiofemoral angle is expected to increase the damage on the lateral compartment; **e** posterior slope is expected to decrease the damage on posterior compartments

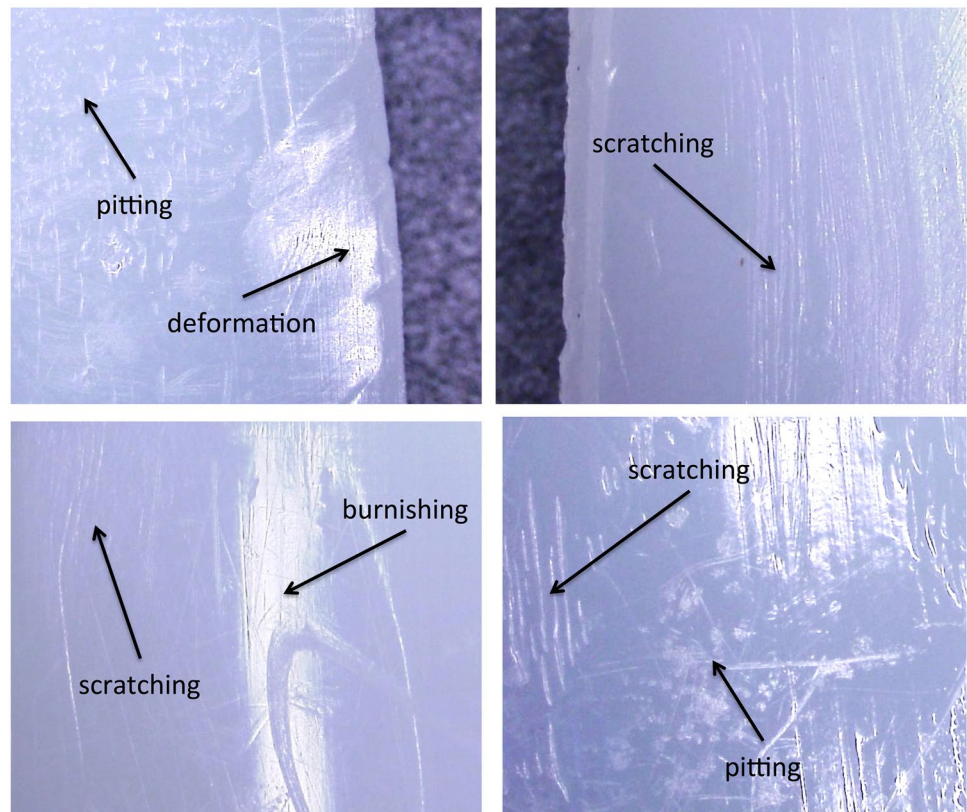
Fig. 6 Different modes of surface degradation found on both the articular and backside polyethylene surfaces, including scratching, pitting, burnishing and deformation, at magnification 20X

The most common modes of surface degradation were scratching, pitting and burnishing, whilst deformation and delamination were rare (Fig. 6). The median total Hood score (range) was 39 (17–72). There was no significant difference ($p = 0.5459$) between lateral and medial compartments (defined by the sum of 0–3 and 4–7 sections, respectively, in a right tibial insert; viceversa in a left tibial

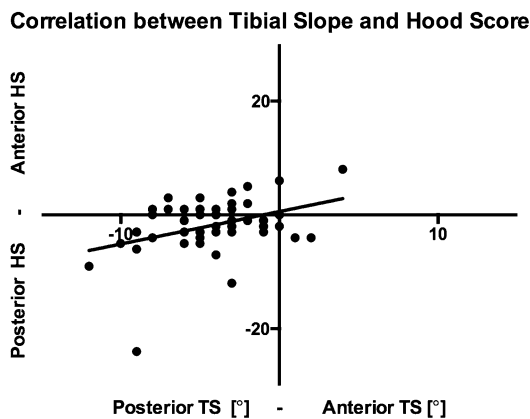
Fig. 7 Graph showing the correlation between tibial slope and Hood score. Posterior tibial slope is associated to higher Hood scores in the anterior side of the polyethylene, whilst anterior tibial slope is associated to higher Hood scores in the posterior side of the polyethylene

There was a significant correlation between tibial slope and damage score on polyethylene tibial inserts: posterior tibial slope was associated with higher Hood scores on the anterior areas of the polyethylene, Fig. 7. Table 6 shows further data.

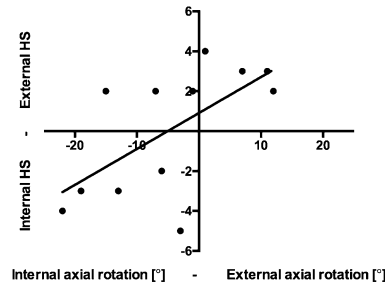
Correlation between Relative Rotational Mismatch and Hood Score in implants revised for malposition

Fig. 8 Graph showing the correlation between relative rotational mismatch and Hood score in implants revised for malposition. Internal relative mismatches are associated to higher Hood scores on the posterior compartment in the medial side and on the anterior compartment in the lateral side, while external ones were associated with higher Hood scores on the posterior compartment in the lateral side and on the anterior compartment in the medial side

Separate analyses of the group revised for malposition revealed a significant correlation between implants’ position in the axial plane and damage score on polyethylene tibial inserts, Fig. 8: internal rotation mismatch was associated with higher Hood scores on the posterior compartment in the medial side and on the anterior compartment in the lateral side, while external ones were associated with higher Hood scores on the posterior compartment in the lateral side and on the anterior compartment in the medial side

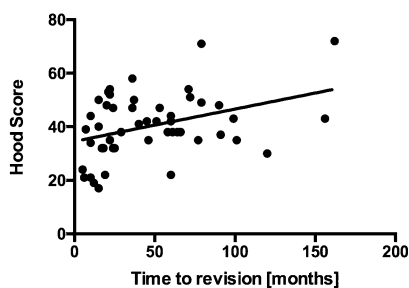
Correlation between Time to revision and Hood Score

**Fig. 9** Graph showing the correlation between time to revision and hood score. Retrieval implanted for longer period show higher total Hood scores

There was a significant correlation between time to revision and total Hood score, Fig. 9.
