Seismic behavior of 1960's RC buildings exposed to marine environment

David Bru, Antonio González, F. Javier Baeza, Salvador Ivorra

Keywords: Seismic loads; plastic hinge; vulnerability; RC building corrosion; marine environment

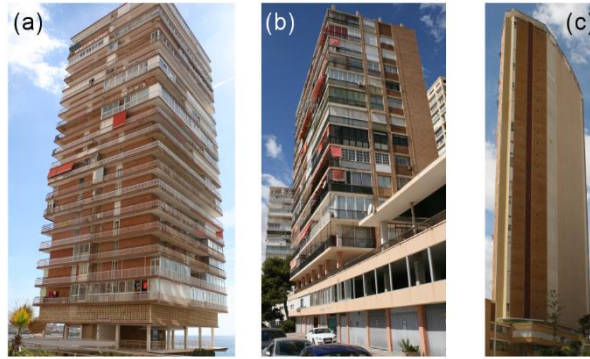
Figure 3. Typical apartment buildings in Alicante. (a) Adoc Tower 10, (b) Adoc Tower 7 and (c) Vistamar tower,

Figure 3 includes different examples of the typical 1960-70's buildings in the East coast of Spain. In general, they can be classified in two different types, depending on the

A real building of fifteen floors (Figure 3b) has been selected as an example of these constructions, and has been used to illustrate the proposed methodology. The general structural scheme of *Adoc Tower 7* is presented in Figure 4. The plan presents structural symmetry with seven parallel frames with spans between 3.30 and 4.30 m. The total frame length is 3.65 m and the height of columns is 2.60 m. Table 1 summarizes the main characteristics of the cross sections of beams (BS), columns (CS) and walls (WS). Mechanical characteristics of each section have been calculated assuming 15 MPa concrete and plain steel bars with 400 MPa yielding stress. Main frames are composed by 50x20 cm² flat beams, connected by 15x20 cm² perimeter beams, and unidirectional slabs (with secondary beams each 80 cm). In order to account for the effect of the concrete slabs in the global structural model, the recommendations of Calavera [19] and Darwell & Allen [20] have been considered. Thus, an equivalent virtual 30x20 cm² secondary beam was defined directly connecting columns on consecutive frames. Columns have a constant 30x40 cm² cross section up to the eighth floor (23.4 m) and progressively decreases upwards until 25x25 cm² at the top floor (41.6 m). The only

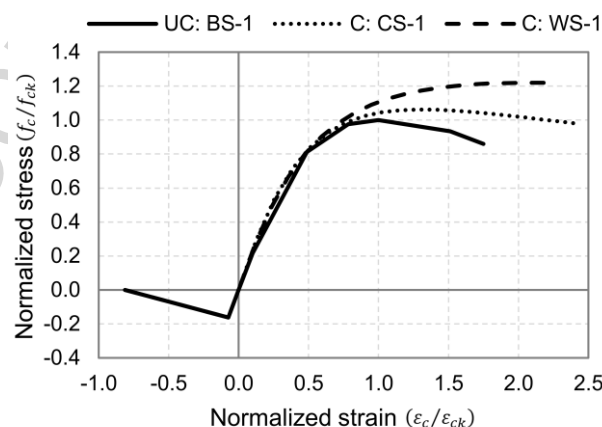
Figure 5. Examples of normalized confined (C) and unconfined (UC) stress-strain curves for different cross sections as defined in Table 1. Both magnitudes are divided by characteristic values of unconfined concrete.

according to its confinement level. Figure 5 includes different stress-strain curves for unconfined (UC) and confined sections (C), as defined in Table 1, all values have been normalized with respect to the characteristic strength and strain values of UC concrete. UC sections assumed a parabolic curve according to EC-2 [37] indications, in which the compressive strength f_{ck} was equal to 15 MPa for a compressive strain $\varepsilon_{ck} = 2\text{‰}$. The elastic modulus considered in the first phase was 16.18 GPa, and the ultimate strain was 3.5‰ (i.e. a normalized 1.75 strain) for a compressive strength of 13 MPa. Tensile strength was 2.39 MPa with an ultimate tensile strain equal to 1.6‰. On the other hand, confined concrete (C), was evaluated according to the formulation proposed by Mander [38]. Figure 5 includes two different confined sections, CS-1 and WS-1 (Table 1), both of which showed improvements of compressive strength and ultimate strain. For example WS-1 section presented $1.2f_{ck}$ and $\varepsilon_{cu} = 2.25\varepsilon_{ck}$, because of the effect of the transverse rebars (parallel to the 30 cm side) that prevent the buckling of the longitudinal compressed rebars. Finally, all steel rebars were modelled as an elastoplastic material with 200 GPa elastic modulus, 411 MPa yielding stress, and 10‰ ultimate strain.

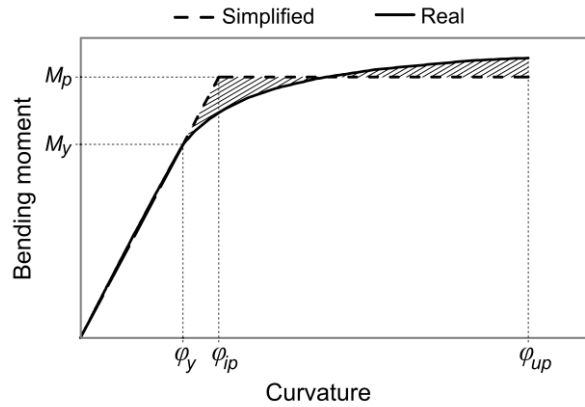
Figure 7. Moment curvature curve for RC sections.

Different moment-curvature diagrams were defined to consider axial-bending hinges in columns, and only bending hinges in beams. For this reason, the interaction diagram (axial-bending) and the moment-curvature diagram of each cross section was calculated for different axial loads, based on force equilibrium (axial and bending forces). Figure 7 includes an example of the monotonic backbone curve used in this research, in which φ_y and φ_{up} are the elastic and ultimate plastic curvatures respectively. Also, a simplified bilinear function, according to Caltrans standard [42], is included, where φ_{ip} is the equivalent plastic curvature. In particular, the $M - \varphi$ behavior has been modelled as the bilinear function in Figure 7, in which a final negative slope step (30% of elastic stiffness) was used to improve the convergence of the numerical models after $M_p - \varphi_{up}$ [43]. However, to control the global behavior of the plastic hinge in case of brittle

behavior, and in order to avoid the unreal behavior of the plastic hinge rotation, the maximum reduction of the bending moment was fixed at $0.2M_p$.

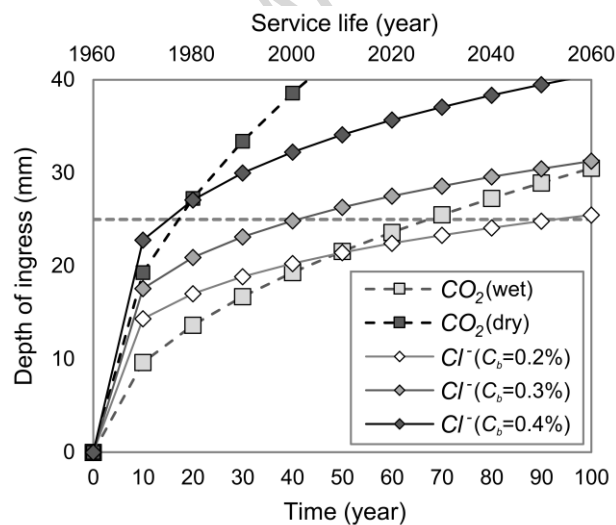
Figure 8. Time of penetration for initial corrosion phase

First, the effect of corrosion on the mechanical properties loss of RC sections was evaluated. Figure 8 includes the time evolution of aggressive agents' penetration in concrete cover for different exposure conditions, according to EHE-08 [27]. Two different CO_2 scenarios (exposure condition type IIa) and three chloride initial contents C_b (exposure condition type IIIa) have been modeled. Also a 25 mm concrete cover has been represented, as the usual value for these coastal buildings in 1960's [44], [45]. The worst-case scenarios for each corrosion type were dry CO_2 and a 0.4% Cl^- content, which presented initiation times of 17 (CO_2) and 15 (Cl^-) years. If chloride concentrations were lower, this time interval would be increased up to 41 years or more.

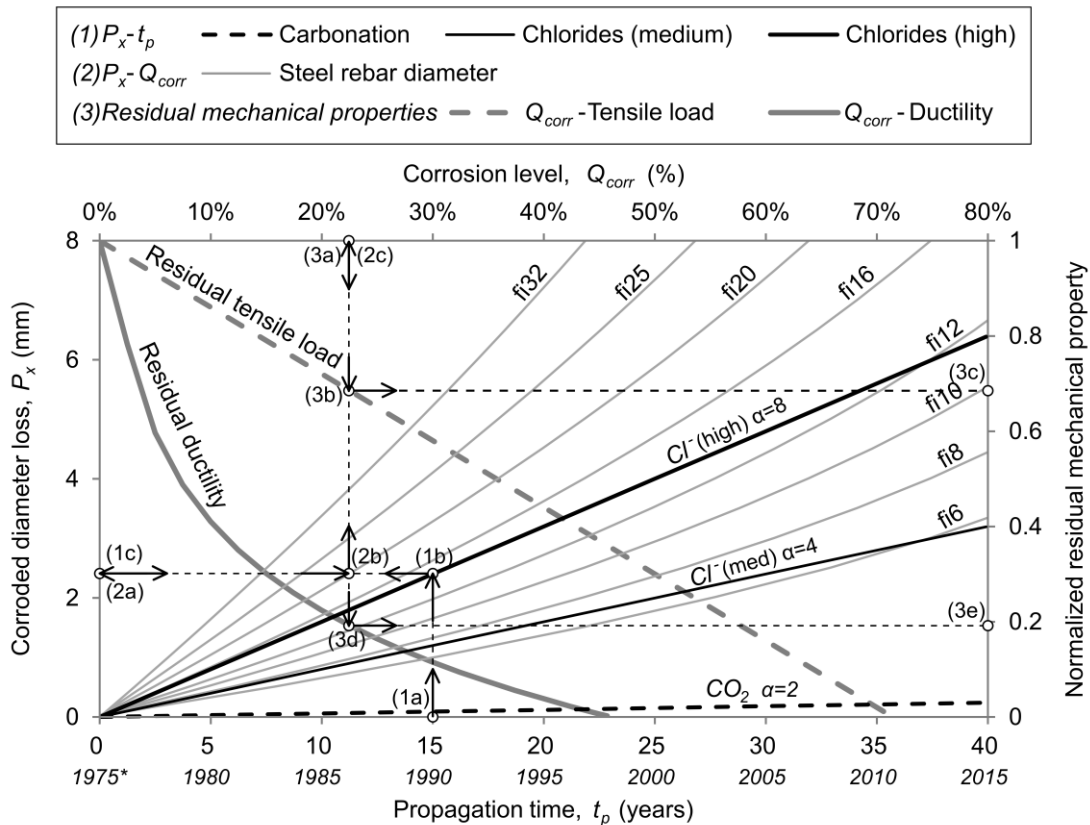
- (I) Diameter loss vs propagation time
- (1a) Determine the propagation time t_p
 (1b) Select the corrosion type:
 --- CO_2 $\alpha=2$ — Cl^- $\alpha=4$ — Cl^- $\alpha=8$
 (1c) Obtain the diameter loss P_x
- (II) Corrosion level vs diameter loss
- (2a) For the obtained P_x
 (2b) select the steel rebar diameter:
 — rebar diameter in mm
 (2c) Obtain the corrosion level Q_{corr}
- (III) Mechanical loss vs corrosion level
- (3a) For the obtained Q_{corr}
 (3b/3d) select the mechanical property: --- Tensile load (3b)
 — Ductility (3d)
 (3c/3e) Obtain the normalized residual values for (3c) ultimate load, (3e) ductility.

Figure 9. Evolution of the mechanical properties of reinforced steel rebars with the level of corrosion (* propagation time for the analyzed building, considering a 15-year initiation time since construction in 1960).

Once the propagation phase has begun, the diameter loss can be assessed applying the expressions in Eq. (6) to (10), included in section 2. Figure 9 summarizes the corrosion evolution in different conditions, i.e. carbonation ($V_{corr} = 3 \mu m/year$, $I_{corr} = 0.258 \mu A/cm^2$), and chloride corrosion ($V_{corr} = 20 \mu m/year$, $I_{corr} = 1.724 \mu A/cm^2$). Besides different penetration factors were assumed, e.g. $\alpha=2$ for carbonation attacks,

$\alpha=4$ for medium exposure chloride attacks (partially protected elements), and $\alpha=8$ for structural elements highly exposed to marine environment (columns and beams in open balconies). The loss of diameter in carbonation-damaged rebars would be negligible considering the time intervals in this research. On the other hand, the structural elements exposed to medium or high Cl^- contents ($C_b = 0.3$ or $C_b = 0.4$) would have suffered 15 years (1a in Figure 9) or 40 years of corrosion, according to the results presented in Figure 8. Therefore, an effective diameter loss of 6.4 mm and 2.4 mm, (1c) in Figure 9, would have been produced respectively.

After, the section loss can be related to the corrosion level Q_{corr} depending on the actual steel diameter. As an example, point 2a in Figure 9 represents a 2.4 mm loss, which in a 20 mm rebar (2b), will correspond to a 23% Q_{corr} (2c). Finally, the normalized residual strength and ductility are presented versus the corresponding corrosion level. Once the corroded section has been determined, Eq. (6) in section 3.1, the level of corrosion Q_{corr} (3a) can be related to the ultimate tensile load F_u (3b) and strain ε_u (3d) of the corroded section according to Eq. (9) [7] and Eq. (10) [31], respectively. Both expressions only depend on the corrosion level Q_{corr} and the undamaged values F_{u0} and ε_{u0} . Hence, the 6.4 and 2.4 mm diameter loss obtained above would correspond to corrosion levels of 54 and 23%, whose corroded mechanical parameters would be $F_{u,Q=54\%} = 0.25 F_{u0}$, $\varepsilon_{u,Q=54\%} = 0.0 \varepsilon_{u0} \geq \varepsilon_y^*$ (hence there wasn't any plastic strain, and brittle failure would occur for effective yield strain ε_y^*) and $F_{u,Q=23\%} = 0.69 F_{u0}$, $\varepsilon_{u,Q=23\%} = 0.19 \varepsilon_{u0}$ (3c and 3e in Figure 9). These damaged mechanical properties, because of corrosion, can be observed in Figure 9 as a decrease in the mechanical capacity of rebars, and especially in the ductility of steel, as shown in [8]. The decrease of ε_u is important in seismic areas, in which the steel plastic deformation is limited to 10‰ to guarantee the design code conditions for ductile behavior of concrete sections. Therefore, the ductility reduction will be especially critical for a 33% level of corrosion, as the loss of global ductility would be 91.7%.

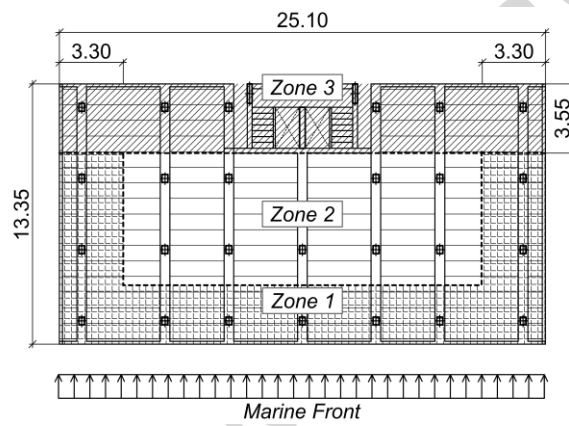
Figure 10. Areas of exposure considered for the structural analysis depending on the corrosion level.

All structural elements were classified into three different areas of exposure for the seismic analyses, considering the aforementioned constructive characteristics of the studied buildings, whose mechanical properties were modified based on the curves included in Figure 9. This marine exposure distribution of the structural elements is represented in Figure 10, in which outer elements were considered in IIIa conditions

(zone 1 with $\alpha=8$, and zone 3 with $\alpha=4$), while inner elements were assumed as IIa ambient ($\alpha=2$). Table 4 summarizes the mechanical properties reduction (as the ratio with respect the original value in Table 1) for each section affected by corrosion. These values were used in the seismic evaluation of the presented structural typology (residential tall buildings of 1960's), whose mechanical properties have been decreased by corrosion since 1975, and its seismic structural capacity could have been compromised.

On the other hand, zoning defined in Figure 10 should be considered to evaluate the corrosion effect in local ductility capacity. Zone 2 has been considered as non-corrosion affected area after the analysis presented in section 3.1. Regarding Zone 1, all elements showed a high level of corrosion and therefore, a high level of reduction coefficient for ductility and strength was applied, and then, brittle behavior was considered (i.e. without ductility), Table 4. In particular, bending strength was reduced between 75% and 90% for beams, and between 65% and 55% for columns, and ductility was equal to 1 for all affected elements, Figure 16. As a summary, localized corrosion due to high chloride attack (zone 1) decreased the bending strength of all exposed structural elements. Besides, plastic hinges were also affected and ductility was reduced. Hence the structural collapse, under seismic accelerations, occurred earlier than in the original model without corroded RC sections.

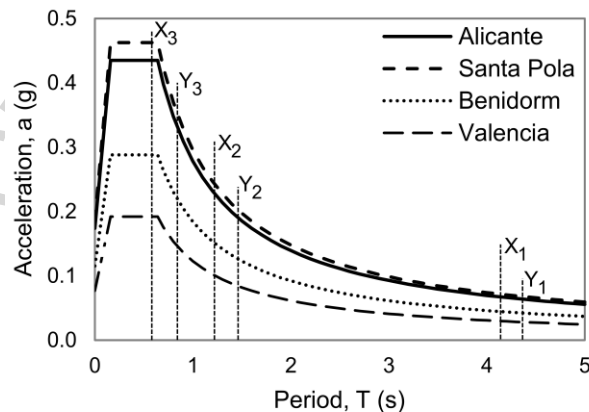
Figure 11. Elastic response spectrum for touristic urban areas in Spanish Mediterranean Coast, according to Spanish Seismic Code NCSE-02 [1].

Figure 11 includes four response spectra corresponding to different coastal cities (assuming identical geotechnical conditions), in which the aforementioned structural typology was widely used in the 1960's. Moreover, the periods corresponding to the main bending modes, either in x and y directions, are represented in Figure 11. Table 5 summarizes the results of the modal analysis, i.e. the calculated elastic fundamental periods, and the elastic demands for the RC frame model. According to different standards [18], [17], [16], and due to the regular modal behavior in both directions, only the direction of the principal frames has been used in this research, corresponding to the modes included in Figure 12. The modal analysis considered only the elastic properties of the structural model, therefore there wasn't any difference between the undamaged and corroded structures. Hence, it is worth noting that the corrosion effect only affects the nonlinear behavior of the structure.

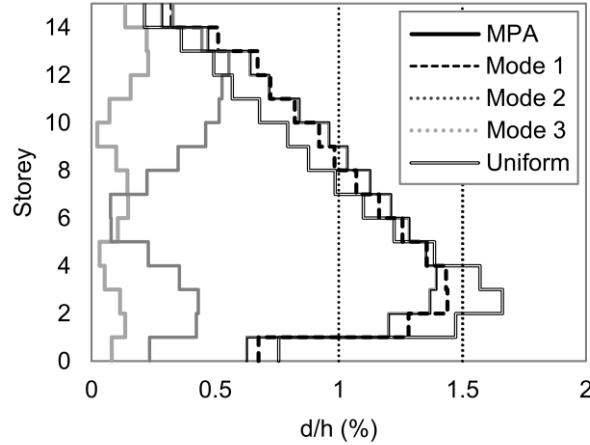
Figure 15. Relative drift distribution for seismic evaluation.

Figure 15 includes the relative drift variation along the height of the building for each load shape. The drift of the corroded structure could not be assessed because the performance point was not reached for all load distributions (first mode and uniform pattern). Hence, the structural safety of the building could not be assured for the assumed corrosion damage. On the other hand, the models (MPA and uniform loading) of the undamaged structure also presented some problems to accomplish the limit values of standards for the stories below the ninth floor, and especially under the fourth. Nonetheless, these limitations refer to nonstructural elements, thus no collapse problems have been detected for this building.

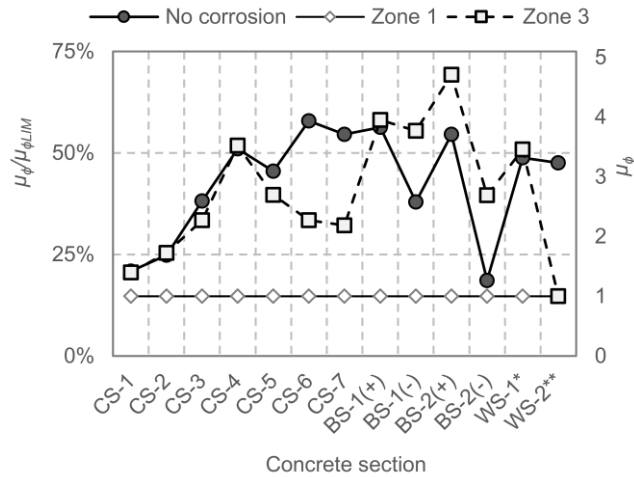
Figure 16. Local ductility evaluation for concrete sections, considering medium ductility class (EC-8).

Eq. (12) is valid for buildings with the first bending frequency in the constant velocity part of the elastic response spectrum, and it is very useful to evaluate the nonlinear capacity of RC sections and to compare the ductility and the rotation capacity of concrete hinges. Figure 16 includes the local ductility μ_ϕ and the evaluation criteria $\mu_\phi/\mu_{\phi LIM}$, for the main concrete sections with and without the effect of corrosion. First, the undamaged sections of the columns up to the sixth floor (CS-1 and CS-2) presented ductility values lower than 25% of the minimum value for medium ductility

level, according to EC-8 [16]. Higher floors showed better ductility due to the reduction of the axial load, but in any case was enough to reach the minimum value for medium ductility class, 6.8. These results were expected according to the design rules during 1960's. Regarding the ductility capacity of non-corroded beams, an approximately constant value equal to 57% for positive bending, BS-1(+) and BS-2(+), was obtained, Figure 15. However, for negative bending, BS-1(-) and BS-2(-), the ductility capacity was significantly reduced, especially for section BS-2, due to the high level of steel rebars, the small depth of concrete section and the insufficient level of lateral confinement (which could have improved the concrete compressive strength). Finally, shear walls showed a 50% approximately value similar to positive bending value for beams.

This limitation value predicts a similar behavior compared to the results of the numerical models. In particular, if the local ductility demand is compared with the global ductility capacity of the building, it can be seen that the relationship between collapse and plastic roof displacement was 1.51 and 1.6 for mode 1 and uniform load patterns, respectively. These values were slightly lower than the global ductility factor recommended in the Spanish standard for low ductility structures, which is equal to 2. Therefore, the non-corroded numerical model showed a similar ductility behavior for mode 1 and uniform load patterns, in comparison with European and Spanish standards.
