# Safety assessment of historic timber structural elements

## Abstract

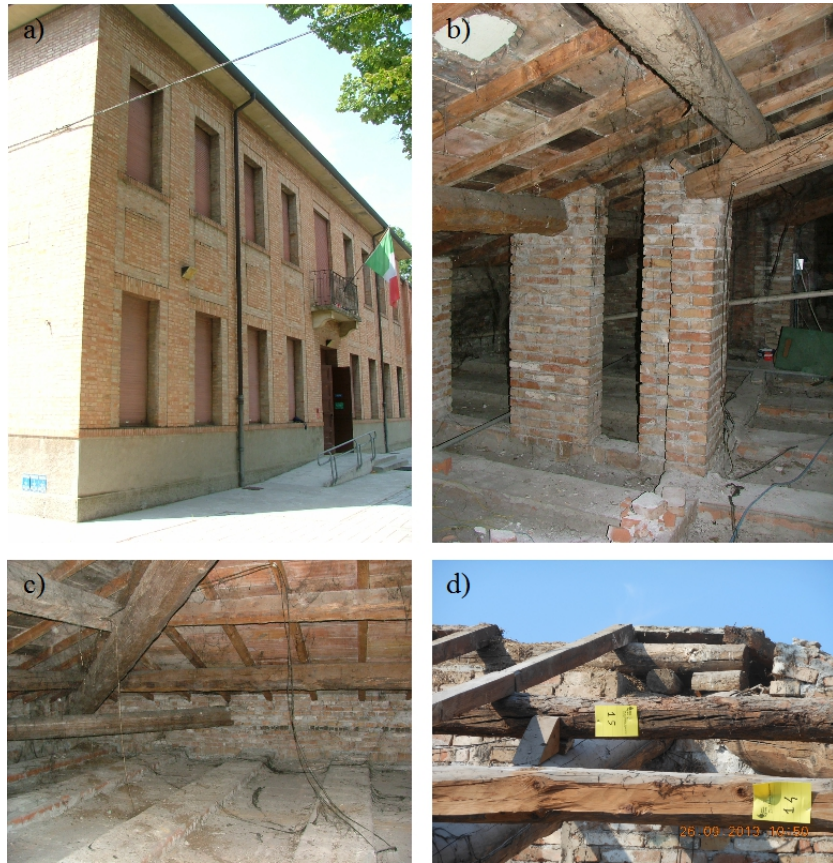
Figure 1: Some images concerning a building damaged by the Emilia Romagna earthquake of May 2012: a) An image of the building, b)-d) images of the timber roof elements.

101 The test material derives from fifteen fir tree timber joists that were re-  
 102 covered from some buildings of the first half of the 20<sup>th</sup> century, damaged  
 103 by the Emilia Romagna earthquake of May 2012 (see Fig. 1). These joists  
 104 constituted the secondary warp of roof. Full-size joists were used for bend-  
 105 ing tests, from the undamaged rests the samples for compression tests were  
 106 sawn<sup>1</sup>.

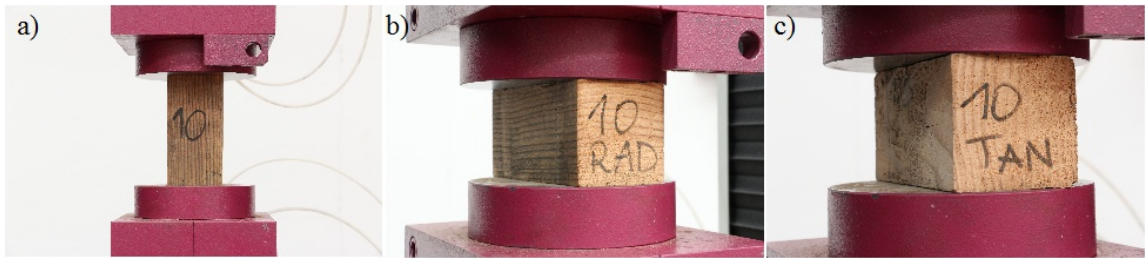
Figure 4: A timber sample under compression test (before the test). a) Longitudinal compression. b) Radial compression. c) Tangential compression.

121 Even though the Standards require samples of specific dimensions for each  
122 type of compressional test it was decided to use samples of the same dimen-  
123 sions (80x80x160 mm) for all tests, essentially because they were extracted  
124 from the rests of the already broken joists and so there was not enough tim-  
125 ber to obtain longer ones. However this limitation on dimensions of samples  
126 length was established warranting the proportion between base and height  
127 and at the same time avoiding any stability problems during the longitudi-  
128 nal compression test. The three types of compression tests configuration are  
129 represented in Fig. 4.

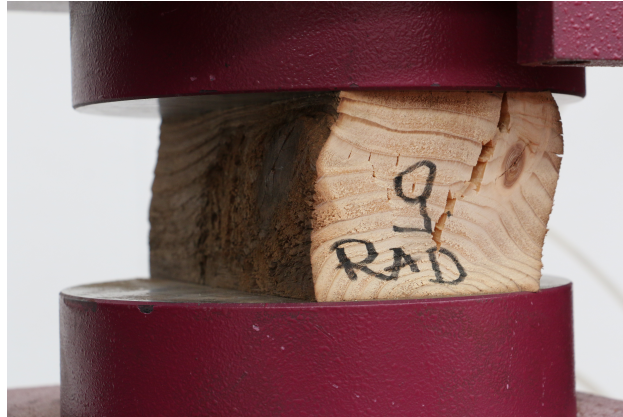
Figure 7: A sample under radial compression.

157 A sample under radial compression is shown in Fig.7. In this situation,  
158 the accentuate vertical shift is combined with a strong lateral expansion that  
159 caused the expulsion of the softer material. Note also that, for the sample  
160 at hand, a strong fracture started close to the knot.
