Understanding Complexities in Overland Flood Behaviour in Coastal Urbanised Catchment using 2D Hydraulic Models

Gurmeet Singh*, Dr Amit Chanan*, Jaya Kandasamy#

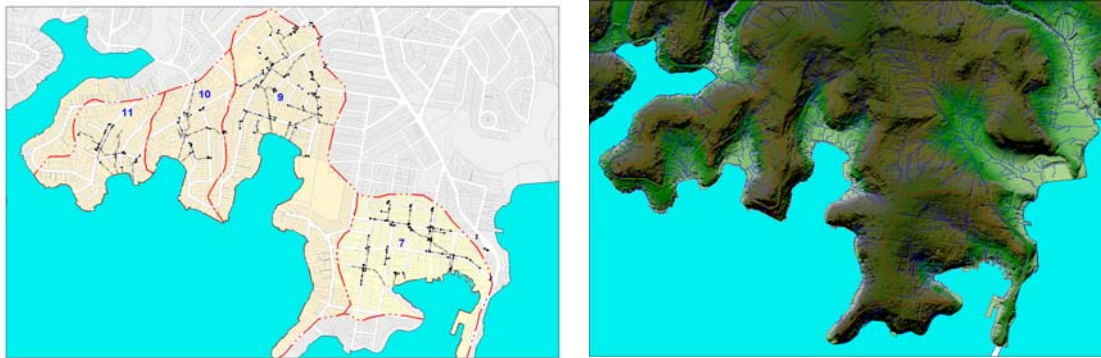
Figure 2 Drainage System (left) and Digital Elevation Map (right) showing naturalised streams

The catchments are a typical “old” urban catchment with an extensive stormwater pipe drainage network (See Figure 2). The majority of the drainage runs under roads and properties within the catchment. The drainage system of this catchment has been built over with pipes constructed to carry flows for all major storm events.

The drainage system was laid in the early 1930s. The overland flow paths generally follow the natural watercourses that were classified as drainage reserves or easements. The digitally synthesised naturalised stream network (Figure 2) provides a good snapshot of the natural drainage in the area and where the major drainage paths follow the terrain. These were the paths that were formal drainage easements to convey the overland flows in the catchment. The flooding generally occurs at sag points on the road when the road drainage capacity is exceeded and overland flows enters properties/or there is restriction or blockage in conveyance of flows on designated overland flow paths.

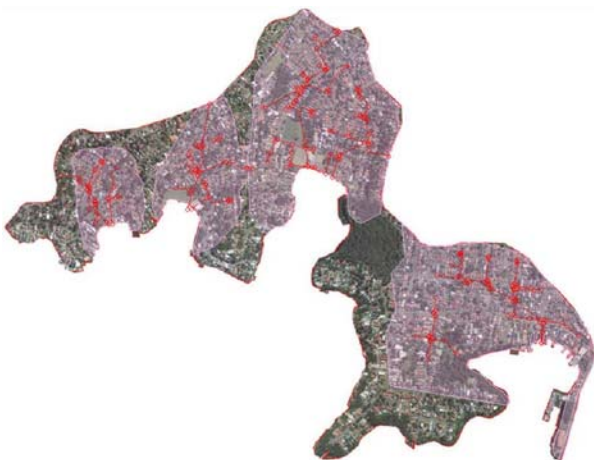
Modelling was carried in-house using stormwater modelling program XP-Storm developed by XP-Software, Australia (XP-Storm, 2008). XP-Storm is a link-node model that performs hydrology and hydraulics of stormwater drainage systems including automatic pipe design for the entire system or just a portion of the network. The 2D modelling add-on in XP-Storm utilizes the TUFLOW program developed by WBM Oceanics Australia and The University of Queensland (Syme W.J., 2001).

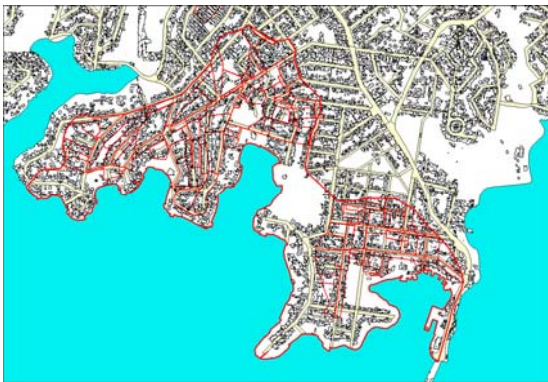
2D roughness parameters were derived using combination of landuse maps, building polygons, roads and fences and other built up areas. Building polygons together with road polygons were used to derive base map of impervious areas in the catchment. The maps were used for historical level of development for calibration/validation and ultimate level of development for design flood events. The ground and non-ground data was used to derive the roughness for the 2D models. The tailwater levels were based on ocean water levels for the recorded 1975 flood event and recommended levels for the design flood events.

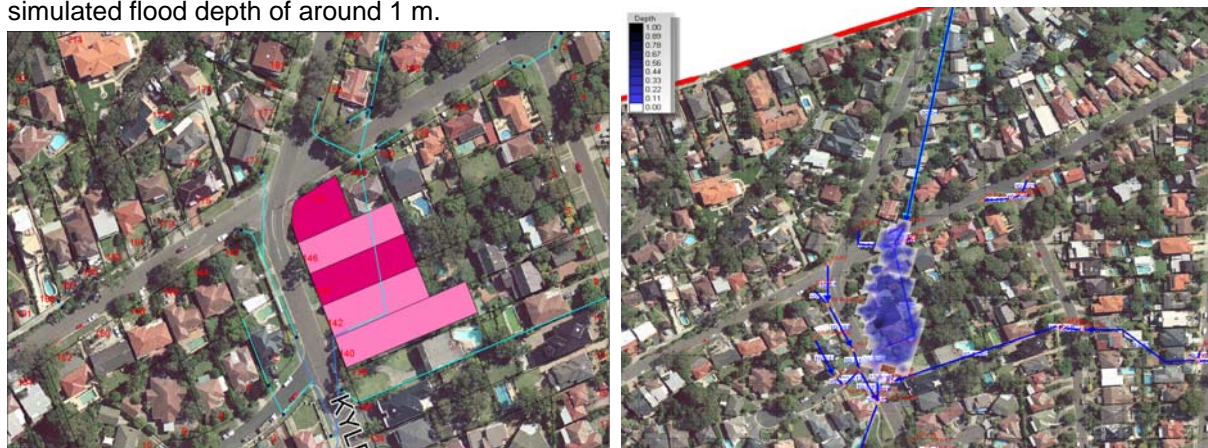
Figure 5 Recorded 1975 Flooding of properties (left) and Simulated 1975 Flood Event (right)

There is no flow gauging data available in the catchment to verify the historical flood events. However for the historical March 1975 flood event Council recorded flood marks and levels for varied properties affected by overland flooding compiled in a report. The adopted approach for calibration and verification was to simulate flood levels at the worst flooded area in the catchment (i.e. March 1975 storm event). This area is around the intersection of Kyle Parade and Terry Street. The flood levels of around 3 feet (0.9m) were reported in the garage of properties in Kyle Parade (see Figure 5). Overland flooding was also reported at all other properties (the worst flooded are in light red and minor flooding in pink). The calibrated hydraulic 2D model results mimics closely observed flooding in the area with a simulated flood depth of around 1 m.
