Materials and technologies in Art Nouveau architecture: Façade decoration cases in Italy, Portugal and Poland for a consistent restoration

F. Sandrolini^(*), E. Franzoni^(*), H. Varum^(**), R. Nakonieczny^(***)

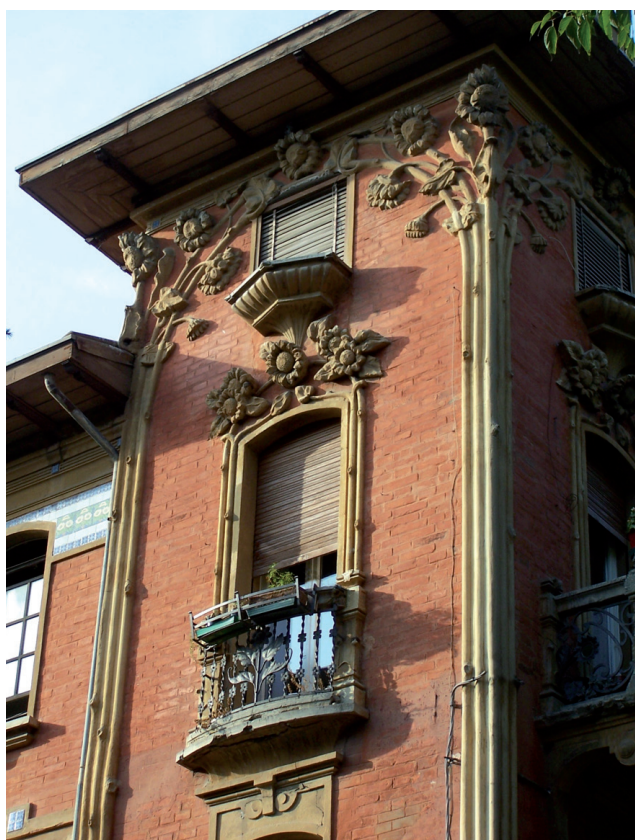
1. Cement-based façade decorations in the Girasoli [Sunflower] House in Bologna, Italy (Paolo Sironi, 1905).

Church in Bologna by Edoardo Collamarini (early years of '900 and 1901-1912 respectively) (8); the *Girasoli* (Sunflower) House in Bologna by Paolo Sironi (1905) (Figure 1); the *San Donnino* House in Modena by Ferdinando Masserotti Bevenuti (1910-11) (Figure 2); and some residential buildings in the towns of Messina and Reggio Calabria,

In the investigated case-studies, the *Art Nouveau* movement was interpreted in very different ways in terms of architectural style as well as building materials and technologies. In Italy the ornaments were mainly made of modern materials, i. e. cement-based mortar and concrete (Figure 1-2), purposely designed to resemble natural stone. Cement binder was used to manufacture 'artificial stones', which could be reproduced by means of moulds in many exemplars, with great time and money saving. The so obtained agglomerated cement-bound stones could be produced in a large variety of colours and textures, depending on the formulation and manufacturing and laying technology: e. g. the use of coloured aggregates and/or pigments for a final granite effect, the employ of coarse common salt spread on the frameworks to reproduce (after hardening and washing) the travertine surface effect.

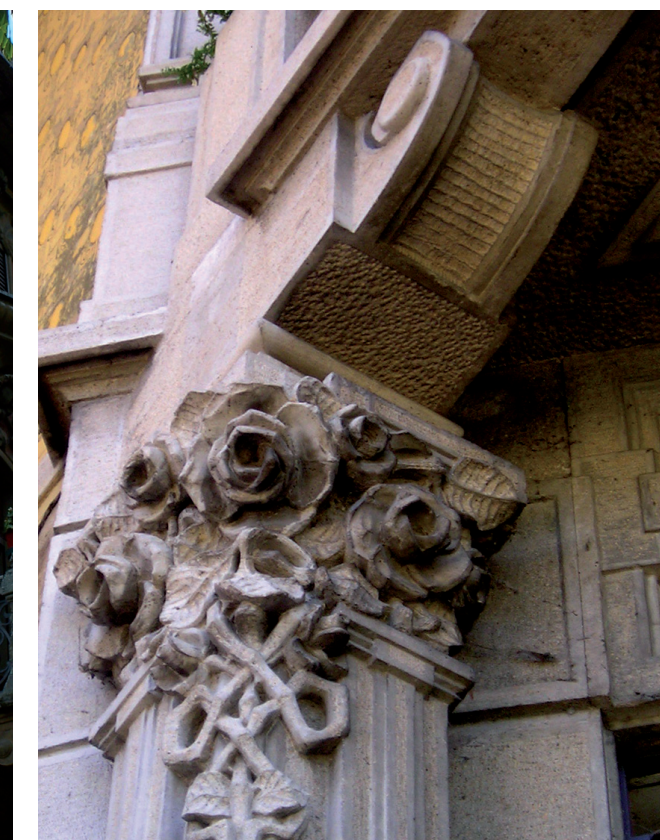
2. Cement-based particular at the entrance of Villa San Donnino in Modena, Italy (Ferdinando Maserotti Bevenuti, 1910-11).

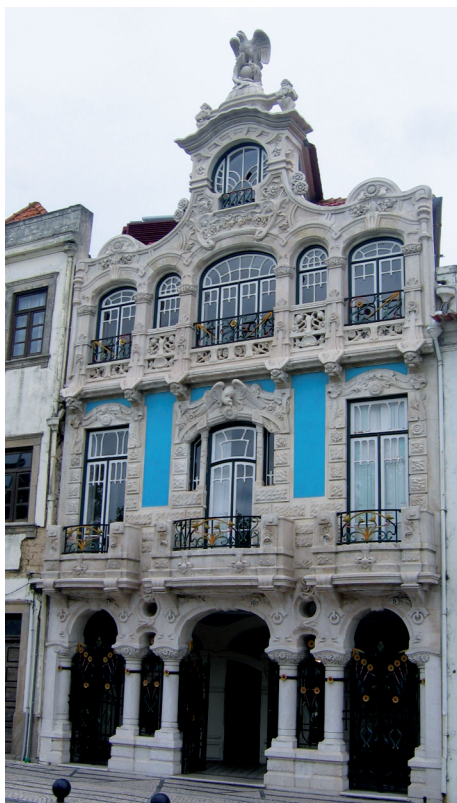
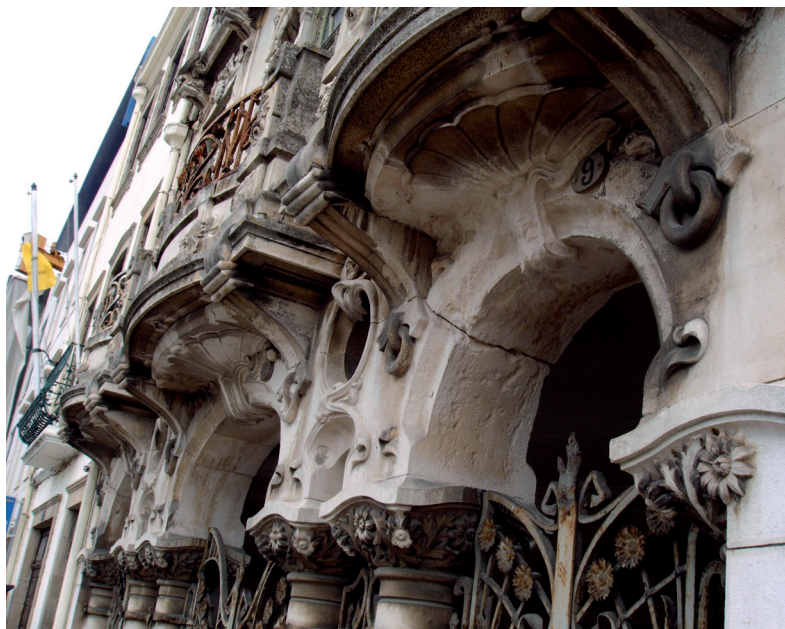
3. Natural stone decorations at the Casa Major Pessoa in Aveiro, Portugal (Francisco Silva Rocha and Ernesto Korrodi, 1907-1909): a) façade; b) detail previously to the restoration works.

In Portugal the scenario was quite different, as the *Art Nouveau* decorations were mainly realized with traditional materials: hand-carved stone (Figure 3), lime plaster mortars (sometimes reinforced with vegetable fibres, as in the example in Figure 7) and gypsum plaster. Even the ceramic tiles, characterized by typical *Art Nouveau* figures, were manufactured with the ancient technology of *azulejos* (14), simply adapting the decoration motifs to the new fashion. All the loads-bearing structural walls were built mainly with *adobe* bricks, but in some particular locations with fired clay bricks or wood (traditional *tabique*, a wood structural wall coated by thick plaster layers). In fact, as the majority of the constructions of that period in Aveiro region, the main structural system of the *Art Nouveaux* constructions used local building materials and traditional construction techniques, namely *adobe* structural walls and timber systems for floors and roofs. In Aveiro, *adobes* were made as a mixture of a sandy earth and lime (4:1), dried in the sun.

The structure of Casa Major Pessoa was basically defined as described in the following (8): i) *adobe* bearing-load walls (perpendicular to the façades); ii) heavy limestone blocks in the façade, laboriously hand-carved, supported in some particular points by slender stone columns (Figure 3); iii) timber trusses in the roof; iv) timber beams in the floor, bearing directly on the *adobe* walls.

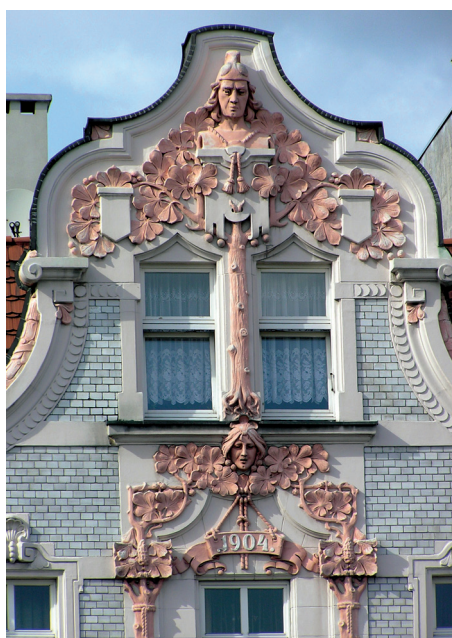
4

4. Cement-based façade decorations in a residential building in Maja St. in Katowice, Poland.

Steel was used for stairs/window rails and for gates, according to the current *arte nova* taste. In Poland the façade decorations were made mainly of cement-based mortars/concrete (Figure 4), while natural stone was only occasionally used, essentially for statues embellishing the external walls. The mortar/concrete decorations were mostly manufactured and cured outside the building site (by small in-series productions) and simply placed during the construction, but in some cases cast-in-place ornamental particulars were detected too.

The cement-based decorations were inserted either in plastered façades or in unplastered brick walls, usually trying to achieve a colour and/or texture contrast between the decorations and the background (Figure 4). The decorations were often colour-painted, hence their purpose was not a simple imitation of stone, as frequently detected in Italy.

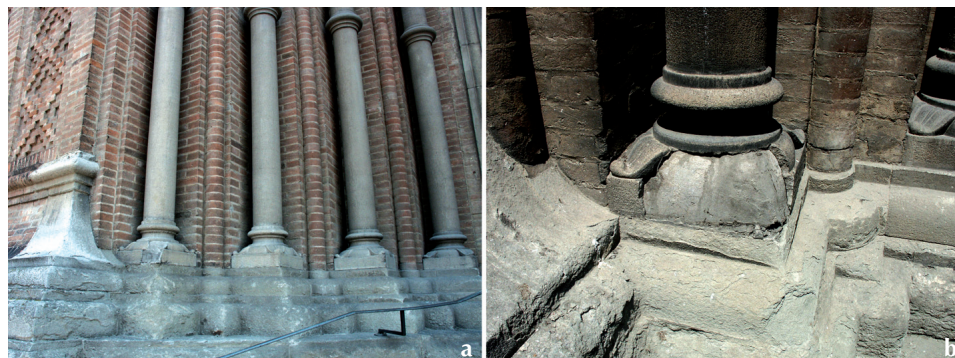
5. a) Precast concrete columns on a weak sandstone base in the Sacro Cuore Church in Bologna, Italy (Edoardo Collamarini, 1912); b) a detail of a column where the external cement-based mortar layer detached and the concrete core can be observed (right).

Sometimes the mixed use of traditional and new materials reveals a poor knowledge of the latter ones and/or a scarce confidence in them: e. g. in the *Sacro Cuore* church in Bologna a local weak and porous sandstone was used as basis for precast concrete columns.

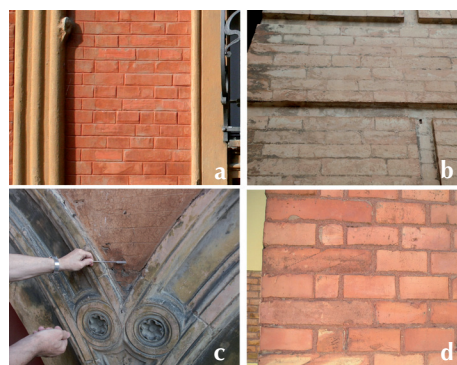
6. a) Scratched cement-based plaster imitating sagramatura in the Girasoli House; b) sagramatura finishing in the parish church at Baggiovara, Italy; c) scratched lime-based plaster in the XV cent. Isolani Palace in Bologna, Italy; d) the external brick joints containing potsherd, resembling traditional "sagramatura" in the Chalet Restaurant of Giardini Margherita in Bologna.

It's noteworthy that modern materials were employed side by side with traditional ones, such as natural stones, lime mortars with ground brick, etc. E.g., in the *Girasoli* House in Bologna, the common brick walls were coated with a cement-based plaster which was carefully scratched at the fresh state to imitate the brick-to-brick joints and finally red painted (Figure 6a), to hide the possibly irregular bricks texture and to reproduce *sagramatura* (11). *Sagramatura* was an Italian traditional surface finishing technique, in which the newly built masonry wall was continuously rubbed by a masonry brick fragment, to produce a very thin protective layer made of a fine mixture of scraped brick powder and joints lime mortar (due to the pozzolanic activity of potsherd with lime (12)); an example of traditional *sagramatura* is shown in Figure 6b. This "scratched" plaster technology was actually very ancient: an identical red-painted plaster imitating brick wall was found out by the present authors in the XV cent. *Isolani* Palace in Bologna (Figure 6c), with the only difference that such plaster

was, of course, lime-based. This shows how ancient placing techniques sometimes co-existed with new materials during the *Art Nouveau* age. The link with tradition was also evident in the use of lime-based mortars added with potsherd for the external finishing of the joints among the bricks: while the masonry was built with cement based bedding mortar, the external surface was finished with rose-coloured mortar, again to imitate traditional *sagramatura* (Figure 6d).

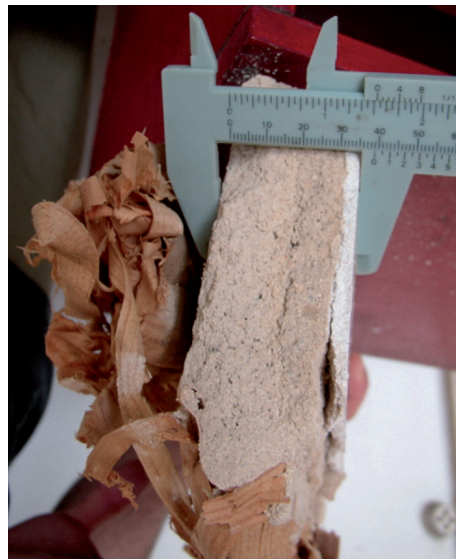
7

7. Thick lime-based plaster with vegetable fibres in the interior of Casa Major Pessoa in Aveiro.

The lime-based plasters were characterised by large thickness (up to about 5 cm) and high porosity (ascribed also to the low binder content, about 15 wt%), both of them probably to give the wall good thermo-acoustic performances (especially in the slim *tabique* walls).
