Evaluation of Strengthening Techniques of Traditional Masonry Buildings: Case Study of a Four-Building Aggregate

Romeu Vicente¹; Hugo Rodrigues²; Humberto Varum³; and J. A. R. Mendes da Silva⁴

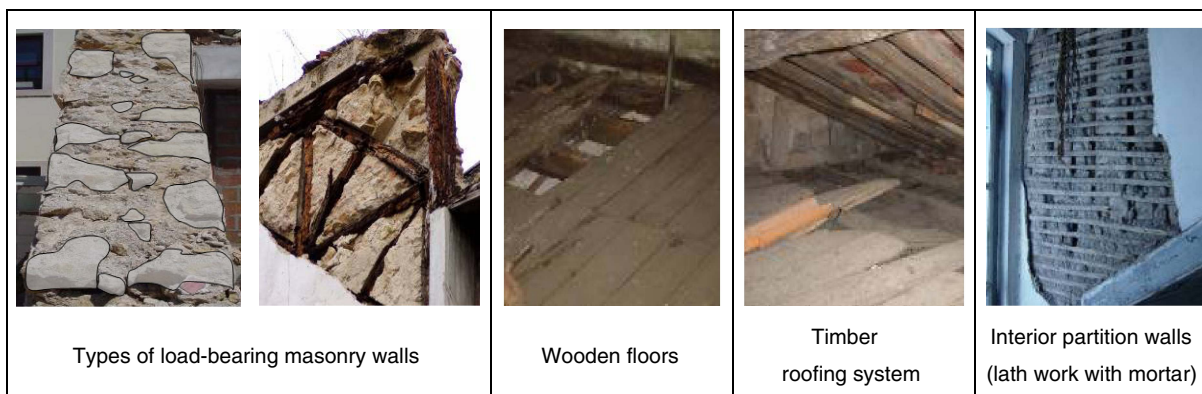
Fig. 3. Construction details of old housing

The geometry of the aggregate is irregular in height; buildings E_1 and E_2 (in the southeast quadrant) are constituted of a ground floor, two elevated floors, and an attic. Buildings E_3 and E_4 are composed of a ground floor, three elevated floors, and an attic. These buildings have no basement, because the major area of this part of the historical center of the town is quite close to the river. The dimensions and nobility of buildings are ruled by the architectural typology and traditional construction techniques. With respect to housing buildings, very simple structural schemes are observed: load-bearing external stone masonry walls and wooden floor slabs (Fig. 3).

In the majority of buildings that were inspected, particularly these four buildings, the systematic use of wood was observed in structural elements of floors, roofing structures, floor coverings, and interior partition walls. Mainly, the abundant use of dolomitic limestone was registered in external load-bearing walls, and the wall thickness varies, normally, in height from a mean value of

50 cm (at ground level) to 26 cm at roof level. The use of river sand for bed joints and external mortar renderings is also very common. In most cases, roofs are covered with clay tiling. Window sashes are predominantly wooden with simple glazing windows. Interior partition walls are thin and sometimes suffer warping, revealing some kind of structural deformation, often as a consequence of creep and aging phenomena.

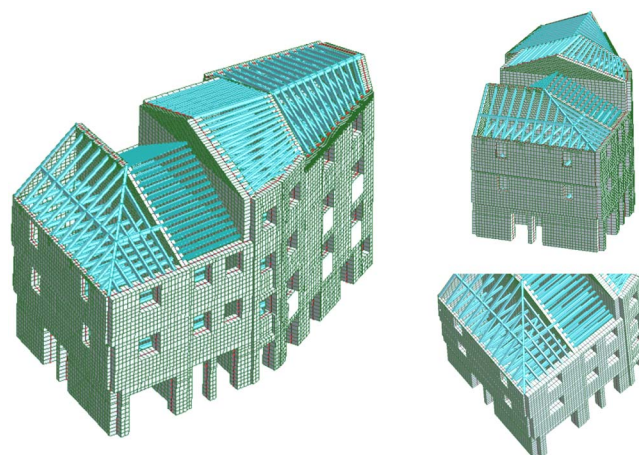
Fig. 4. Extruded three-dimensional model of the aggregate

The structural model to simulate the behavior of the group of buildings was developed using the finite-element program Robot Millenium v17.5 (Robot Millenium v17.5). The structural geometry of the buildings was defined starting from computer-aided design (CAD) drawings in digital format and complemented by technical visits. The global three-dimensional structural model mesh was defined with four-node shell elements for the masonry and two-node bar elements for timber beams, joists, and rafters, as shown in Fig. 4.

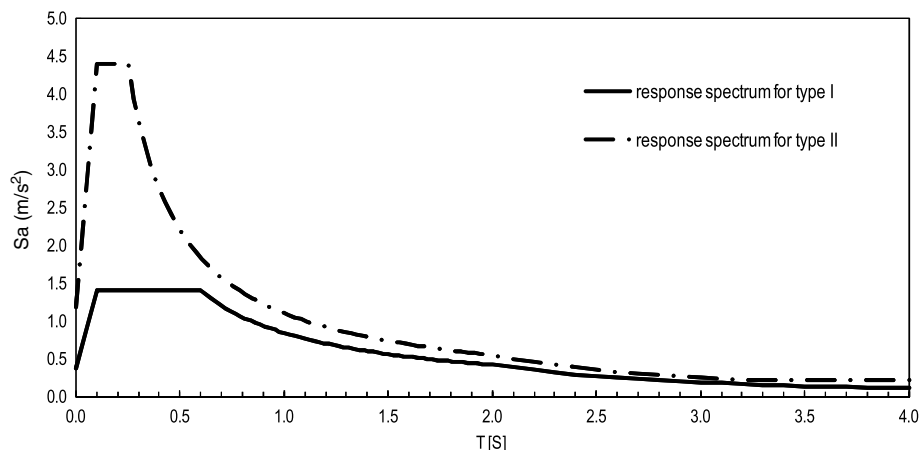
Fig. 5. Elastic response spectrum Type I and Type II for Ground Type C (CEN 2004)

on Eurocode 8 (CEN 2004), and is in accordance with the ground type and seismic zones defined in the national annex (Carvalho 2007), considering the maximum values as a function of the reference ground acceleration and the frequency of the structure, given by the response spectrum for Type II (Zone 4) and Type I (Zone 6), Soil Type C, and 2% damping, as presented in Fig. 5.

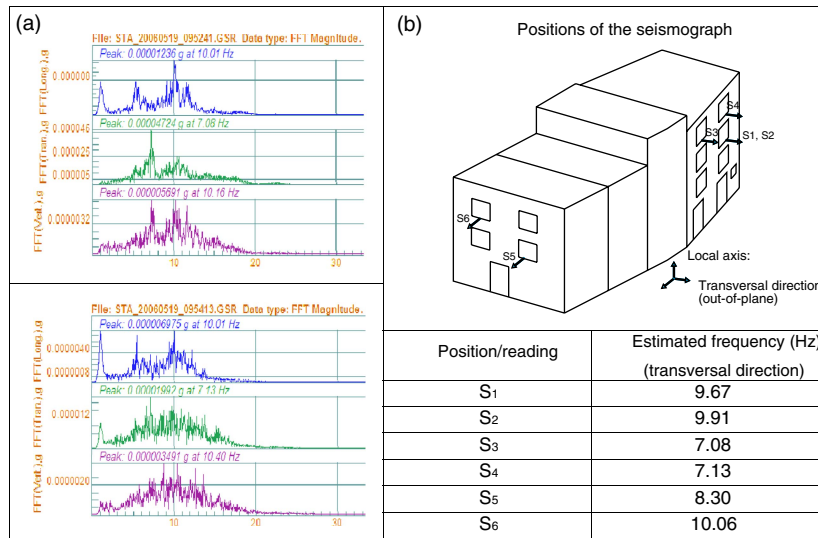
Fig. 7. Dynamic identification: (a) FFT for readings S_2 and S_3 in the 3 directions; (b) natural frequencies estimated by the power spectrums for the transversal direction of the walls

In situ dynamic identification testing was carried out with a seismograph, model GSR-16 (GeoSIG 1999), with the objective of estimating the natural frequencies that lead to the numerical model calibration (Júlio et al. 2008). Data acquisition was done for five different locations, as shown in Fig. 7, and for each, a five-minute

reading was acquired with 250 samples/s. The longitudinal, transversal, and vertical axes were defined in accordance with a local reference point.

With the data acquired for each position (input signals), the corresponding power spectra were calculated through a fast Fourier transformation (FFT) after previously applying a low and high filter and a Hanning time domain filter, using the strong motion detection software GeoDAS 2.17. Fig. 7 shows the power spectra obtained from the accelerograms acquired from Building E_4 (readings S_2 and S_3). Using the peak values of the spectra, the natural frequencies of the structure locally, specifically over the facade wall, are estimated.

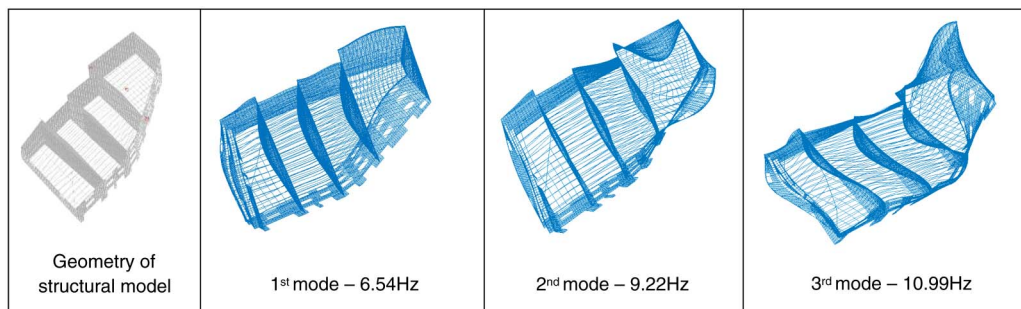
Fig. 8. Geometry of the structure and vibration modes

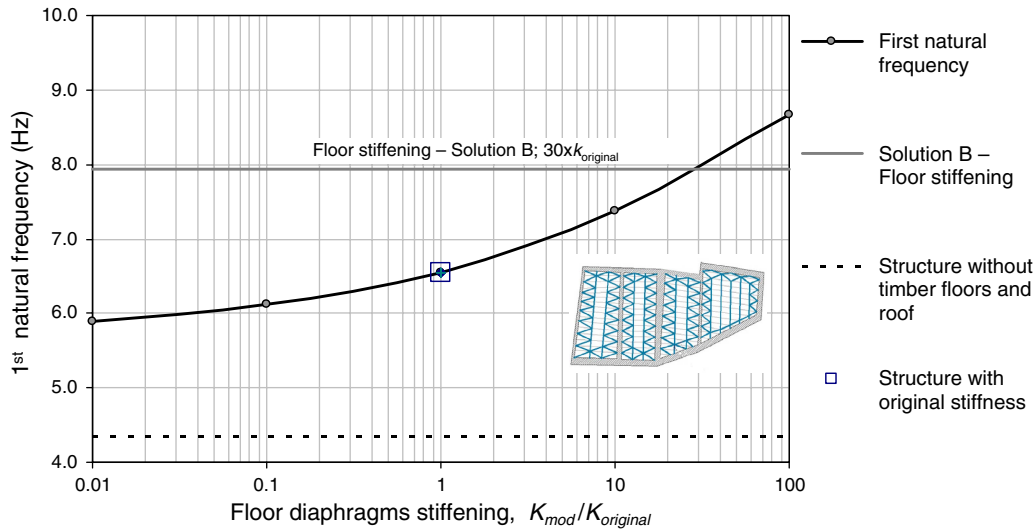
Fig. 10. Sensitivity of the structural response to the variation in the floor diaphragm stiffness

- A reduction in timber structure stiffness reveals a lower impact on the first natural frequency of the structural system than with a stiffness increase (for example, comparing an equal increase and reduction, $k_{\text{mod}}/k_{\text{original}} = 0.01$ and $k_{\text{mod}}/k_{\text{original}} = 100$, in which k_{mod} is the modified stiffness and K_{original} is the original stiffness);
- Considering, for example, the degradation of the timber diaphragms' stiffness owing to poor conservation status

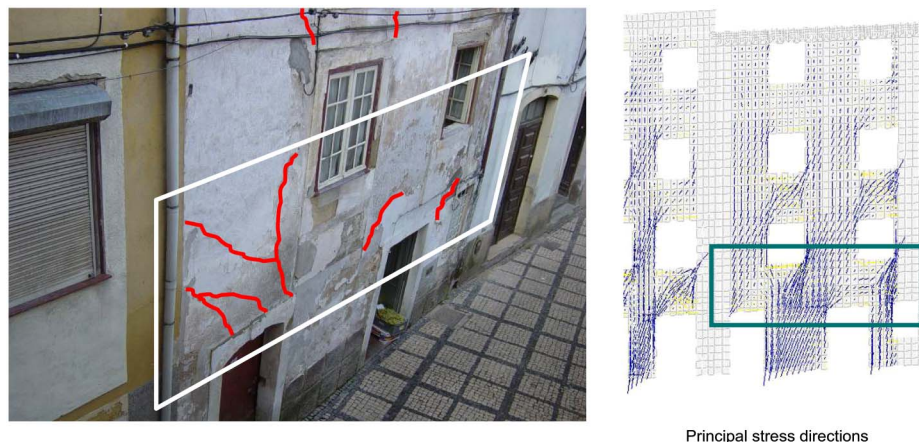
Fig. 11. Cracking observed and distribution of principal stresses for vertical loading conditions

Considering the vertical loading to which the building is subjected (self-weight and live load) and admitting a maximum tension stress for this type of limestone masonry of approximately 50 kPa, it was possible to identify the areas in which the cracking process will start, as shown in Figs. 11 and 12.

Analyzing Figs. 11 and 12, the influence of the vertical opening misalignment on the stresses in the masonry walls and consequently the origin of the observed diagonal cracking are clear. The preferential load path attributable to the opening distribution and stress concentration at the base of the walls and under the window openings, because of the more rigid stone panels used, can also

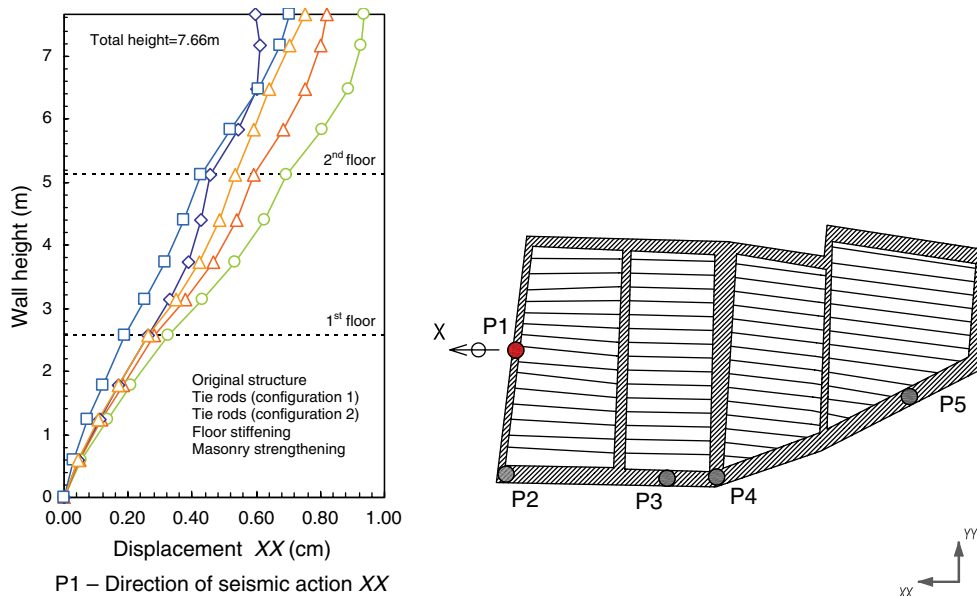
Fig. 13. Out-of-plane displacement profiles of the façade

Analysis of Control Node P1 allows the efficiency of the simulated strengthening solutions in the reduction of the out-of-plane masonry façade wall movement in the northeast direction to be evaluated. The displacement profiles (Fig. 13) show that Strengthening Solution C is the most globally efficient, reducing the top-displacement by approximately 25%.

Solution A (the floor stiffening retrofitting technique) demonstrates a better efficiency in comparison to all other retrofitting solutions with regard to the top-displacement reduction (approximately 36%); however, globally it is not the most efficient in terms of the total wall height.

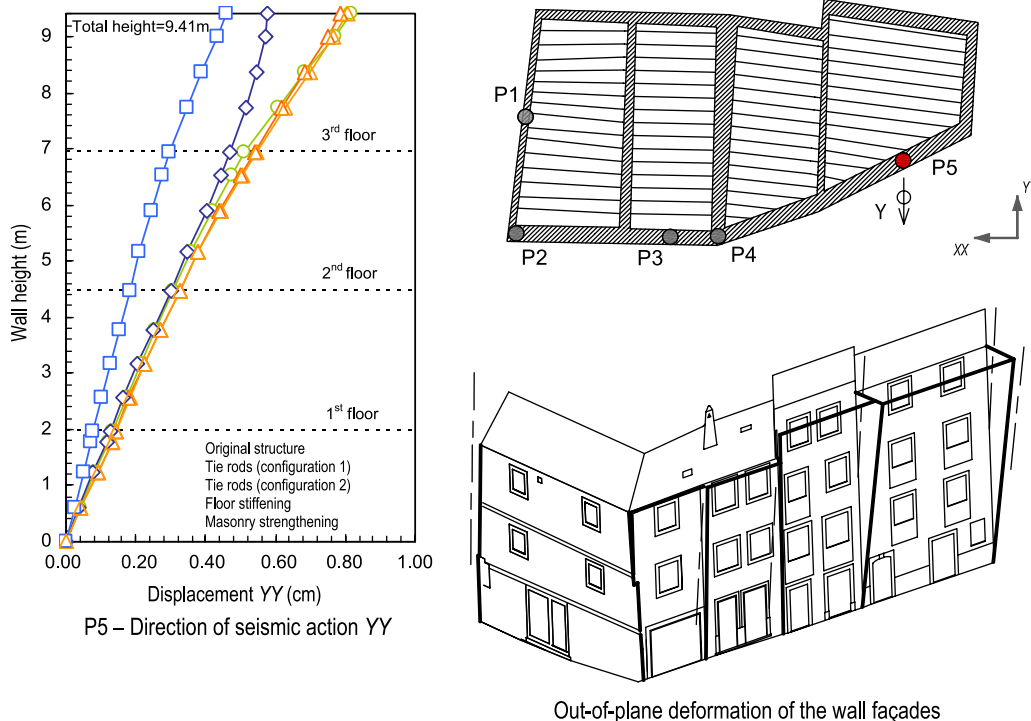
Fig. 15. Displacement profiles of the façade

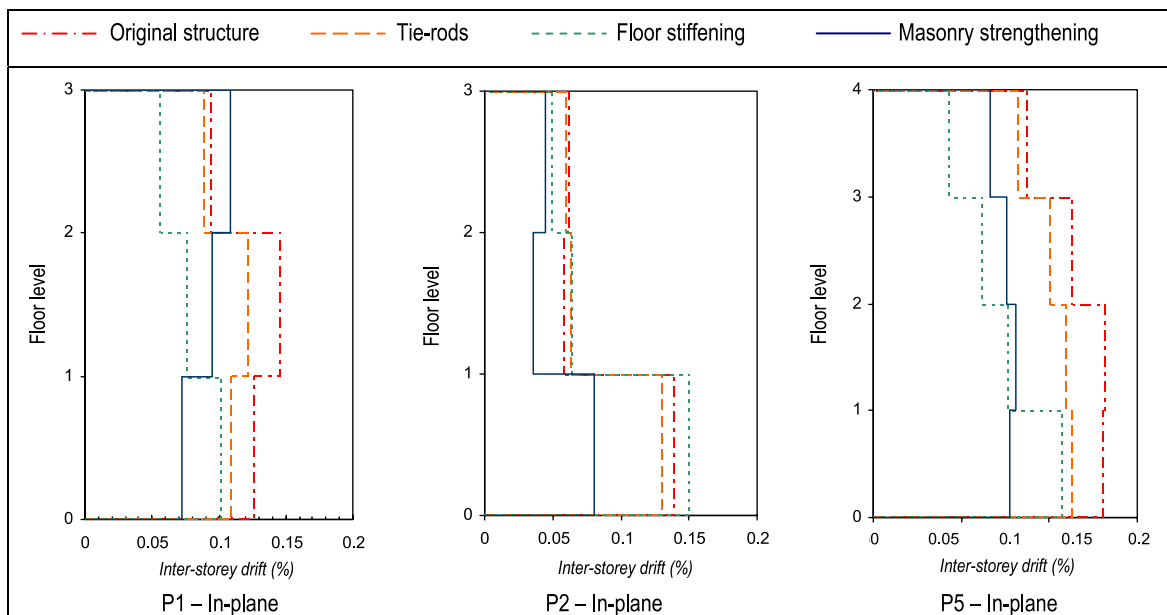
Fig. 17. Interstorey drift profiles for Control Nodes P1, P2, and P5

Considering the low to moderate level of seismic action in this study, Control Nodes P1, P2, and P5 were selected to analyze the interstorey drift. Up front, none verify the first level of in-plane deformation, which was defined as immediate occupancy (IO), with a drift-limit of 0.10% (FEMA-356 2000), and slight damage can be expected (hairline cracking). This is the only performance level evaluated because the linear elastic model does not allow security for the evaluation of other levels of performance and more severe damage states associated with the nonlinear behavior regime.

The interstorey drift profile for Control Node P5 (Fig. 17) shows that the masonry strengthening solution is most efficient and is the exception to the verification of the IO performance level. However, the timber floor in-plane stiffening solution is found to significantly reduce the in-plane deformation at higher floor levels for the load-bearing masonry enclosure walls, which are usually more slender and subjected to a lower compression stress state and more vulnerable to lateral loading. FEMA-356 (2000) does not indicate
