Characterization of Traditional Tabique Constructions in Douro North Valley Region

J. PINTO¹, H. VARUM², D. CRUZ¹, D. SOUSA¹, P. MORAIS¹,
P. TAVARES¹, J. LOUSADA¹, P. SILVA¹, J. VIEIRA¹

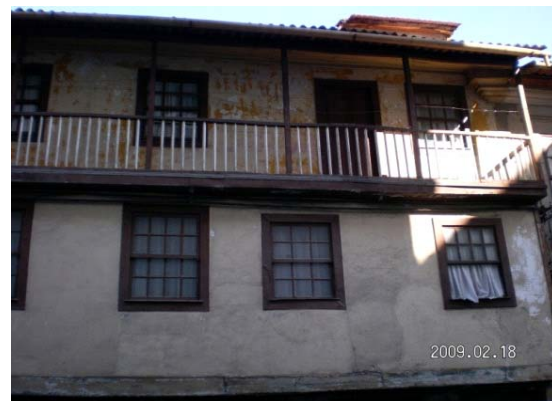
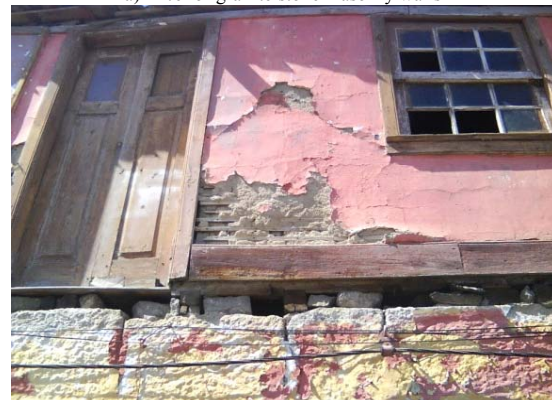
Fig.2 - Two examples of typical tabique houses

a) Exterior granite stone masonry walls

b) Exterior tabique walls

The type of tabique construction that is frequent to find is single houses of two floors in which the exteriors walls are granite stone masonries and the interior ones are tabique. At the same time, there are also cases in which the exterior walls of the upper floors are also in tabique, Fig.2.

A tabique constructive system can be found in several building components/elements as walls, verandas or even chimneys (see examples in Fig.2 and Fig.3). These last examples give indications of the capacity of tabique elements to resist even to very aggressive actions, if properly protected.

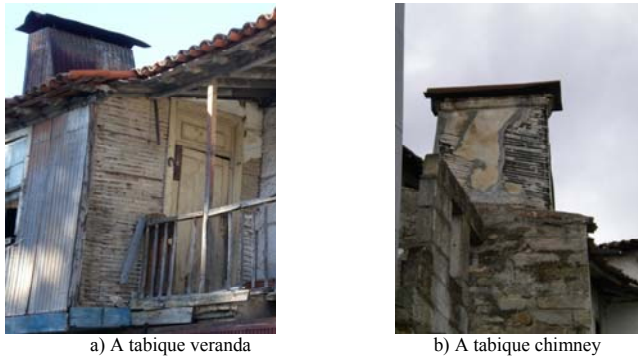
Fig.3 - Examples of tabique constructive elements (veranda and chimney)

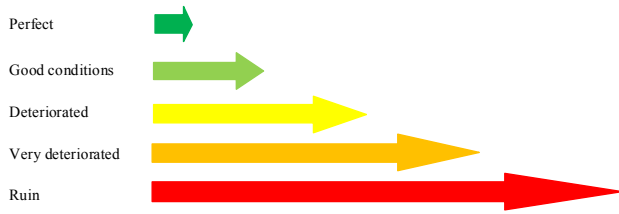
Fig.6 - Conservation scale

For this research work, it was defined a global conservation scale to identify the deterioration stage of each tabique constructions analyzed. Fig.6 shows the proposed conservation scale.

From the conservation stage observed *in-situ*, the majority of the inspected constructions were classified as “deteriorated”, according to the conservation scale presented in Fig.6. Only one of the studied tabique constructions showed a good level of conservation.

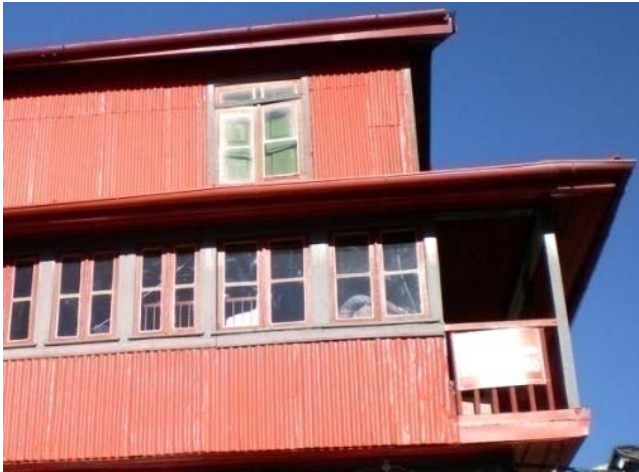
Fig.7 - Conservation state: Perfect

Fig.7 to Fig.11 exemplify, for each conservation scale level respectively, an example of the typical damage scenario.

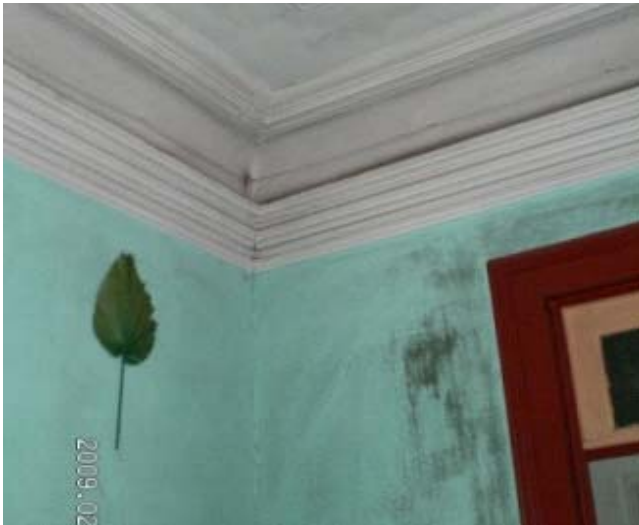
Fig.8 - Conservation state: Good conditions

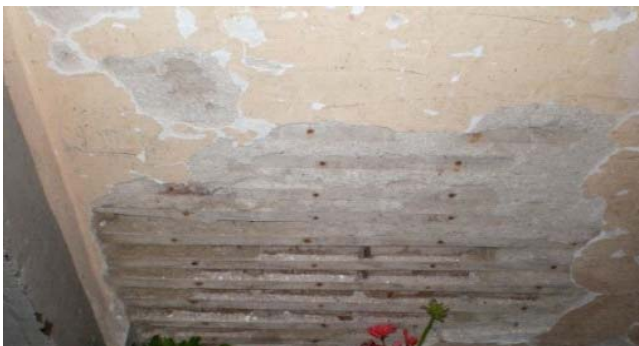
Fig.9 - Conservation state: Deteriorated

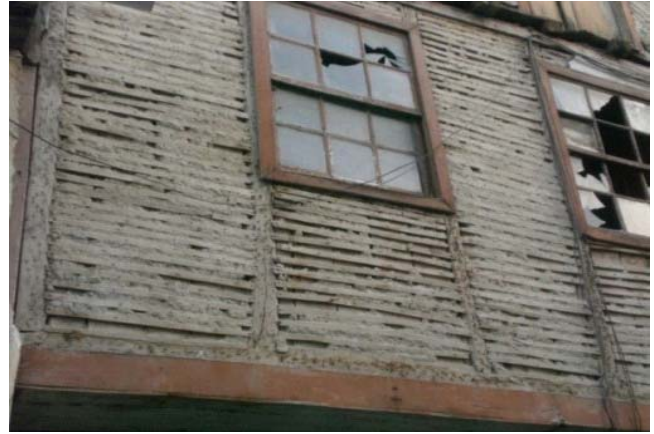
Fig.10 - Conservation state: Very deteriorated

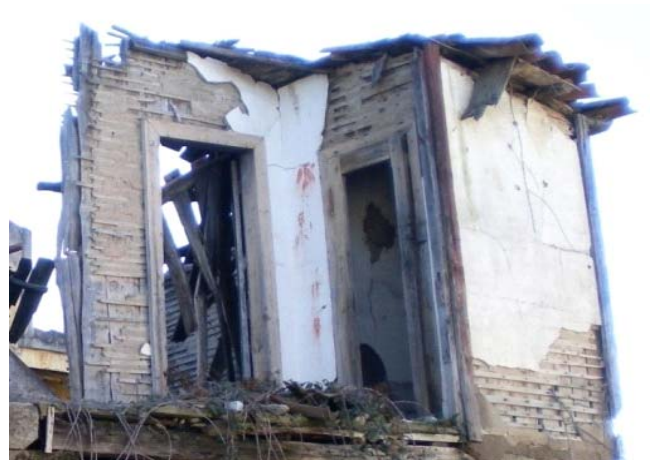
Fig.11 - Conservation state: Ruin

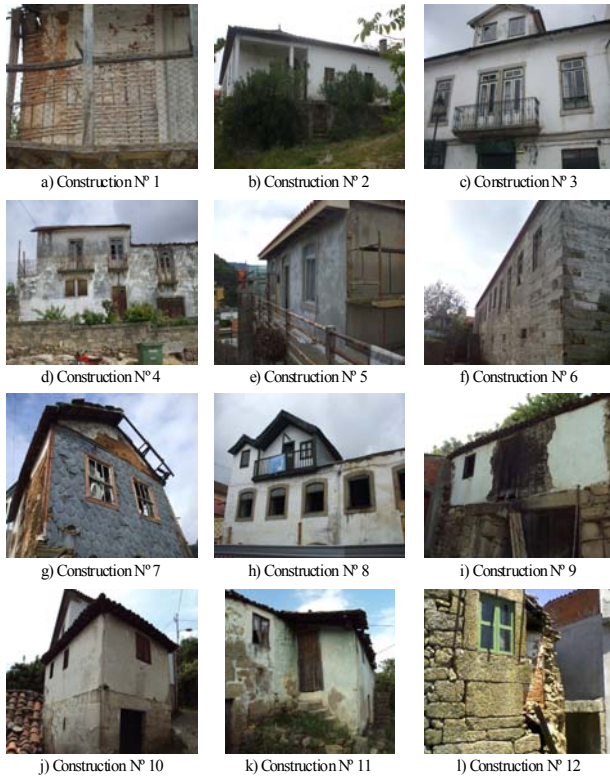
Fig.12 - Tabique constructions studied in the AMVDN

Fig.12 shows the twelve constructions studied in this research work. This figure also indicates the adopted designation for each construction, which will be related to the designation used for the different material samples collected and studied.

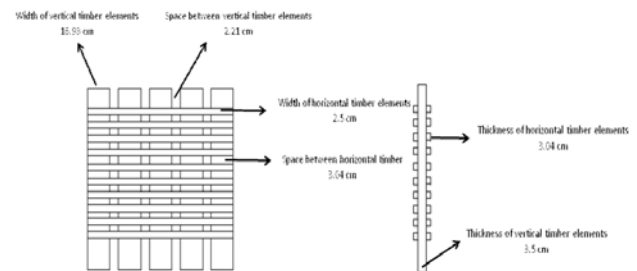
Fig.13 – Detail for the timber structure of a typical interior tabique wall

Regarding to the timber structural components of the tabique construction elements, data of Table 1 shows that no uniform dimensions of the timber elements were found. However, typical dimensions details of tabique walls are presented in Fig.13 and Fig.14, for interior and exterior tabique walls, respectively.

The dimensions presented are the most common dimensions founded for each component of the inspected tabique constructions, which individual dimensions were presented in Table 1.

It is important to underline that the gap between the vertical timber elements allows for a better adherence of the earth based plaster mortar. The traditional application of the plastering mortar in this way guarantees that the timber elements are completely surrounded and covered by this earth based mortar, which creates good conditions for their natural protection. The observation of examples of tabique walls in many existing constructions proves that an adequate conservation can be assured of the timber elements by the traditional lime plasters.

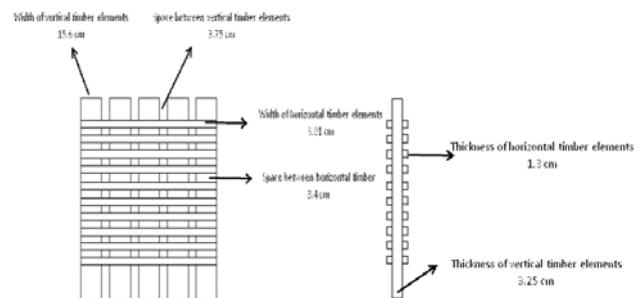
Fig.14 – Detail for the timber structure of a typical exterior tabique wall

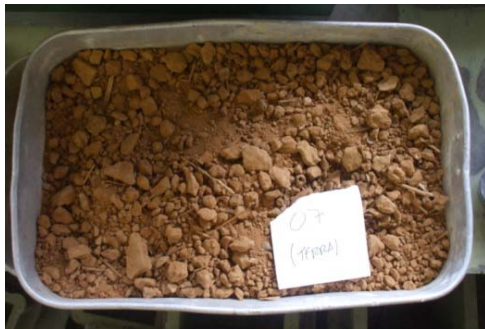
Fig.15 - Mortar sample for the granulometric analysis

A granulometric analysis was done at the Material and Soil Laboratory of the University of Trás-os-Montes e Alto Douro (UTAD) of the mortar samples collected in the existing constructions under analysis (see example of a mortar sample in Fig.15), using the procedures according to the ASTM standards. Results of the granulometric analysis have shown that the soil typically used for the production of these mortars is approximately composed by 80% of sand and 20% of silt and clay and, as the results in the granulometric curves presented in Fig.16 indicate.

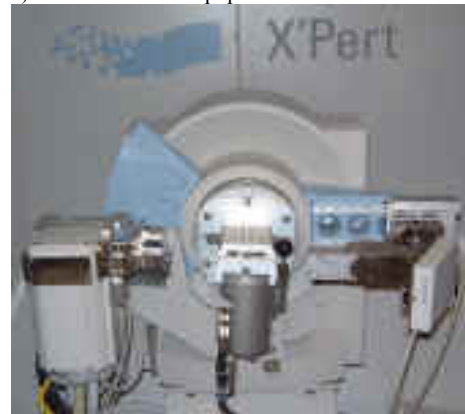
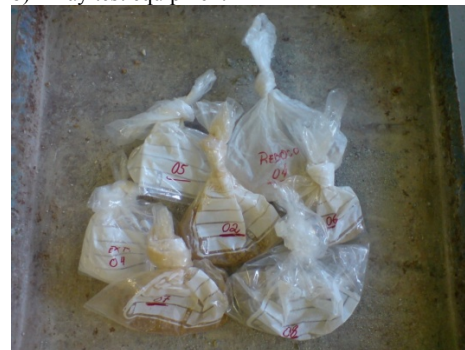
Fig.17 - Equipment and samples used for the SEM/EDS and X-ray tests

a) SEM/EDS's test equipment

b) X-ray test equipment

c) samples for the tests

In order to identify the chemical and mineralogical elementary composition of the samples mortars collected, scanning electron microscopy/energy dispersive spectroscopy (SEM/EDS) and X-ray tests were performed, in the Microscopic Electronic Unity of the UTAD (see Fig.17-a and Fig.17-b, respectively). The material samples used for this study are also shown in Fig.17-c.

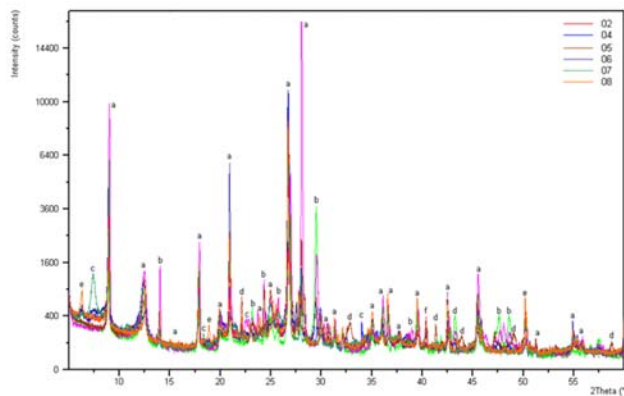
Fig.18 - Results of X-ray analysis of the sample

The results obtained by the SEM/EDS test are presented in Table 2 and the results of the X-ray test are shown in Fig.18.

According to the information in Tables 2 and 3, and in Fig.18, the covering material of the timber structure is an earth-based material, generally without the addition of an agglutinant component like cement.

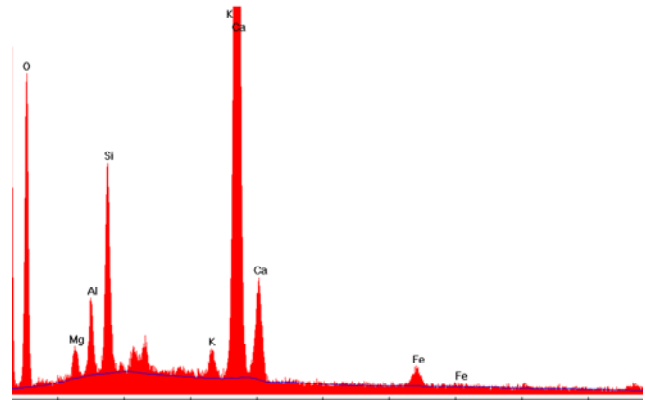
Fig.19 - X-ray diffraction results

a) Lime

b) Hydraulic lime

In addition, in order to complement and to guide this analysis, it is presented in Fig.19 the results of the X-ray diffraction test of the lime and of the hydraulic lime samples, which are the most used binder type used in this traditional building technique. It is noticed that both of them has a considerable percentage of calcium in their constitution.

Meanwhile, this test also indicates that the mineralogical elementary compositions of the lime and of the hydraulic lime tested are calcite and calcium oxide and calcite, quartz and plaster, respectively.

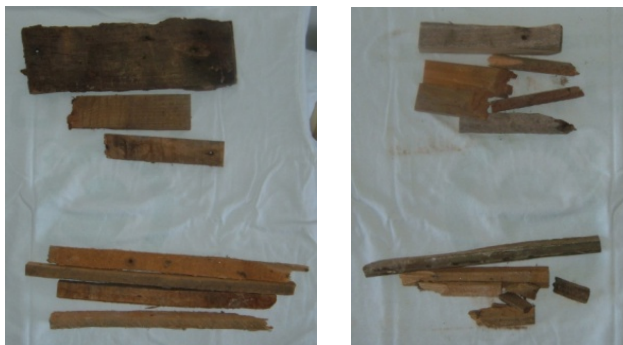
Fig.20 - Timber samples

The experimental identification and characterization process of the six timber samples was done at the Laboratory of the Forest Department of UTAD. Fig.20 shows examples of the tested timber samples, collected from the studied tabique constructions, and analyzed within this research project.

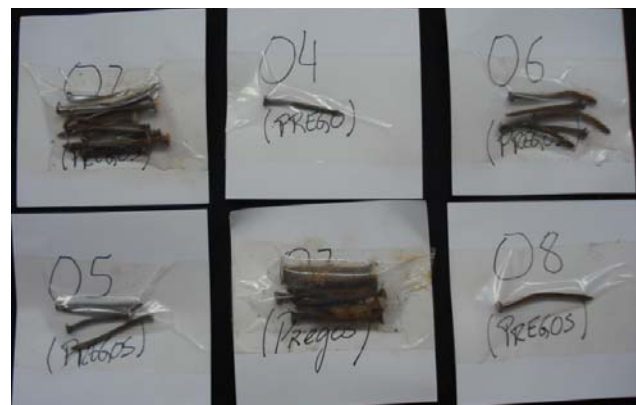
Fig.21 - Nail samples tested

The mechanical connection between the timber elements was usually made with nails. Hardness tests and reaction to chemical agent tests were done at the Materials Laboratory, of the Department of Mechanical Engineering, of the UTAD, for six nail samples, collected during the inspection works to the constructions. Fig.21 shows examples of the nail samples collected and tested.

From the characterization tests of these connectors, the experimental results indicate that these nails are made of steel. This fact contradicts the information gotten during the fieldwork, when retired builders were interviewed about this subject. They said that normally the nails used to connect the horizontal timber elements to the vertical ones were zinc based material in order to avoid any oxidation process that could deteriorate the plasters or finishings of the walls.
