Bull Earthquake Eng (2012) 10:27–44
DOI 10.1007/s10518-011-9276-0

ORIGINAL RESEARCH PAPER

Seismic vulnerability assessment and characterisation of the buildings on Faial Island, Azores

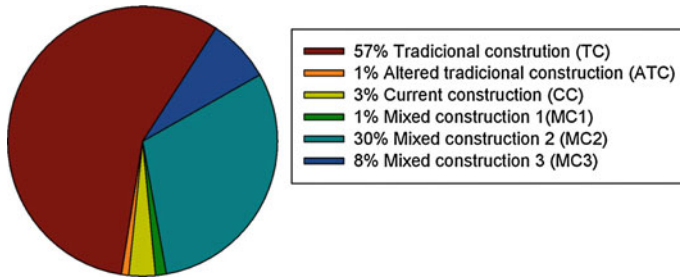
Fig. 1 Construction types. Distribution of the construction system types in Faial Island (sample of 2305 buildings dated from July 1998)

characterised by a greater degree of intervention related to the evolution of the building. This new extension is an entirely reinforced concrete structure (columns, beams and slabs) with a concrete block infill. The structural elements of the original construction (roof, floors and walls) are preserved. Finally the mixed construction type 3 (MC3) is characterised as current construction and preserves the original stone masonry wall as a fill element and not as structural element. Figure 1 presents the statistics for the distribution of the different construction types.

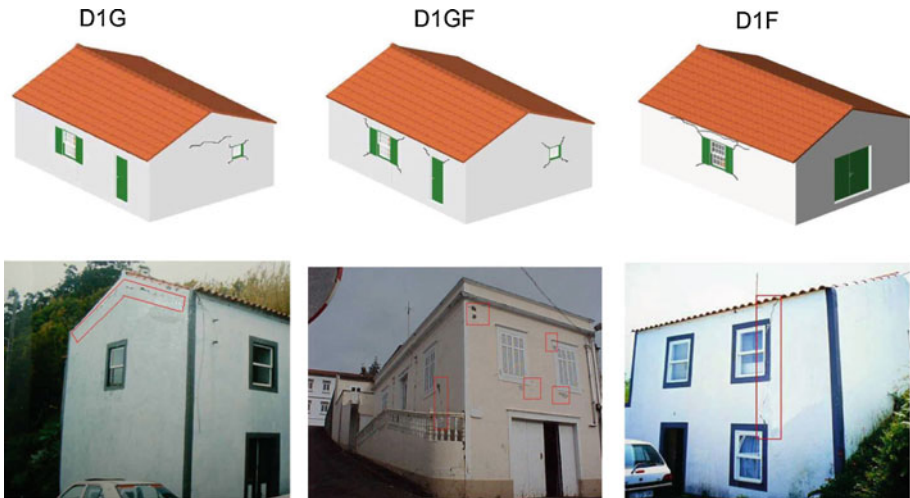
Fig. 7 Slight cracking damage examples (D1). D1G shows slight cracking in gable end wall, D1GF in gable end wall and front wall and D1F in front wall

Slight cracking (D1) (see Fig. 7) includes the widespread cracking around openings and hair line cracks (cracks of less than 1 mm in width).

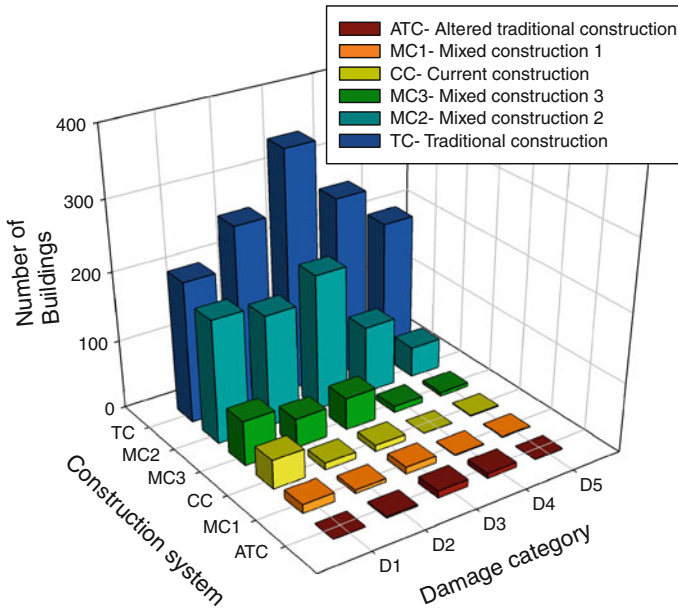
Fig. 12 Damage distribution. Relationship between damage (D1, D2, D3, D4 and D5) and the construction system type for 3,154 buildings evaluated on Faial and Pico Islands

In Fig. 12 shows the results correlating the damage and construction system type. To easily analyse the results, damage is grouped in to the 5 categories as previously explained.

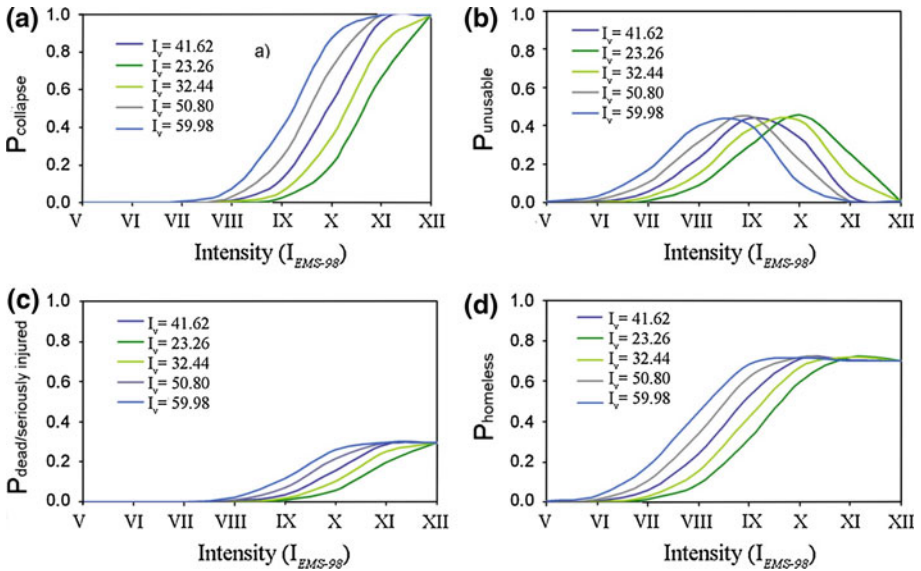
Fig. 15 Probabilistic assessment for different values of I_v , ($I_v, mean - 2 \sigma I_v$; $I_v, mean - 1 \sigma I_v$; $I_v, mean$; $I_v, mean + 1 \sigma I_v$; $I_v, mean + 2 \sigma I_v$) (sample 260 buildings). **a** Collapse probability for different values of I_v ; **b** probability of unusable buildings for different values of I_v ; **c** probability of dead/severely injured; **d** probability of homeless

The collapse probability (Fig. 15a) and unusable building probability (Fig. 15b) are represented for different values of I_v ($I_v, mean - 2 \sigma I_v$; $I_v, mean - 1 \sigma I_v$; $I_v, mean$; $I_v, mean + 1 \sigma I_v$; $I_v, mean + 2 \sigma I_v$). It is possible to observe that the number of unusable buildings decreases with the increasing intensity, as the number of collapsed buildings increases.
