Experimental Tests for Seismic Assessment and Strengthening of Adobe Structures

C. Oliveira, H. Varum, A. Figueiredo, D. Silveira & A. Costa
Universidade de Aveiro, Aveiro, Portugal

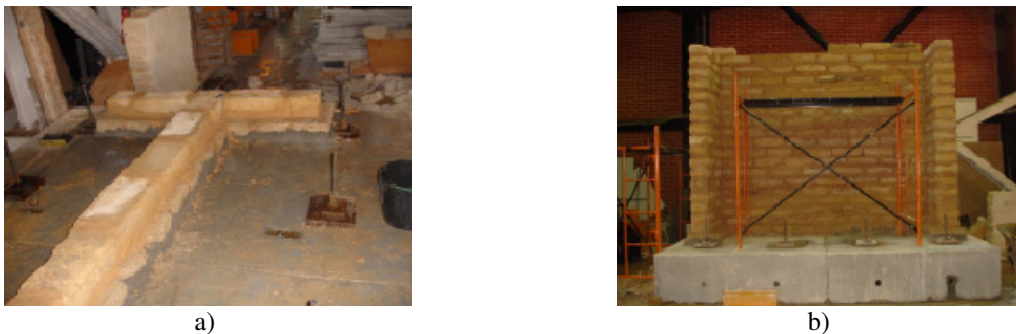
Figure 2.1. Adobe wall construction: a) beginning of the construction; b) final phase of the construction (before plastering)

In the Laboratory of Civil Engineering Department of Aveiro University, a real-scale adobe wall was built with an “T” shape in a plan view (Figure 2.1). Its construction used adobe blocks with average dimensions of $28 \times 45 \times 12 \text{ cm}^3$, from a demolition in Aveiro region. In order to simulate an adobe construction representative of the vast patrimony existent in the district, a mortar using hydraulic lime was chosen. The joints mortar used was composed by hydraulic lime and arenaceous soil. The plaster had the same composition. The wall was built with a height of 3,07m, a length of 3.5m and a mean thickness of 0.29m [Pereira, H.; 2008].

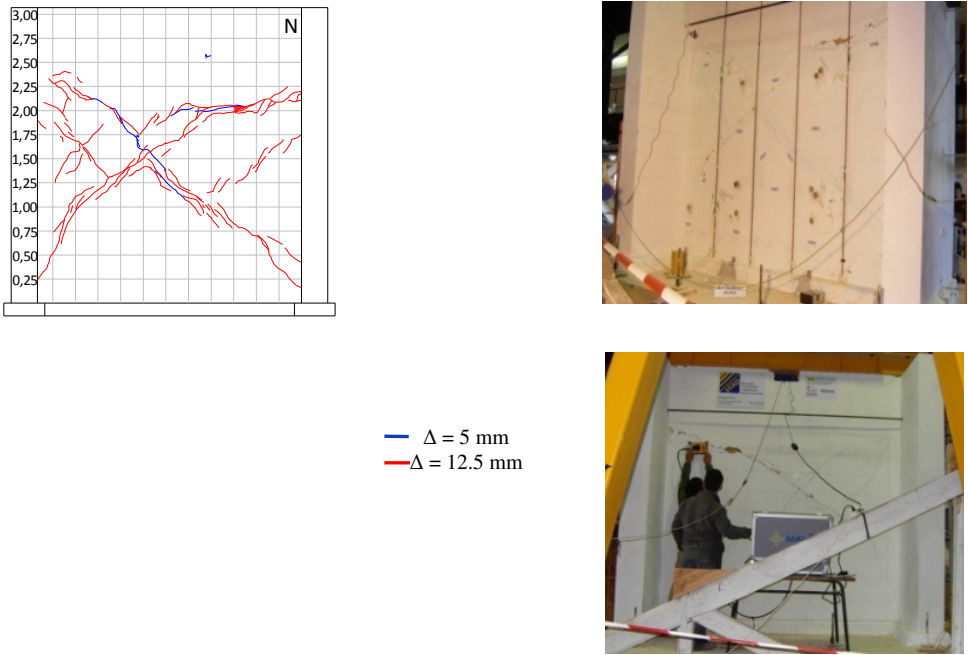
Figure 2.7. Damage evolution (North and South faces)

The lateral displacements imposed on the wall with increasing amplitude caused an evolution of the damages, beginning with the propagation of small cracks until the detachment of the plaster in local areas (Figure 2.7). The fissures were only perceptible after a lateral displacement of 5mm. The following cycle, with a maximum imposed displacement of 12.5mm, heightened and intensively propagated the cracks already installed. Many new fissures were also formed with apertures between 0.5 and 1.0mm. Subsequently, for imposed displacements of 25.0 and 37.5m, a large detachment of the plaster happened in a highly cracked area. Next to the application point of the concentrated horizontal force, it was observed crushing. Figure 2.8 displays the plaster detachment during the last cycles of imposed displacements. It is also possible to observe the cracks that trespass the wall.

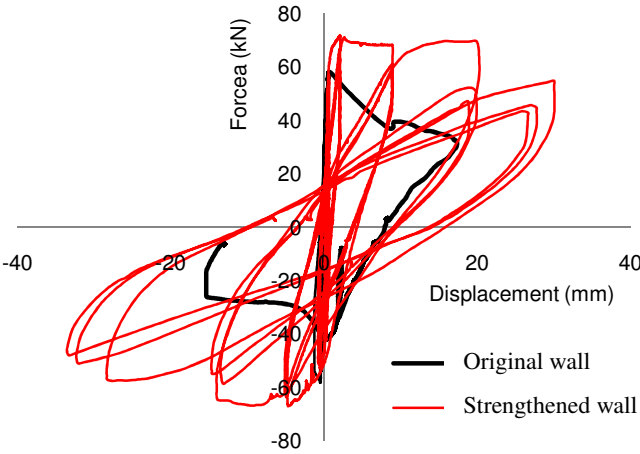
Figure 2.10. Horizontal force versus displacement: original and strengthened wall

Figure 2.10 presents the results in terms of force versus displacement obtained for the original wall and for the strengthened reinforced wall.

The strengthened wall presented an initial stiffness very close to the one of the original wall. The maximum shear capacity had an increase of approximately 25% and the maximum lateral displacement imposed was approximately the double of the one applied on the original wall. The analysis of the post-peak strength reduction, for the original and strengthened walls, reveals that the fragility observed in the original wall was significantly decreased with the strengthening solution adopted, increasing its ductility and the energy dissipation capacity.

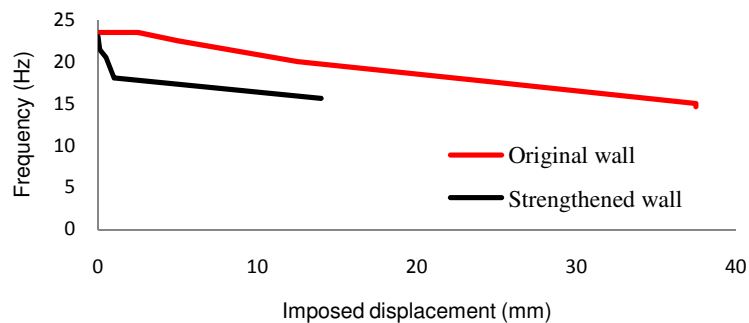
Figure 2.12. First natural frequencies evolution on the original and strengthened walls

The evolution of the first natural frequency, for both walls, original and strengthened, is displayed in Figure 2.12, as a function of the maximum displacement imposed. The stiffness decrease during the cyclic test on the strengthened wall is smoother, which causes an also smoother decrease on the first natural frequency. The rehabilitation of the wall provided and initial stiffness close to the one of the original non-damaged wall.
