Tabique construction in the Municipalities Association of the Terra Quente Transmontana

Abstract: *Tabique* is one of the main Portuguese traditional building techniques which use basically natural and local building materials such as earth and timber. A *tabique* building component such as a wall is build up using a simple timber structure covered on both sides by an earth based mortar. The earth based mortar has an important role in this building system technology since it not only protects the internal timber structure but it also acts as finishing elements. Meanwhile, earth has the advantage of being abundant, natural, local and recycled which gives to this technique a special importance in the sustainability context. It has been noticed that this traditional building technique has an expressive incidence in the region of *Trás-os-Montes and Alto Douro*, Portugal. Taking into account that the *Trás-os-Montes and Alto Douro* region is very large, there was the necessity to divide it in to more manageable areas. The manageable areas are the six Municipalities Associations, which are: *Alto Tâmega*, *Terra Quente Transmontana*, *Terra Fria do Nordeste Transmontano*, *Vale do Dour

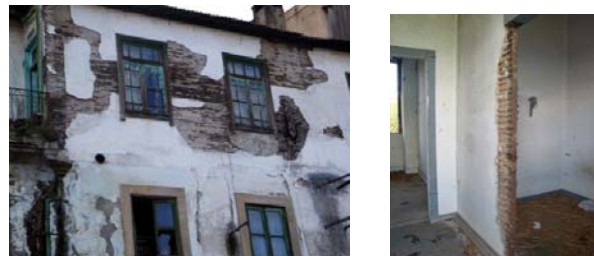
Fig.2 - Examples of the most representative elements of *tabique*

The *tabique* constructions identified in the study area are older, single-family housing, mostly they which are have two floors and feature a degraded condition: They are a severely degraded and ruins. The building construction elements the most representative are partition walls and walls exterior located always on the upper floors, Fig.2.

a) Exterior wall

b) Partition wall

Generally, the constructions that have *tabique* elements in the AMTQT are detached houses of two floors and the *tabique* elements are more commonly used as an interior partition wall. However, exterior *tabique* walls can also be frequently founded at the first floor level.

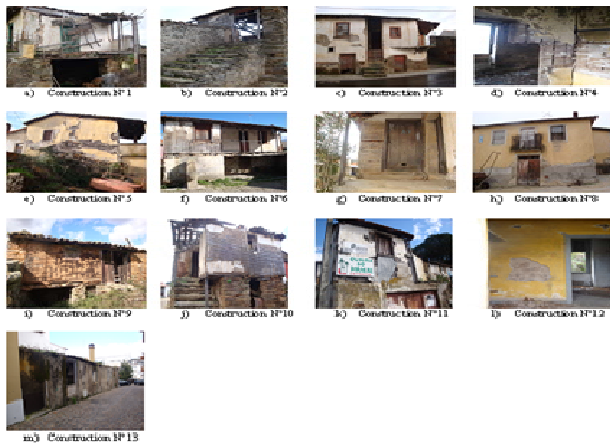
Fig.4 - *Tabique* constructions studied in the AMTQT

Thirteen selected constructions were considered of being representative samples of the existing *tabique* constructions in the AMTQT, Fig.4. Their location is shown in Fig.5.

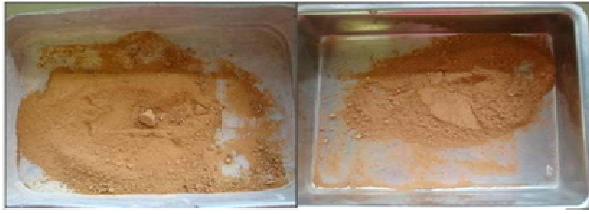
Fig.6 - Some mortar samples for the granulometric analysis

A granulometric analysis was done at the Laboratory of Materials and Soils of UTAD of the mortar samples collected in the existing constructions under study (see example in Fig.6), using the procedures according to the ASTM standards. Results of the granulometric analysis have shown that the soil typically used for the production of the mortars is approximately composed by 20% of fine fraction, as the results in the granulometric curves presented in Fig.7.

It was only possible to get adequate mortar samples for this analysis in two *tabique* constructions (No.9 and No.10).

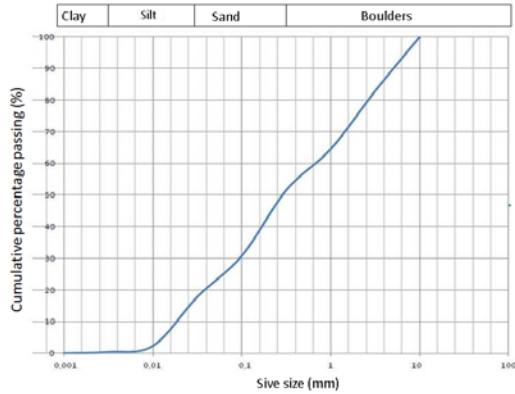
a) Sample 9

Fig.7 - Granulometric curves

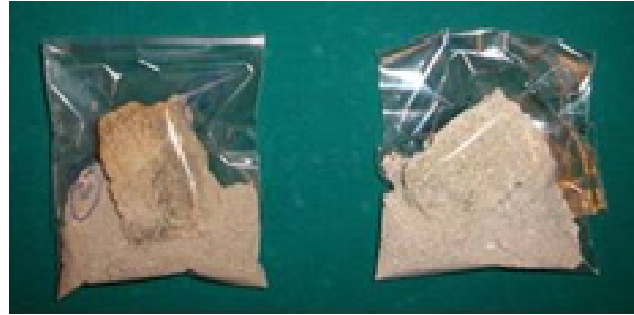
Fig.8 - Samples for the SEM and X-ray

In order to identify the chemical and mineralogical elementary composition of the samples mortars collected, (SEM/EDS) and X-ray test were performed, in the Microscopic Electronic Unity of the UTAD. Two examples the material samples used in this study are shown in Fig.8.

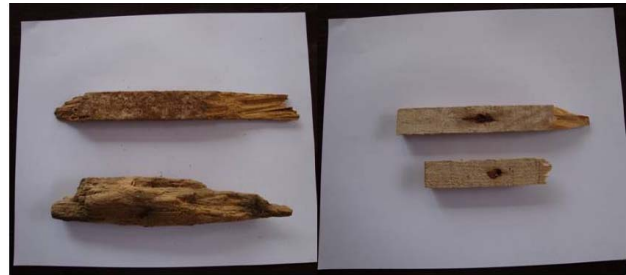
Fig.9 - Timber samples

The experimental identification and characterization process of the eleven timber samples was done at the Laboratory of the Forest Department of UTAD. Fig.9 shows example of the tested timber samples.

It was concluded that the *pinus pinaster* is the most common type of wood traditionally used in the timber structural components of the *tabique* elements, Table 3. Moreover, *pinus pinaster* is the most abundant type of tree of this region of Portugal.
