AdobeUSA 2007, May 18-20  
NNMC and Adobe Association of the Southwest, El Rito, NM

## Structural Behaviour Assessment and Material Characterization of Traditional Adobe Constructions

**Authors** Humberto Varum\*, Aníbal Costa, **Dora Silveira**, Henrique Pereira, João Almeida, Tiago Martins  
**Address** Civil Engineering Department, University of Aveiro, Campus Universitário de Santiago, 3810-193 Aveiro, Portugal  
**E-Mail** \* hvarum@civil.ua.pt

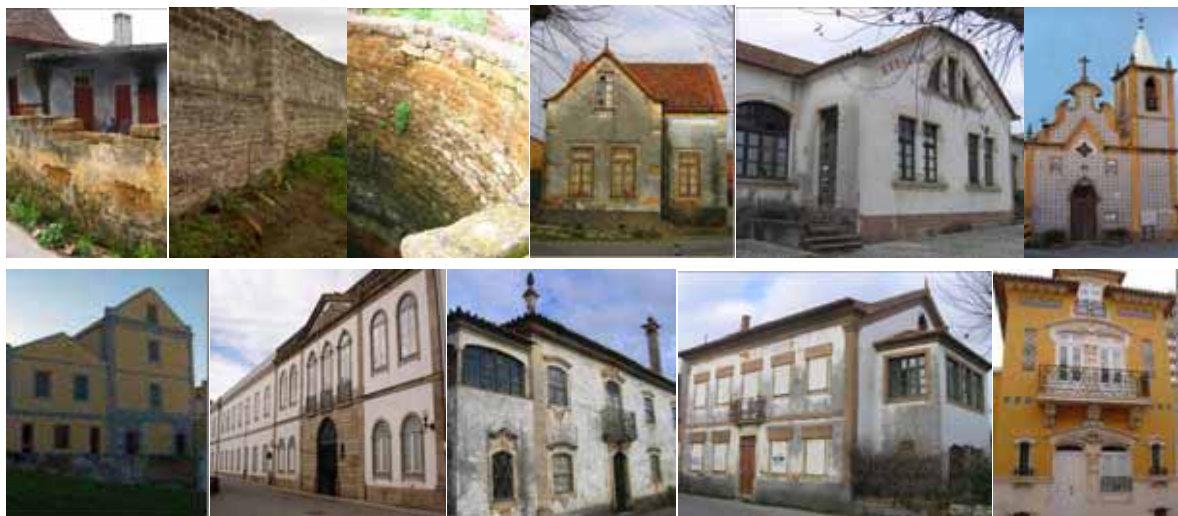
**Figure 1.** Examples of existing adobe constructions in Aveiro district.

the delimitation of properties, water wells, churches and warehouses (Fig. 1). An important number of the urban adobe buildings are of cultural, historical and architectonic recognized value, namely of the “Art Nouveau” style. The old Aveiro fire station building, the church of Quintãs, and the old flour-mill building recently converted by the University of Aveiro into a space for science results diffusion, among many others, are just good examples of existing adobe buildings in Aveiro district with important socio-cultural value. A more detailed description of the predominant constructive typologies can be found in (3).

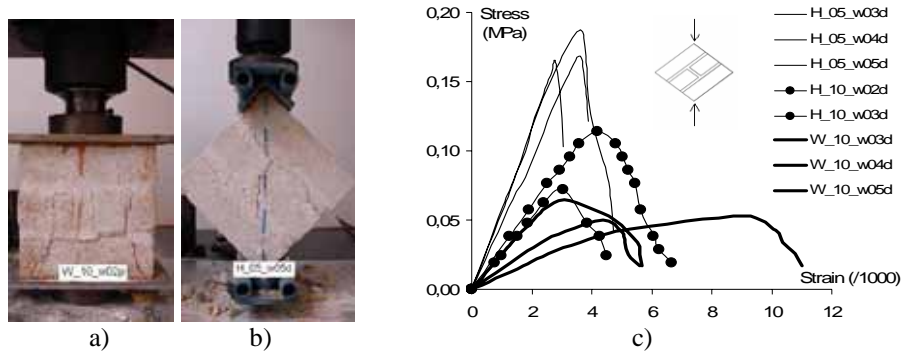
**Figure 2.** Compression test on wallet, a) perpendicular and b) diagonal to the bed joints. c) Stress vs strain relation obtained in diagonal to the bed joints compression tests on small wallets.

To estimate the compressive and shear strength of adobe traditional masonry walls, 13 small wallets with 17×17×10cm were constructed and submitted to compression tests, perpendicular to the bed joints and diagonally (Fig. 2). The wallets were constructed at a reduced scale (1:3). For the construction of the wallets, prismatic blocks were extracted from adobe units taken from existing constructions, and a mortar with a composition similar to the traditionally used was adopted.

The compressive and shear strength obtained from compression tests on wallets are between 0.77 and 1.57MPa; and between 0.05 and 0.19MPa, respectively. For the wallets constituted by adobe units with a lower compressive strength, lower shear and compressive strengths were obtained. Transversal modulus of elasticity and shear strength, for each series of tested wallets, are about 1/10 of the corresponding modulus of elasticity and compressive strength evaluated in compression tests perpendicular to the bed joints.

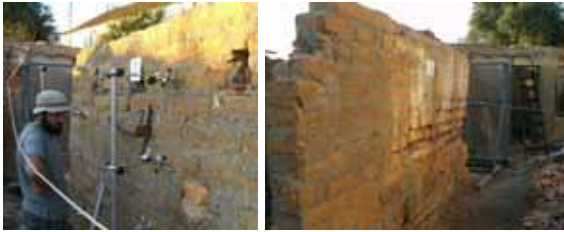
**Figure 6.** In situ out-of-plane cyclic testing layout: wall; horizontal displacement transducers; and horizontal loading system.

The wall tested *in-situ* conditions had the following dimensions: 2.03m height, 3.73m width and 0.22m thickness. It presented a significant deterioration level, as can be observed in Fig. 6. This

In a second phase, adopting a different testing setup (Fig. 6), out-of-plane horizontal forces were applied to the wall, in cycles of increasing amplitude, but without inversion of the force signal, till the collapse was reached (Fig. 7).

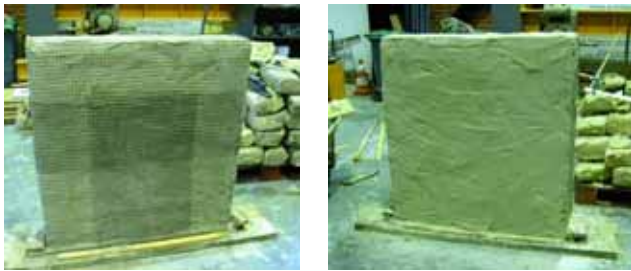
**Figure 8.** Strengthening of the wall with a wrapping polymeric mesh, and with plaster mortar.

In addition to the work that has been developed for the mechanical characterization of adobe masonry walls, it has also been initiated work on the study of adobe masonry strengthening solutions. The wall tested in laboratory, presented in section 2.5.1, was strengthened with a wrapping polymeric mesh and coated with a mortar layer with composition similar to the traditionally used in the existing constructions (Fig. 8). The structural response of the strengthened wall when subjected to imposed horizontal cyclic displacements is currently under investigation. The behaviour improvement achieved with the applied strengthening solution will then be evaluated. This analysis is just the first step of a larger work that aims to develop effective strengthening solutions for the existing adobe constructions.
