Study of the traditional *tabique* constructions in the *Alto Tâmega* region

Abstract

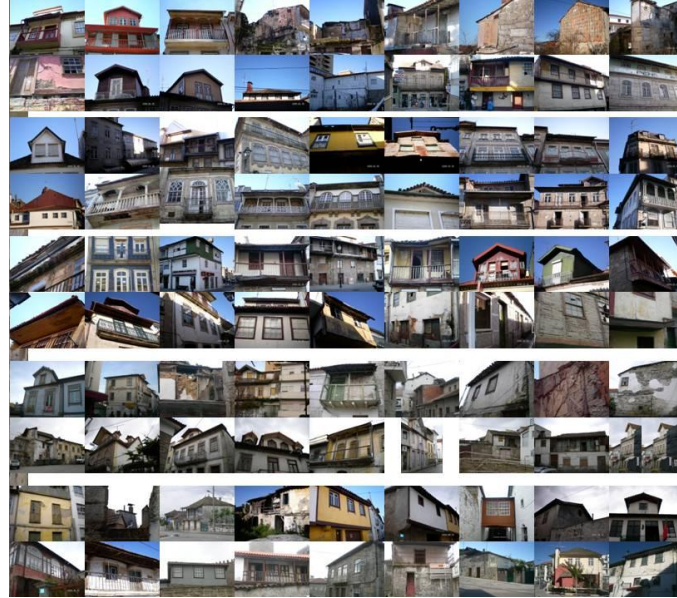
Figure 2: *Tabique* construction used as study cases.

Fig. 2 shows examples of the studied *tabique* constructions, which were in total 100. As can be observed from the images in Fig. 2, a large variety of architectural solutions can be found in the existing *tabique* constructions in MAAT. Fig. 2 also includes the coordinates of the buildings location.

a) Examples of the constructions studied

Based on the data collected from the one hundred *tabique* constructions used as study cases, Fig. 2, during the fieldwork of this research, it was possible to conclude that: i) An expressive amount of the constructions (about 50%) require a conservation process since they are very deteriorated; ii) Frequently, these constructions are dwellings of 2 floors (about 70%); iii) The adoption of *tabique* walls in the ground floor was normally avoided, in particular, concerning exterior *tabique* walls; iv) White wash, zinc plate, ceramic tiles and slate boards are finishing solution options for exterior *tabique* walls commonly adopted. However, white wash was the finishing option most frequently chosen (65%).

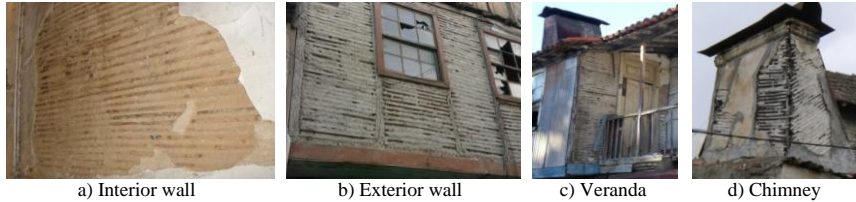
Figure 4: Examples of *tabique* building components.

a) Interior wall b) Exterior wall c) Veranda d) Chimney

technique is more commonly found in the north and, in particular, in the region under study in this research project. The existing *tabique* constructions were built mainly during the XVIII and XIX centuries, and it started to fall into disuse in the beginning of the XX century, when the reinforced concrete and the ceramic bricks were introduced in the construction. The most common structural solution for buildings is composed by external granite stone masonry walls and interior/partition *tabique* walls, Fig. 3-a. Meanwhile, building structural solutions using *tabique* in exterior and interior/partition walls for the upper floors can be also found in the region, which is of particular interest for this study, Fig. 3-b. A *tabique* constructive system can be found in several building components or elements such as interior/exterior walls, balconies or even chimneys (see examples in Fig. 4).

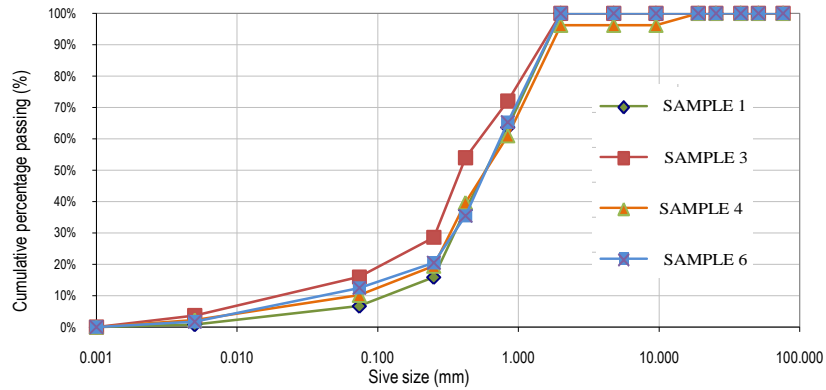
Figure 6: Granulometric curves.

Unfortunately, it was only possible to collect mortar material samples in seven of the studied *tabique* constructions. A granulometric analysis was done at the Material and Soil Laboratory, of UTAD, using the mortar samples collected. Examples of analysis results are presented in Fig. 6, which show that the soil

typically used for the production of these earth-based mortars in the MAAT region was approximately composed by 80% of sand and 20% of silt and clay.
