SEISMIC STRENGTHENING OF BEAM-COLUMN JOINTS WITH MULTIDIRECTIONAL CFRP LAMINATES

Abstract

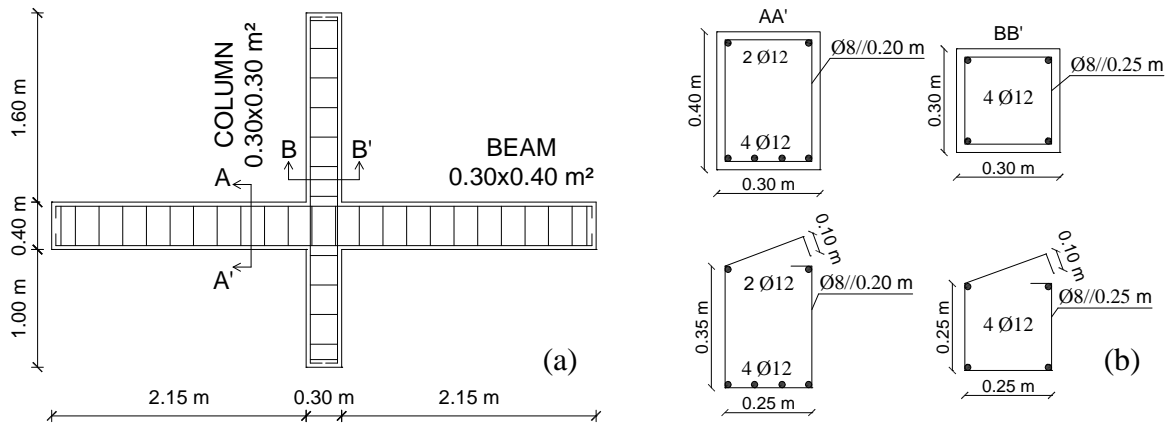
Figure 1 presents the geometry of the joints, as well as the detailing of the beam and column cross sections adopted for all the specimens. In the beams, with a cross section of 0.30 m wide and 0.40 m height, the longitudinal reinforcement was composed of 2 steel bars of 12 mm diameter (2Ø12) at the top and 4Ø12 at the bottom. The transverse reinforcement consists of 8 mm diameter stirrups spaced 0.20 m. In the columns, with square cross-section of 0.30 m edge, the longitudinal reinforcement was composed by 4Ø12 and the transverse reinforcement was formed by 8 mm diameter stirrups spaced 0.25 m. The concrete cover was 20 mm thick for the beams and columns of all elements.

Figure 1. Geometry and reinforcement detailing: (a) joint; (b) cross-sections of the beams and columns.

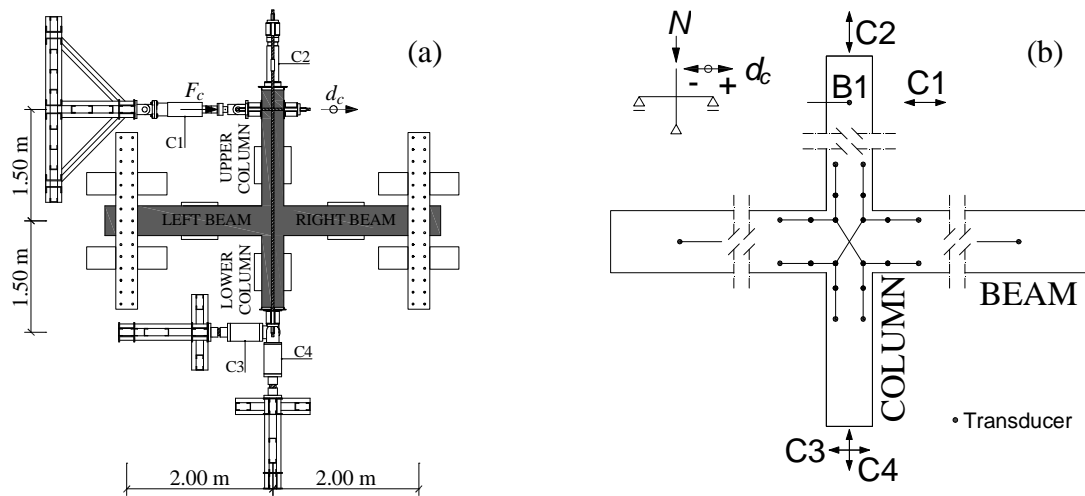
Figure 2 presents the adopted test setup and the instrumentation applied. The beams are

simple supported at their extremities, and the “lower” column is supported in both directions. The transverse and axial loads at the top of the “upper column” were applied by two hydraulic actuators equipped with two load cells C1 and C2 (see Figure 2b) to measure the corresponding forces. Additionally, one load cell (C3 in Figure 2b) was used to register the horizontal reaction at the base of the column and another one to register the vertical reaction at the same point (C4 in Figure 2b). Several inductive linear position sensors and linear variable differential transducers were used to measure relative displacements along the specimen. Further details about the test configuration and instrumentation can be found elsewhere [4, 5].

Figure 2. (a) Testing setup; (b) instrumentation.

All the tests were carried out under displacement control at B1 (see Figure 2b). The imposed law consisted on applying complete reversal cycles throughout eighteen displacement levels of increasing amplitude: ± 1 mm, ± 2 mm, ± 4 mm, ± 6 mm, ± 10 mm, ± 15 mm, ± 20 mm, ± 25 mm, ± 30 mm, ± 40 mm, ± 50 mm, ± 60 mm, ± 70 mm, ± 80 mm, ± 90 mm, ± 100 mm, ± 110 mm and ± 120 mm. From level ± 1 mm to ± 4 mm only one complete cycle per displacement level was performed. From level ± 6 mm to the end of the test three complete cycles per level were applied.

Figure 5 shows, for all the tested specimens, the global response in terms of lateral force (C1 – see Figure 2a) *versus* lateral displacement at the top of the column (B1 – see Figure 2b), as well as the corresponding envelopes. Table 1 presents the main results obtained in terms of maximum force reached and the corresponding displacement (in both directions) for the original (JD, JPA1 and JPA2) and strengthened (JDR, JPA1R and JPA2R) specimens.

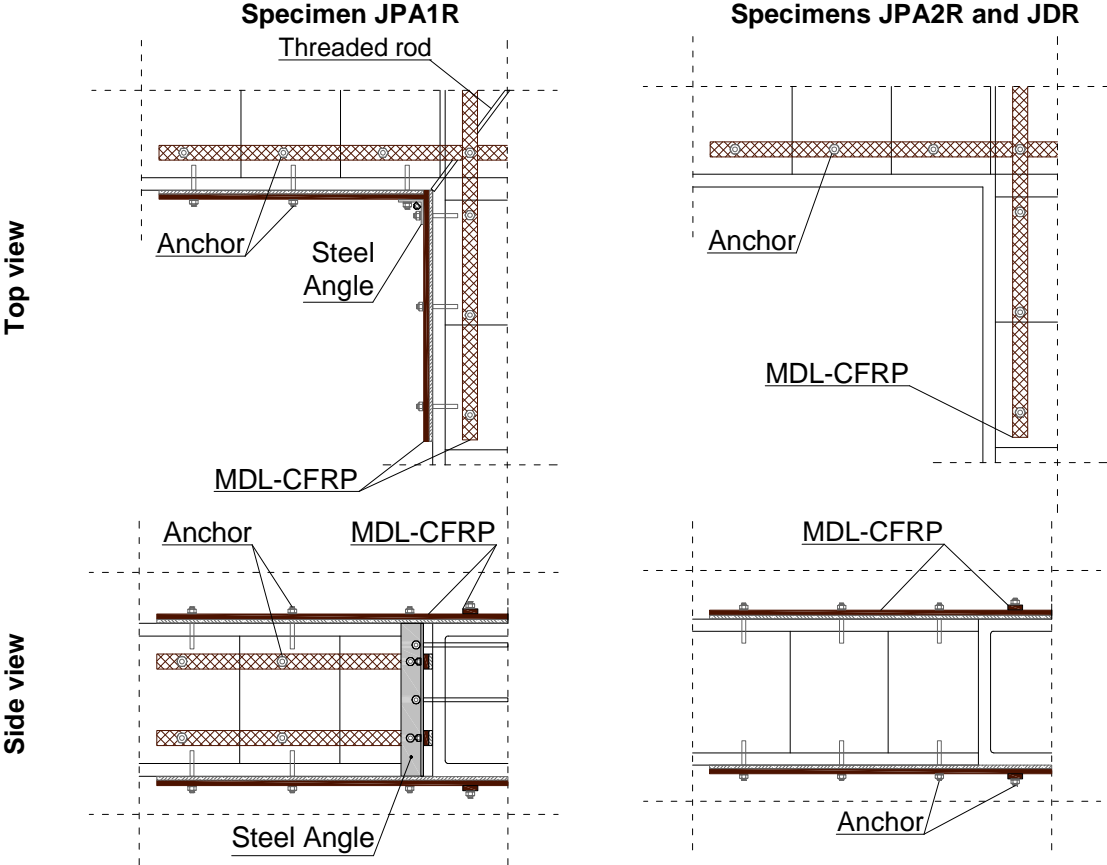
The experimental program was developed in two different phases. Initially, the three joints (denominated JD, JPA1 and JPA2) were submitted to a cyclic loading in order to introduce typical damages in these elements due to seismic actions. All the details about this testing phase can be found elsewhere [5]. In the second phase, all the joints were strengthened with MDL-CFRP according to the strengthening configurations and detailing represented in Figure 3. In this phase, the nomination adopted for the retrofitted joints is JDR, JPA1R and JPA2R.

Figure 3. Strengthening solutions detailing adopted in the context of the present work.

successive stiffness degradation is observed from the beginning of the test. The better performance of JPA1R is justified, by the threaded rods that avoid the concrete crushing at the corners of the joint and confine the core of the joint, and also by the strengthening strategy solution adopted for this specimen (see Figure 3).
