### IMPLICATIONS OF ACI 288 ON INSITU NDT OF CONCRETE COMPRESSIVE STRENGTH

# IMPLICATIONS OF ACI 288 ON INSITU NDT OF CONCRETE COMPRESSIVE STRENGTH

**KEYWORDS:** Concrete, NDT, rebound hammer, ultrasonics, sonics, GPR, impact-echo, analysis, Impulse response (mobility).

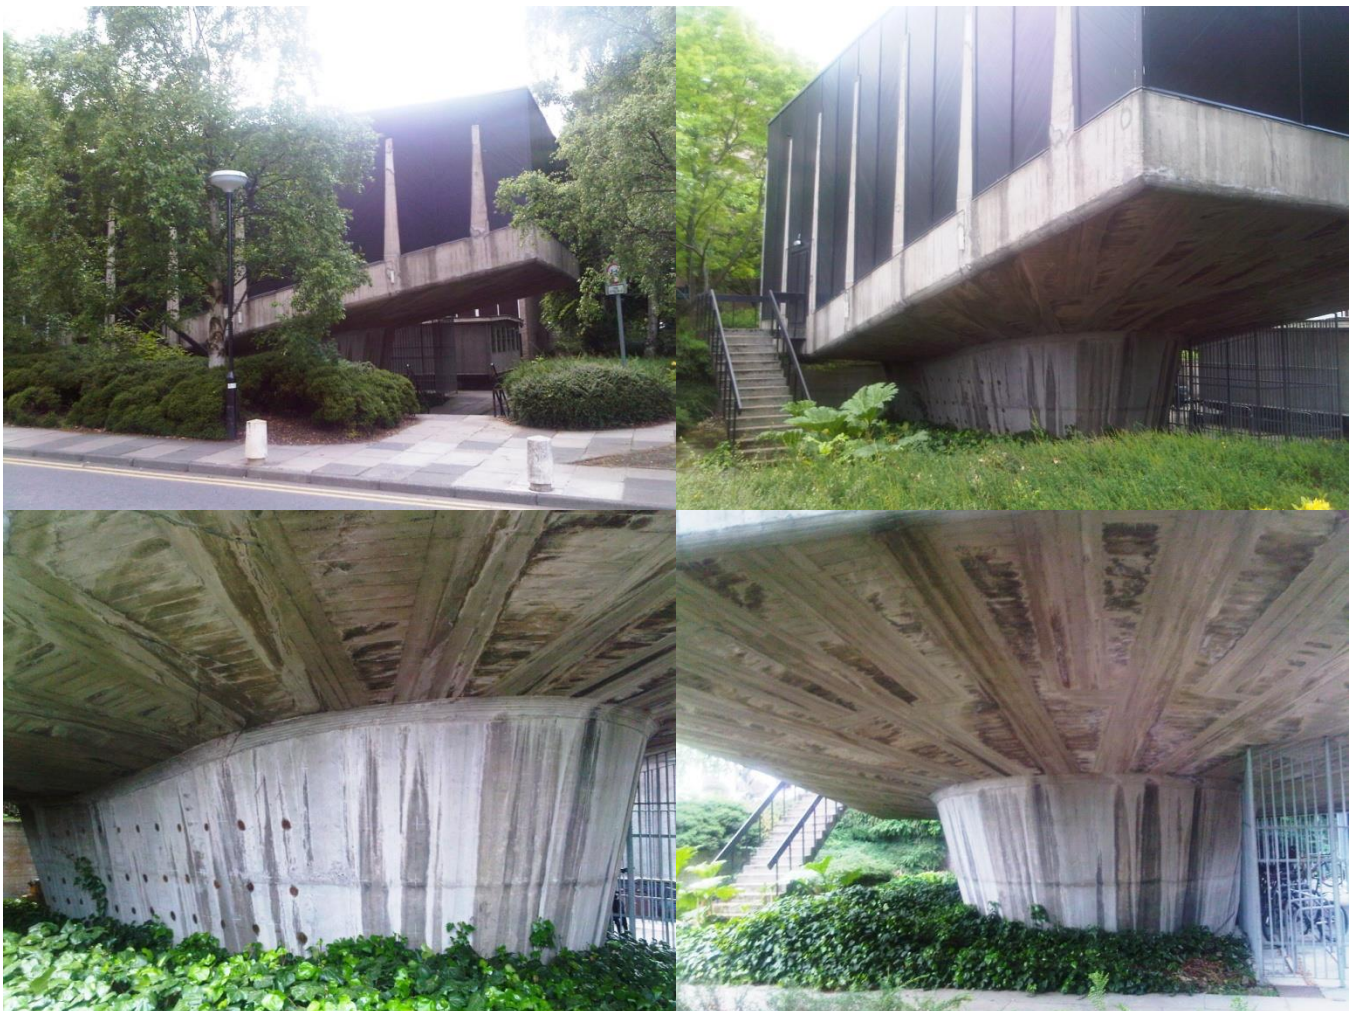
Figure 1 Engineering Lecture Theatre

As can be seen in Figure 1, the building cantilevers in three directions from a relatively small concrete base.

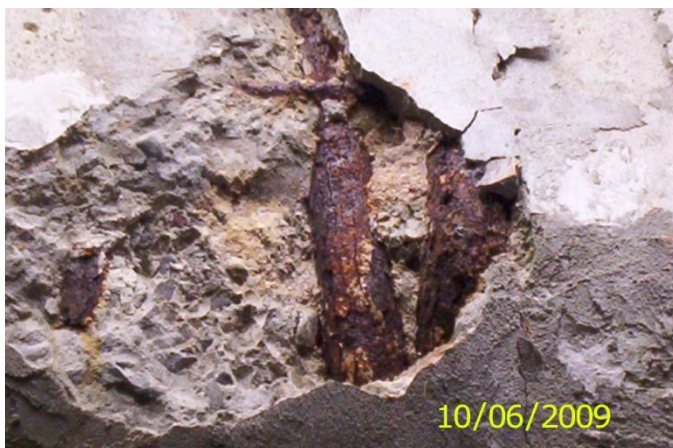
*Figure 3 Exposed reinforcement*

- In Figure 3, where reinforcement is exposed, it can be seen that there is hardly any depth of concrete cover, only a thin film of surface mortar that has subsequently fallen off; the exposed reinforcement has also become badly corroded. According to Section 3.3 of BS 8110-1:1997 (BSI), this does not satisfy the requirement minimum cover depth to reinforcement for fire protection, or to Section A4 of BS 8500-1:2006 (British Standards Institution) for corrosion protection.

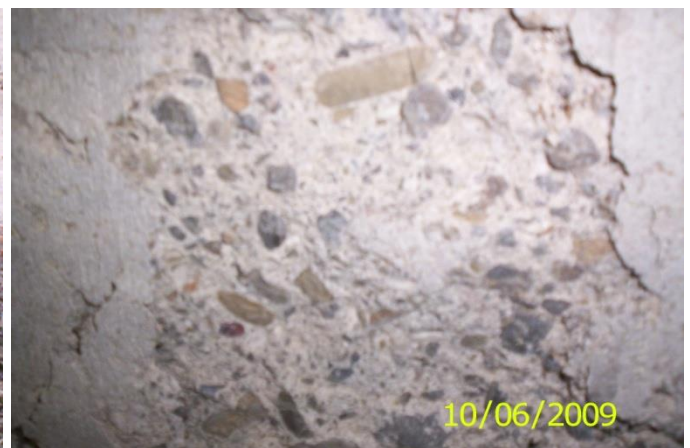
*Figure 4 The matrix of the structure*

- In Figure 4, where the concrete structure curves, parts of the concrete surface have come away in layers. It is important to note that the structure was not rendered; therefore, the concrete that has detached off is from the structural concrete.

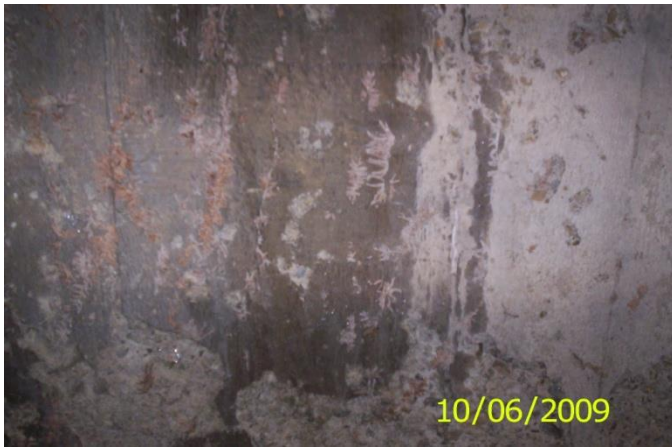
*Figure 5 Discolouration of concrete surface*

- In Figure 5, there is apparent discolouration of the concrete surface. This can be due to environmental condition, i.e., moisture penetrating the structure due to poor concreting; therefore, the concrete may suffer from carbonation.

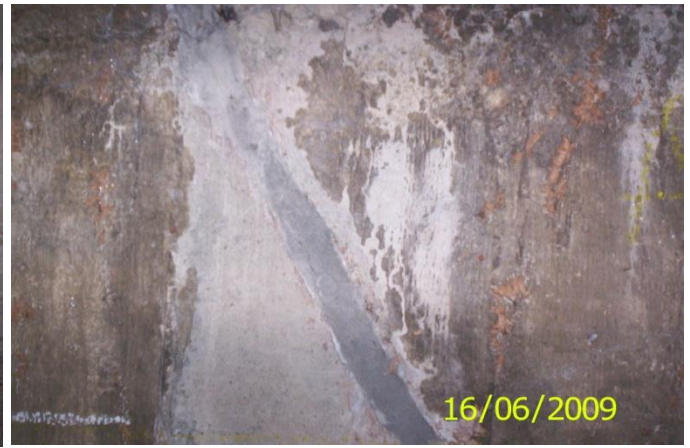
*Figure 6 Minor repair on the structure*

- In Figure 6, there have been some repairs made to the concrete surface indicating poor workmanship in the initial construction.

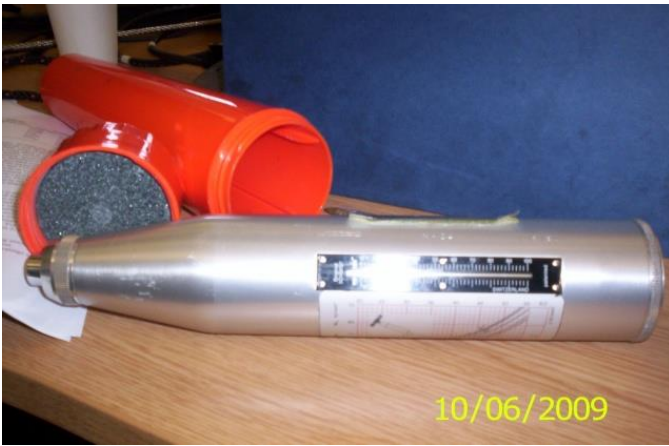
Equipment: Schmidt rebound hammer  
 Manufacturer: Proceq  
 Supplier: ELE International Ltd  
 Serial No: 108782

*Figure 7 Hardness tester*

The equipment used was as shown in Figure 7. At least ten hammer readings were taken from each grid location. Additional readings were taken if specific results were considered spurious.

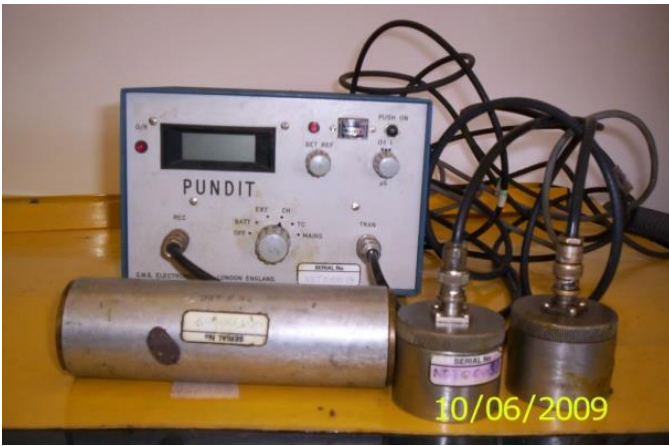
Equipment: Pundit  
 Manufacturer: CNS Instruments Ltd  
 Serial No: 8622174  
 Transducer: 54MHz  
 Calibration rod 26 $\mu$ s

*Figure 11 Ultrasonic tester*

The Pundit ultrasonic tester, as seen in Figure 1, was used on the concrete base structure where the Pundit transmitter and Pundit receiver were placed on numerous different locations on its surface.

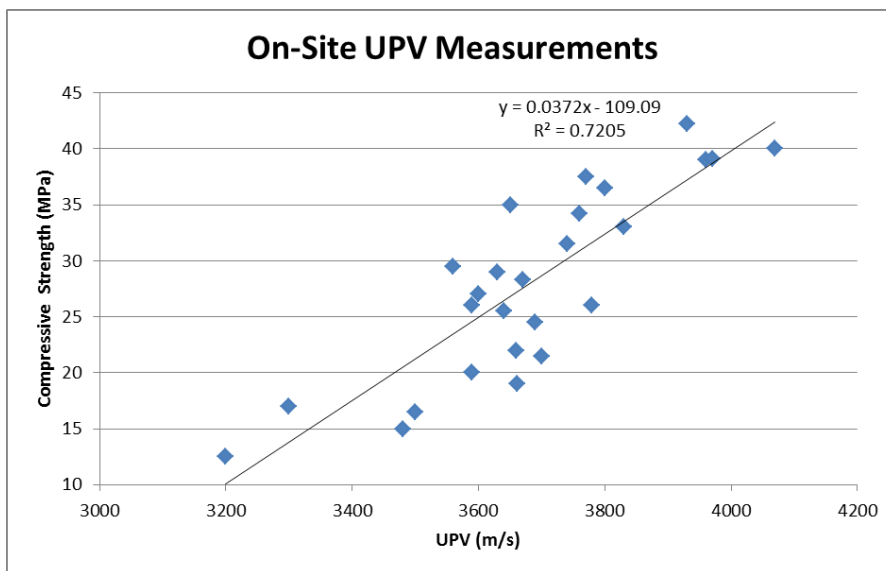
Figure 16: UPV versus Core Strength Relationship (Data from Birse et al, 1983)

Birse’s strength and UPV data for a range of aggregates were plotted and linear regression analysis was carried out so that a correlation between UPV and strength could be established (Figure 16). A linear relationship for UPV and compressive strength was established with an  $R^2$  value of 0.7205.

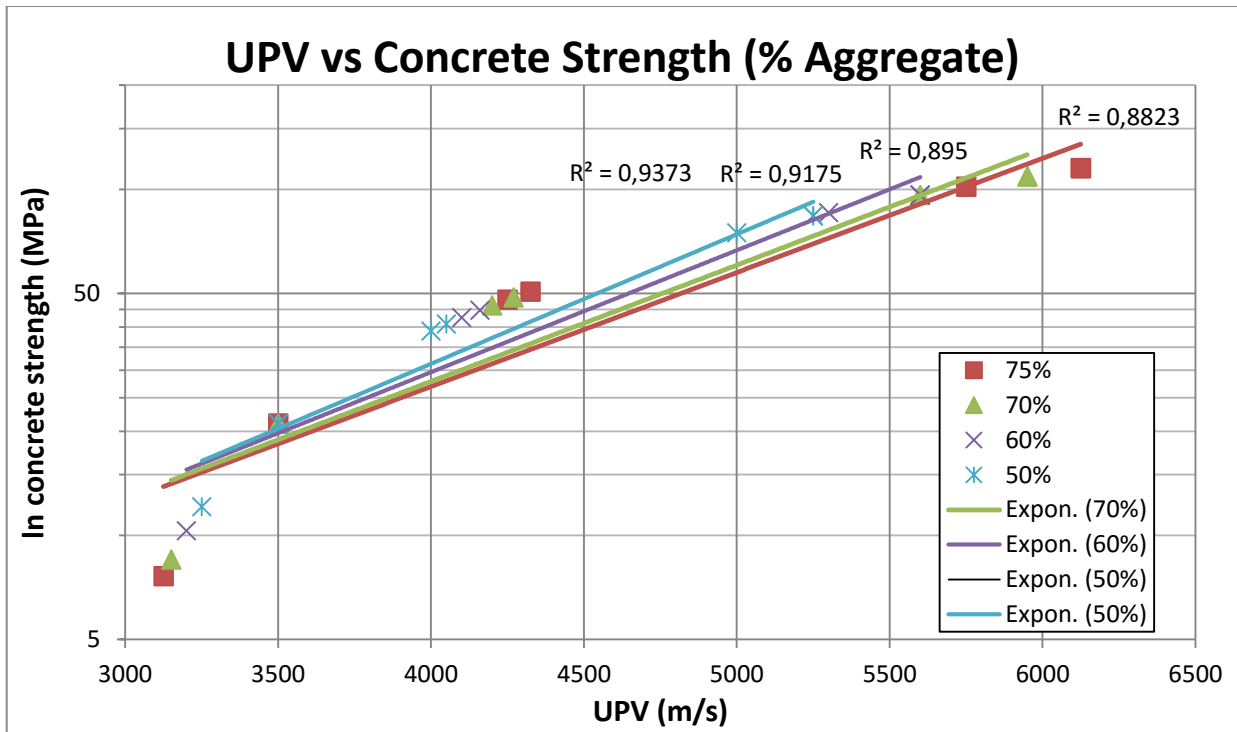
Figure 17: Influence of Aggregate Content on UPV Speed

Now that that the UPV values for mixtures with different aggregates and aggregate contents are known and a UPV-strength correlation was established, the relationship between aggregate content and strength can be established (Figure 17). Figure 17 does show a family of lines for four different aggregate contents, as expected. All of them have really good correlation coefficients – varying between 0.88 and 0.93. However, the lines are not parallel as expected. All four of the lines start approximately from the same origin and then branch out, indicating that for small strengths (under 15 MPa), the UPV values are not affected by aggregate content. And then, the stronger the concrete mix is (and thus aggregate in it), the more aggregate content would influence the pulse velocity of the mix.

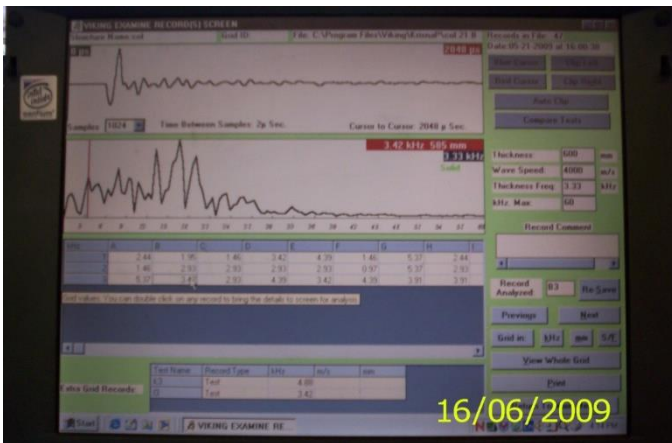
Equipment: DOCTer  
 Manufacturer: Germann Instruments A/S  
 Transducer: Displacement transducer

Figure 9 Impact echo software interface

The Mark IV transducer unit was mounted on the Star support with ball impactors and connected to the computer cable. The “Viking software” interface is as can be seen in Figure 9.

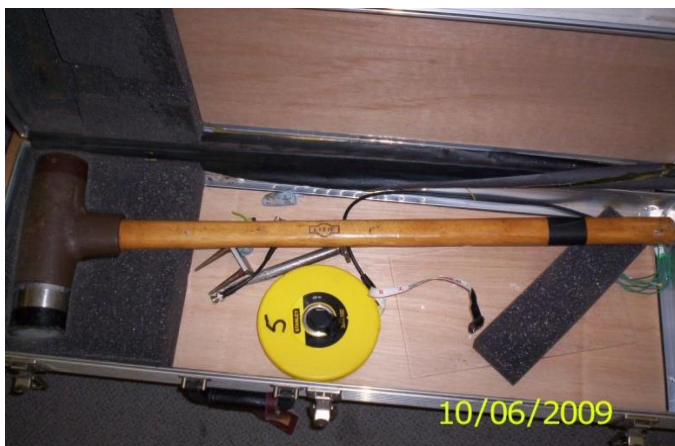
Figure 20 6kg Sledge hammer

The impact-impulse hammer is seen in Figure 20, and equipment was setup as seen in Figure 1021.

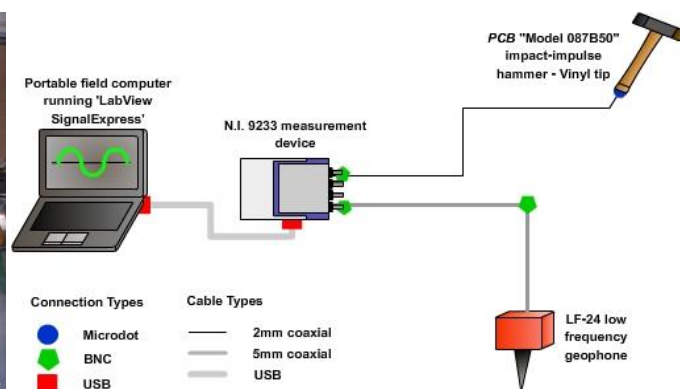
Figure 10 Experimental Setup Schematic

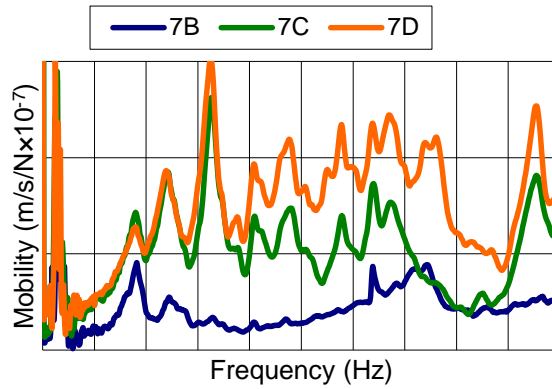
Figure 22 Mobility plot for sound and unsound system

The example graph shown in Figure 22 shows the mobility plotted against frequency of three observations over the 0Hz to 500Hz range. It can be seen that for area 7B, its mobility is less than for 7C and 7D - indicating that 7C and 7D may be subject to delamination (Davis et al, 2004). High mobility is related to delamination.

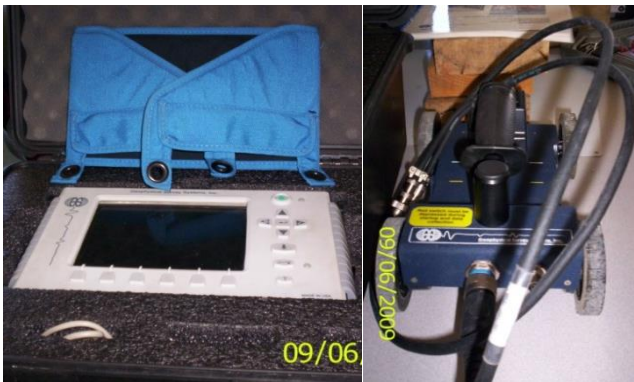
Equipment: SIR -3000

Manufacturer: Geophysical Survey Systems Inc (GSSI)

Figure 25 GPR control unit and 1.5 GHz antenna

The equipment used is as per Figure 25. Using a high frequency radar antenna, ie, 1.5GHz, is particularly suited to locating reinforcing bars in a concrete structure due to their high reflectivity, ie, there is a great difference in electro-magnetic impedance of concrete and steel, and the high resolution relates to the high frequency used.
