Mapping and characterization of a green biofilm inside of Vilar de Frades Church (Portugal)

A. Miller & M.F. Macedo

ABSTRACT: Vilar de Frades church is integrated in the Vilar de Frades Monastery, located in the North part of Portugal (Barcelos). The monastery, founded in 566, suffered several architectural modifications and restoration works, the most relevant was in the XVI century. The church, in granite, has one nave and six bays, holding ten chapels with vaults of crossed ribbings. Nowadays, the chapels present a severe biological colonization characterised by an intense green biofilm, which becoming apparent in other locations inside the church. In the course of a general survey concerning the conservation state of the church, an accurate campaign was planned in order to assess the main biodeterioration agents, map biological colonization and determine the environmental conditions. Laboratory analyses were accomplished with optical microscopy and spectrofluorometry. This study presents the results of this campaign. Details on conservation or preservation works that need to be implemented are also presented.

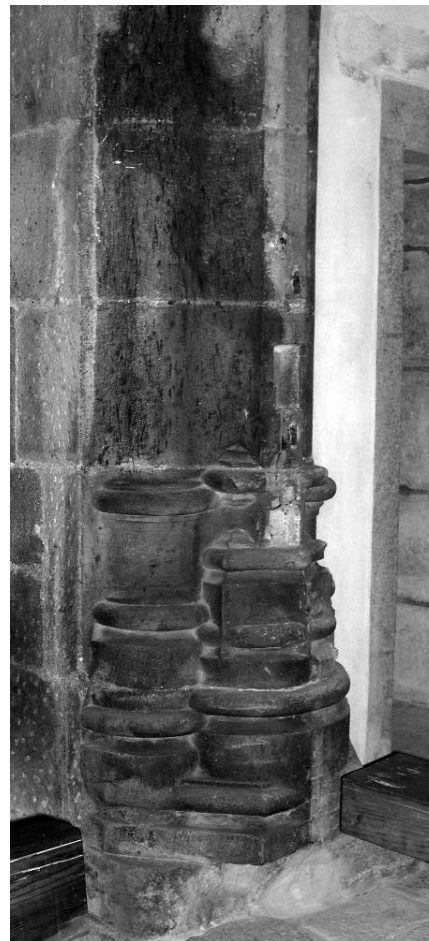
The granite surfaces of the chapels were abundantly covered with a green biological colonization. Biodeterioration phenomena were evident through these extensive and thick green biofilms. The biofilms from each chapel present different extension and distribution, and were firmly bounded to the stone surfaces (Fig. 4). Mapping of green biological patina, in chapels 3 and 4, is presented in Figures 5a, b, 6a, b.

Figure 4. Green biofilm covering the granite surface of chapel 3 left column.

This study shows that stone-degrading cyanobacteria and microalgae are present on the interior walls of Vilar de Frades church. The visible deterioration of the interior of Vilar de Frades church is mainly due to biological phenomena and it is strictly related to the environmental conditions. Therefore, in order to improve the conservation state of interior walls of the church the environmental conditions have to be altered. First, it would be recommended to avoid sunlight inside the church. In this way, there would not be enough light for the photosynthetic organisms growth, since artificial light are usually turned off. Secondly, the relative humidity and temperature of the church should be controlled to avoid the growing of heterotrophic microorganisms (fungi and bacteria). Values of relative humidity around 55 – 65% and temperature between 18°C and 20°C can be suggested. However, special care is necessary in order to avoid fast environmental changes that could damage the materials inside the church. The biofilms should be cleaned with a vacuum cleaner and a soft brush. Afterwards the moisture content of the walls should decrease. Meanwhile, different hydrophobic protective mixed with different biocide should be tested *in situ*, in order to select the mixture to be applied. After the application of the selected treatment monitoring plan should be implemented. This plan should include an hourly determination of air relative humidity, temperature and light. And a survey with photographic records, samples collection and surface moisture content determination, on a monthly basis.

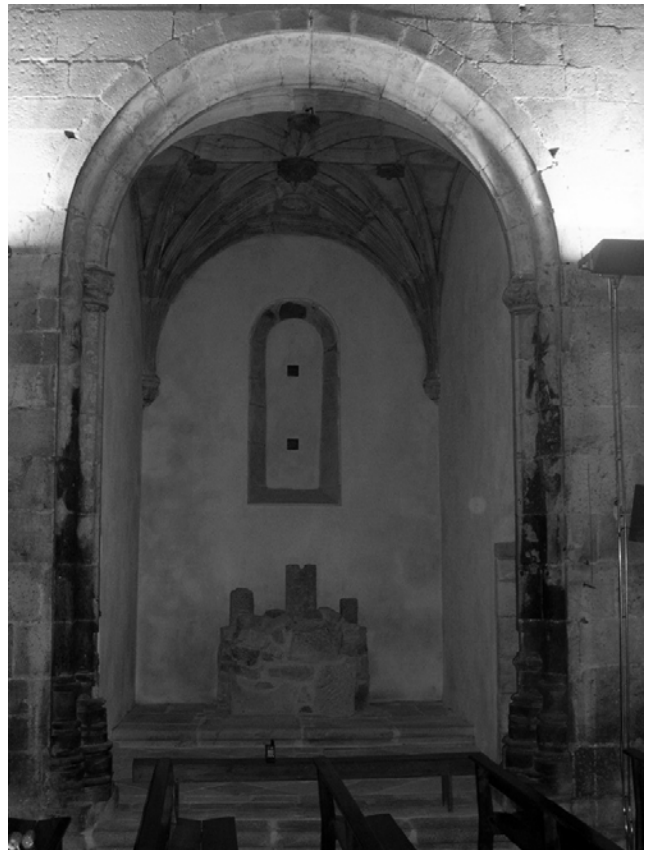
Figure 5. a) Mapping of biological colonization from chapel 3.

b) Chapel 3.

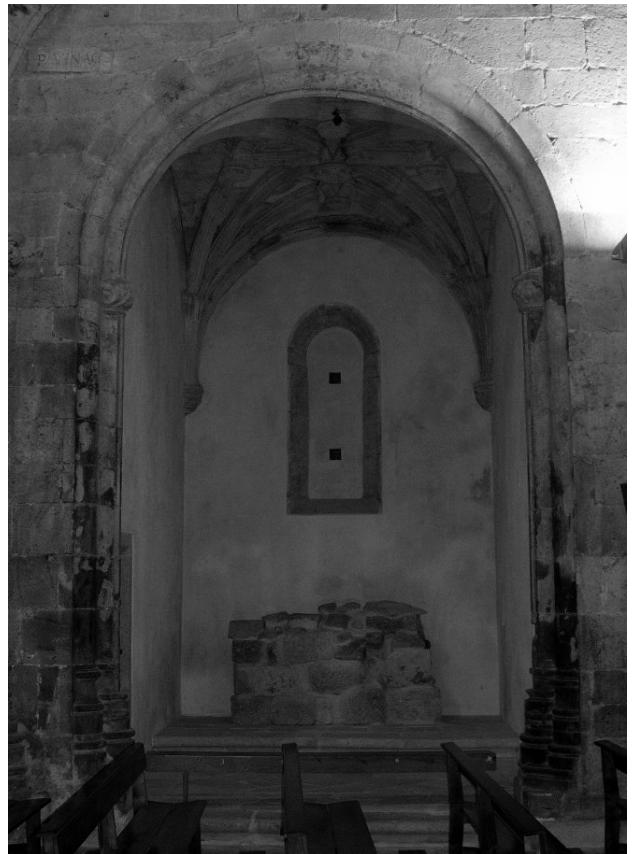
Figure 6. a) Mapping of biological colonization from chapel 4.

b) Chapel 4.
