Earth mortars from pre-historic *habitat* settlements in south Portugal

Case studies

ABSTRACT:

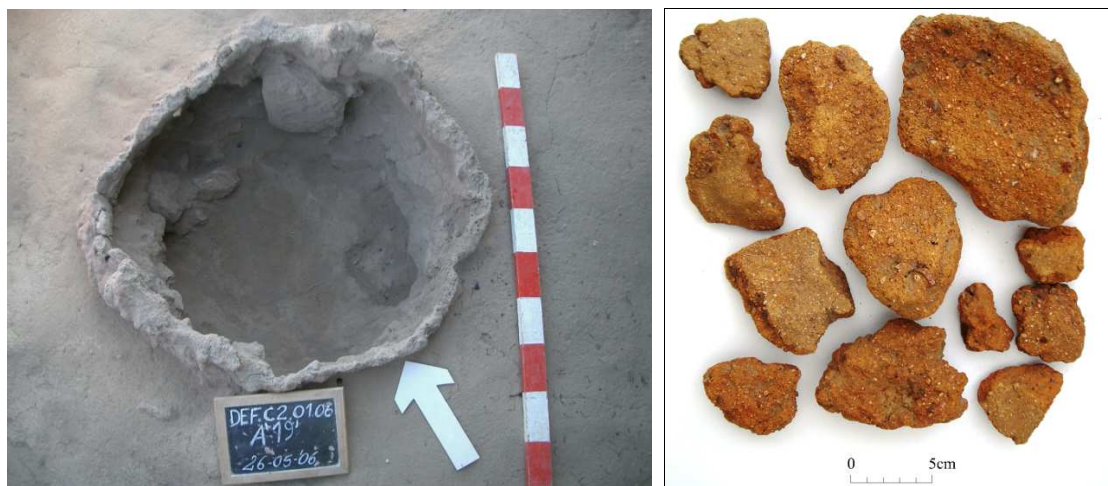
Figures 1 and 2 – Defesa de Cima 2: left, pit 5 after excavation (photo: Arqueohoje); right, samples from pit 5 rendering

Pit 5 (figure 1) had circular plan, with 0.80 m of diameter and 0.83 m of maximum preserved depth; inside, close to the basis, contained imbricate stones with combustion vestiges. Clayish renderings were continuous, surfacing the pit's lateral walls.

Morphologically, all samples were composed by small nodules and plaques of various dimensions, with 3.0 cm of maximum thickness (figure 2). Concave faces of the plaques were smoothed and some of them had finger prints.

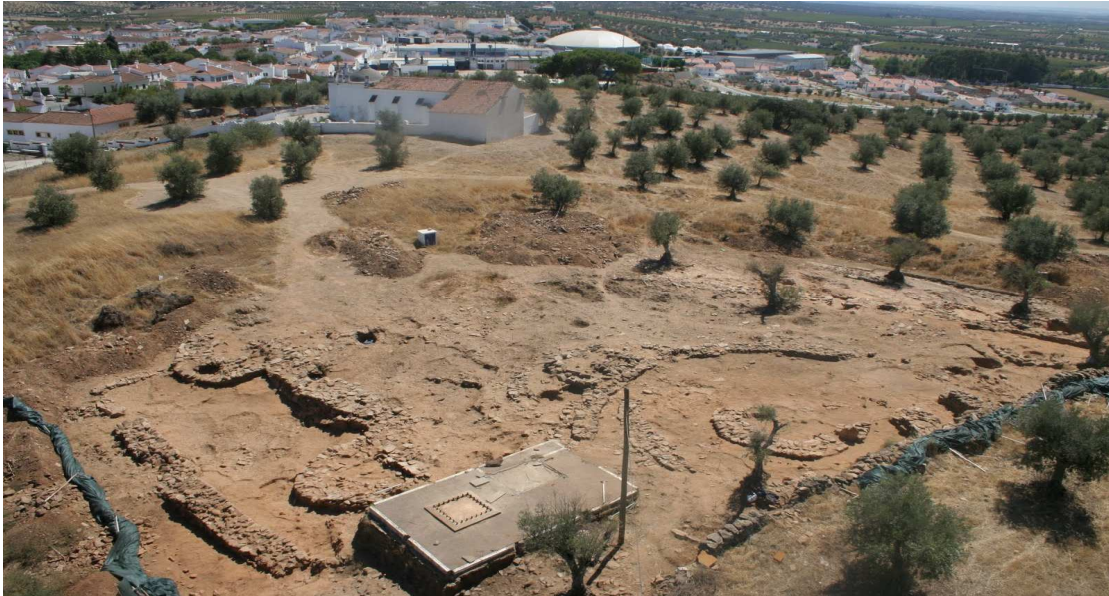
Figure 3 – São Pedro: general view of the excavated area, taken from North (photo: Rui Mataloto)

Calcolithic settlement of São Pedro (figure 3) was located in Redondo (Évora), occupying the top and the strands of a hill at the Northeast current area of the village, with wide visual field of the landscape.

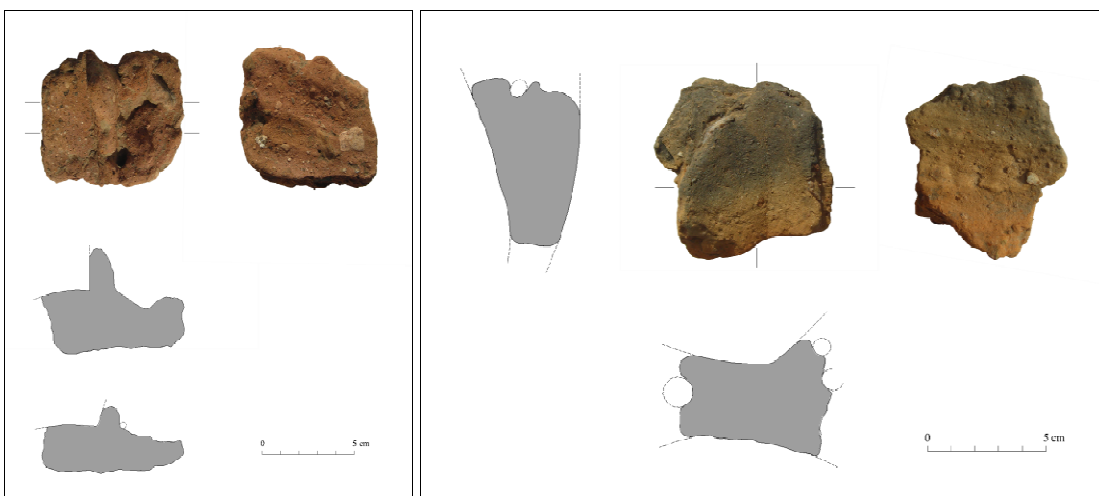
Figures 4 and 5 – São Pedro: samples SP-11 and SP-12

Sample SP-11 (figure 4), seemed to have two smoothed surfaces, forming a right angle between them, suggesting the existence of a probable wall, perpendicular to the opposite face, also smoothed.

Sample SP-12 (figure 5) also showed three smoothed surfaces, two of them forming corner, with an open angle of about 140°. One of those faces may probably correspond to a wall.

Both samples had finger prints in their smoothed faces.

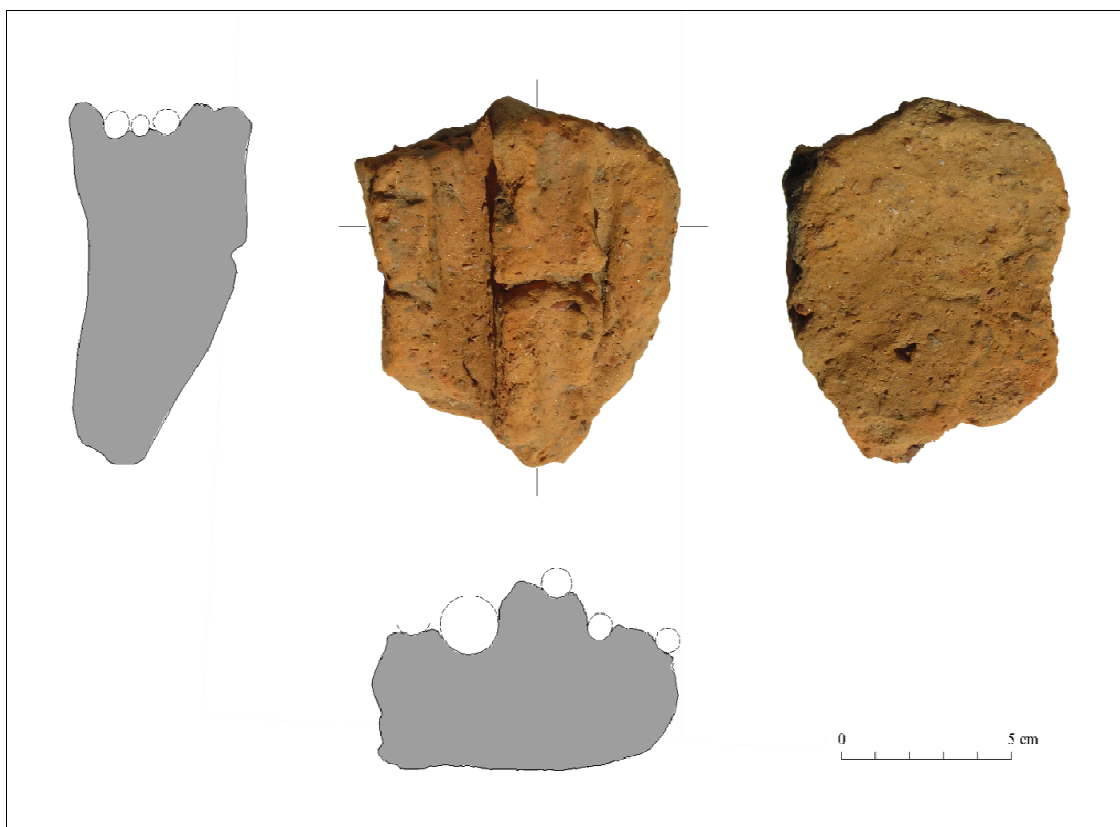
Figure 6 - São Pedro: sample SP-13

Sample SP-13 (figure 6), showed several parallel and perpendicular branches prints. This sample registered the higher thickness of all the set (6.0 cm). In the face with branches prints, a very fine branch, like a thread followed the bands of the larger branches, suggesting that branches were bound by that element.

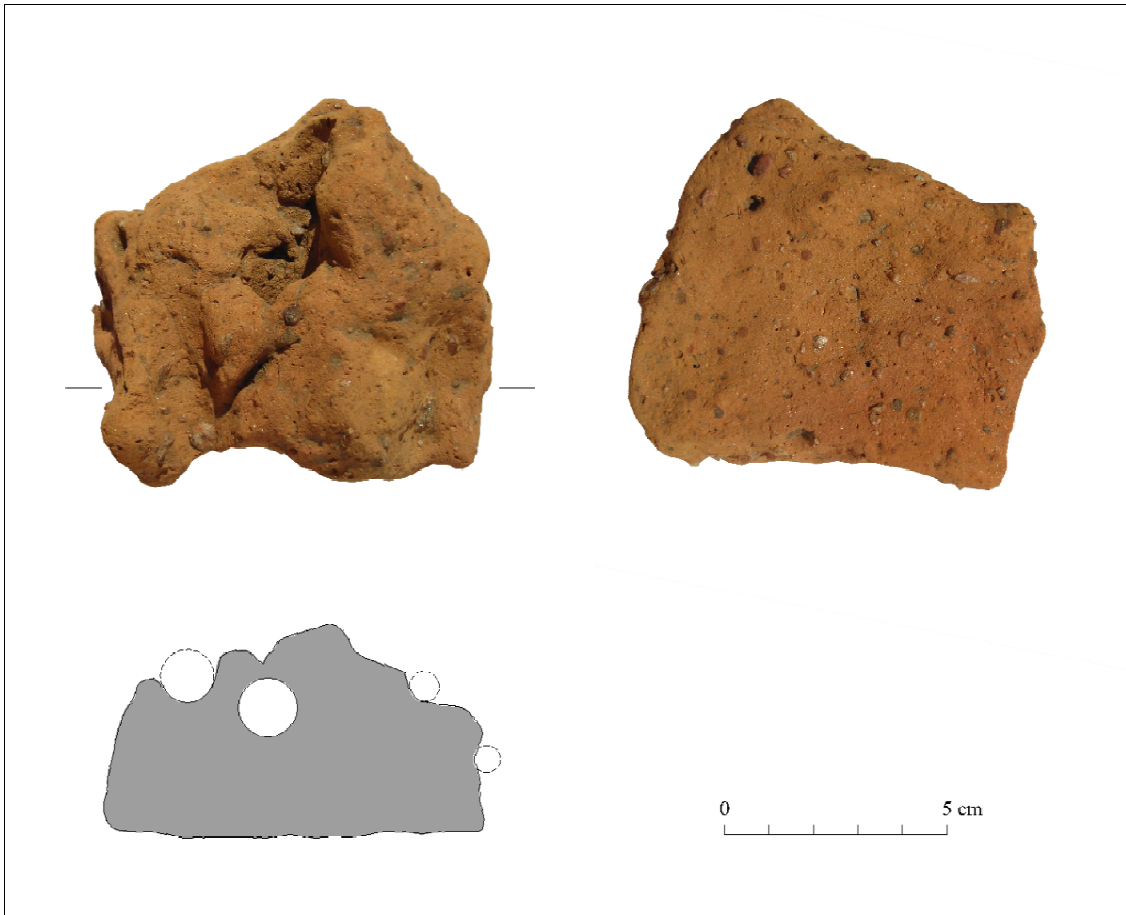
Figure 7 - São Pedro: registro SP-15

From this set, only detached sample SP-15 (figure 7), which had several parallel branches, with diameters between 0.5 cm and 1.5 cm. One of them conserved the integral negative section, which proves that, contrary of what was thought, combustion not always causes the total fracture of coating layers in contact with branches (Bruno, 2006).

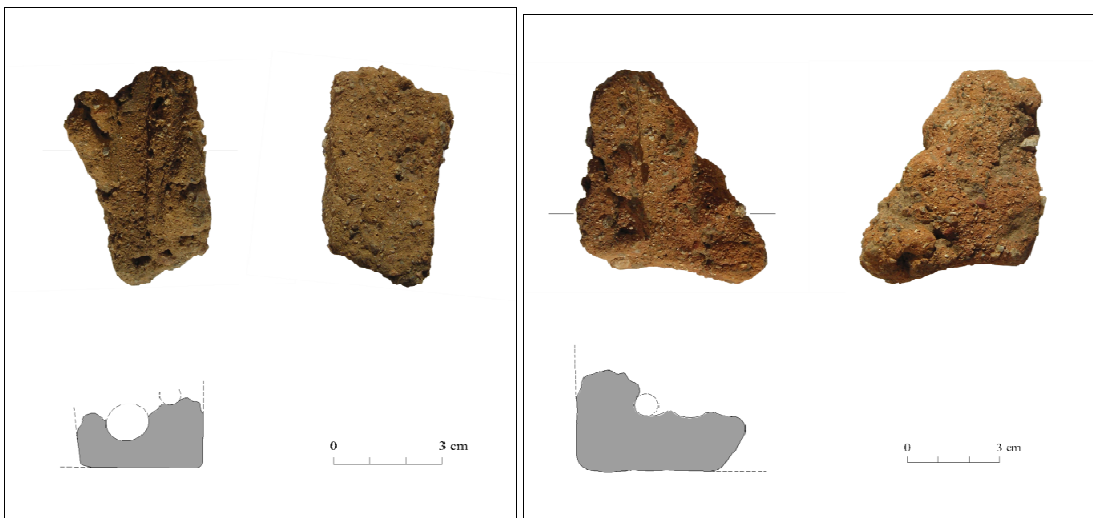
Figures 8 and 9 – São Pedro: samples SP-19 and SP-20

Samples SP-19 and SP-20 (figures 8 and 9) detached from the rest because they showed rectangular sections, defined by plain and smoothed surfaces forming almost perfect squares.

The fragments aspect, especially SP-19, suggests that they could belong to delimitation elements like frames or strips, or even fixed or semi-fixed domestic equipments.

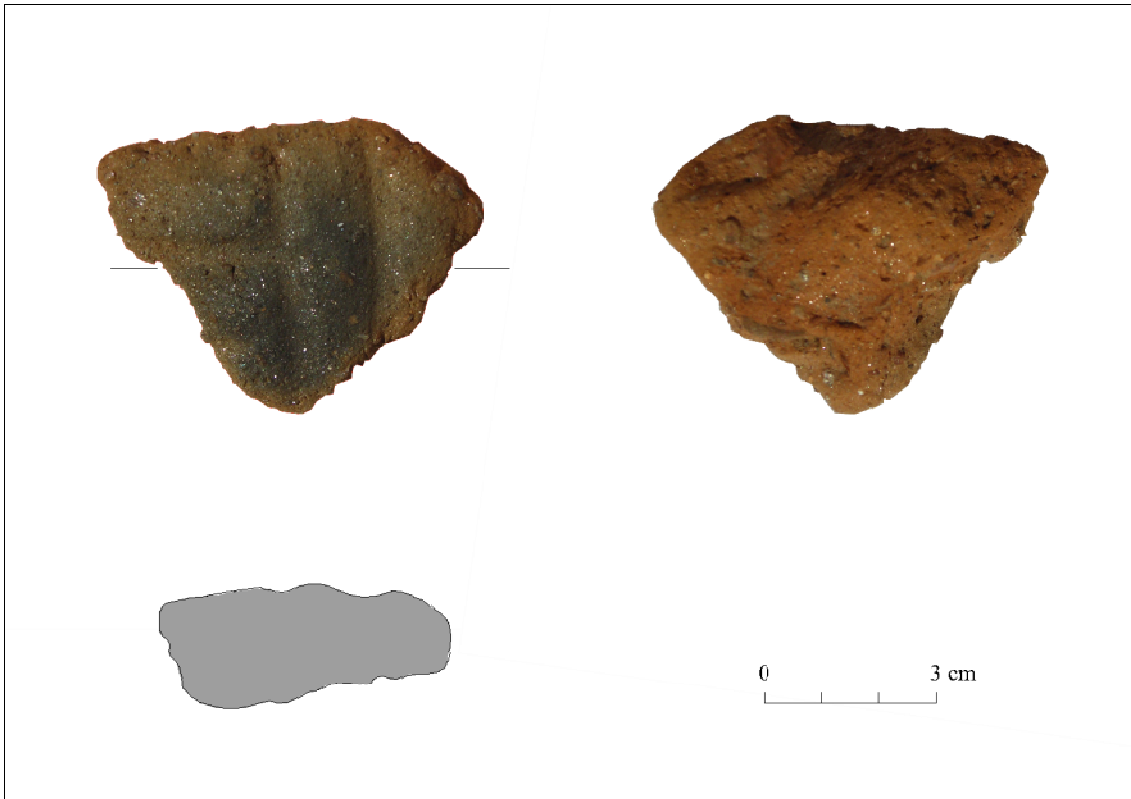
Figure 10 – São Pedro: sample SP-27

From that set of materials, detaches SP-27 (figure 10), which had a smoothed surface with 4 incised straight lines, perpendicular between themselves, and probably coming from the finish surface of a decorated wall.

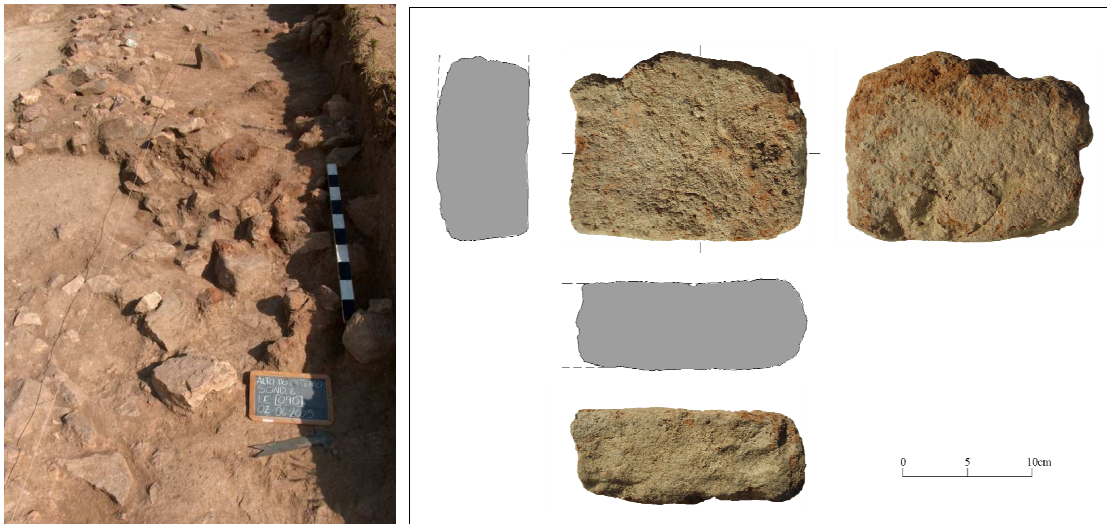
Large quantities of fragmented mudbricks were detected upon the clogging levels of the most exterior moat (figure 11) and an adjacent stone base, with about 0.5 m of thickness. Those mudbricks, apparently coming from structure decay, probably belonged to a wall upon that stone base.

One of the faces (the smallest) showed two finger prints, which seemed to result from the mudbrick handling while he was still in plastic state. The fragment weighed 2.832 kg and measured 17 cm x 14 cm x 6.5 cm, showing two fractured faces.

Figures 11 and 12 – Alto do Outeiro: left, clogging levels of the exterior moat, were mudbrick fragments were found (photo: Carolina Grilo); right, fragment of mudbrick AO-706, from unit 90

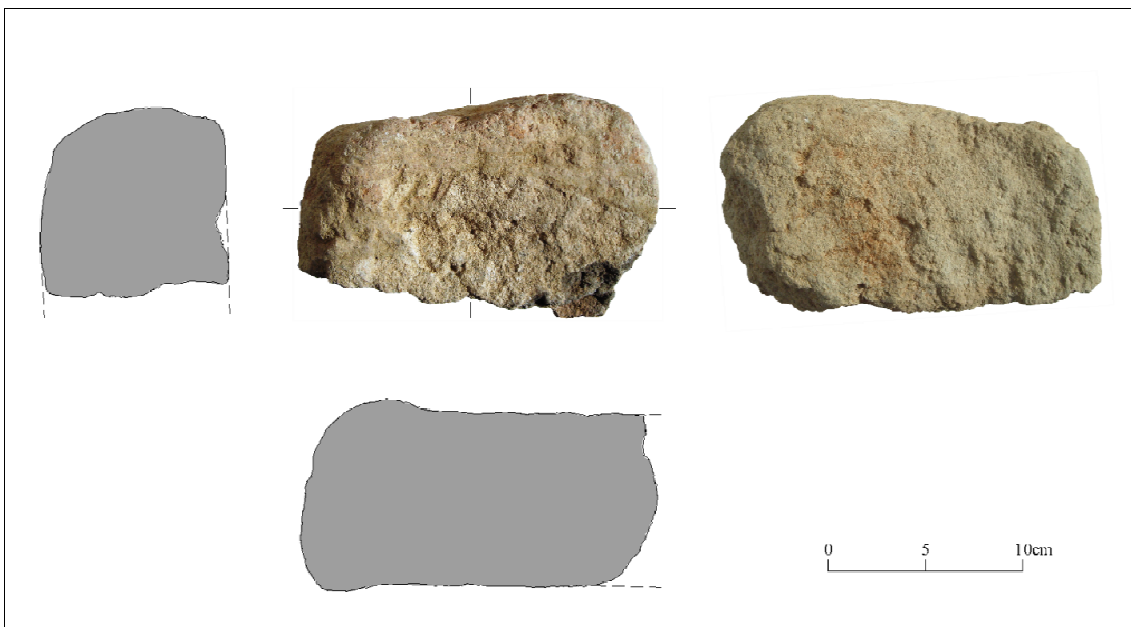
Figure 13 – Alto do Outeiro: fragment of mudbrick AO-729, from unit 101

Materials from unit 101 were also composed by several nodules of clay mortars and a big mudbrick fragment of yellowish color (sample AO-729, figure 13). Mudbrick fragments measured about 16 cm x 9 cm x 7 cm and had two fractured faces. The other four faces seemed smoothed, however not plain. Edges were rounded. The fragment weighed 2.476 kg.

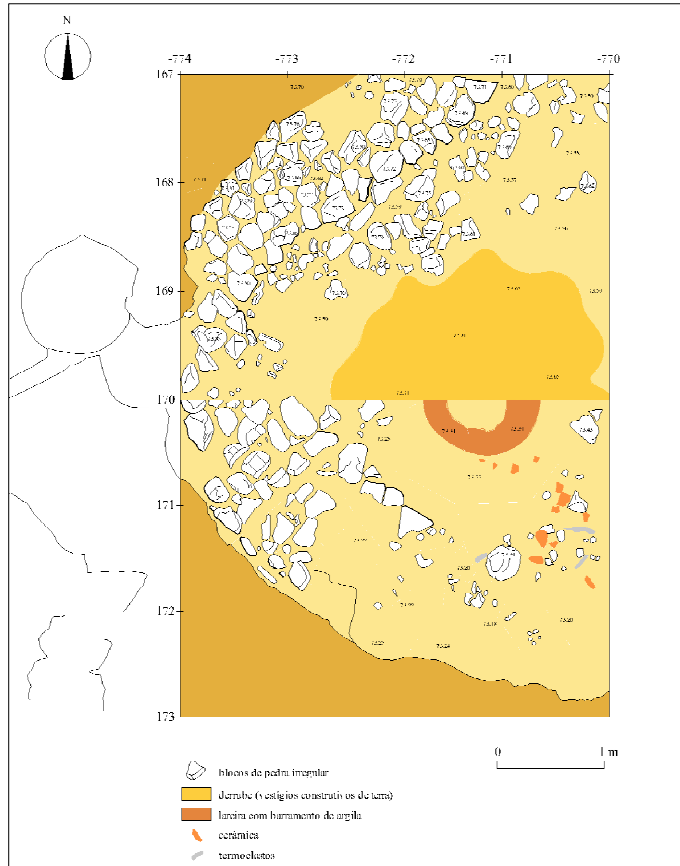
Figure 14 – Alcalar: final plan of hut from “Corte 5”, redrawn upon original from Elena Morán

Analyzed materials were collected from a drop inside a big hut with oval plan (figure 14), located in the settlement's central area. They were found upon the hut's large stone base and in its interior and probably belong to a massive earth wall.

In the hut's interior existed a fire place, with circular plan on torus form, made on small pebbles and clay mortar, clay rendered.

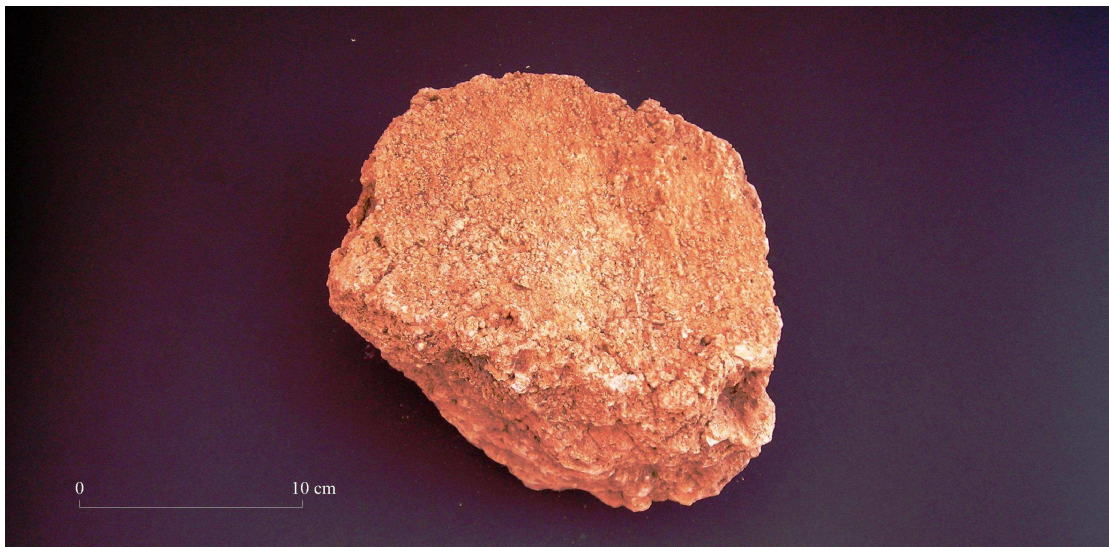
Figure 15 – Alcalar: sample ALC5-10

Generally, selected samples (figure 15) showed irregular textures and seemed apparently rich in fine aggregates (sands), with some pebbles of larger dimensions (limestones and shells), comparing to other analyzed materials; almost all fragments showed carbonated aspect, possibly caused by chemical modification of aggregates.

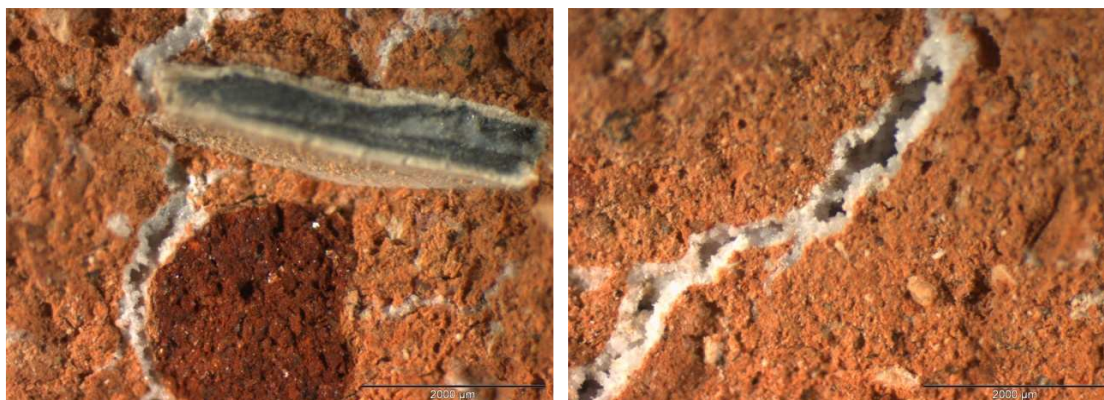
As to conservation status, materials showed chemical modification, by generalized presence of calcareous concretions, probably due to water percolation in the interior of materials. Those concretions were majority associated to large and numerous cracks.

Figures 16 and 17 – Alcalar: binocular glass photos of two mortar samples, 20x amplified

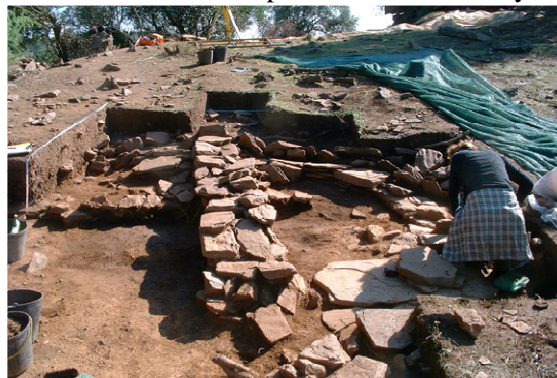
Figure 18 – Rocha do Vigio 2: oval hut excavation (photo: Manuel Calado)

Excavation allowed identifying the traces of an oval plan hut (figure 18), composed by a stone base and a row of slabs of shale, vertical arranged, which defined its exterior perimeter (Calado, Mataloto & Rocha, 2002).

In the interior of that structure were found abundant fragments of clay mortars with branches prints, probably belonging to the walls and roof of the hut, composed by wood structures.

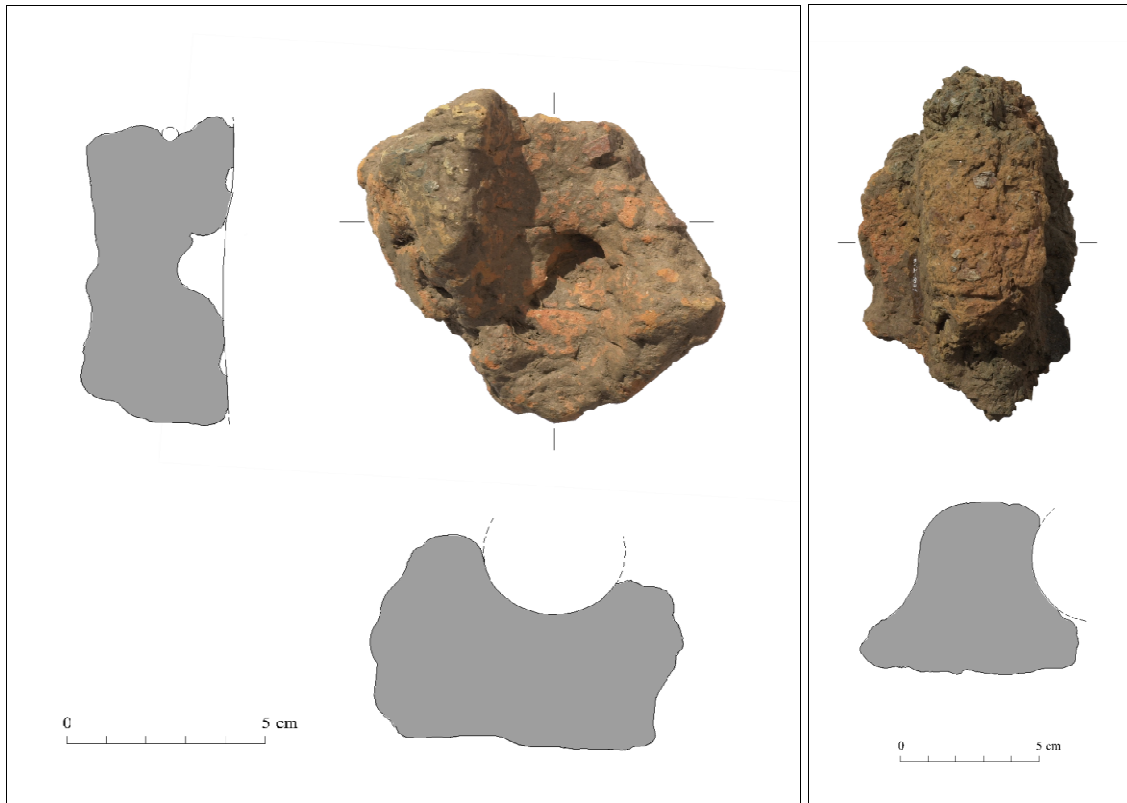
Figures 19 e 20 – Rocha do Vigio 2: individual records 445 and 1031

Individual record 445 (figure 19) had 5.6 cm of thickness. The fragment showed a concave smoothed face and, on the opposite site, an irregular surface, with a branch trace with about 3.6 cm of diameter; one of the lateral faces had a small branch trace, with 0.5 cm diameter, perpendicular to the larger branch.

Individual record 1031 (fig. 20) had only one branch, with 4.0 cm of diameter. Alongside this, the fragment showed a shaped surface, that seems to have made the frame finish of a jamb or lintel of a doorway.

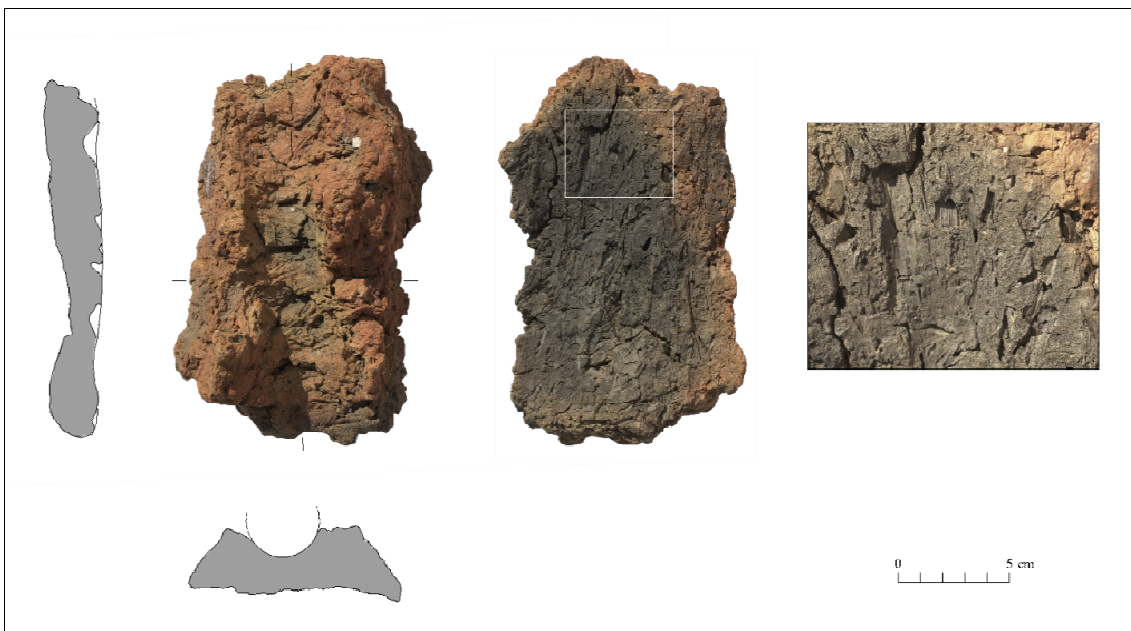
Figure 22 - Rocha do Vigio 2: individual record 975

Individual record 975 (figure 21) showed a big branch print, with about 3-3.5 cm of diameter, and several node prints in its longitudinal development.

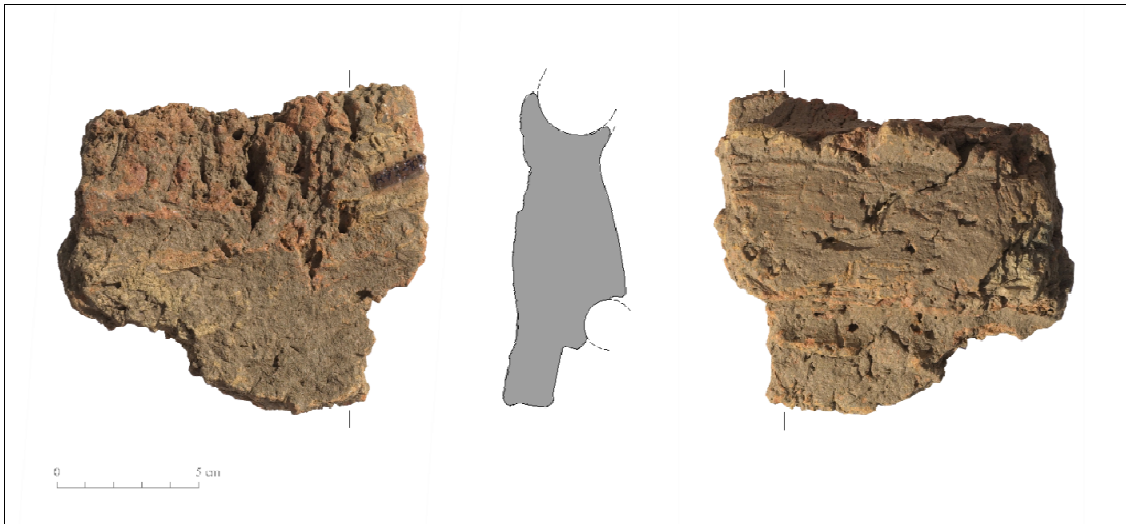
Figure 23 – Rocha do Vigio 2: individual record 901

Individual record 901 (figure 23) had about 4 cm of thickness. It showed a smoothed face, with finger prints; in the opposite face had two branch prints, with diameters of about 1.8 and 2.9 cm, and two planks, all parallels.

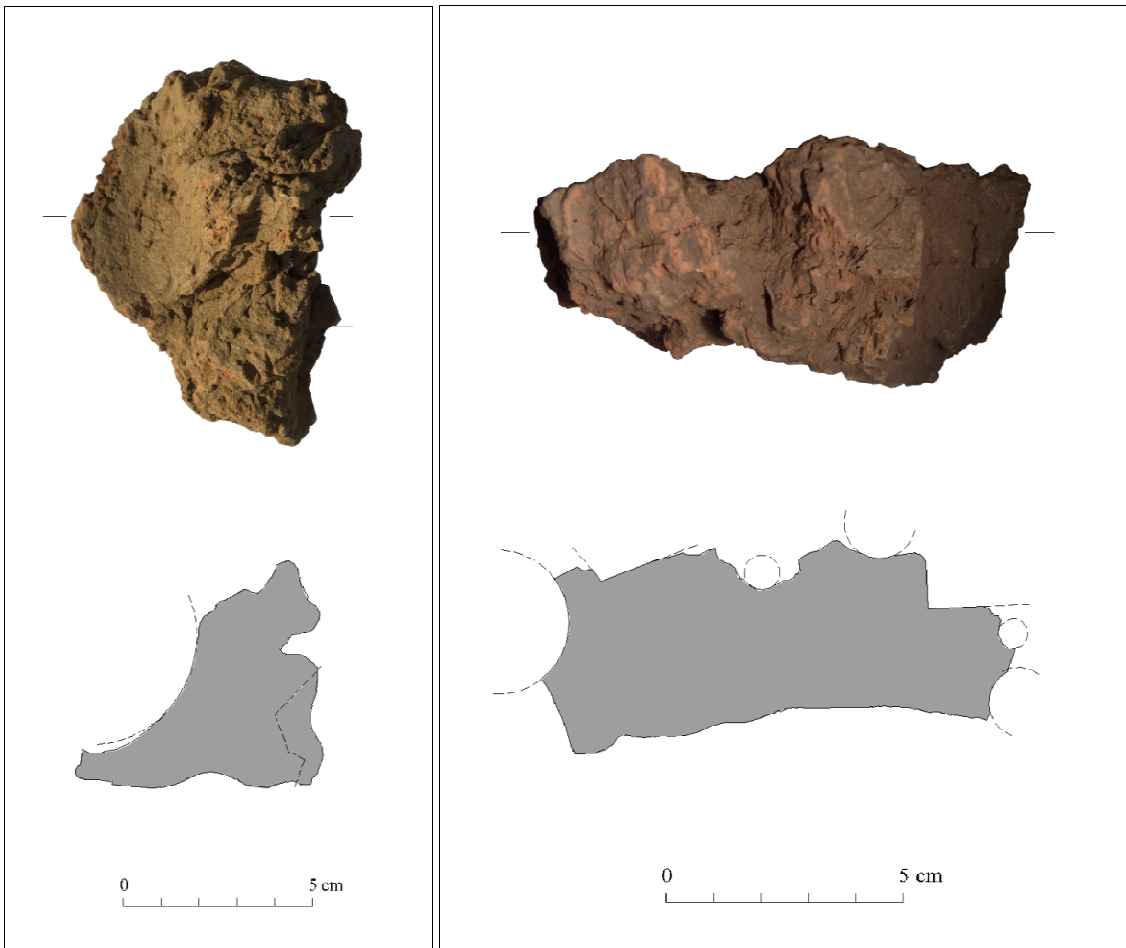
Figures 24 and 25 – Rocha do Vigio 2: samples RV-14 and RV-15

Sample RV-14 (figure 24) had 5.6 cm of thickness. It showed a smoothed face, with finger prints; in the opposite face had two perpendicular branch prints, with 5.5 and 0.5 cm of diameter. The fragment also showed a probable plank print.

Sample RV-15 (figure 25) measured 4 cm of thickness. It showed a smoothed face, with finger prints, and five parallel branch prints in the opposite face, with diameters of 0.7-1.5 cm. also had two plank prints, apparently parallels to the branches.

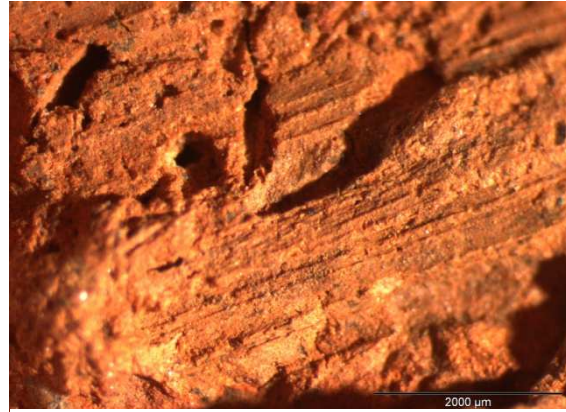
Two samples from unit 59 were observed at binocular glass (figure 26).

Mortars had brown red colors and homogenous composition. Straw prints were observed.

Samples showed some circular pores, with diameters until 0.5 mm; some microfissures were also detected, with apertures until 0.2 mm.

Figure 26 – Rocha do Vigio 2: binocular glass photo of a sample from unit 59, 20x amplified
