LOURENÇO T, MATIAS L, FARIA P (2017), Anomalies detection in adhesive wall tiling systems by infrared thermography. *Construction and Building Materials*, 148, 419-428 (September 2017), <https://doi.org/10.1016/j.conbuildmat.2017.05.052>

Anomalies detection in adhesive wall tiling systems by infrared thermography

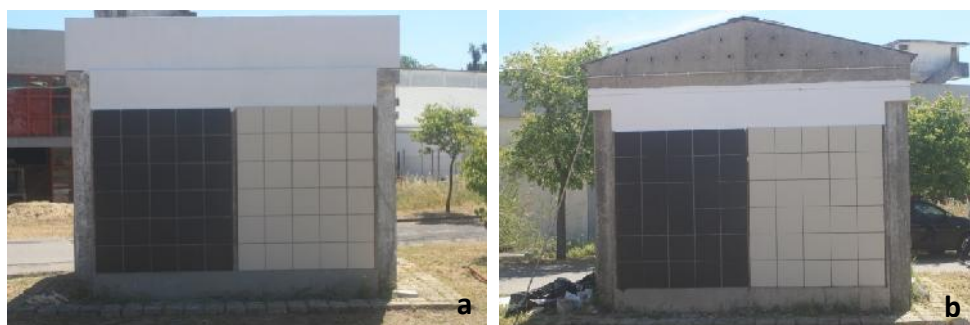
Four tiled panels were applied on two West facing facades (figure 1) of two experimental cells situated in National Laboratory for Civil Engineering (LNEC) Campus, Lisbon, Portugal. Panels have differences in terms of the tiles' colour and kind of support. Cell 1 tiled panels were applied as finishing coating of ETICS (External Thermal Insulating Composite System). Therefore, a thermal insulation is beneath the tiling system. Cell 2 tiled panels were applied on a traditional solution of a brick masonry cementitious regularization render. Each cell had then two panels, one with black tiles (on the left) and one with white tiles (on the right).

Figure 1 – Experimental cell 1 (a) and experimental cell 2 (b)

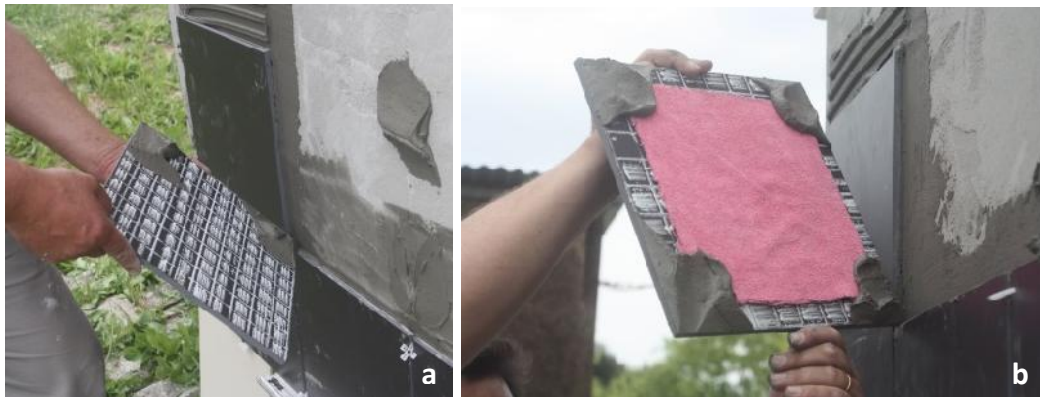
Purposely within each panel there are tiles with provoked detachments. The detachments were simulated by leaving an empty space approximately between 2 and 3 mm beneath the tile where the adhesive grout was not applied (figure 2a). Each panel had also one tile on its top (figure 2b) where a piece of cloth was placed in the detached area aiming to help in further moisture testing by trapping the injected water and preventing runoffs. In order to prevent infiltrations before the moisture testing, a polyurethane sealant was used to seal the panel's edges.

Figure 2 – Simulation of the anomalies of detachment (a) and placement of the water absorptive cloth beneath a tile (b)

Figure 2 shows the anomalies' simulation (detached tiles and detached tiles with a cloth beneath).

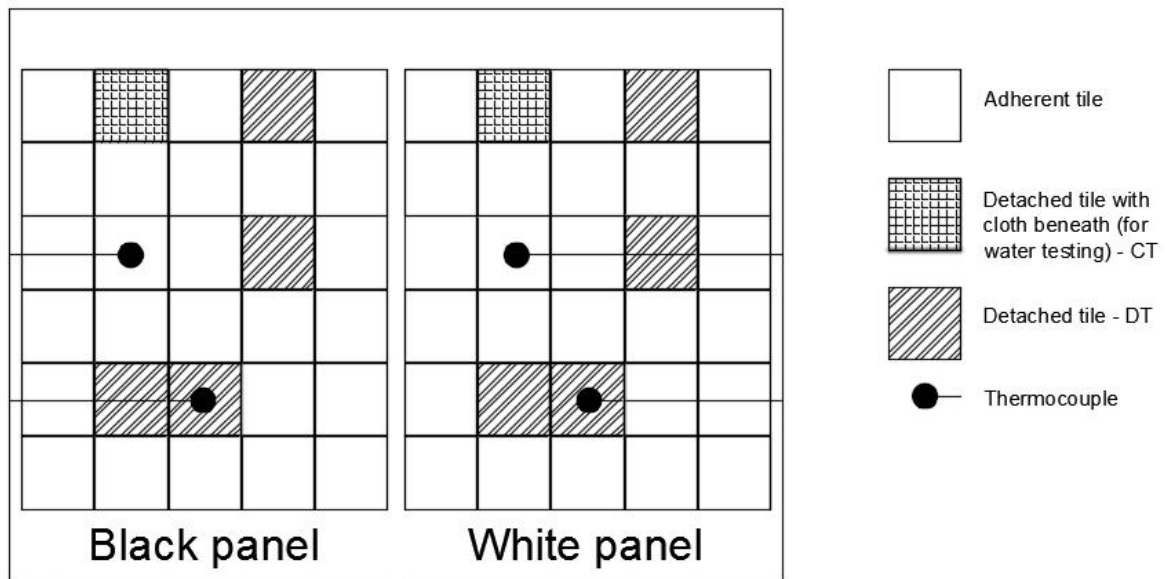
The positioning of the detached tiles within each panel is the same for all the four panels according to the scheme on figure 3. On the same figure, it is possible to see the positioning of thermocouples type T - Copper/Constantan - that were placed beneath the tiles, in the adhesive layer, in order to allow continuously reading of temperatures and, therefore, reinforce the thermographic data. Those

Figure 3 – Schematic representation of the panels with the detached anomalies and instrumentation

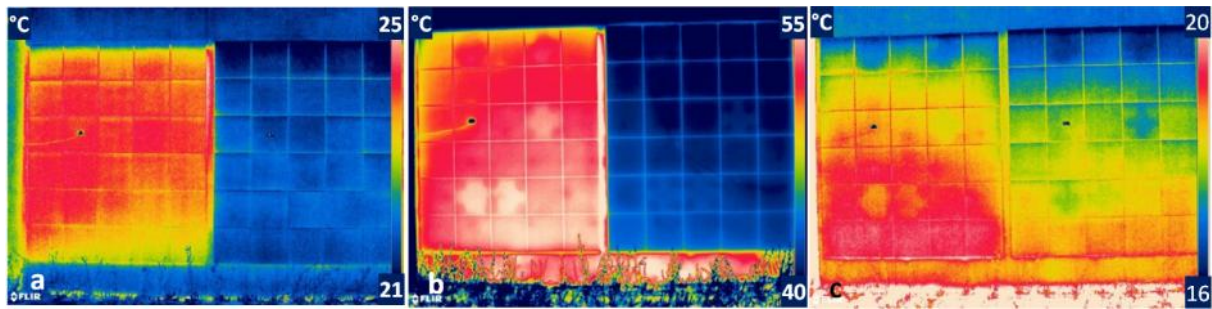
As a first result of this survey, figures 4 and 5 show two sequences of thermograms where the thermal variations during the same day are presented for each experimental studied cell. Therefore, on figure 4 there are three general thermograms: the first in the morning - before solar incidence (air temperature: 24°C); the second after one hour of solar incidence (air temperature: 30°C) and the third at night - cooldown period (air temperature: 21°C) of the experimental cell 1. In each case the black panel (C1_B) is on the left and the white panel (C1_W) is on the right. Similarly, figure 5 contains three thermograms, each with a black panel (C2_B) on the left and a white panel on the right (C2_W). In the thermograms, black panels appear in reddish colours due to the higher emitted temperature when compared with the white panels (represented in bluish colours). The temperature scale had to be adopted to each thermogram containing both black and white panels (with major thermal differences between them), which compromises the visibility of smaller thermal differences such as the ones that suggest anomalies. As mentioned, for analysis purposes two thermograms per panel were taken from closer distances allowing a narrower scale adoption and, therefore, facilitating the anomalous spots visualization. It is of note that thermograms from figure 4 and 5 are not in the same

Figure 4 - C1 (ETICS) at 9:30 am (a); 3:30 pm (b) and 10:15 pm (c)

Analysing qualitatively the thermograms it is possible to take the following conclusions, which are consistent with the results obtained in a previous survey with open joints [33]:

- In the morning period, without solar incidence, the thermal differential between panels with different colours is attributed to diffuse radiation as both tiles are made out of the same material and the roughness is similar. Furthermore, the tiles' emittance value, carefully measured in laboratory for both the two colours, was the same (0.88) [31].
- Temperatures obtained for cell 1 (with thermal insulation of the ETICS) are higher than the ones registered on cell 2 (without thermal insulation).
- Anomalies detection is easier on cell 2.
- In the heating phase (two first thermograms) the detached tiles are hotter than the adherent ones; contrariwise, on the cooldown phase, detachments are presented as colder spots.

In a first analysis, it is easy to identify the effect of moisture beneath tiles in these two thermograms. Comparing the results obtained with the “dry results” (figures 4 and 5) the main conclusion is that

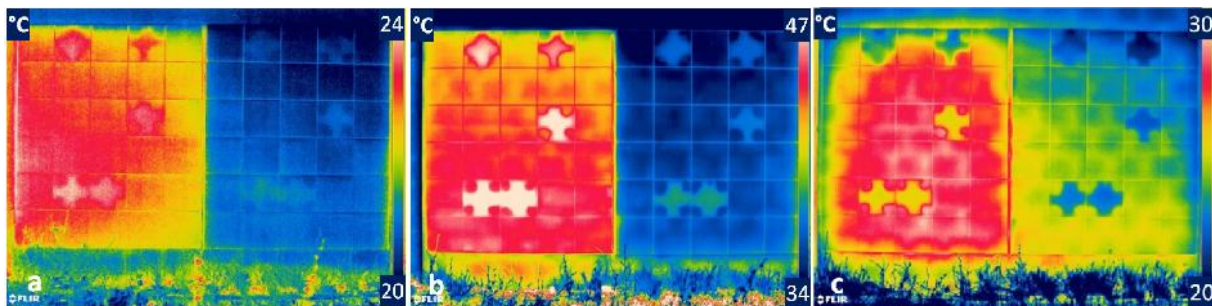
Figure 5 - C2 (rendering system) at 9:30 am (a); 3:30 pm (b) and 10:15 pm (c)

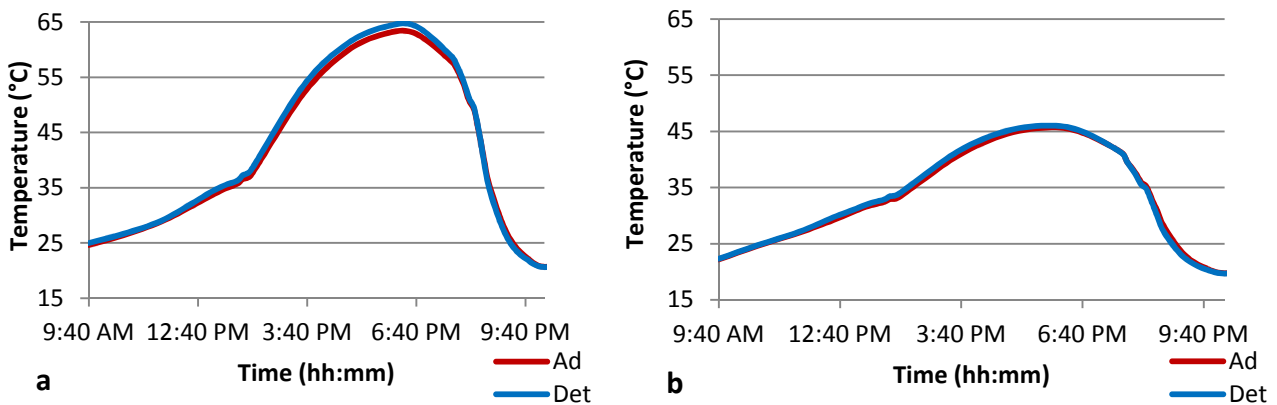
In order to study numerically the thermal variations in both the detached and adherent tiles of each panel, the graphics of figures 6 and 7 were created for the 20th July 2016. The temperatures presented in the graphics were obtained by measuring each tile's average temperature (area of tile) and afterwards calculating average temperatures for both the adherent and detached tiles of each panel, resulting in two curves per panel.

Figure 6 - Evolution of adherent (Ad) and detached (Det) tile's average temperatures in **cell 1's**

black panel (a) and white panel (b)

Analysing both the thermograms and the graphics that describe the evolutions of the temperatures obtained for the detached (Det) and adherent (Ad) tiles it is possible to take some similar conclusions regarding the cladding's behaviour.

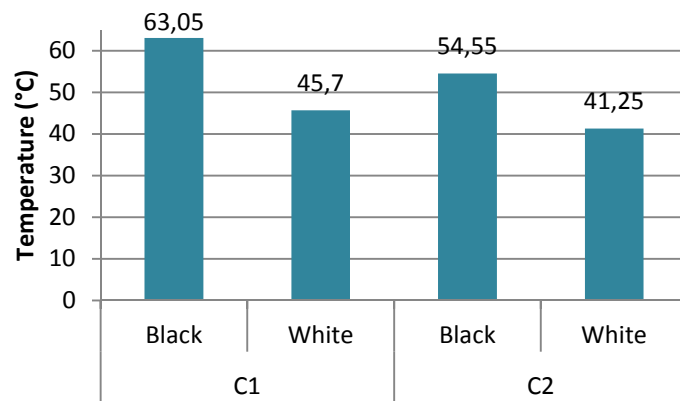
Observing figure 8 it is possible to compare adherent tiles' maximum temperatures verified during

Figure 8 - Maximum average temperatures obtained in all panels' adherent tiles

When the differences between adherent tiles of both colours are analysed, as expected and seen in the thermograms, black panels reach higher temperatures than white panels (about 17°C above on cell 1 and 13°C above on cell 2).

Regarding the differences between the two cells, i.e. between the two supports, the ETICS solution reaches higher temperatures. In the case of black panels, ETICS based panels' temperatures are 9°C higher, while in the case of white panels the difference is 4°C.

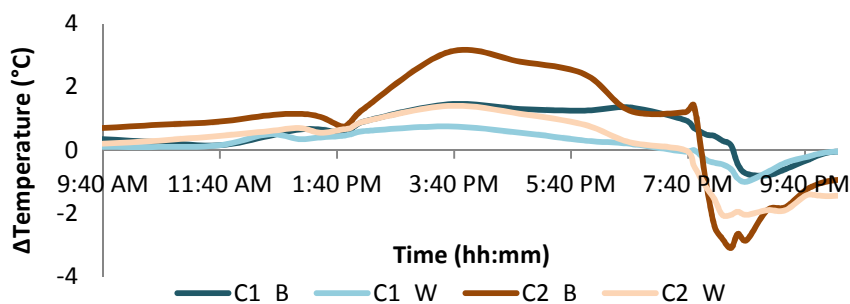
Figure 9 shows the variation of the thermal differential between detachent and adherent tiles with time.

Figure 9 - Thermal differentials between detached and adherent tiles

Analysing Figure 9 it is possible to distinguish the existence of different phases:

- The differential drops slowly until 7:30 pm
- With the panels' cooldown, the differential changes from a positive value (detachments' temperatures higher) to a negative value (detachments' temperatures lower).
- While temperature drops and the sun sets the differential also drops reaching its minimum at around 8:30 pm.
- After reaching the minimum the differential fades, making it more difficult to visualize the anomalies.

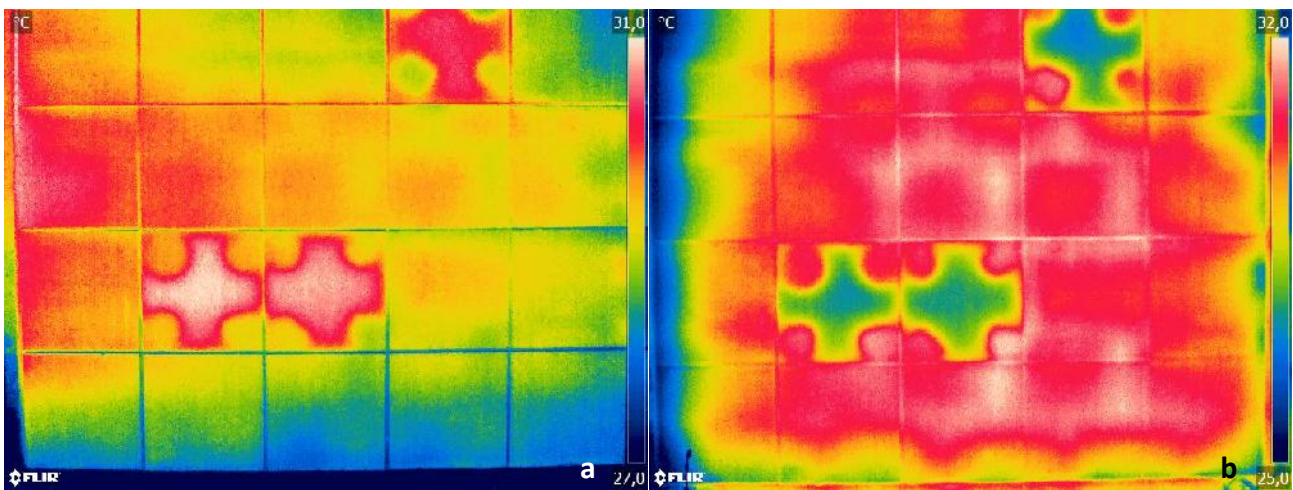
Figure 10 presents two thermograms taken to the bottom half of the black panel from cell 2 (C2_B) taken during the day (maximum differential – 3:30 pm) and at night (minimum differential – 10:15 pm).

Figure 10 – Thermograms from the bottom half of cell 2's black panel taken during the day (a) and at night (b)

In these thermograms, taken from a closer distance to the panels, it is possible to verify that, as shown before on the quantitative analysis, the thermal differential is positive during the heating phase (day) and negative after some time of cooldown (night) ; ie in the first thermogram it is possible to see higher temperatures in the detached tiles (reddish / whitish coloured in the thermogram) and in the second the opposite, as detached tiles are colder (blueish).

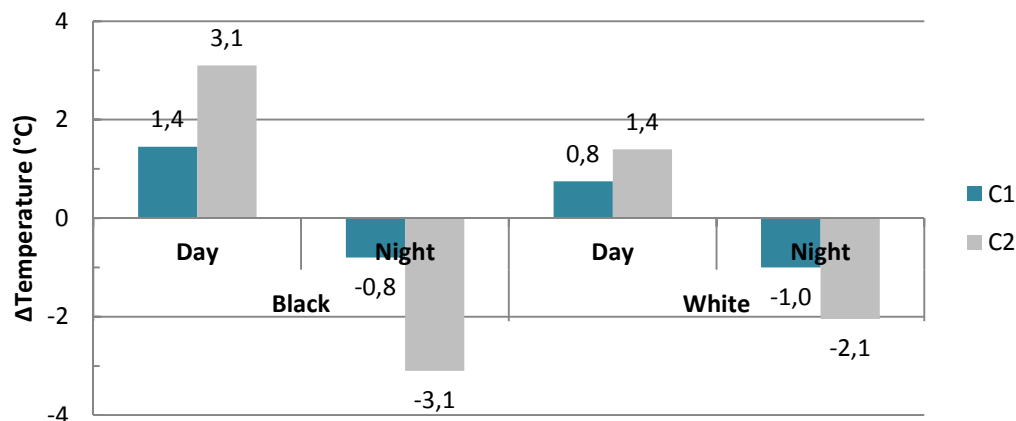
Figure 11 shows the day and night differentials (corresponding to the maximum and minimum differentials respectively), manifested during this survey.

Figure 11 - Maximum and minimum thermal differentials between adherent and detached tiles on cells 1 and 2

From figure 11 it is possible to identify certain particularities about the thermal differential between detached and adherent tiles:

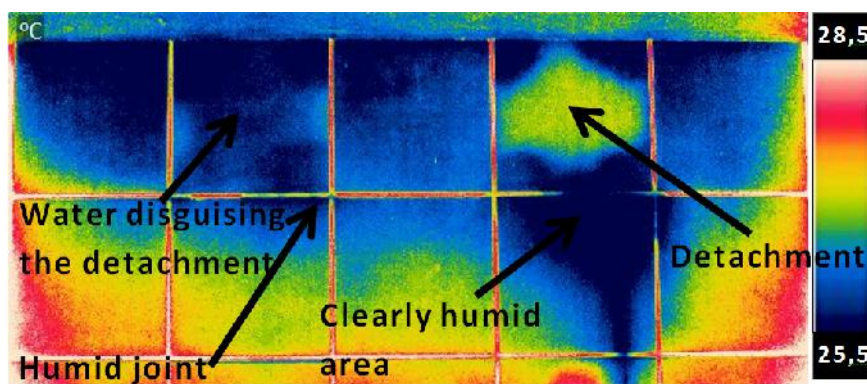
- Despite, as mentioned, every tile having verified some water leakage from the joints, being classified as so in the thermograms taken 30 min after the injection, the leakage from C1_B's CT did not appear visible on the thermogram.
- Tiles with a cloth beneath (CT) verified in general both presence of water making it difficult to detect the detachments and presence of water in the joint and surroundings (figures 12 and 13).
- Simply detached tiles in general presented a wide humid area after the injection, sometimes partially disguising the detachments (only partially because the water was only present in the

Figure 12 - Thermogram taken from C2_W at 12 pm - The classification of the anomalous tiles is presented in table 1, where CT (second from the left) is classified with a 4 and DT (fourth from the left) with a 6

water lowers the cladding's temperature resulting, for example, in a cooler area (bluish area in the thermogram), such as the one identified as "clearly humid area" in figure 4. In some cases, especially when there is a cloth beneath the detached tile, the water lowers the tile's temperature hindering the differential expected.

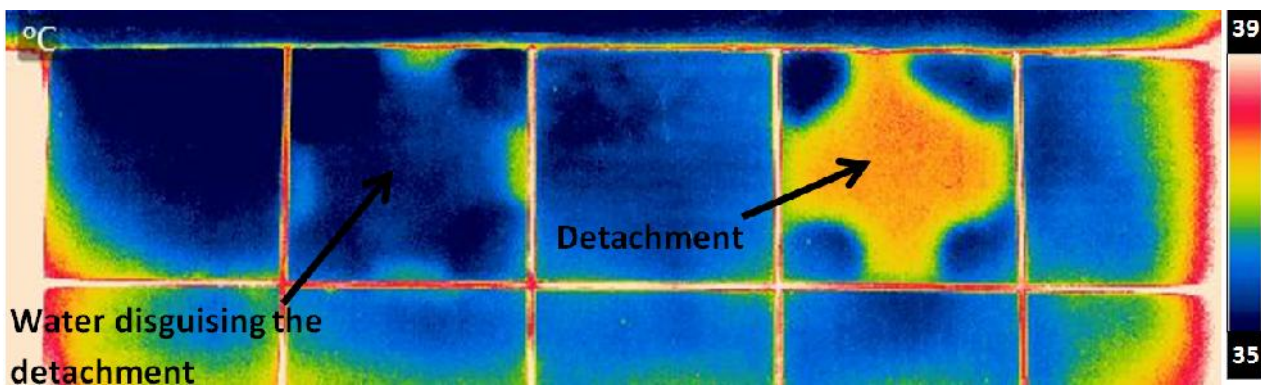
Figure 13 - Thermogram taken from C2_W at 3 pm - The classification of the anomalous tiles is presented in table 1, where CT (second from the left) is classified with a 4&5 and DT (fourth from the left) with a 3
