Characterisation of old *azulejos* setting mortars: a contribution to the conservation of this type of coatings

Abstract

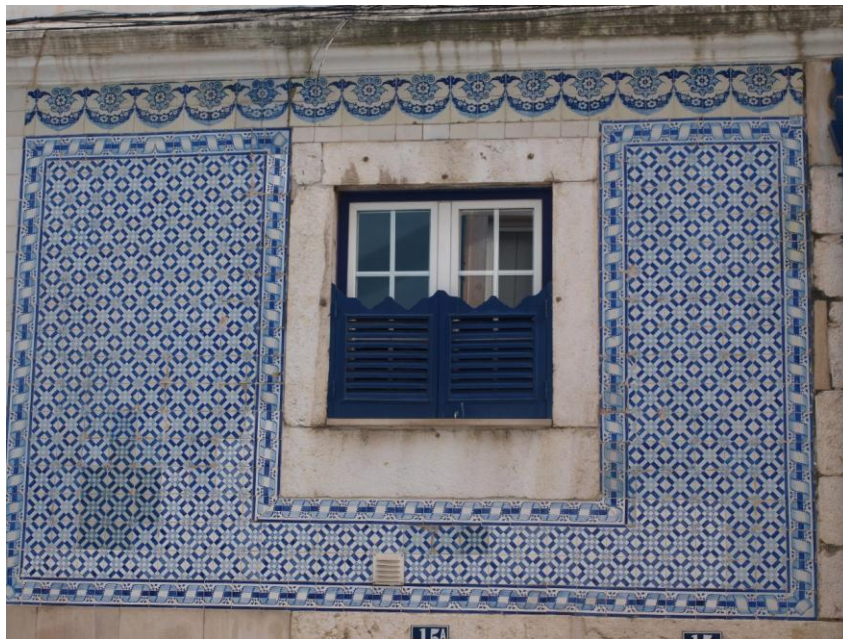
Figure 1 – Azulejos facade coating of a building in *Calçada do Cardeal*, Lisbon

One of the most typical types of wall coating in Portugal is the glazed tile coating system – named *azulejos* in portuguese (Figure 1), which is closely linked to the Portuguese history, thus constituting an important testimony of great cultural and touristic interest.

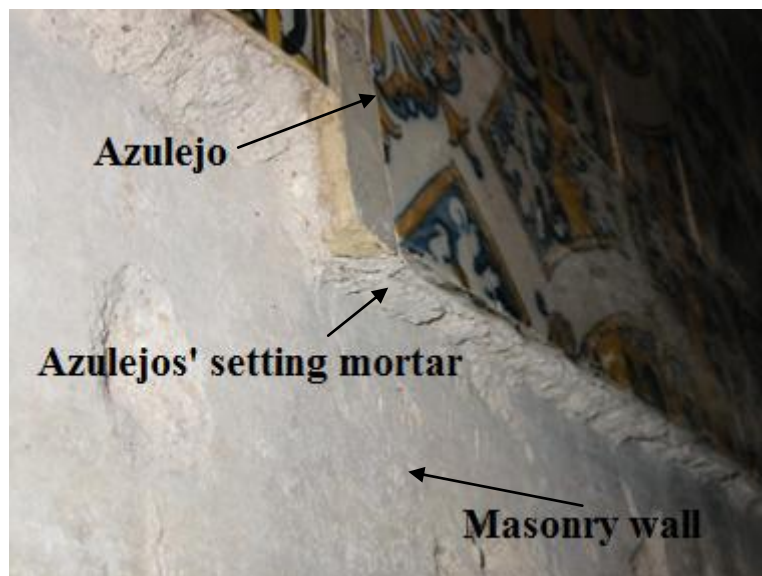
Figure 2 – Azulejos' internal coating system (Elvas Cathedral)

In these old coatings, the mortar is the bond between the substrate and the azulejo itself; so its behaviour directly influences the system as a whole (Figure 2).

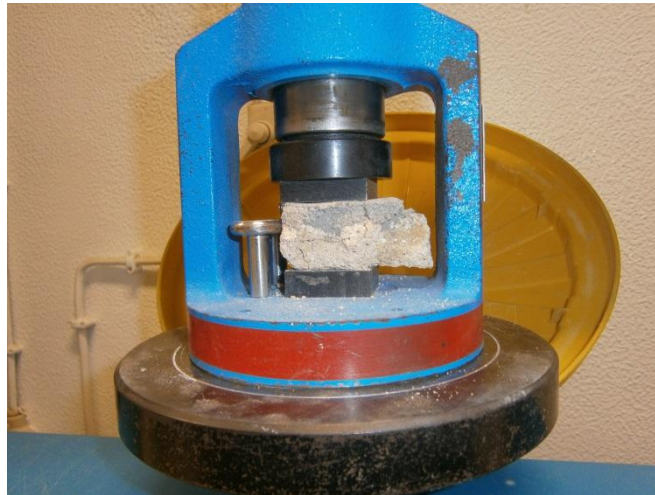
Figure 3 – General view of the applied compressive strength test

Given the irregularity and friability of the samples, it was impossible to follow exactly the standardized test method for mortars, as described on EN 1015-11 [16]. Therefore, for the compressive strength study of the setting mortars, a method developed under earlier research projects of ancient coating mortars and previously validated [17, 18] was used. It consisted on the application of a shaping mortar of cement and sand with a

volumetric proportion of 1:3 (harder than the one under testing) to regularise the faces of the samples that would be in contact with the plates of the test device, in order to get a good distribution of the applied force (Figure 3).

The contact area of the tops of the specimens did not follow specific dimensions since the main objective was to regularise the surface with the thinnest possible layer of cement mortar, so it would not compromise the results. This test was carried out in five specimens, from four different buildings, and the device used for the test was an ETI HM-S equipment with a 2kN load cell.

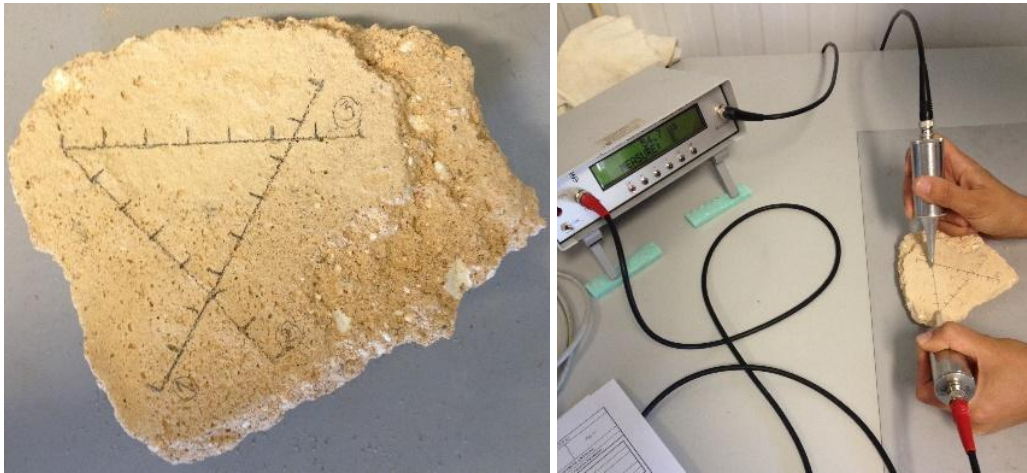
Figure 4 – Images showing a sample marked for the application of dynamic modulus of elasticity test (left), and the test being performed (right)

However, it was only possible to perform this test in sample TAV4 because, for accuracy, this test needs a large dimension in at least one direction and TAV4 was the only sample that included a specimen that respected this condition, with approximately

110x120x20 mm³ (Figure 4). The test was carried out with a Steinkamp Ultrasonic Tester BP-7 and based on EN 14146 [19]. The Poisson coefficient admitted for the determination of the E_{us} was 0.2.

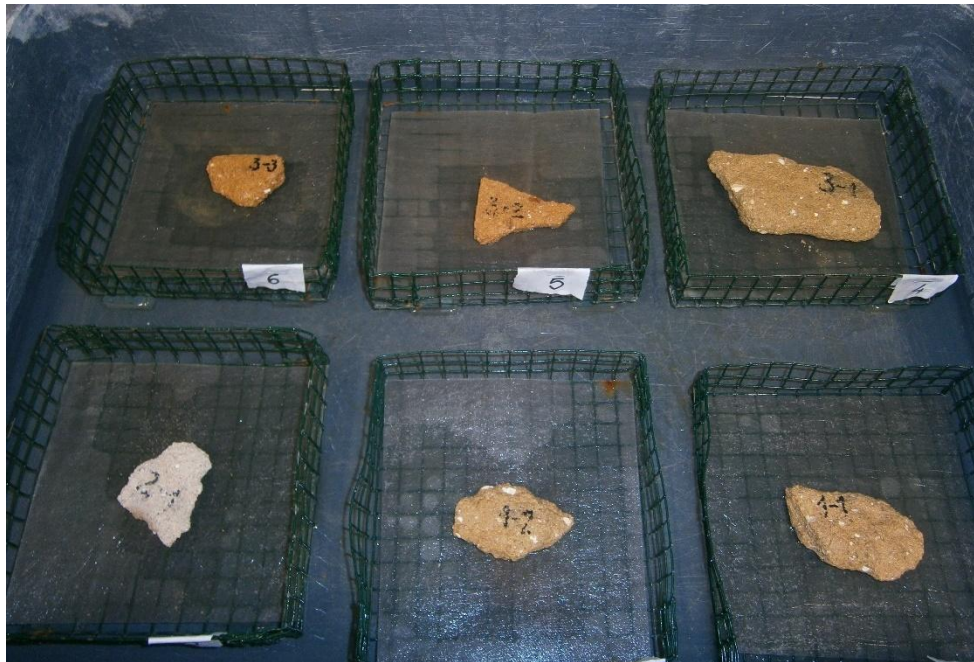
Figure 5 – Image showing the samples during the capillary absorption test

This test was carried out in 12 specimens. The irregular shape and the friability of the mortars made it impossible to exactly apply the standard test methods described in EN 15801 [20]. For that reason, an adapted method was used which was developed and validated for friable and irregular samples [21]. It consists of allowing the absorption of

water through contact with a saturated geotextile sheet in contact with water (Figure 5) and it was performed in a conditioned room under $T=20 \pm 2 \text{ }^\circ\text{C}$ and a $HR=65 \pm 5 \%$.

The azulejos setting mortar face in contact with the wet geotextile sheet was the one that had been in contact with the rear face of the azulejo before its removal. The weight of the sample was measured, with a precision balance of 0.01 g, every minute in the first 10 minutes, then every 5 minutes until 40 minutes, then at 60, 90, 180, 300, 480 and 1440 minutes, and thereafter each 24 h until the saturation of the sample. From this test it was possible to determine the capillary absorption coefficient by contact (C_{cc} in $\text{kg}/(\text{m}^2 \cdot \text{min}^{1/2})$) of each sample. This parameter expresses the initial water absorption rate of a specimen and is determined by the slope of the initial phase of the curve, based on a linear regression, as specified by EN 15801.

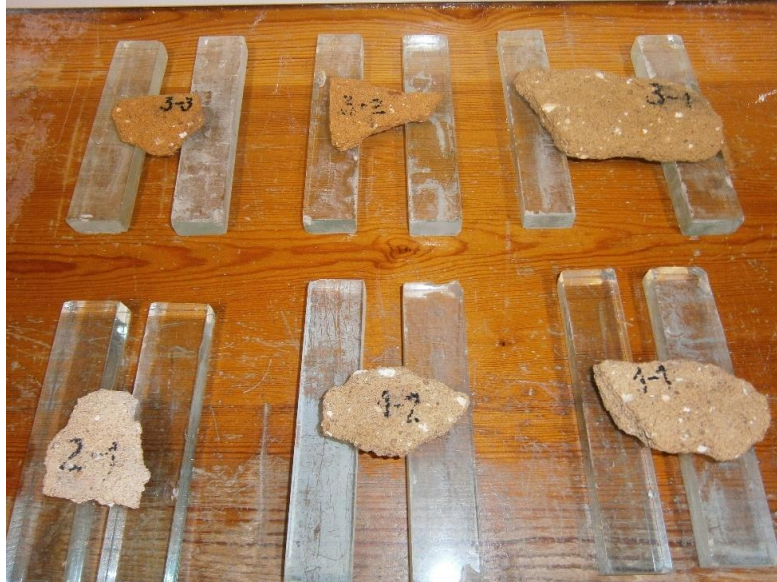
Figure 6 – Mortar samples during the drying process

The drying process consisted of placing each specimen on two glass strips (Figure 6) and registering their weight at 30, 60, 90, 270, 450 and 1440 minutes and thereafter each 24 h until constant weight. The drying rates corresponding to the first drying phase (D_1 in $\text{kg}/(\text{m}^2 \cdot \text{min})$) and to the second drying phase (D_2 in $\text{kg}/(\text{m}^2 \cdot \text{min}^{1/2})$) were

determined according to EN 16322 [22]. The drying area was considered as the sum of the upper and lower faces. In fact, the contact area of the samples with the glass strips was very small in comparison with the free area because of irregularities of the contact surface of the samples, and was therefore despised.

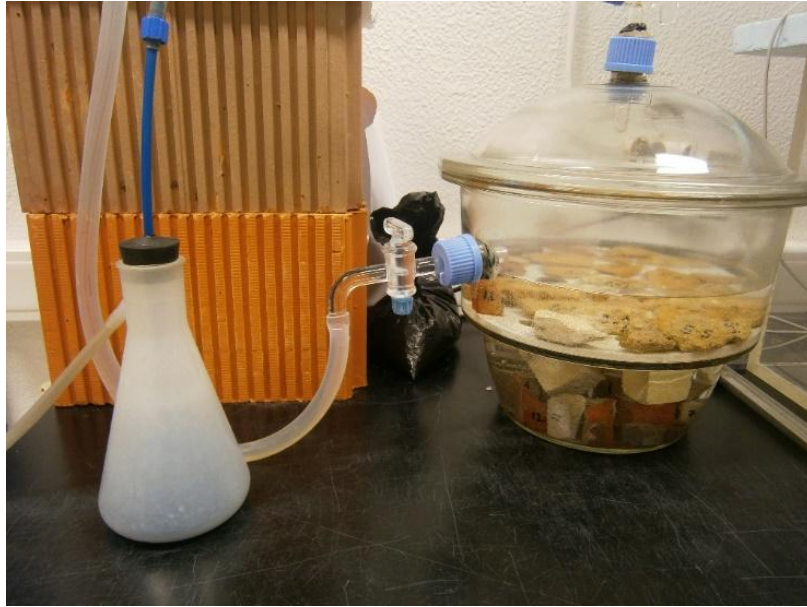
Figure 7 – Apparatus used for the open porosity test

Open porosity test was performed in 14 mortar specimens based on EN 1936 [23] (Figure 7) with vacuum and hydrostatic weighting. The percentage of open pores was measured as well as the mortars' bulk density (kg/m^3).

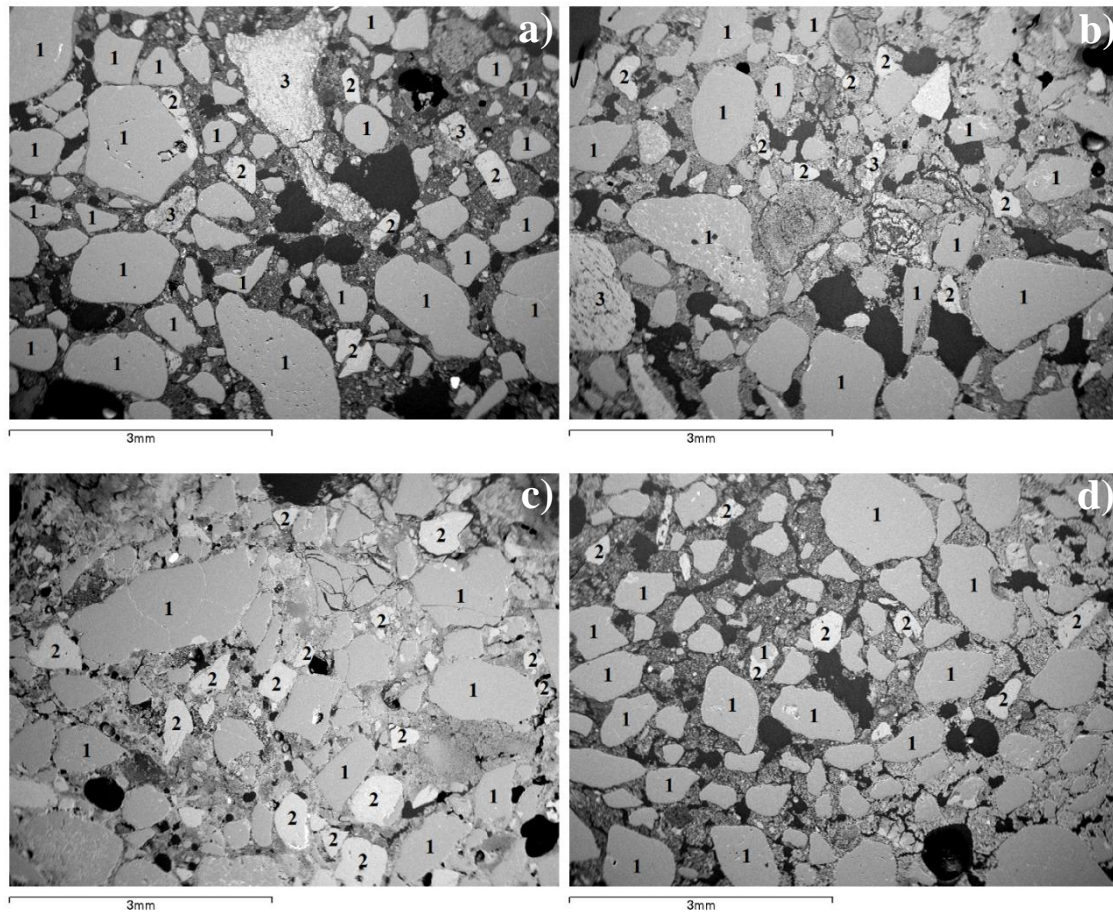
Figure 8 – SEM images of polished sections of samples TAV2 (a), TAV4 (b), HA1 (c) and IMD (d) showing the presence of silica (1) and feldspar (2) aggregate grains, and lime lumps (3) of the binder

SEM/EDS analysis (Figure 8) confirmed that the aggregates are of siliceous nature, presenting a large amount of quartz (identified with “1”) and feldspars (identified with “2”). Lime lumps (identified with “3”) were also visible in some cases. With this confirmation, it is safe to say that the carbonate content present in the samples comes only from the binder, allowing to state that the values of binder:aggregate ratio obtained have a high degree of confidence.

This analysis confirms the XRD mineralogical composition, namely that quartz and feldspars are the main constituents of the aggregates in samples TAV2, TAV4 and HA1, while in the IMD sample the feldspar presence is only minor.

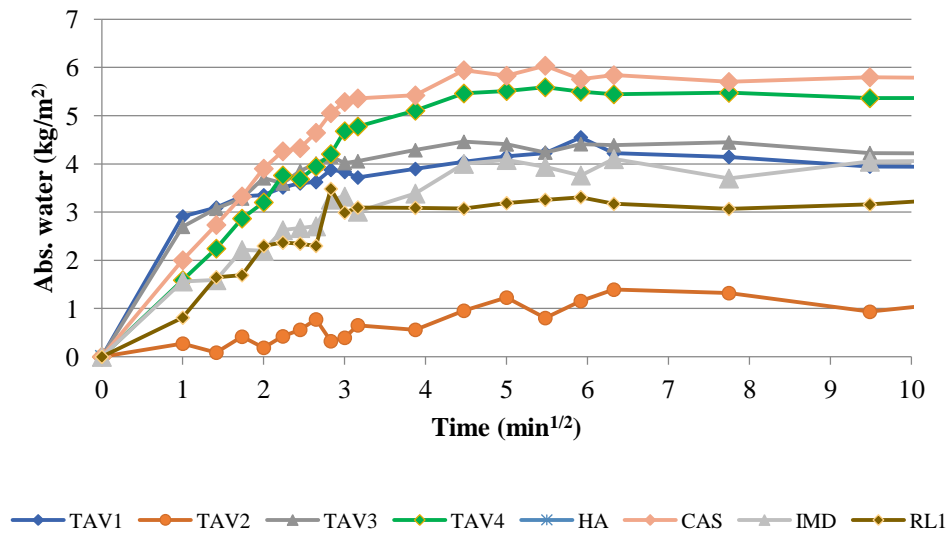
Figure 9 - Capillary absorption curves during the first 90 min ($9.49 \text{ min}^{1/2}$)

Since old lime based mortars have currently a high proportion of large pores [27], and because the samples are very thin (approximately 1-1.5 cm) leading to quick saturation of these pores, the highest water absorption occurs in the first few minutes. Therefore, the range of points to be considered in the calculation of Ccc was adjusted case by case in order to perform the determination in the straight part of the graphic: the more significant capillary absorption stage. The capillary absorption results are presented in Table 5 and Figure 9 shows the absorption curves of all samples during the first 90 minutes ($9.49 \text{ min}^{1/2}$). Figure 10 shows some examples of determination of capillary coefficient. TAV2 was clearly the sample with the lowest Ccc value ($0.27 \text{ kg}/(\text{m}^2 \cdot \text{min}^{1/2})$). Considering the low binder:aggregate weight ratio of this sample, this Ccc value may be due to the possible presence of some product/treatment with water repellent effect applied for repair of the azulejos, that can slow down the capillary absorption. The use of a more compact setting mortar in an intervention of that area of the azulejo panel is another possibility. The presence of clay minerals, detected in this sample, may also reduce water absorption.

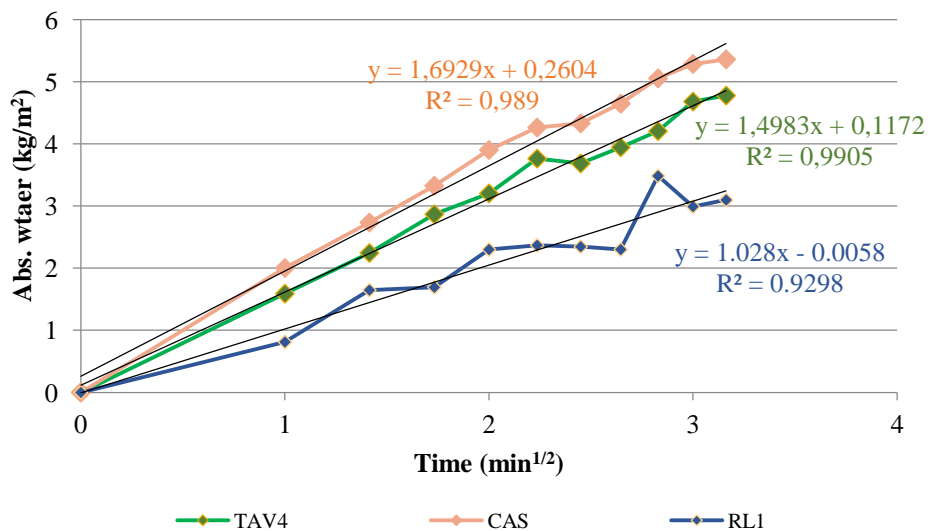
Figure 10 – Examples of calculation of capillary coefficients as the slope of the trendline for the linear part of the graphic

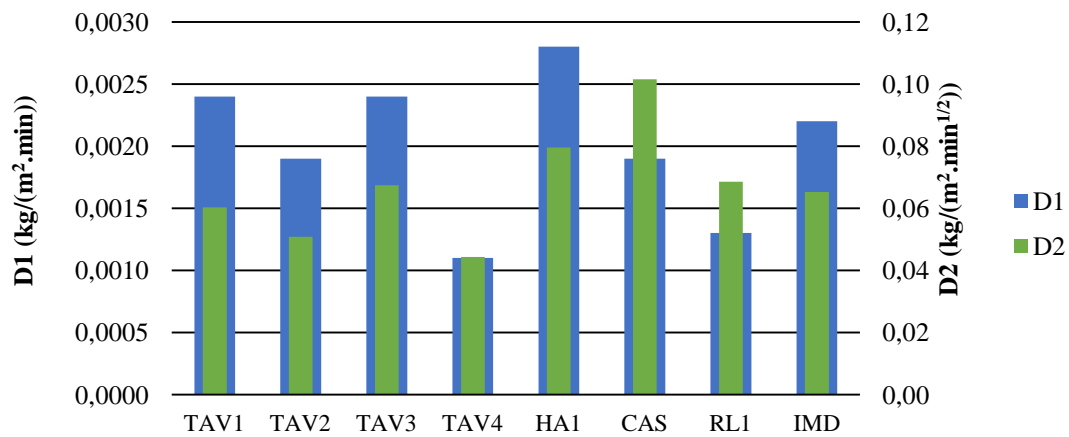
Figure 11 – Comparison between the two main drying phases (D1 and D2)

Drying rates are presented in Table 5. In Figure 11 it can be verified that samples TAV1 and IMD show simultaneously high D_1 and relatively high D_2 , indicating high transport of liquid water to the surface of the sample, followed also by high evaporation, which are consistent with their high C_{cc} and medium porosity, possibly with predominance of macropores. On the contrary, CAS and RL1 present lower D_1 and higher D_2 , i.e., lower

liquid water transport to the surface but higher diffusion of water vapour, which may indicate a predominance of small pores that slow down the first phase of evaporation.

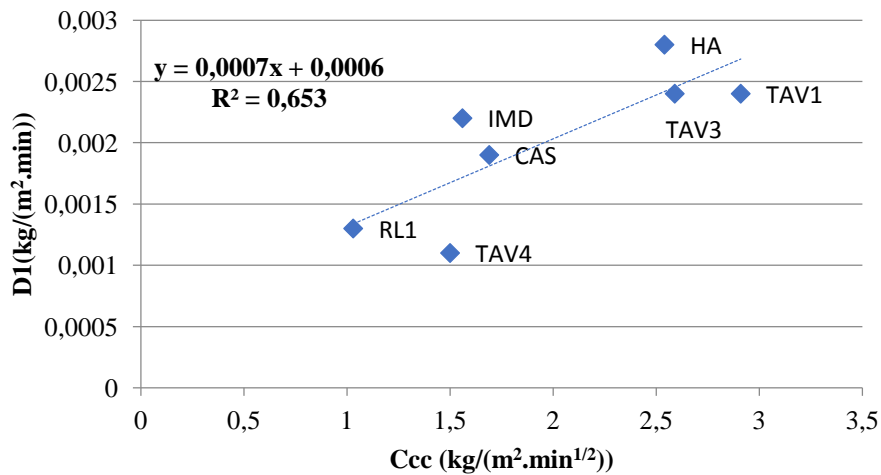
Figure 12 – Correlation between the first drying phase (D1) and capillary absorption (Ccc)

Figure 12 indicates a general trend of increase of D1 ($\text{kg}/(\text{m}^2 \cdot \text{min})$) with Ccc ($\text{kg}/(\text{m}^2 \cdot \text{min}^{1/2})$), even if the correlation is poor. In this correlation TAV2 was not considered, as it has already been concluded that its Ccc is probably affected by a treatment product.

Generally, high C_{cc} are related with a high volume of large capillaries (> 0.05 micron [28]) and lower C_{cc} , for the same porosity, corresponds to a predominance of smaller pores [29, 30], which in the case of air lime mortars would be mainly in the medium capillary pores range (10 to 50 nm) [28]. The significant correlation between D_1 and C_{cc} confirms that also D_1 is related with a high volume of large capillaries.

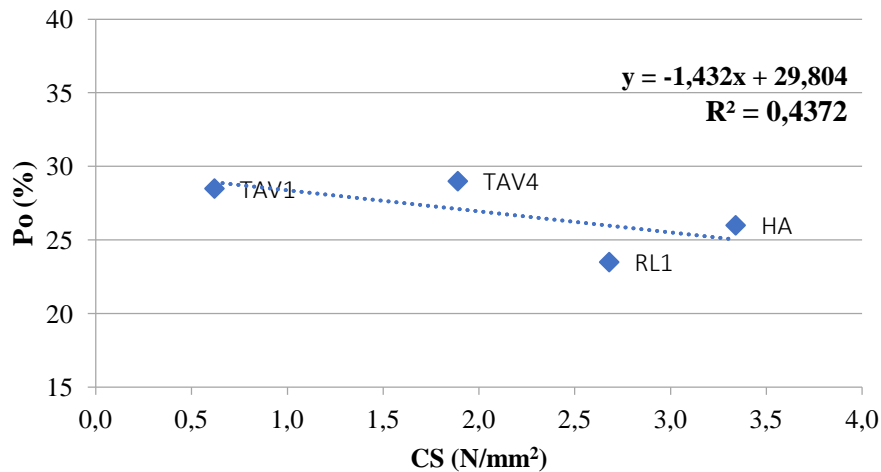
Figure 8 - Correlation between open porosity and compressive strength

Figure 13 presents the correlation between open porosity and compressive strength, excluding the sample CAS whose abnormally high porosity seems to indicate a high deterioration degree. Although the correlation is poor (low R^2 of 0.44), due to the influence of other factors in compressive strength (such as the nature of aggregate) in general, it can be verified that samples with lower CS present higher P_o . In addition, Tables 4 and 5 show that the samples with highest CS and lowest P_o are also the ones with highest binder: aggregate ratios.
