# Nondestructive Testing of Nonmetallic Pipelines Using Microwave Reflectometry on an In-Line Inspection Robot

IEEE Transactions on Instrumentation and Measurement

# Nondestructive Testing of Non-Metallic Pipelines Using Microwave Reflectometry on an In-Line Inspection Robot

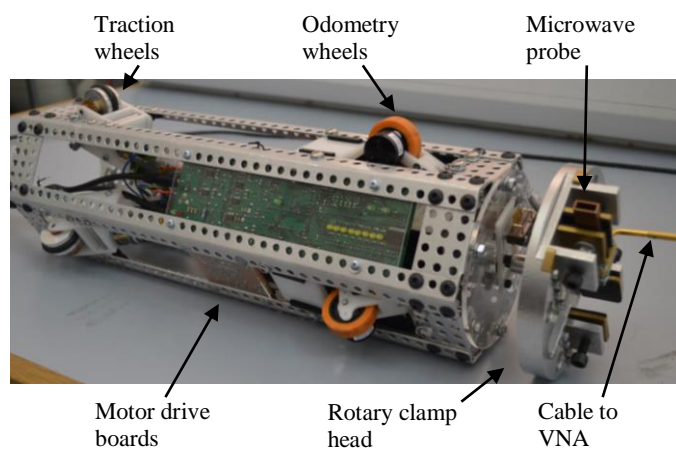
Fig. 1. Prototype of pipe crawler with microwave waveguide probe clamped onto its rotary scanning head.

A robotic pipe crawling apparatus, illustrated in Fig. 1, was created to position and scan the microwave probe within the pipe. The pipe crawler consisted of two sets of three wheels that were sprung against the pipe wall. The rear set was motorized to position the pipe crawler. Rotary encoders were fitted to the front set of wheels to measure the linear distance travelled. A rotating clamp head on the front of the robot held the probe and controlled its angular position.

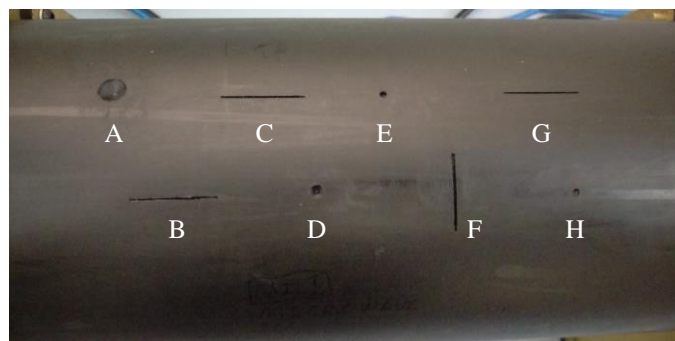
Fig. 7. Defects on outer surface of HDPE pipe sample that were scanned by the pipe crawler setup.

Eight defects were machined onto the pipe's outer surface as shown in Fig. 7, consisting of four notches and four holes drilled partially into the pipe wall, decreasing in depth from left to right. The dimensions of the defects, given in Table III, were selected to assess and demonstrate the sensitivity of the microwave probe. The width of 1 mm was the minimum achievable for the manufacture of notches within the project's scope, so the ability to identify much narrower structural cracks typical of slow crack growth is a subject for future work. Notch G and hole H were cut to the Plastic Pipe Institute's [15] recommended limit of 10% of the wall thickness—1 mm in depth.

Notches B, C, and G were oriented in the probe's H-plane, whereas notch F was cut perpendicular to the others to enable comparison between the H-plane and E-plane sensitivities on the pipe with different external environments. It should be noted that notch F was cut 50% wider in error.

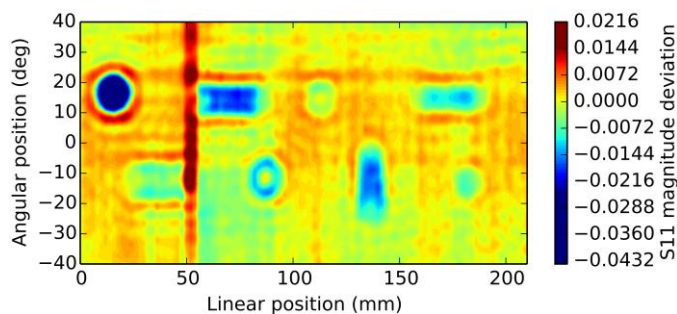
Fig. 8. Magnitude scan image at 19.5 GHz of pipe sample without foil or impurities.

The scan image in Fig. 8 is of the HDPE pipe sample without foil backing (as in Fig. 6) at 19.5 GHz. The image shows clear indications of all the defects on the pipe. The smallest defects, G and H, are completely identifiable over the noise in the image. The indication on the image is generally greater in amplitude and size as defect size increases, but notch B's indication is lower in amplitude (although wider) despite the notch being greater in depth. This is due to the complexity of

the signal's interaction in the probe's near-field region, so different parts of the deeper notch can contribute to increases as well as decreases in the reflection coefficient's magnitude in this case. The long vertical lines at linear positions between 50 mm and 65 mm in the scan images were caused by a previously unknown inhomogeneity in the pipe material.

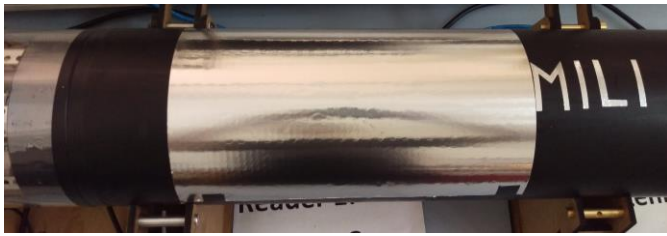
Fig. 9. Pipe sample with aluminum foil backing wrapped over the defects.

A second scan was performed at 24 GHz with a reflective aluminum foil backing wrapped over the pipe surface, covering the defects as pictured in Fig. 9. The phase component of the scan, shown in Fig. 10, was slightly clearer than the magnitude component in this configuration, whereas in the free space environment (without foil backing), the magnitude component was preferred due to the lower reflection level. With the foil backing, the image in Fig. 10 has a higher level of 'noise' that completely obscures notch G and hole H, and partially obscures notch C. The reflection from the backing is much greater than the reflections from the notches, so any deformations in the backing have a large effect on  $S_{11}$ , obscuring the smaller indications from the air-filled notches. The larger defects can be identified by their symmetrical ripples on the image.

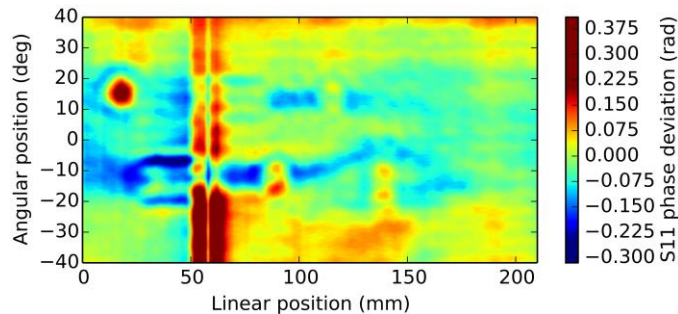
Fig. 10. Phase scan image at 24 GHz of pipe sample with foil and without impurities.

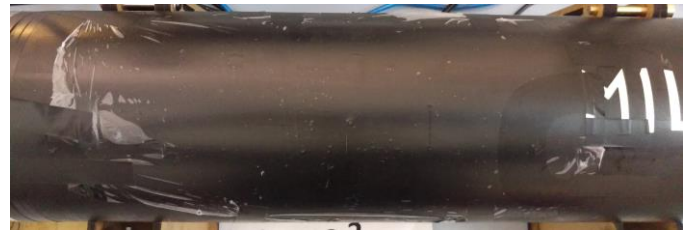
Fig. 11. Pipe sample with saltwater sealed inside defects (before aluminum foil is applied).

A further two scans were performed at 22.5 GHz and 24 GHz with the notches filled with saltwater of conductivity 35 S/m. The liquid was sealed in by a plastic film as illustrated in Fig. 11, and aluminum foil was laid over the film as previously.

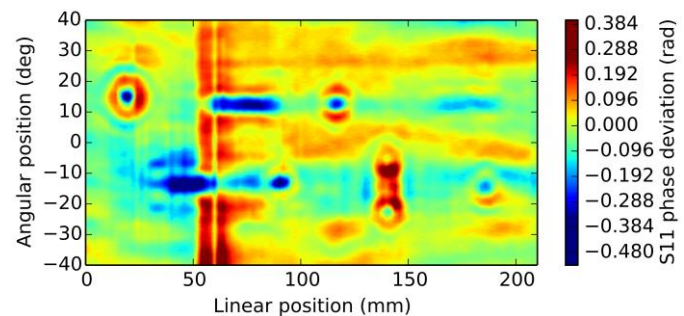
Fig. 12. Magnitude scan image at 22.5 GHz of pipe sample with foil and saltwater in defects.

The magnitude scan image at 22.5 GHz is shown in Fig. 12, and the phase scan image at 24 GHz is shown in Fig. 13. All the defects can be clearly identified in the phase image, which can be explained by the greater amount of signal reflected from the defects when filled with conductive liquid, more comparable to that from the foil backing. The magnitude sensitivity to notch C is about 0.12 in saltwater according to Fig. 12, up from 0.025 in free space according to Fig. 8. The indication of notch G is more pronounced in the phase image than in the magnitude image.

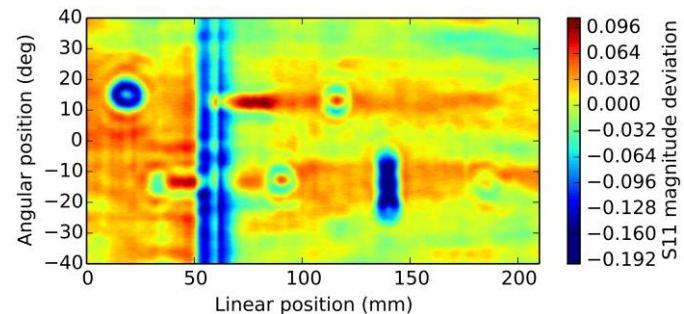
Fig. 13. Phase scan image at 24 GHz of pipe sample with foil and saltwater in defects.
