**Aerospace  
Systems Division**

Prototype "A" Thermal Vacuum  
Test Summary Analysis

ALSEP THERMAL VACUUM TEST  
SUMMARY ANALYSIS

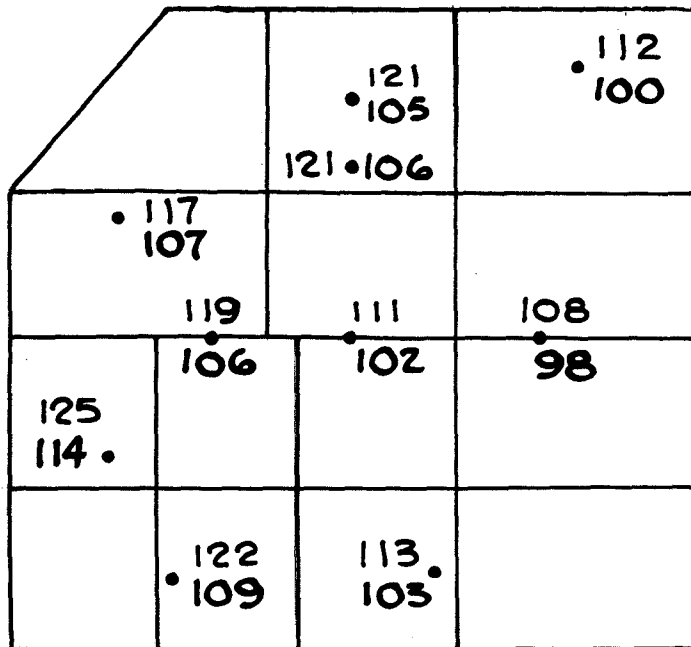
$T_{pred.} = 115^{\circ}F$   
 $T_{meas.} = 105^{\circ}F$

Figure 4.4-7 Predicted vs Measured Radiator  
Temperatures for Lunar Noon

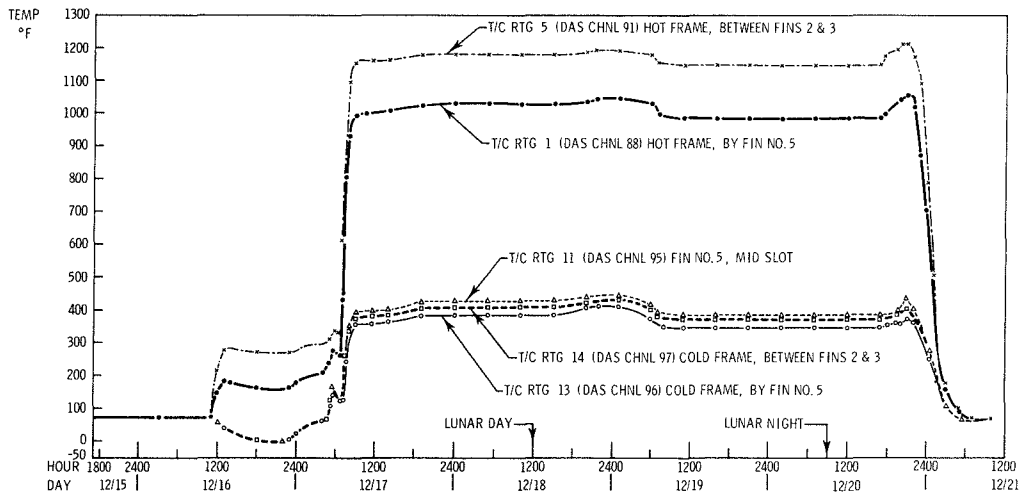
Figure 4.4-12 Temperature Distribution on the RTG

4.4.1.6 Subpackage No. 2 - Figures 4.4-11 and 4.4-12 illustrate the temperature distribution on subpackage No. 2. The surface temperature of Pallet 2 below the RTG ranged from a maximum of 375°F during lunar noon to 177°F during lunar night compared to predicted temperature limits of 394°F and 187°F respectively. The differences between pretest predictions and the Prototype test results are attributed to the lower RTG power setting of 1400 watts instead of the 1500 watt RTG dissipation used in the analyses.

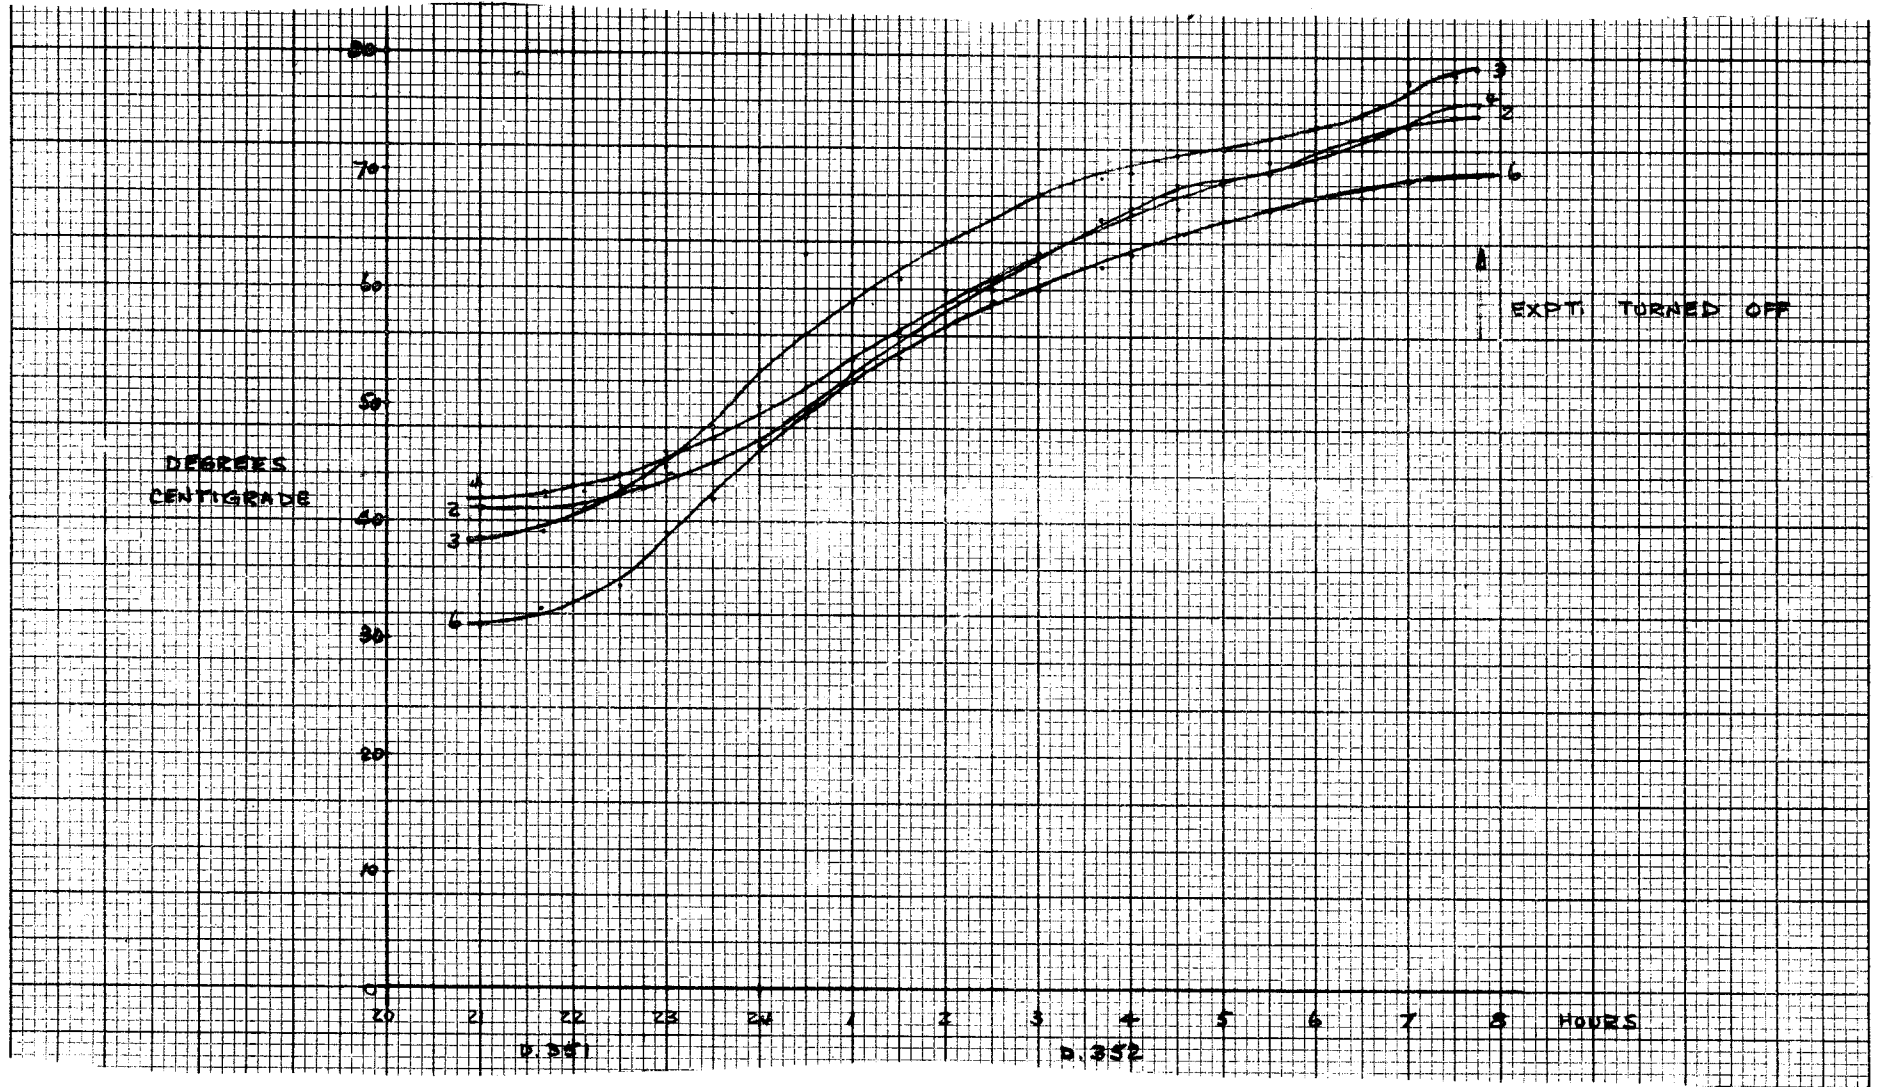
Figure 4.6.4-1 SIDE Internal Electronics Temperatures  
 Prior to Lunar Noon IST - 17, 18 December 1967

The following graphs, Figures 4.6.4-1 through 4.6.4-6, are included to show temperature variation rates at critical times. The graph of internal temperatures during Standby gives only a rough indication of the temperature trends during the period, since few readings were available.
