Coal Operators' Conference

Guanyu Yang, Naj Aziz, Haleh Rasekh, Saman Khaleghparast, Xuwei Li and Jan Nemcik, Profile of Sheared Cable Bolts Strand Wires, Proceedings of the 18th Coal Operators' Conference, Mining Engineering, University of Wollongong, 343-352.

PROFILE OF SHEARED CABLE BOLTS STRAND WIRES

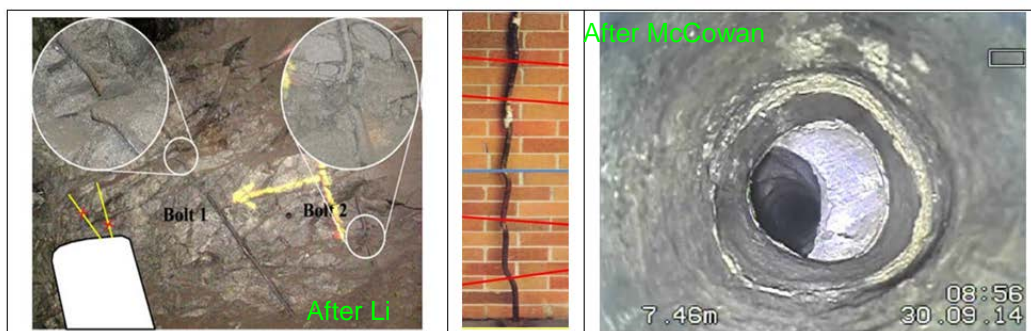
Figure 1: Sheared tendons recovered from field and a hole view of sheared rock (McCowan, 2015 and Li, 2017)

For the past several years, a significant knowledge has been gained on tendon load transfer mechanisms and strength characterisation mainly by pull testing (Aziz and Jalalifar, 2005, 2006, Hagan, *et al.*, 2015), however little has been known about the cable bolt shear behaviour, since the interest in cable bolt failure in shear has been confined to small amount of work carried out based on the British Standard of shear testing (BS 7861-part 2, 2009) and the work of Craig and Aziz, 2010, and Aziz, *et al.* 2015a). Also, no credible test results are available from the field and only pictorial evidence has recently been surfaced for both failed solid rock bolts and cable bolts. Typical signs of sheared tendons recovered from the field and a borehole view shear displacement in rock layers is shown in Figure 1, as reported by McCowan (2015), and Li (2017)

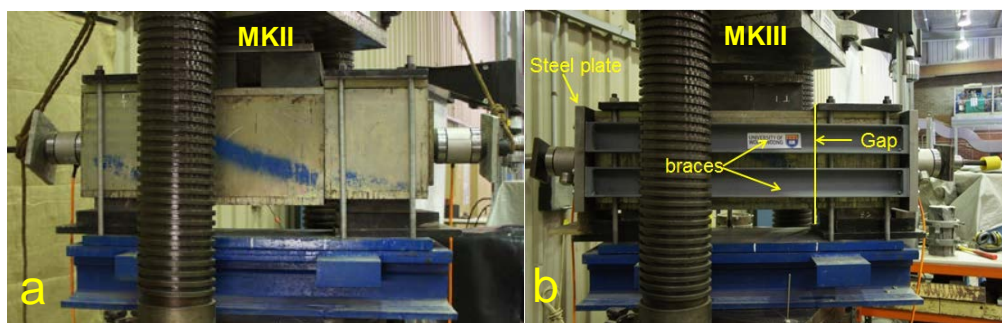
Figure 2: Double shear test rigs (a) MKII and (b) MKIII.

Two types of double shear testing methods were available for evaluating the shear characteristics of cable bolts; (a) The DSTR-MKII with opposing concrete joint faces being in contact with each other, where the resultant shearing force is a combination of the shear failure load and friction force of the sheared host medium faces, (b) A modified DSTR (MKIII), with opposing concrete joint faces not in contact with each other and the measured shear resistance force is spent on shearing the cable wires. Accordingly, The DSTR-MKIII rig as shown in Figure 2 was used in this study. The DSTR MKIII frame consists of two 300 mm length outer cubic boxes and 450 mm length middle central cuboid box with 300x300 mm² cross-sectional area. A conduit wrapped with 8 mm PVC hose, was laid horizontally along the mould to precast a rifle hole through the centre of concrete blocks. Once the concrete was poured it was left to set.

assembling, three concrete blocks were all mounted on the horizontal steel base and held together using a truss system around the double shear assembly as shown in Figure 1 b. The truss system consisted of four 1100 mm length steel braces connected between two 30 mm thickness side steel plates. The brace system impedes subjecting lateral axial load on concrete blocks during shearing. When assembled, gaps of almost 5 mm were left between concrete blocks, thus the adjacent sheared concrete faces are kept apart thus eliminating the contact between the sheared faces and hence no friction force. Next the cable bolt was inserted into the central axial hole and was followed by mounting 100 t load cell on each protruding side of cable in the assembled concrete blocks and tensioned to the predetermined axial pretension load, using a “Blue Healer” tensioner. Tensioning of the cable was retained by the barrel and wedge retainers. This was followed by the injection of the grout in the central concrete blocks hole for bolt encapsulation. Grouting of the cable in the concrete block was achieved via 20 mm diameter holes cast on top of each concrete block. Once the cable was pretensioned, grout mortar was injected the space between central and cable strand from the vertical pre-cast hole in the top of each concrete blocks. After seven days of grout/resin curing time, the double shear assembly was then placed on the carrier base frame consisting of a parallel pair of rail track sections welded to a 35 mm thick steel plate. The outer side 300 mm³ cube blocks of the double shear apparatus was mounted on 100 mm steel blocks, leaving the central 450 mm long block free to be vertically sheared down using a 500 t capacity hydraulic universal testing machine at the rate of 1 mm/min for the maximum 100 mm vertical displacement. A hydraulic universal testing machine with a capacity of 500 t was used to compress middle block for shearing cable strand at the rate of 1 mm/min for the maximum 100 mm vertical displacement.

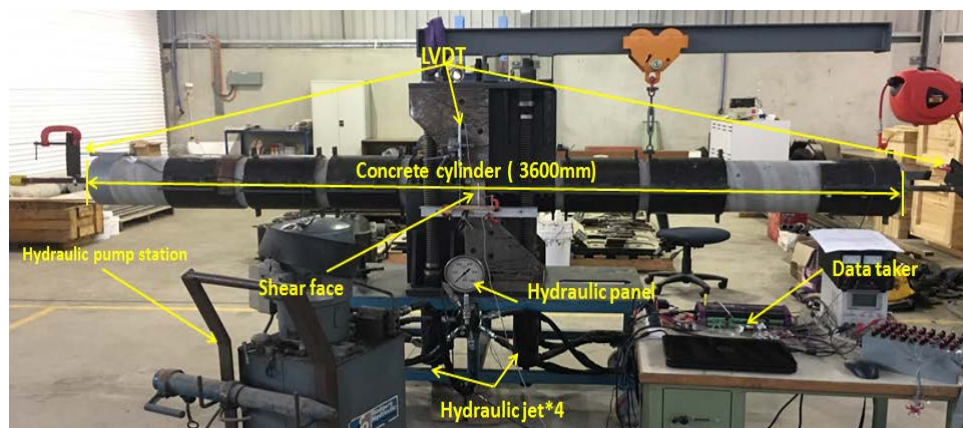
Figure 3: Megabolt integrated single shear rig (MISSTR)

To replicate as closely as possible the field conditions for the installed cable bolts, the Megabolt Integrated Single Shear Test Rig (MISSTR) shown in Figure 3 was used to evaluate the behaviour of cable strand in shear. Based on the principle of British Standard 7862-part 2 (2009) the whole length of the concrete cylinder used in MISSTR is 3600 mm (1800 mm on each side) with 250 mm outer diameter hole diameter of 28-55 mm in diameter. The diameter of the central axial hole in the concrete was dependent on the diameter of tested cable bolt.

The MISSTR is a horizontally aligned integrated system consisting of a shearing rig and an integrated 120 t capacity compression machine. The 3.6 m long concrete shearing cylinder consists of two sections, each containing 1.8 m long concrete cylinders. The concrete cylinders are covered by steel clamps, which provide confinement during the shearing process. Either a hand pump or a power pack of a suitable capacity applied the hydraulic pressure for compression machine legs. The pressure in the manifold was monitored with a digital pressure transducer (Type Measure X, range 0- 800 Bar) in conjunction with an analogue pressure gauge (0-700 bar). The rate of loading was applied manually, which was not constant, however the aim was to apply a constant load at the rate of around 1 mm/min (0.018 mm/sec), in line with BS7861-2 standards. The displacement at the shearing plane

was measured using a Linear Variable Differential Transformer (LVDT) as shown in Figure 3 a. Two other LVDTs were also mounted on the cable ends to enable monitoring of cable debonding. A data taker recorder was used to collect data during the tests.

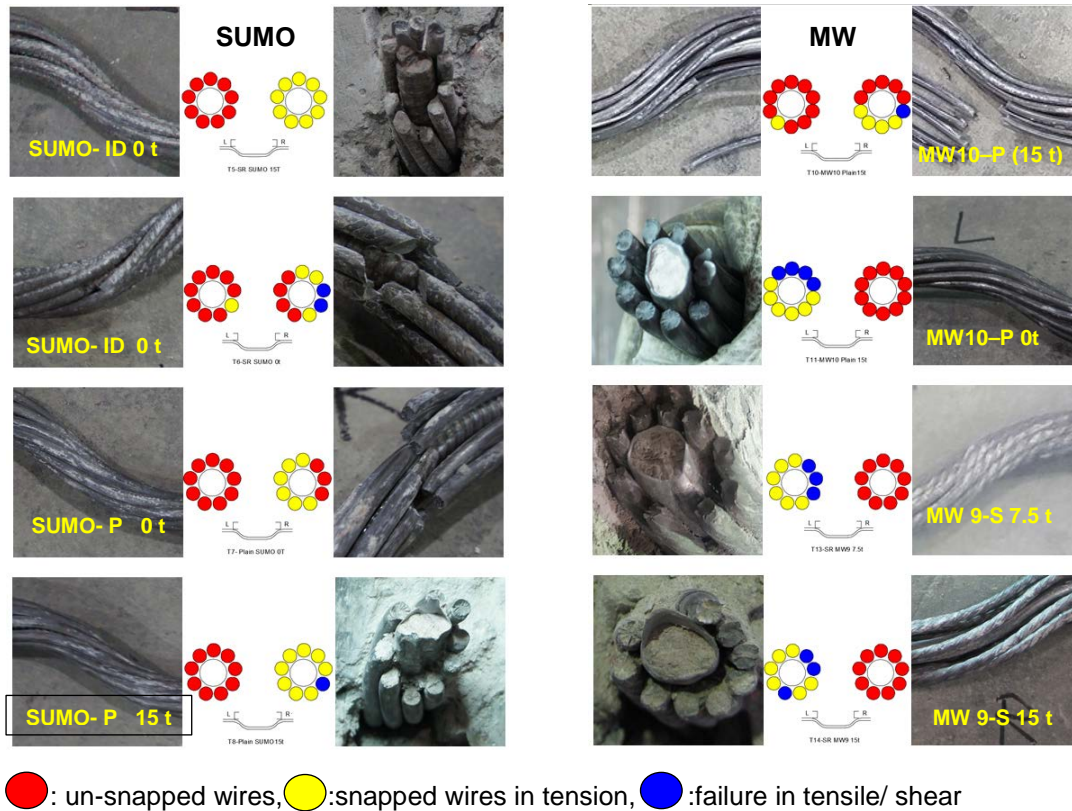
Figure 4: Strand wires failure profiles in Sumo and Megabolt cables tested in DSTR-MKIII Equipment. Both left and right shear failure faces are shown

Double shear tests: Figure 4 shows the profiles of both SUMO and Megabolt MW9 and MW10 cable bolts tested in double shear rig

Because of the ineffective concrete confinement in rectangular and cubical double shear rig, the radial cracking of the concrete blocks, as shown in Figure 5 generated conditions that caused increased sheared cable vertical displacement. The increased displacement contributed to increased cable failure loads, significantly greater than that would have occurred with effective confinement and no radial cracks. The radial cracking of the concrete enables the sheared cables to bend excessively along the weak cracked zone making the cable bent zone behave as though being pulled apart leading to failure by pulling rather than shear and hence increased failure load. As can be seen from Figure 4 and profiles of cut strand wires, it is obvious that most wires have failed in tension and a combination of shear and tension.

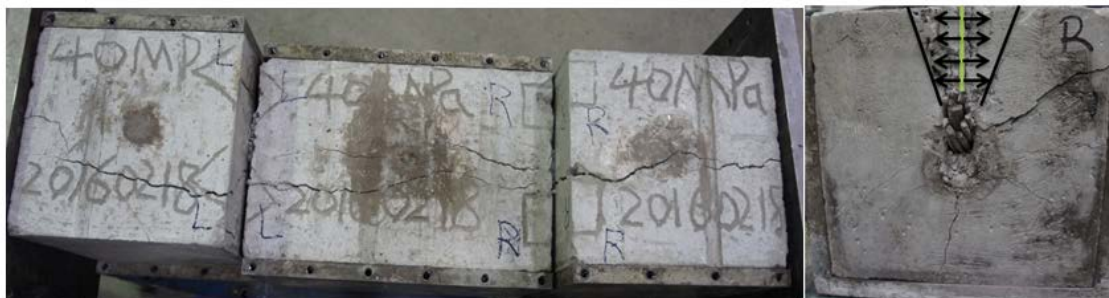
Figure 5: Double shear post-test concrete blocks crack

Also, unconfined concrete host medium may end up being radially cracked during the shear process, making the cable shear displacement greater, causing the cable to snap or fail as if it is being pulled to failure rather than being sheared and the resulting failure being greater, at around 70%, than would normally be the case.

- Increased cable displacement causes cable wires to fail mostly in tension. The cable failure in tension also occurs in double shear testing as a result of concrete medium cracking axially as shown in Figure 5, thus resulting in excessive bending and stretching of the cable section in the vicinity of joint faces, and shear displacement travel in double shear tests was mostly in excess of 70 mm. Often the failure loads were in excess of the failure loads obtained from single shear testing. Thus the majority of wire failures tend to be in tension failures with a small number of wires failing in a combination of tension and shear.

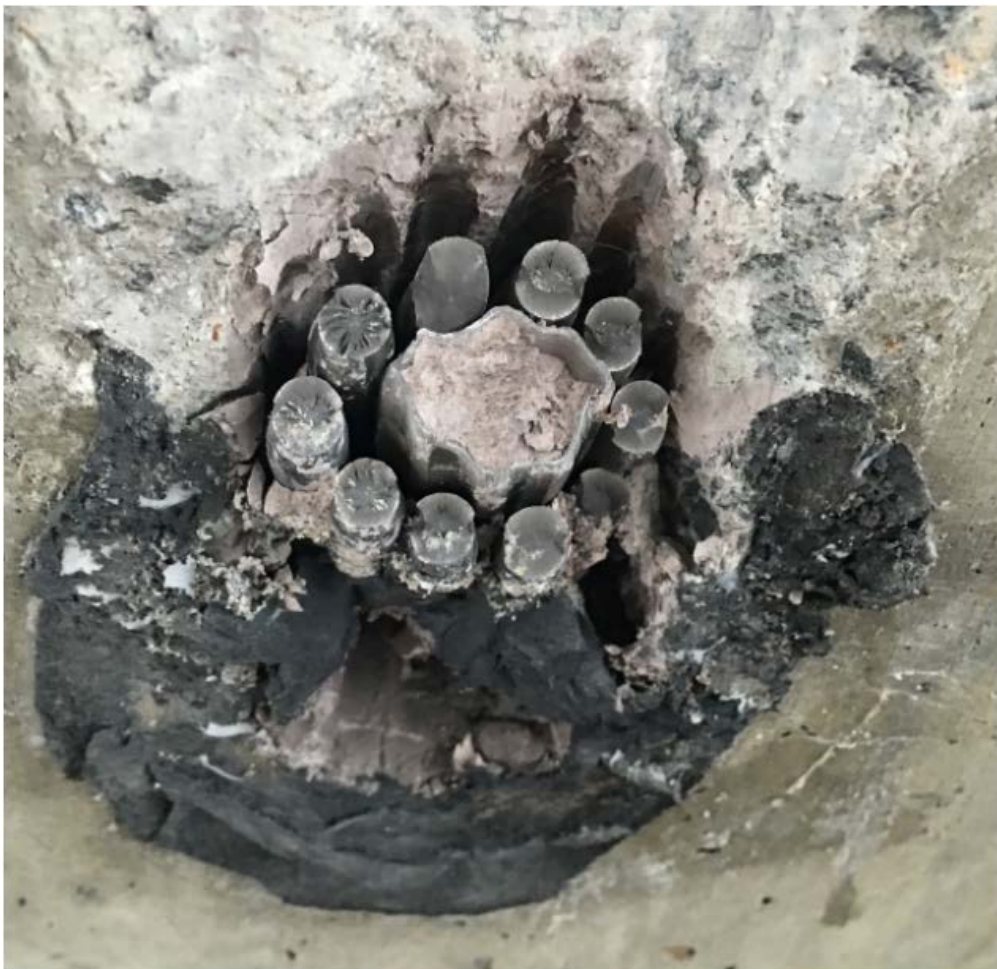
Figure 7: Cross sectional view of Cable bolt Unbulbed, Plain MW10, 15 t pretensioned and debonded. Note the extent of wire failure in tension of Cone and Cup. The failure load of 68.2 t is almost equal the cable axial load capacity of 70 t. The shear load displacement at failure was 68.2 mm.
