Contract Report 647

Continued Operation of a Raingage Network for Collection, Reduction, and Analysis of Precipitation Data for Lake Michigan Diversion Accounting: Water Year 1998

by Nancy E. Westcott

Prepared for the U.S. Army Corps of Engineers, Chicago District and U.S. Geological Survey

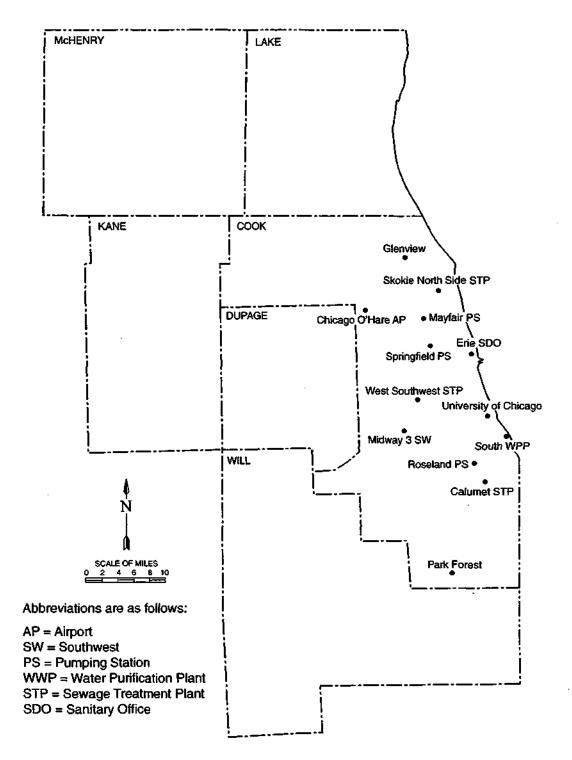
Figure 1. Raingage locations used for diversion accounting purposes prior to Water Year 1990. These include National Weather Service gages located at Chicago O'Hare AP, Midway 3 SW, University of Chicago, and Park Forest; City of Chicago gages located at Mayfair PS, Springfield PS, South WPP, and Roseland PS; and Metropolitan Water Reclamation District of Greater Chicago gages located at Glenview, Skokie North Side STP, Erie SDO, West Southwest STP, and Calumet STP.

The recent unusual patterns were caused by abnormally low precipitation totals at a select number of the 13 sites used by the accounting procedure (Figure 1). Inspection of these sites (Vogel, 1988), which are irregularly distributed over the region, revealed that the low precipitation totals were caused by 1) inadequate raingage exposure (e.g., gages situated on rooftops or too near natural or artificial, flowrestricting obstructions) and 2) different observing, data reduction, and quality control

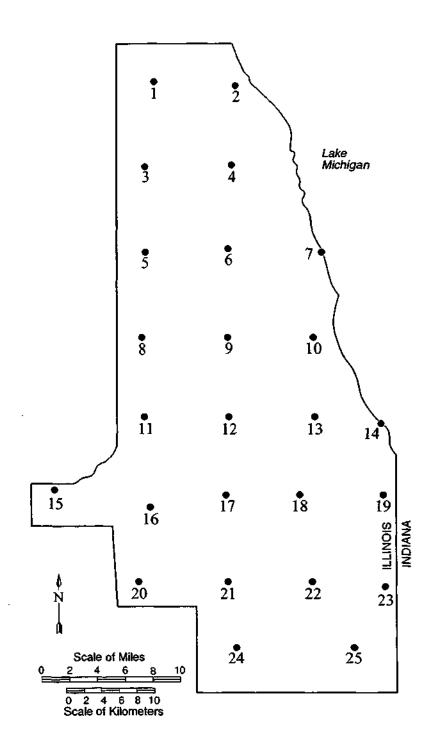
Figure 2. The 25-site raingage network used during Water Years 1990-1998.

In late September and early October 1989, the entire 25-gage network was installed (Figure 2). Each universal weighing-bucket raingage used throughout the network was fitted with a battery-powered electric chart drive for more consistent and reliable operation. The SWS provided all raingages from its inventory. Appendix I contains complete site descriptions for each network location, accurate as of September 30, 1998.

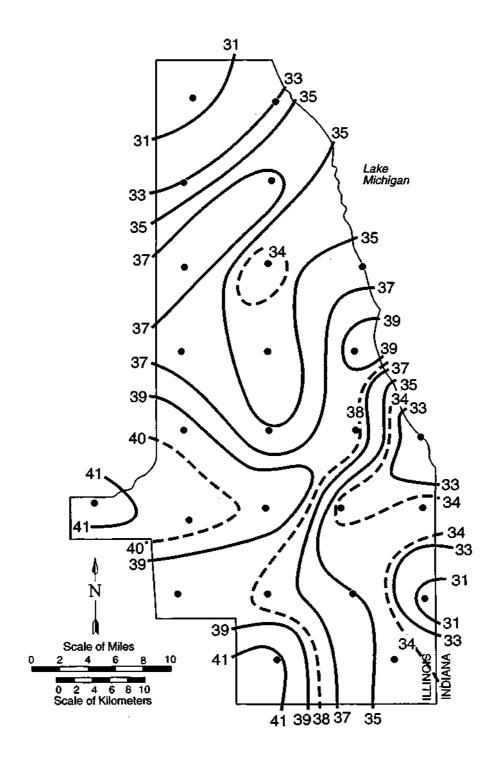
Figure 3. Precipitation pattern (inches) for Water Year 1998.

Table 1 and Figure 3 show Water Year 1998 precipitation amounts. Isopleths in Figure 3 (and Figures 4-11) are labeled in inches, while values in Table 1 are given to the nearest hundredth of an inch. Considering the total annual network precipitation amount, Water Year 1998 was an average year. The Water Year 1998 network average of 36.12 inches was within 1 percent of the 1961-1990 Chicago O'Hare Airport annual precipitation normal of 35.82 inches. Network average rainfall for the network Water Years 1990-1997 were 40.00, 39.19, 36.56, 51.78, 29.23, 34.68, 36.88, and 34.09 inches, respectively. The eight-year network average precipitation was 37.80 inches. There were 138 precipitation events in Water Year 1998, and seven of these events included sites where the storm total exceeded the one-year recurrence interval (Appendix IV). On average, seven such heavy rainstorms occurred in Water Years 1990-1998.

The largest precipitation amounts during Water Year 1998 occurred in the southwestern part of the network (sites #11, #15, #16, #17, and #24, respectively; and at the urban site #10 (see Figure 2 and Appendix I for site information). The lightest amounts occurred in the northern portion of the network (sites #1, #2, and #3) and in the southeastern region at sites #23 and #14. The heaviest precipitation in the network during Water Year 1998 (41.29 inches) fell at site #24 in the southern portion of the network, while the lightest fell at site #1 (30.33 inches) in the far northern part of the network.

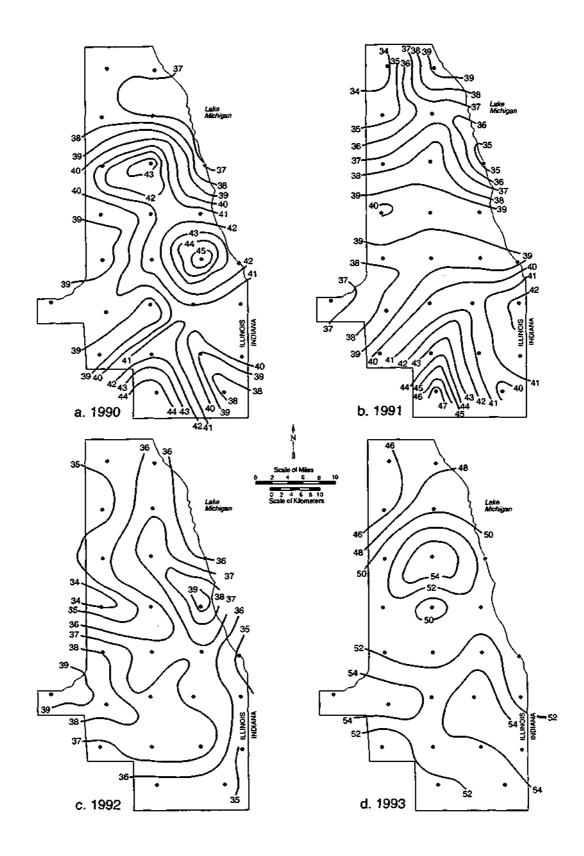
Figure 4. Precipitation pattern (inches) for Water Years 1990 - 1997.

Figure 4 provides maps of precipitation amounts for network Water Years 1990-1997. The general pattern for Water Year 1998 is reminiscent of Water Year 1996 with heavier precipitation in the southwestern portion of the network, and lighter precipitation further north and in the southeastern portion of the network. The "urban high" of the near lake, central Chicago area noted in other network water years (especially Water Years 1990, 1992, 1994, 1996, and 1997) and in other Chicago-area research (e.g., Huff and Vogel, 1976) was present in 1998.

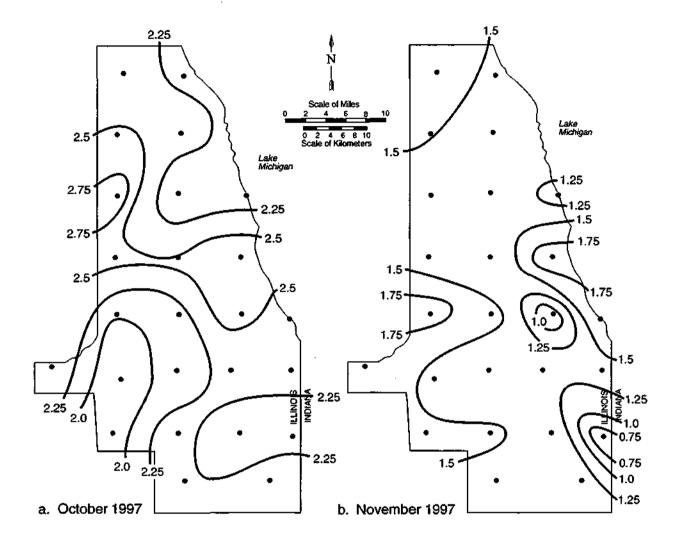
Figure 5. Precipitation pattern (inches) for a) October 1997, and b) November 1997.

Monthly analyses during Water Year 1998 are shown in Figures 5-10 (see also Table 1). The rainiest month of the water year was August when the network average precipitation exceeded 5.0 inches. August precipitation, however, was only about 123 percent of the eight-year August network average of 4.24 inches. The heaviest precipitation was observed in the west-central portion of the network, and in the urban center near the lake. Other months when network precipitation was heavy, those equaling or exceeding 3.25 inches, were found during the spring and summer (March, April, May, June). The March average was about 153 percent of the eight-year March network average of 2.51 inches. In April, May, and June, the network average rainfall was within 7 percent of the eight-year monthly network average. Heavy rainfall amounts in March, April and May, were generally in a band extending from the west-central region east-northeastward toward the urban center and the lake shore. In June, the heaviest amounts were located in the west and southwest portion of the network. During all of these months, there were multiple centers of heavy rainfall.

Precipitation was light during a number of months in Water Year 1998. In October, November, and July, less than 70 percent of the eight-year (1990-1997) network monthly average precipitation was observed. Less than 2.0 inches of precipitation fell during cold season months of November, December, and February. Precipitation amounts and the spatial gradient in precipitation amount were small in magnitude from October 1997 through February 1998.

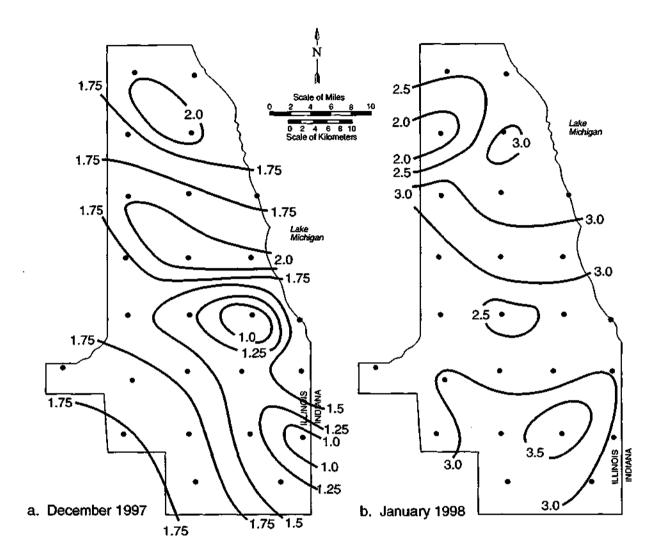
Figure 6. Precipitation pattern (inches) for December a) 1997, and b) January 1998.

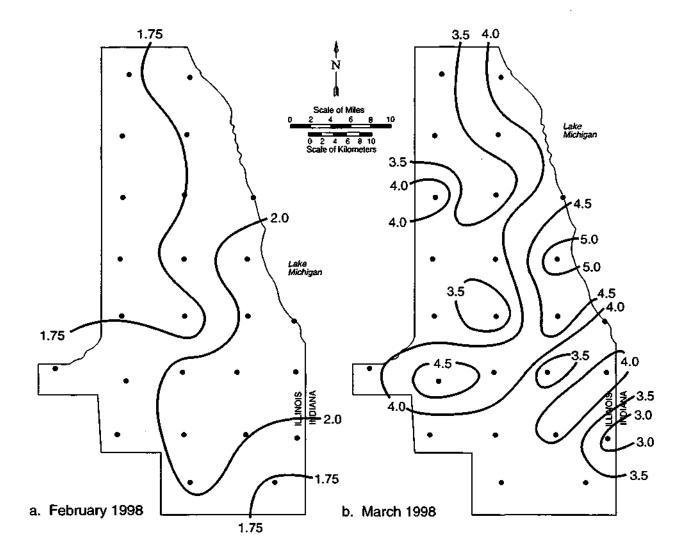
Figure 7. Precipitation pattern (inches) for a) February 1998, and b) March 1998.

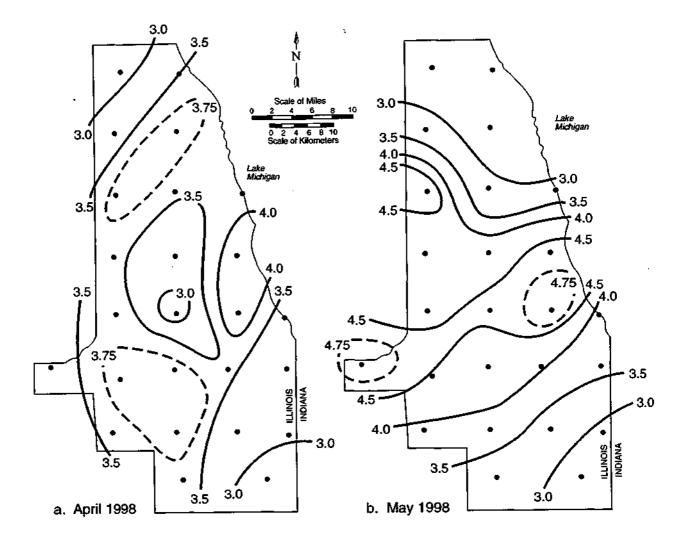
Figure 8. Precipitation pattern (inches) for a) April 1998, and b) May 1998.

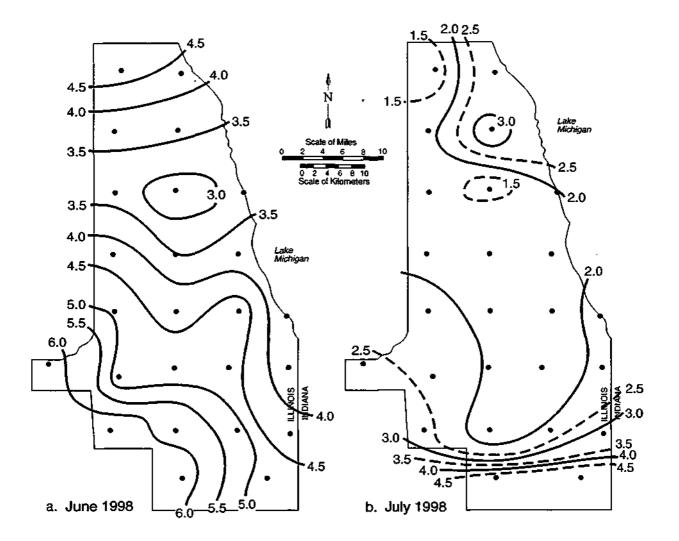
Figure 9. Precipitation pattern (inches) for a) June 1998, and b) July 1998.

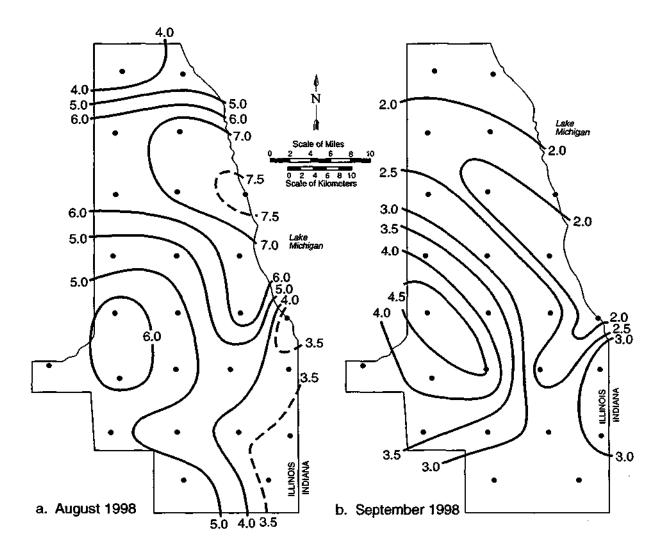
Figure 10. Precipitation pattern (inches) for a) August 1998, and b) September 1998.

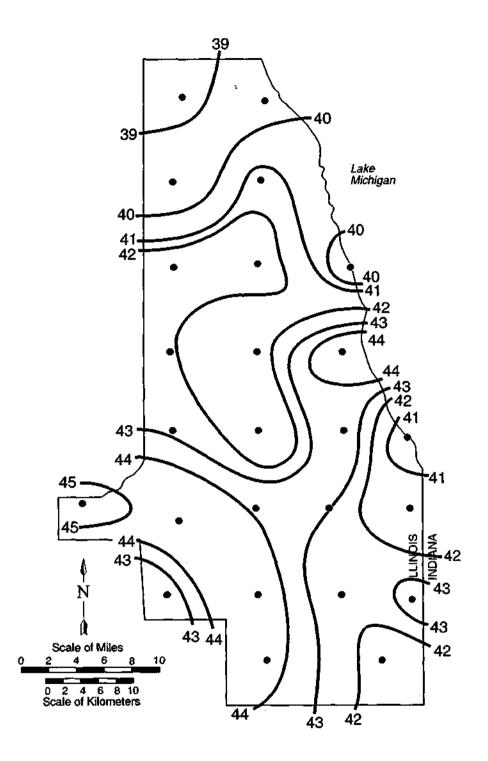
Figure 11. Nine-year average precipitation pattern (inches) from Water Years 1990-1998.

The nine-year (1990-1998) average precipitation pattern (Figure 11) reveals an area of higher values across south-central Chicago (sites #15, #16, #17, #18, #21, #23, and #24), reaching northward to sites #13 and #10. Lower values occurred at the northern sites #1, #2, #3, and #7, and at the lake site #14. The nine-year network-wide average is 37.61 inches.
