Contract Report 2000-03

Kankakee River Basin in Illinois: Hydraulics, Hydrology, River Geometry, and Sand Bars

Interim Report

Illinois State Water Survey
Watershed Science Section
Champaign, Illinois

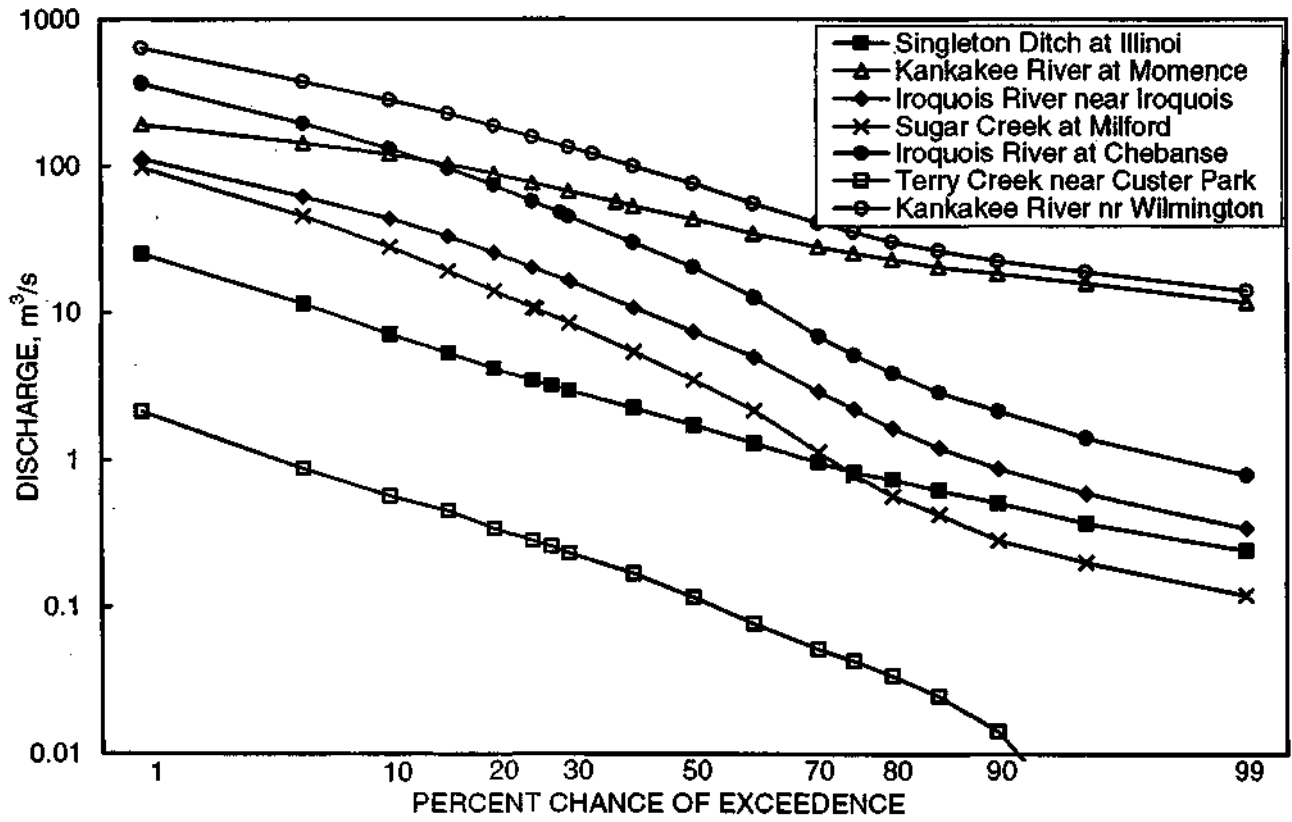
Figure 5. Row duration curves (discharge vs. probability) for gaging stations in the Kankakee River basin in Illinois

Variations in the general shapes of the flow duration curves can often point to significant differences in the hydrology of each stream. The Kankakee River at Mومence and the Iroquois River near Chebanse drain watersheds of similar size and have similar average flow rates. However, the variability in flows for the Kankakee River at Mومence is considerably smaller than that for the Iroquois River, as seen in Figure 5. This reduced range in flows for the upper Kankakee River basin is caused by: 1) its coarse-grained soils, which have increased infiltration and less direct surface runoff, and 2) the direct connection of the river and its tributaries with shallow sand-and-gravel aquifers. Much of the streamflow in this region originates from the ground water, and as a result the upper Kankakee River has substantial low flow even during the most severe droughts.

The variability of flows in the Iroquois River watershed is significantly greater than that for the upper Kankakee River and is more typical of streams throughout much of central Illinois. The Iroquois River watershed is the source of much of the direct surface runoff in the Kankakee River basin, and high flows on the Iroquois River are often more than twice as great as those on the upper Kankakee River. The lower Kankakee River, downstream of the confluence of the Iroquois and Kankakee Rivers, has flow characteristics that combine the high flood discharges

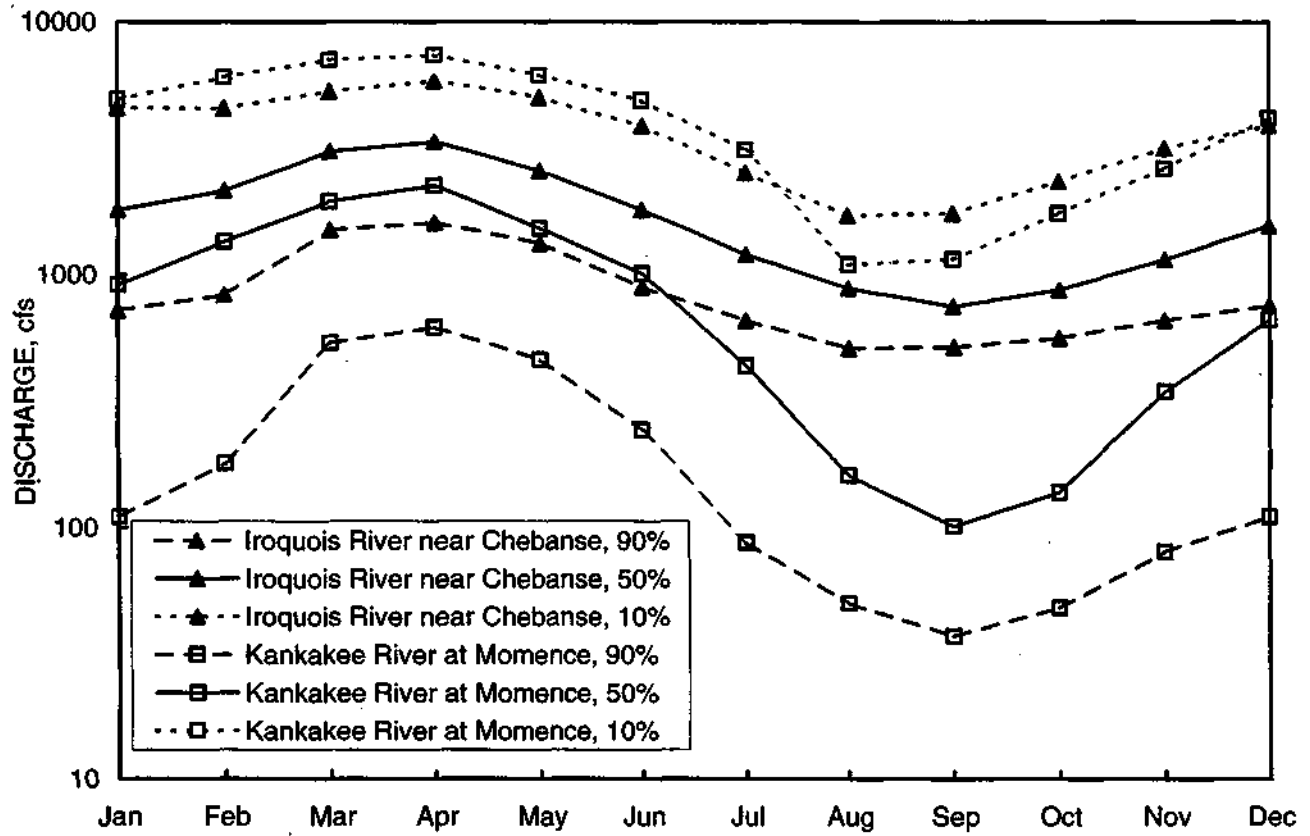
Figure 6. Monthly flow probabilities for the Kankakee River at Momence and Iroquois River near Chebanse

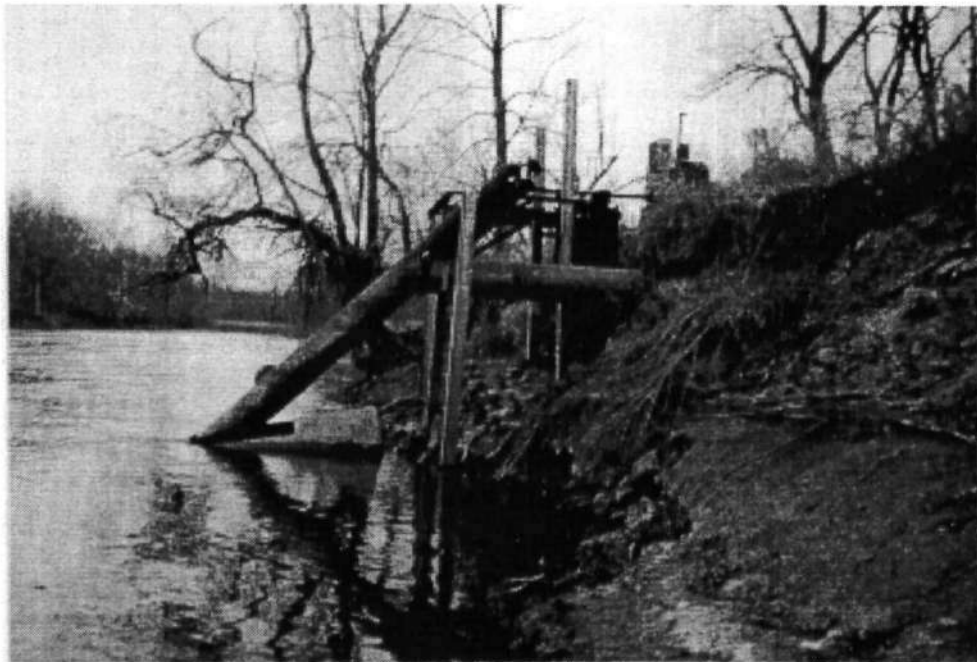
Figure 9b. An example of a rural pump station and bank erosion conditions along the Kankakee River in Indiana

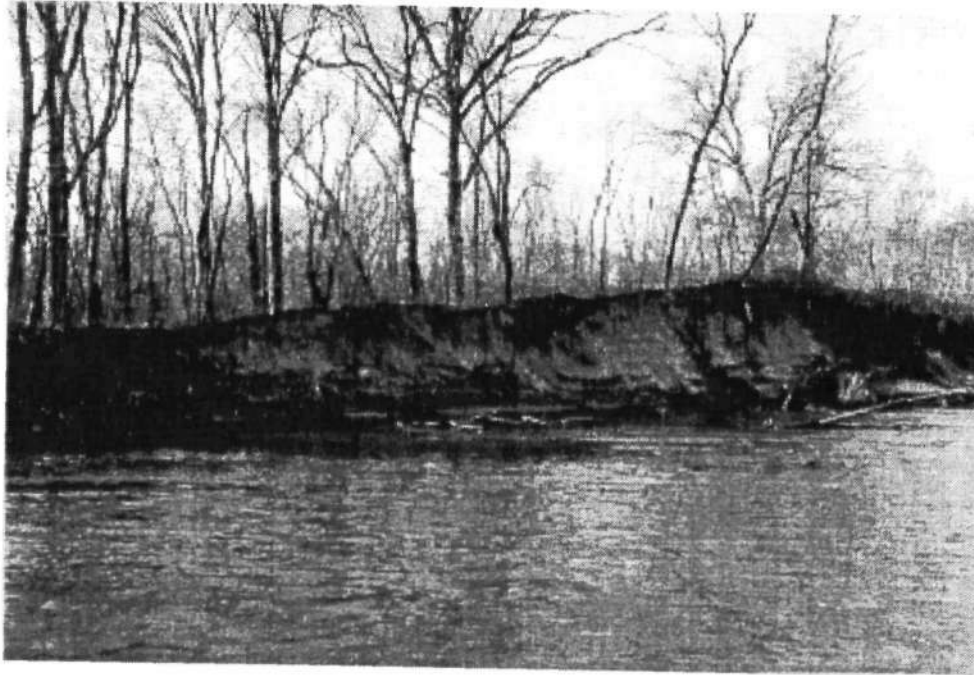
Figure 10a. An example of mass wasting along the Kankakee River in Indiana

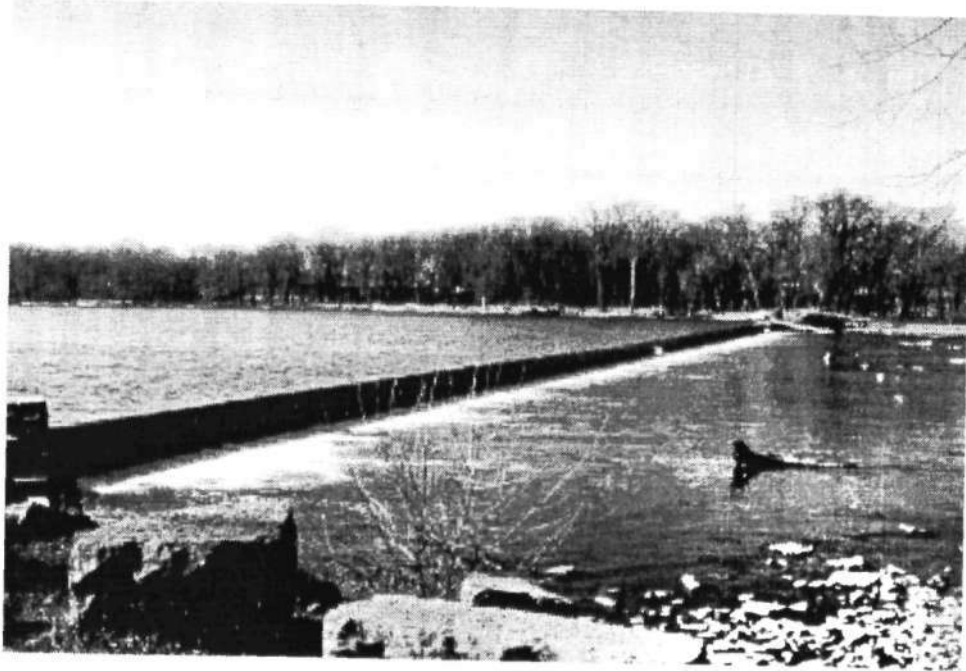
Figure 14a. A view of the Wilmington Dam
on the Kankakee River in Illinois

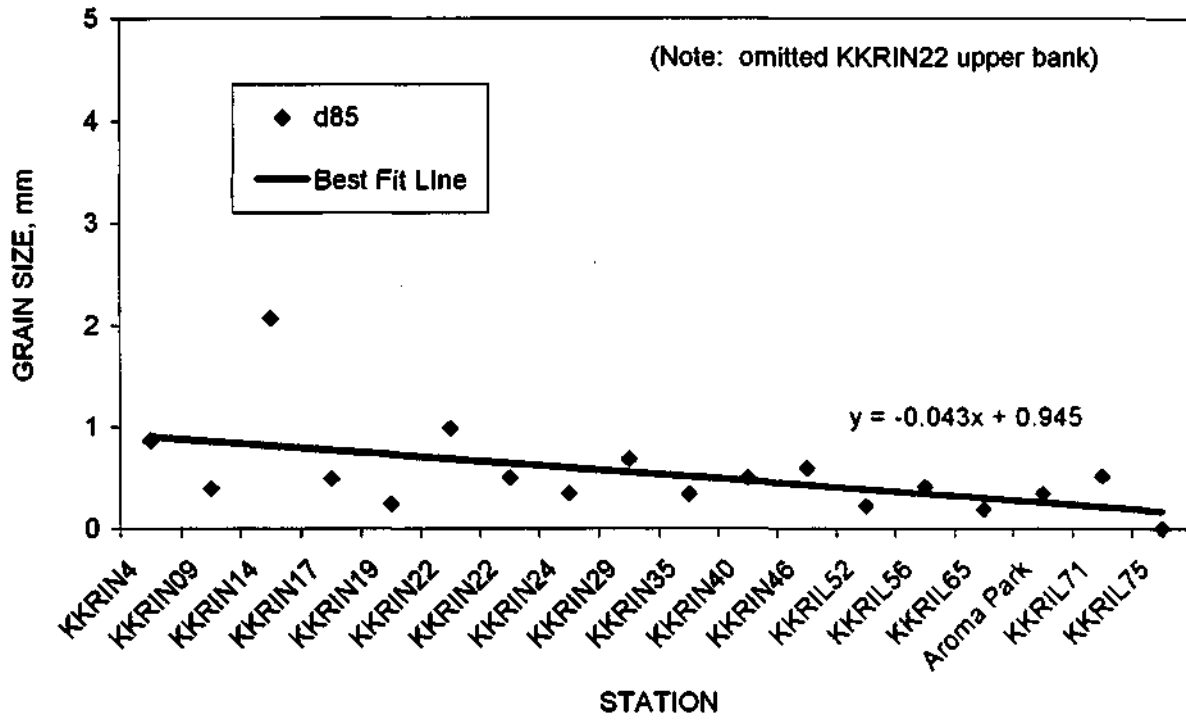
Figure 23. Longitudinal variations of d₈₅ sizes of the bank materials

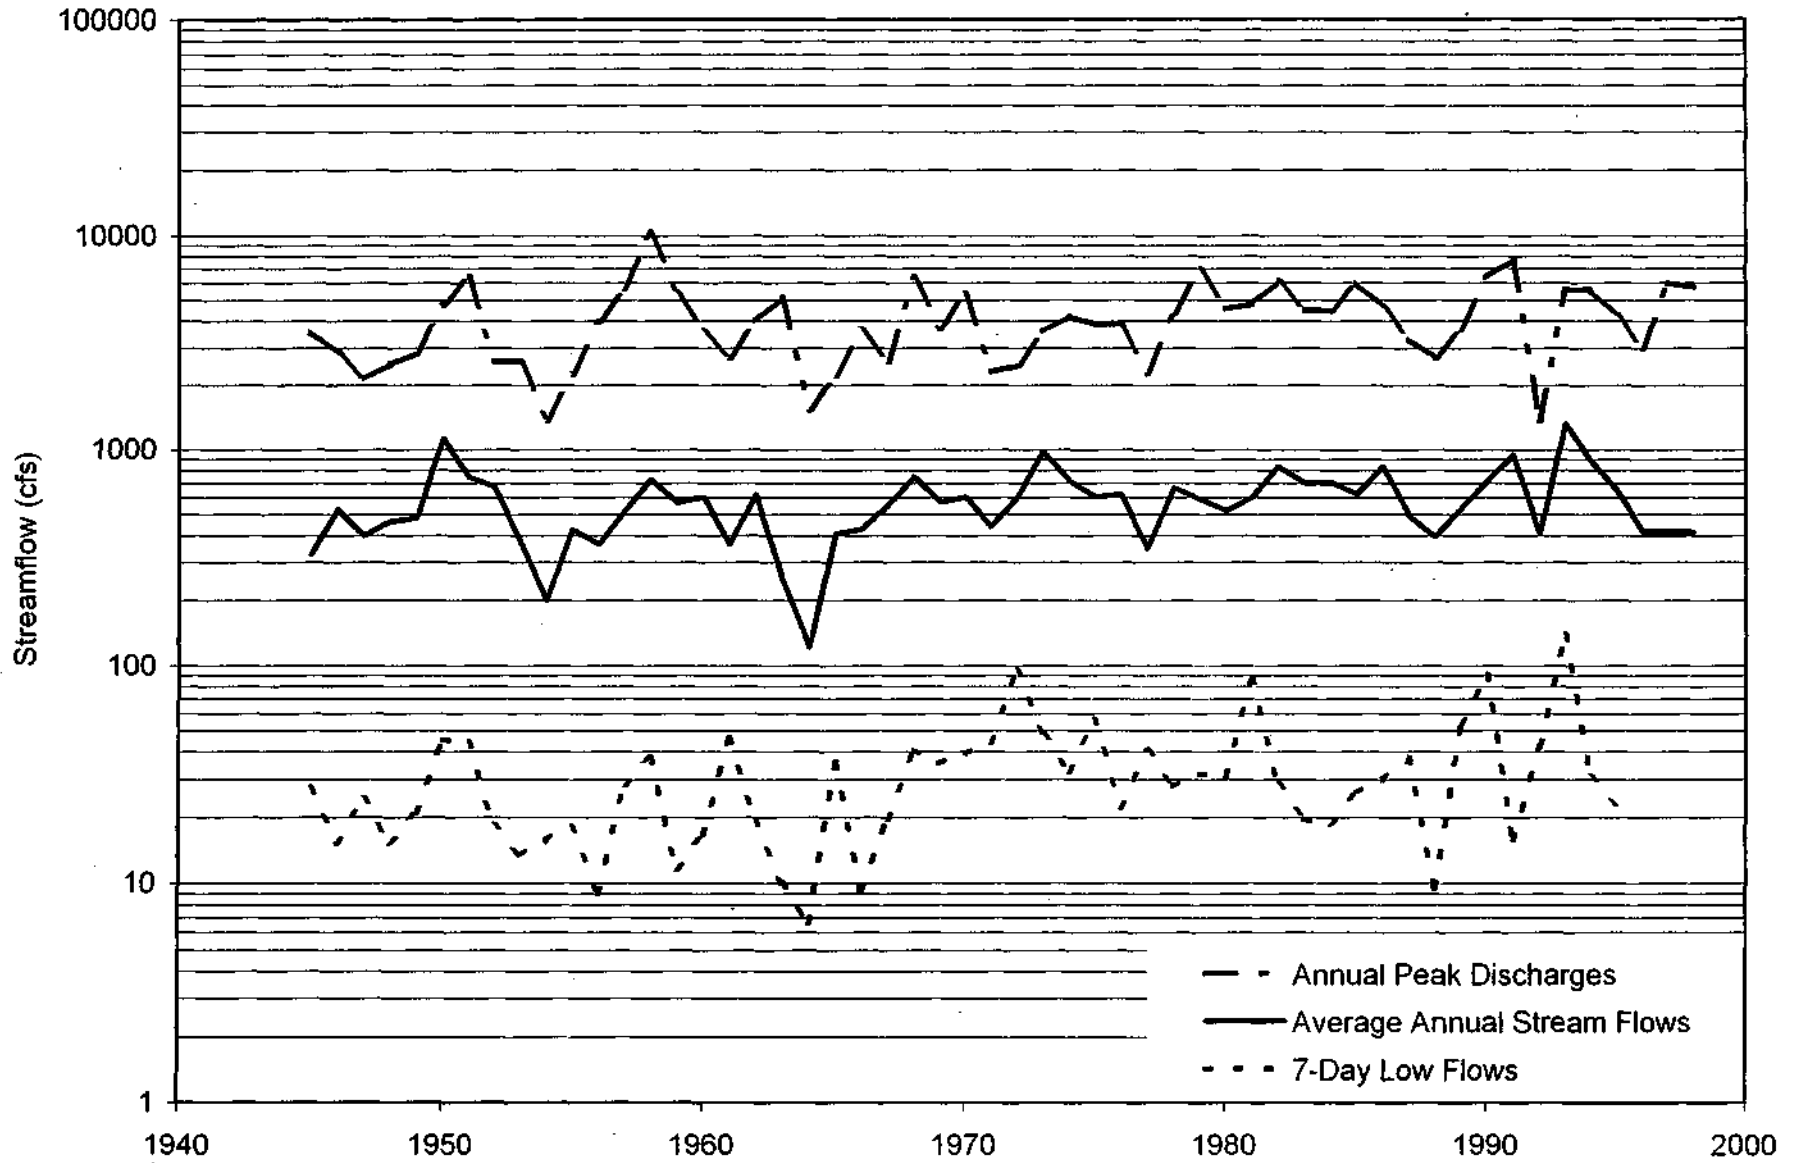
Annual Peak, Average Annual, and 7-Day Low Flows for Iroquois River at Iroquois, IL
