**CONSTRUCTION AND
PERFORMANCE MONITORING
OF VARIOUS ASPHALT
MIXES IN ILLINOIS:
2016 INTERIM REPORT**

Research Report No. FHWA-ICT-17-003

ICT PROJECT R27-161

**Construction and Performance
Monitoring of Various Asphalt Mixes**

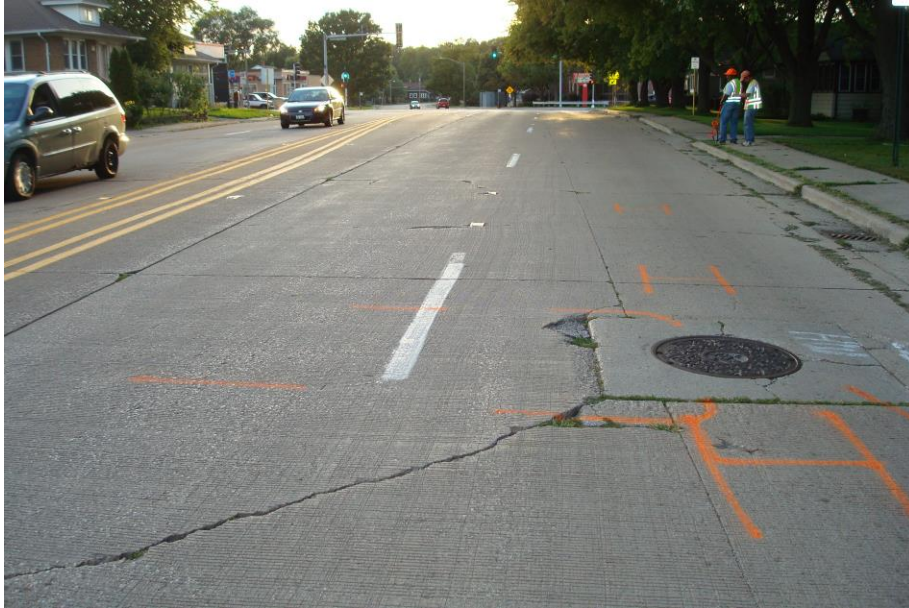
Segment 1. Five-lane and taper: Briggs Street to Peale Street. The westernmost end of the project consists of the original bare 9 in. PCC five-lane pavement with curb and gutter that taper to a two-lane pavement for the remainder of the project. Figure 2 shows the condition of the western segment in 2014.

Figure 2. Washington Street (Segment 1) looking west from near Davison Street.

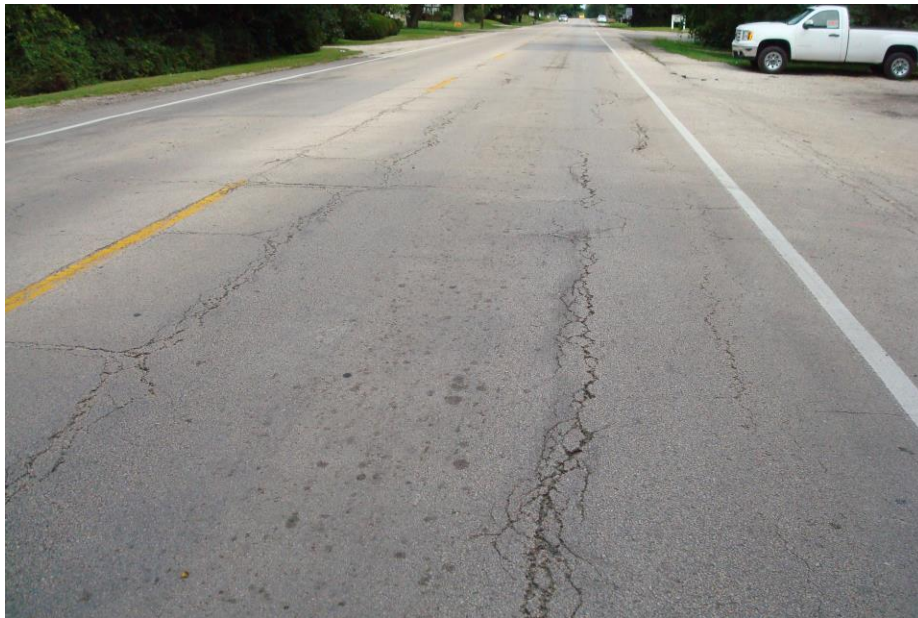
Segment 2. Between Peale Street and US 30. After a short five-lane segment to allow for turning movement at Briggs Street, the section quickly narrows to a two-lane section that is the bulk of the pavement on the project. This segment consists of a 6 in. HMA pavement over an 8 in. stabilized base course and 4 in. granular subbase. The east end of the project has additional turn lanes, with the same pavement section. Figure 3 provides an indication of the section condition.

Figure 3. Washington Street (Segment 2) looking east near Circle Drive.

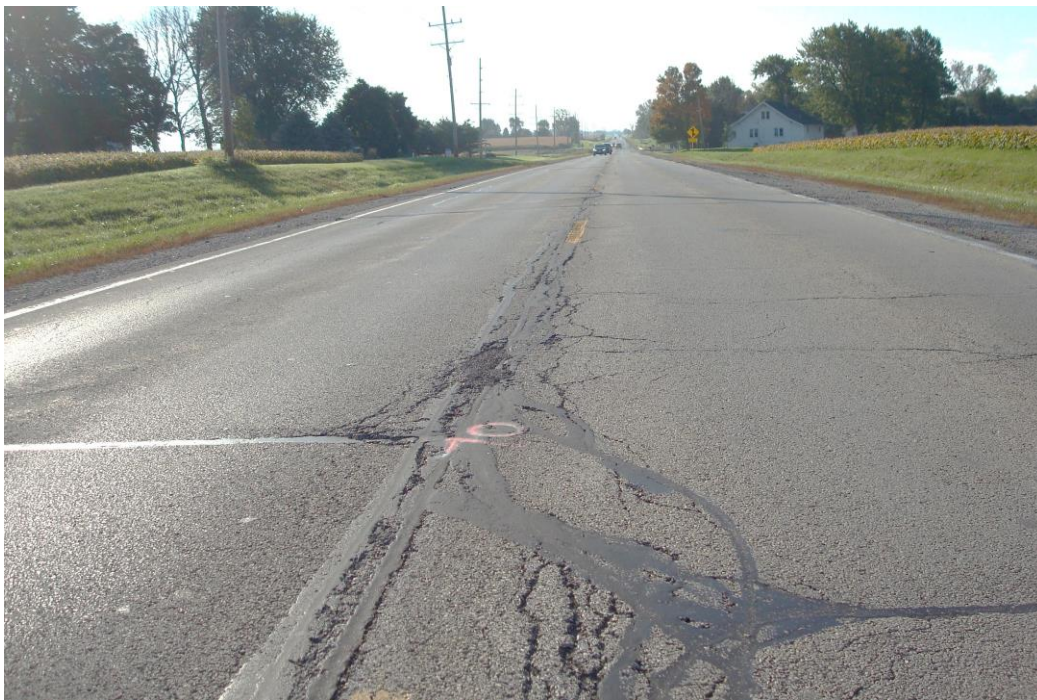
The pavement structure is an 8.25 in. HMA surface that serves as an overlay of a 9 in. PCC pavement, which is consistent throughout the project. Although there are changes in cross-section details such as turn lanes, safety shoulder, and curb and gutter along the project, these items are not expected to impact the performance of the HMA surface. For the purpose of this study, the entire project is considered a single segment. Details of the various existing cross-sections are shown on the plans. Key cross-sections are presented in Appendix A. Figure 5 shows the condition of the pavement on this project in 2014.

Figure 5. US 52 (Laraway Road to Gougar Road) looking south near Station 70+00.

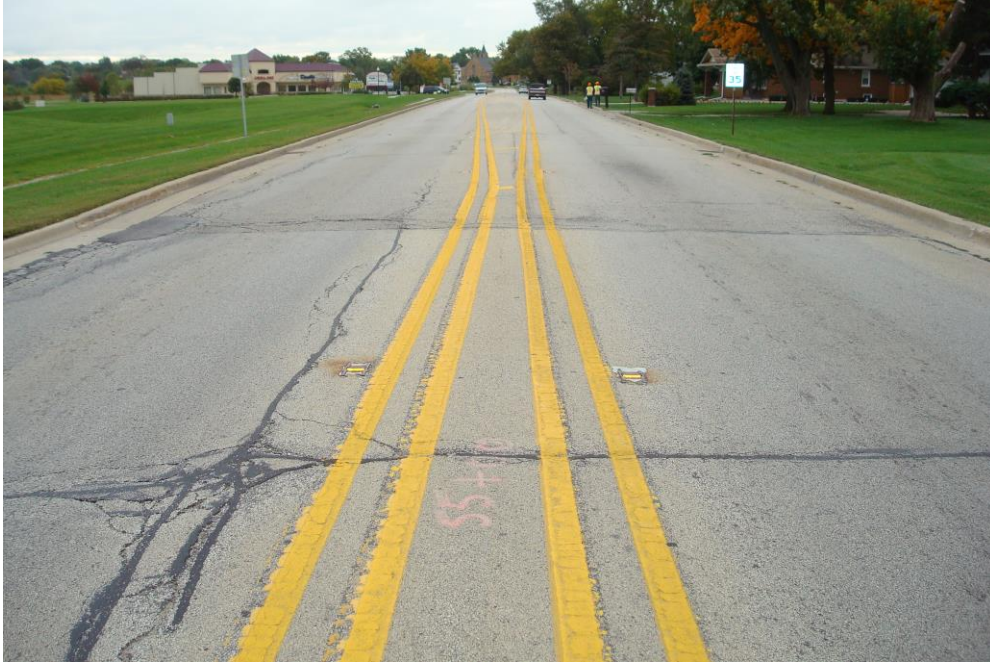
Figure 7 shows the condition of the pavement on this project in 2014.

Figure 7. US 52–Gougar Road to north of Second Street near Station 55+00 looking south.

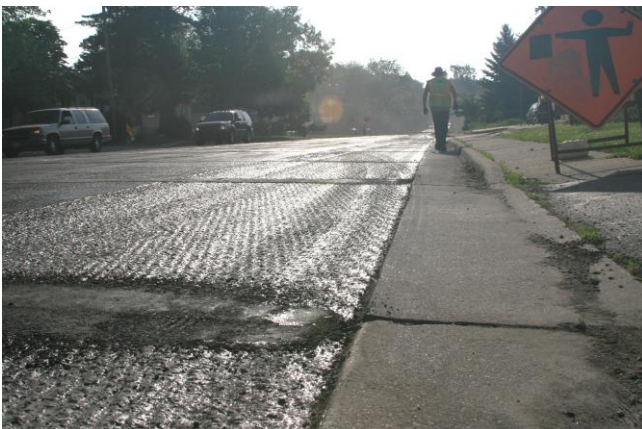
Unlike the projects constructed in 2014, the 2015 milled surface texture of both the PCC and HMA segments was even and fairly uniform across the pavement lane. The first interim report (Lippert et al. 2016) which reported on the 2014 construction noted that there were issues with the resulting texture of the milled surface. For those projects constructed in 2014, a mix of old and new teeth on the milling drum resulted in several deep grooves across the pavement. Winter maintenance of the milling head resulted in new teeth being installed. Because this project had been constructed in spring of 2015, the teeth had yet to experience significant wear or need for replacement. The result was a more desirable and even milled surface.

Figure 8. Segment 1 (Briggs to Peale) cold-milled pavement looking east.

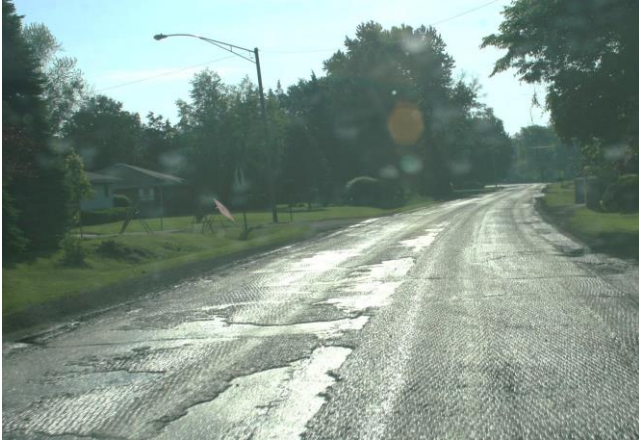
Figure 10. Segment 2 (Peale to US 30) cold-milled pavement looking east.

The milling operation removed a majority of the surface distress in the HMA section that initially seemed to warrant patching. The depth of milling in some areas was very near a lift interface. The result was that, in areas where approximately 1 in. or more of the HMA lift thickness remained in place, it was firmly bonded to the HMA below. In other areas, the remaining HMA lift thickness was 0.5 to 0.75 in., which often debonded from the lower HMA lift and was lost under traffic. Figures 10 and 11 show the resulting milling in various areas.

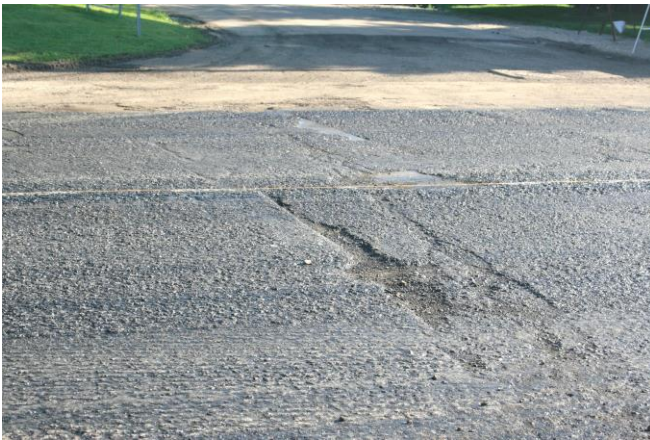
Figure 12. Segment 2 (Peale to US 30) possible area needing patching.

After repairs were complete, the pavement was cleaned then primed. By paving time, traffic had spread the material to fairly uniform coverage. No defining “zebra striping” was evident. Figures 8 through 12 provide an indication of the prime on the milled surface.

Plans and provisions called for patching to be done prior to overlay using Class D patches (full-depth HMA). The plan quantity for patching was 130 yd²; however, the condition of the surface after milling was deemed sufficient, so the patching was eliminated. A couple of areas may have benefited from patching as shown in Figure 12. Monitoring over the study period will determine if there was a need for patching or not in these areas.

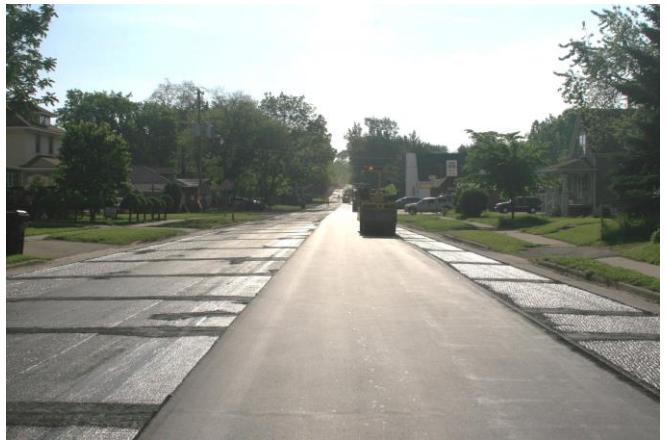
Figure 13. Segment 1 (Briggs to Peale) level binder placed with luted tapered edge (right side) to edge to milled concrete.

It should be noted that the level binder was placed partial width of the cross-sections. On Segment 1, the outside 6 ft was without level binder, and on Segment 2 the outside 1 ft of the pavement was without level binder. See Appendix A for cross-sectional details of level binder placement. Figures 8 through 15 also illustrate this detail. As shown on the plan, the level binder was placed at 0.75 in. thick, with the machine edge forming the longitudinal edge of the level binder. In Segment 1, the contractor tapered the edge by hand luting. The result was that a tapered edge spread over approximately 1 ft.

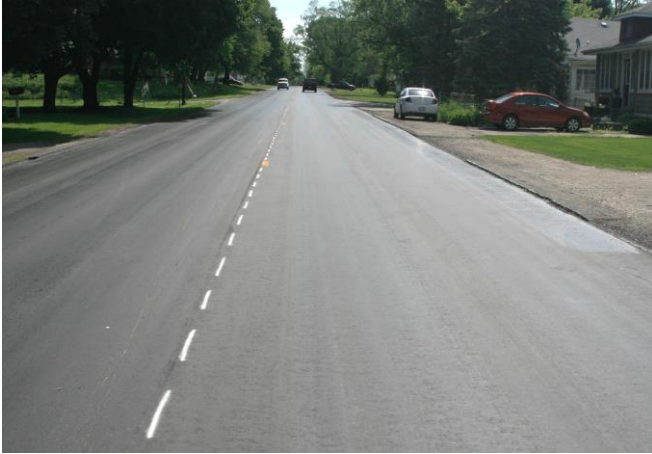
**Figure 16. Segment 2 (Peale to US 30).
Typical tack coat on level binder.**

Prior to placement of the surface, the level binder was primed. Figures 15 through 18 show the level binder primed and ready for paving. On examining the level binder, it was found that several areas had hairline cracks reflecting through the level binder lift. In Segment 1, nearly all the underlying transverse joints and cracks had reflected through the level binder to some degree. Figure 18 shows such an area after the level binder was in place 11 days. In Segment 2, intermittent areas had cracking that was primarily longitudinal near the wheel paths but with some short transverse cracks radiating off of these cracks as shown in Figure 17.

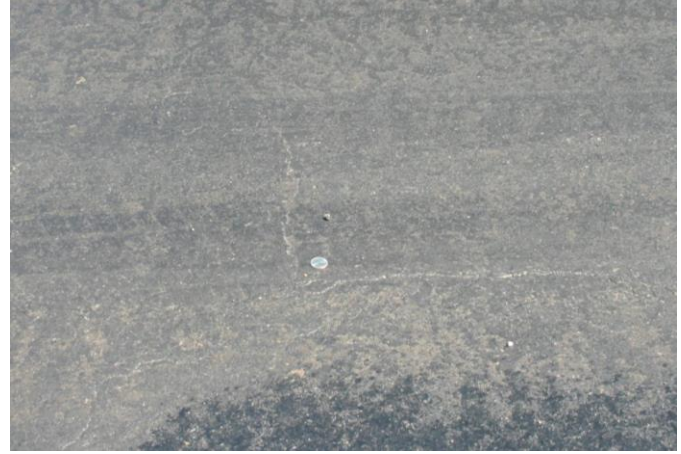
**Figure 17. Segment 2 (Peale to US 30).
Longitudinal and transverse cracks in
newly placed level binder east of NE Circle Drive
in westbound lane outer wheel path.**

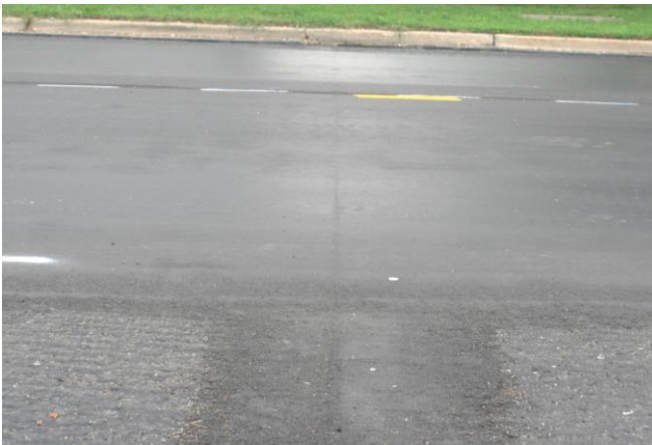
**Figure 18. Segment 1 (Briggs to Peale).
Reflection through level binder at Sta. 23+52.**

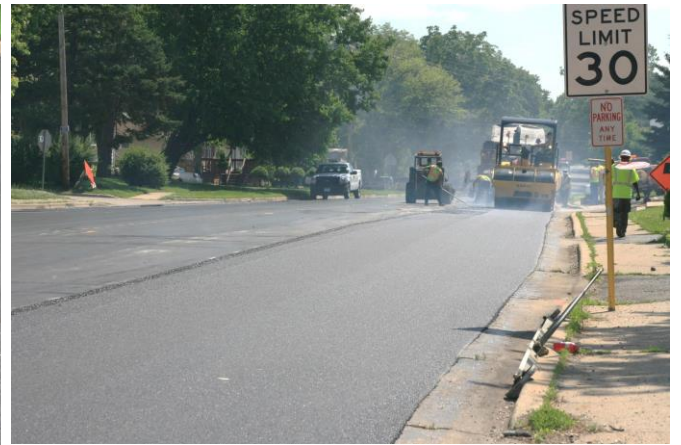
**Figure 19. Segment 1 to 2 transition
at Peale. Paving surface course.**

Appendix F contains the paving sequence map for the surface course. Paving sequence can be important in determining long-term performance related to confined or unconfined compaction edge conditions of the joint. Figure 19 shows paving of the eastbound lanes.

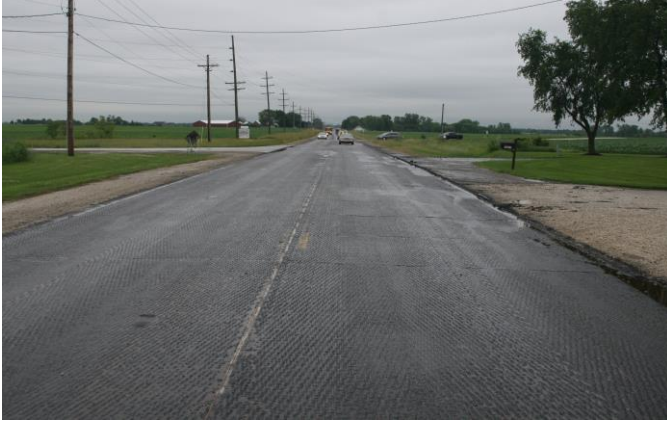
Figure 20. Primed cold-milled surface of US 52 near Sta. 47+00 looking south.

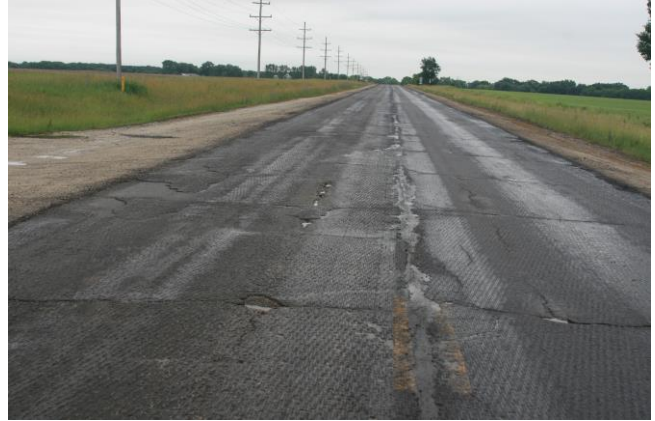
Figure 21. Prime cold-milled surface of US 52 near Sta. 114+00 looking north.

This project consists of an existing HMA overlay that was milled 2.25 in. in depth from edge to edge of pavement, shoulder, or curb and gutter as shown on the plans. Milling was of good quality and generally even in nature. Figures 20 and 21 present the milled surface at various locations.

The pavement was cleaned then primed. Plans called for paving to start several hours later, at daybreak. After priming, the traffic spread the prime somewhat and by morning appeared to be fairly even across the roadway as shown in Figures 20 and 21. Unfortunately, the morning also brought a light rain that caused some of the unbroken emulsified prime to migrate off the road surface as shown in Figures 22 and 23.

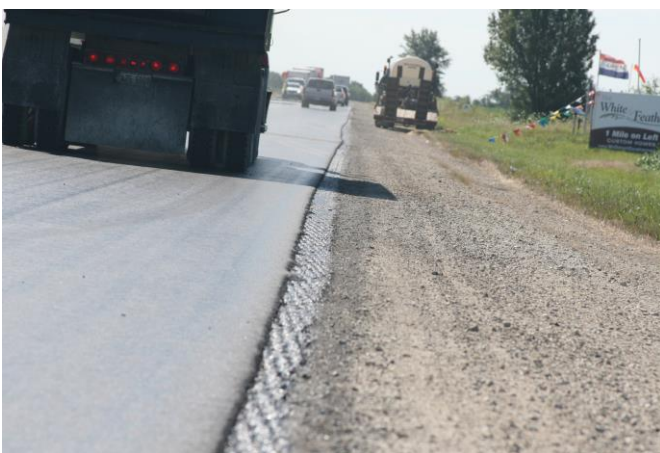
Figure 24. Level binder with 12 in. exposed milled pavement.

A common cross-section detail of Region 1/District 1, the level binder was placed narrower than the pavement area to be resurfaced. The outside 12 in. of the pavement or safety shoulder were not covered with the level binder. See Appendix A for cross-sectional details of how the level binder was placed. Figures 24 and 25 show this detail in relation to surface paving. As shown on the plan, the level binder was placed at 0.75 in. thick, with the machine edge forming the shoulder-side longitudinal joint edge of the level binder. As with the other projects let in 2014, the contractor used two static three-wheel rollers for breakdown and intermediate rolling followed by a finish dual-drum roller.

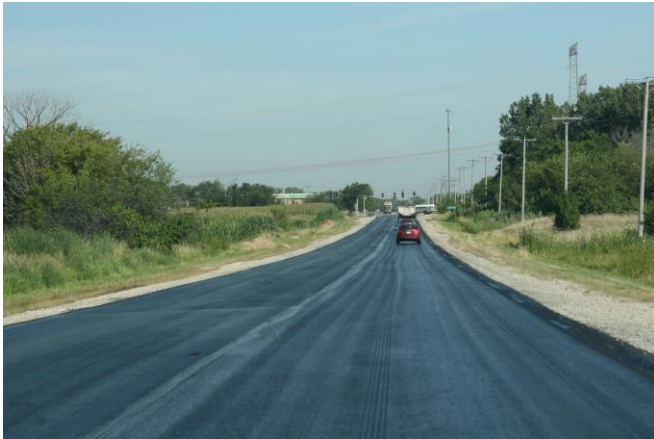
Figure 26. Prime coat on level binder looking north near Sta. 45+00.

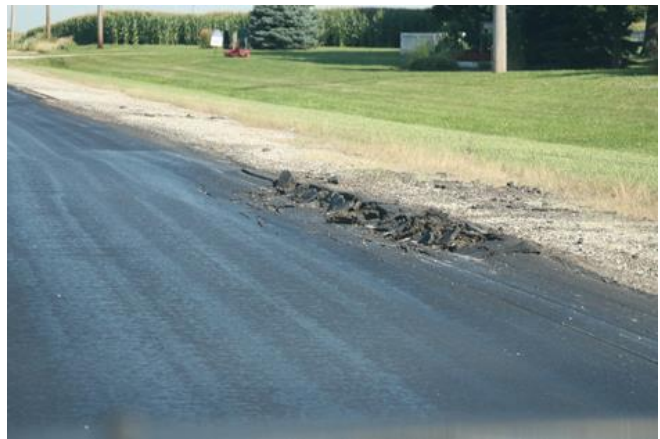
Figure 27. Edge of pavement distress on westbound US 52 near Sta. 77+00.

edge on the binder lift as seen in Figures 27 and 28. Such areas were repaired prior to surface placement.

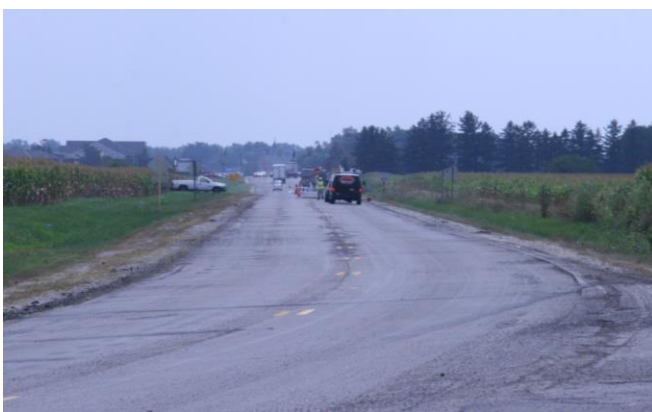
Figure 30. Cold-milled surface of US 52 near Gougar Road (to right) looking south.

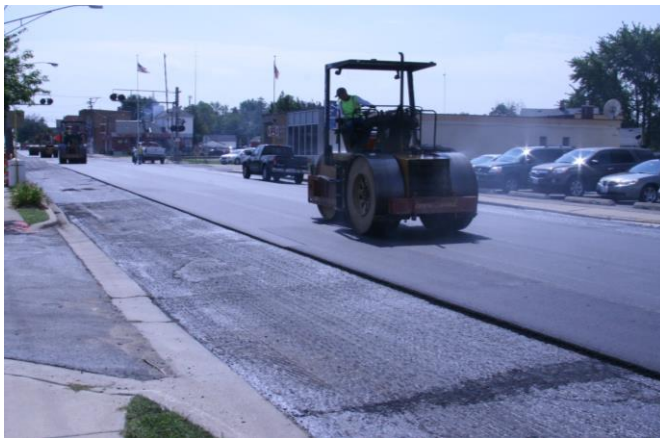
Figure 34. Level binder roller train; primed and milled parking area with filled joint/crack near Sta. 84+00 westbound lane looking south.

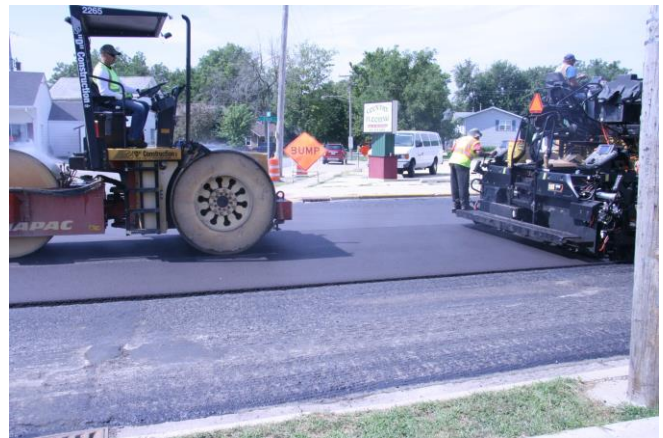
Figure 35. Rolling level binder directly behind paver in westbound lane near Sta. 84+00.

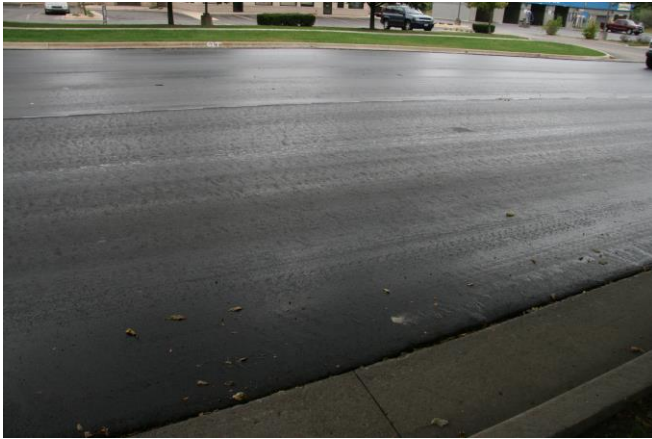
Figure 36. Prime coat on level binder looking west near Sta. 63+00.

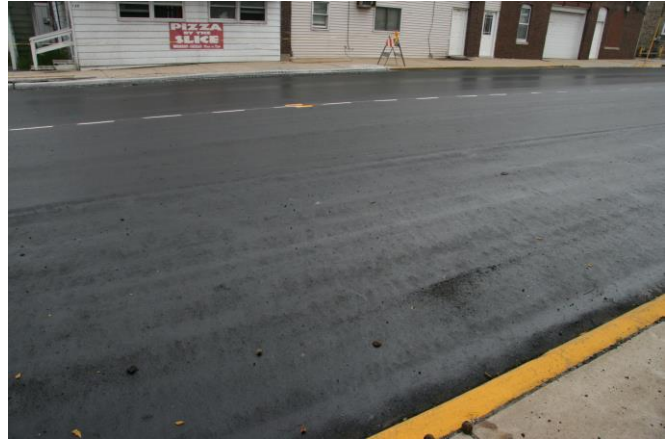
Figure 37. Prime coat on level binder looking west near Sta. 81+00.

Prior to paving the surface, the level binder was primed. Figures 36 through 38 show the resulting coverage in different areas, which was fairly even.

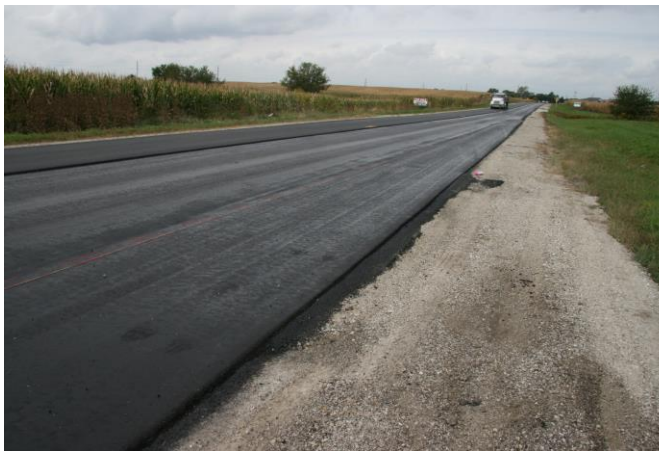
Figure 38. Near Sta. 36+00 looking north with surface placed eastbound. Note level binder placed 1 ft less than lane width.

This project was partly a rural cross-section with shoulders for half the project and the remaining project having an urban curb and gutter cross-section. As with all the rural segments under study in this project, the level binder was placed narrower than the pavement area to be resurfaced on the outside 12 in. of the pavement or safety shoulder. In the curb and gutter area, the level binder was from gutter to gutter. See Appendix A for cross-sectional details of how the level binder was placed and Figures 36 through 38 for this detail. As shown on the plan, the level binder was placed at 0.75 in. thick, with the machine edge forming the longitudinal joint edge of the lift. As with the other projects, the contractor used two three-wheel rollers for breakdown and intermediate rolling followed by a finish dual-drum roller.

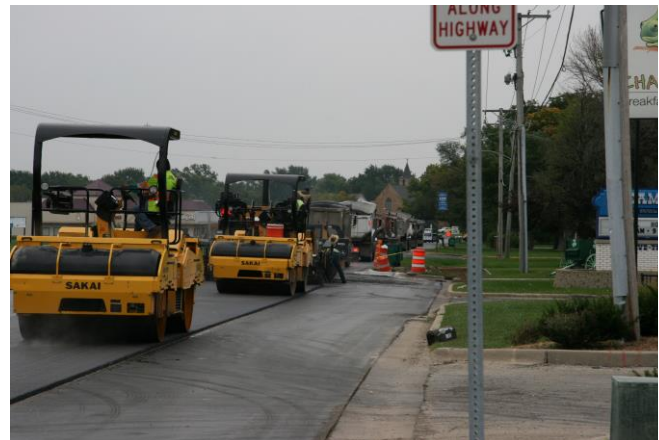
Figure 39. Paving train of surface in eastbound lanes just south of Manhattan Road.

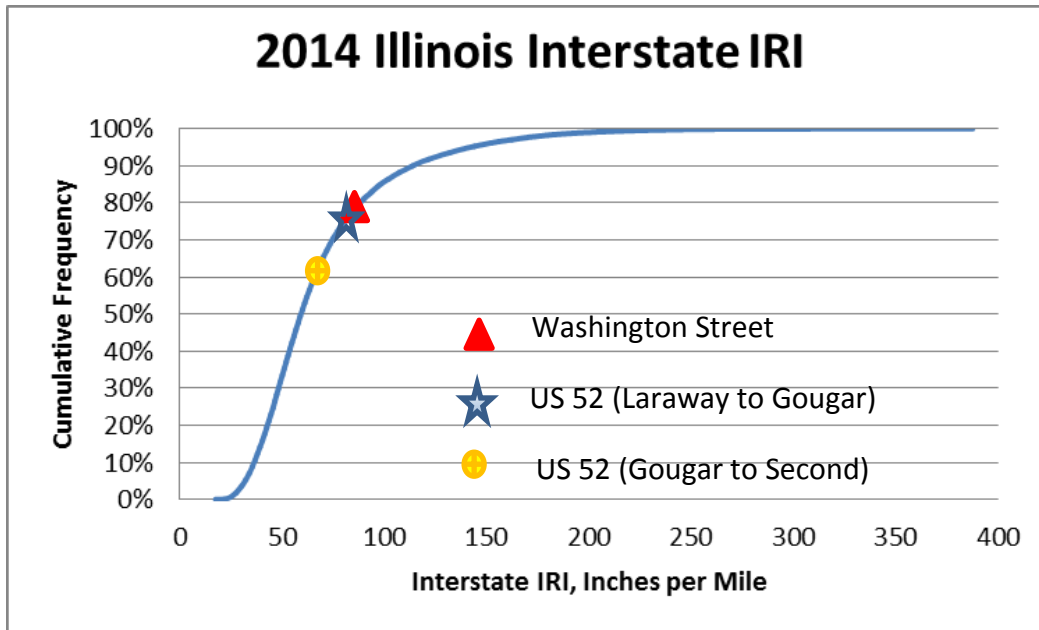
To determine how winter might have an impact on developing distress, pavement smoothness was also collected under frozen pavement sections conditions. Washington Street saw little change in IRI from post-construction to winter/frozen to spring conditions. The IRI values for these conditions were 86, 90, and 87 in/mi, respectively. These values are considered within the error of measurement and essentially unchanged. For US 52–Laraway Road to Gougar Road, the IRI values for the same conditions were 88, 84, and 86, respectively, and were also considered unchanged from season to season. For US 52–Gougar to north of Second Street), the IRI values were 74, 91, and 75. For this section, freezing of the pavement resulted in a considerable increase in pavement roughness that returned to pre-frozen values after the spring thaw.

Figure 40. 2014 cumulative frequency curve of Illinois interstate IRI.

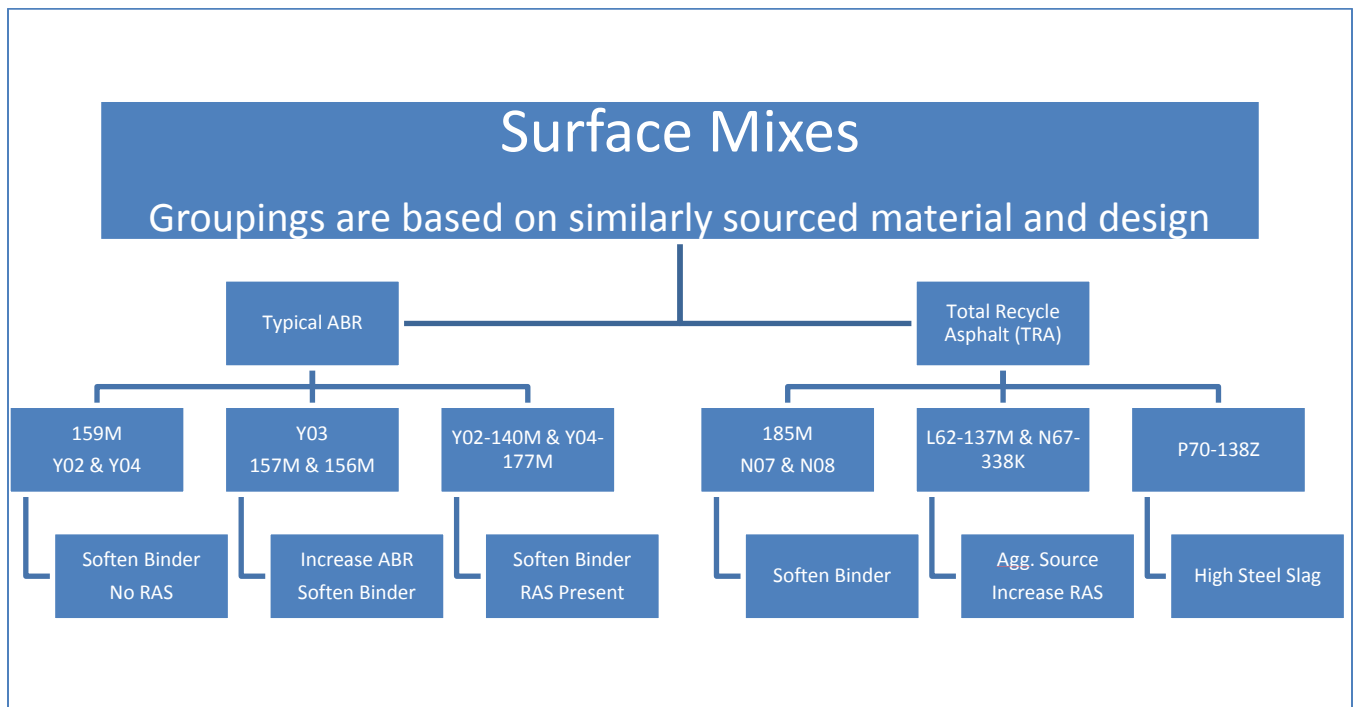
To better illustrate the effect of mix design parameters on mechanical properties, mixes are divided into surface mix and level binder mix. The surface mixes with similar mix design are grouped as shown in Figure 41.

Figure 41. Grouping of surface mixes.

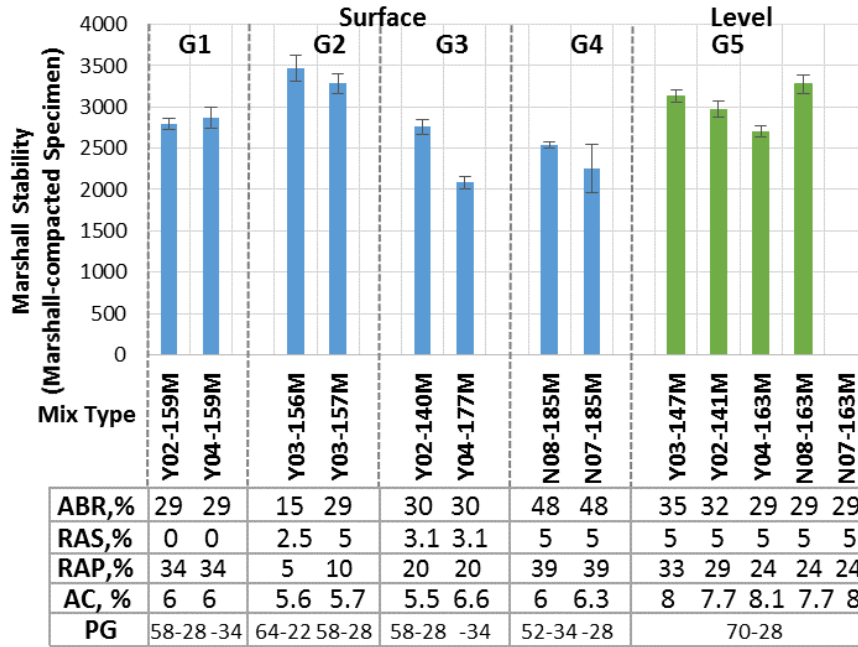
The most significant design parameters for Marshall stability in this study were AC, binder PG, and ABR. Higher AC, lower PG, and higher ABR may result in lower Marshall stability.

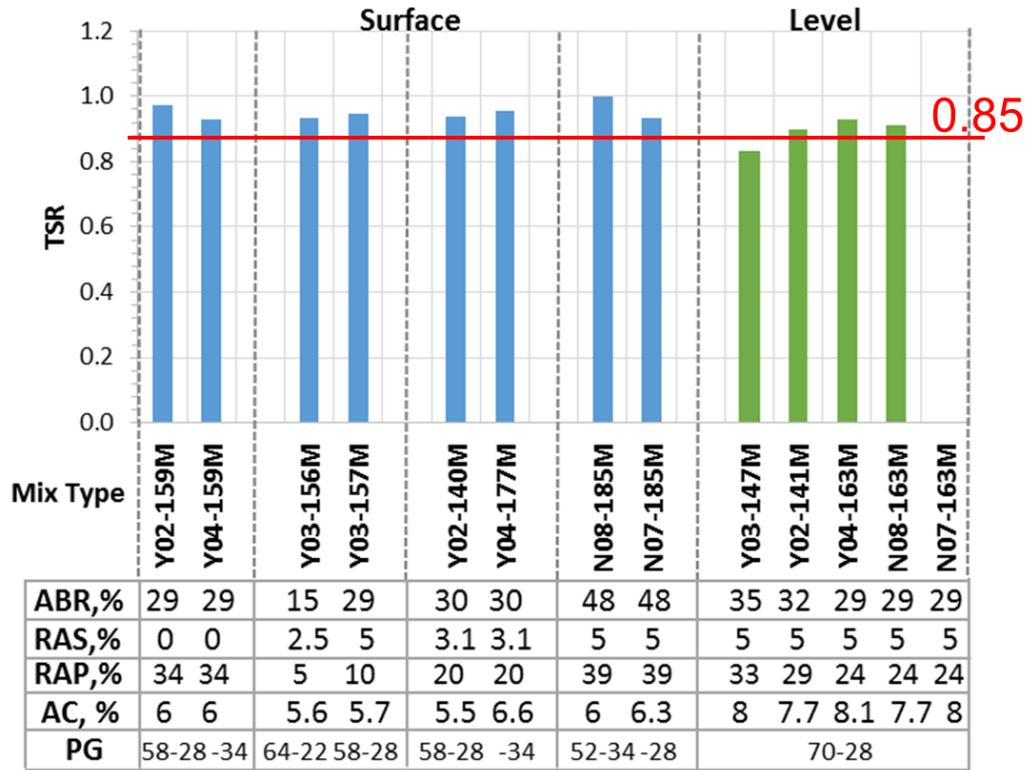
The moisture damage resistance of asphalt mixtures was characterized by the IL-Modified AASHTO T 283 TSR test. Figure 45 presents the TSR for each mix. As shown, all mixes had acceptable ratios, except that the TSR value for the Y03-147M mix was slightly below the threshold value of 0.85. It was verified in the JMF that the Y03-147M mix passed the TSR requirement.

Figure 44. TSR test results

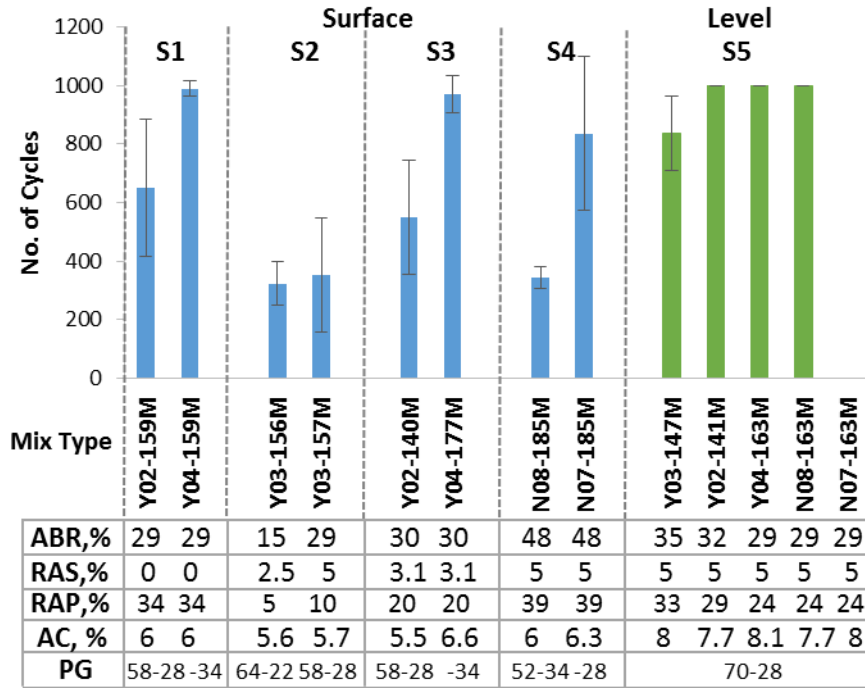
For level binder mixes (Group S5), the number of cycles were all high because of the polymer-modified binder used and higher AC.

Figure 45. Texas overlay test results.

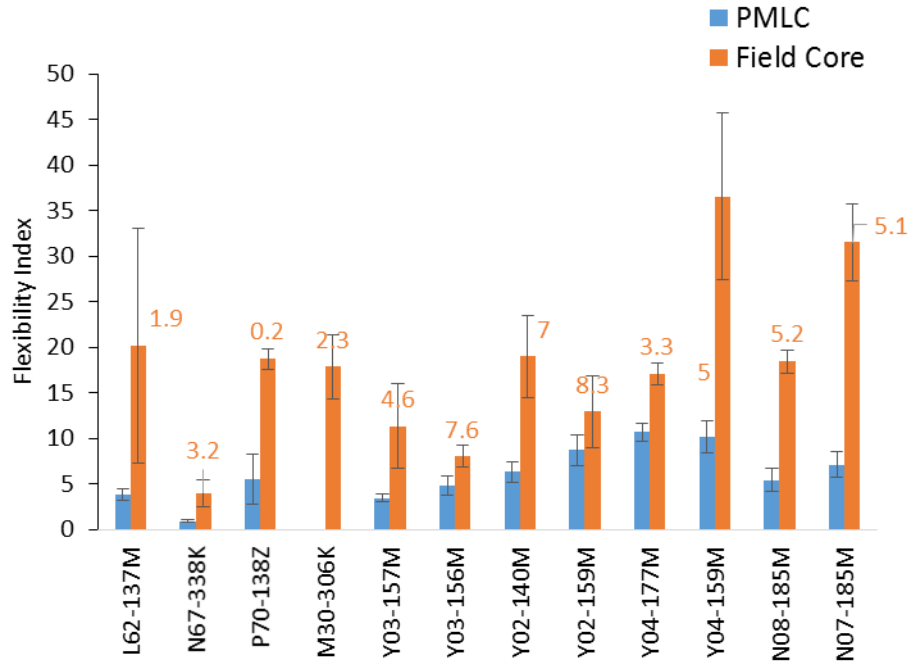
Figure 46 compares the FI values between the plant mixes and field cores. Only surface mixes had field cores. The numbers in orange denote the air void of field cores. The field cores showed higher FI values than the plant mixes, which is due primarily to the difference in compaction efforts, specimen thickness, and air void contents.

Figure 46. FI comparison between field cores and plant mix.

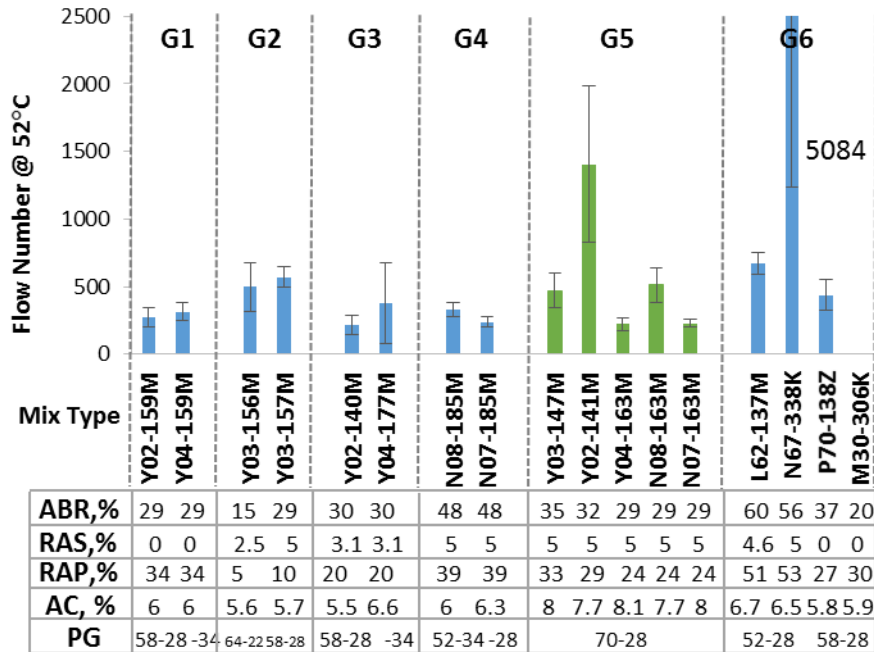
The N67-338K mix in Group G6 had an extremely high flow number, which is consistent with the Hamburg wheel tracking test results that its rut depth was lowest among all mixes because of its highest ABR and RAS content.

Figure 47. Flow number test results for plant mix.

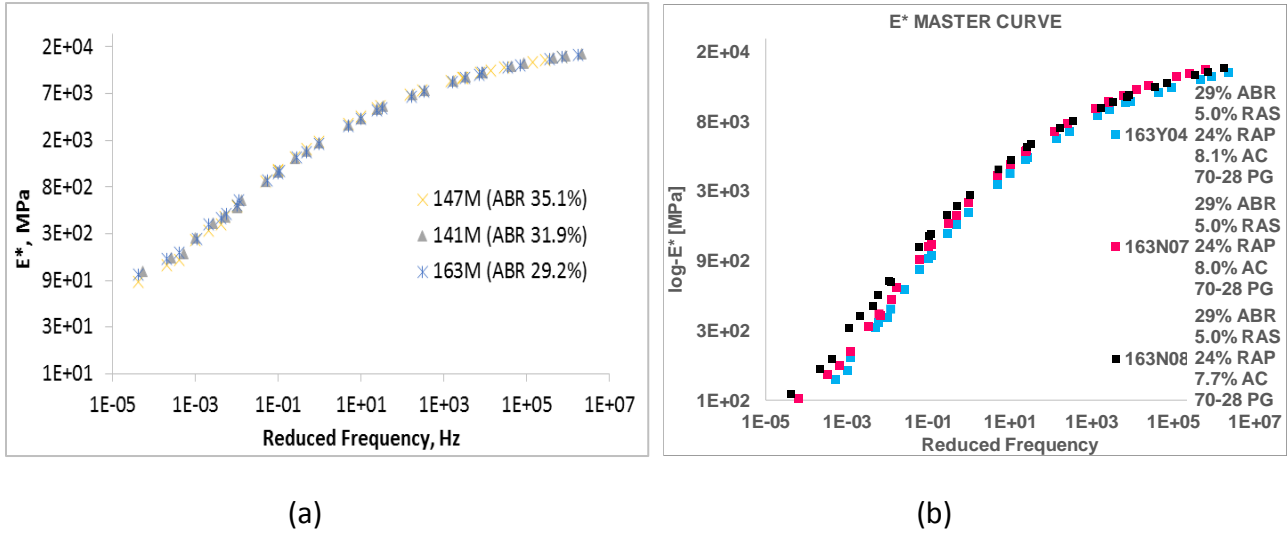
Figure 49(b) compares the same mix 163M in three contracts (Y04, N07, and N08). The mix in contract N08 had the highest modulus, especially in the lower frequency range, followed by N07 and Y04, which again indicates that different aging effects may have occurred for the mix production for each contract.

Figure 49. Dynamic modulus master curves of level binder mixes at reference temperature of 21°C

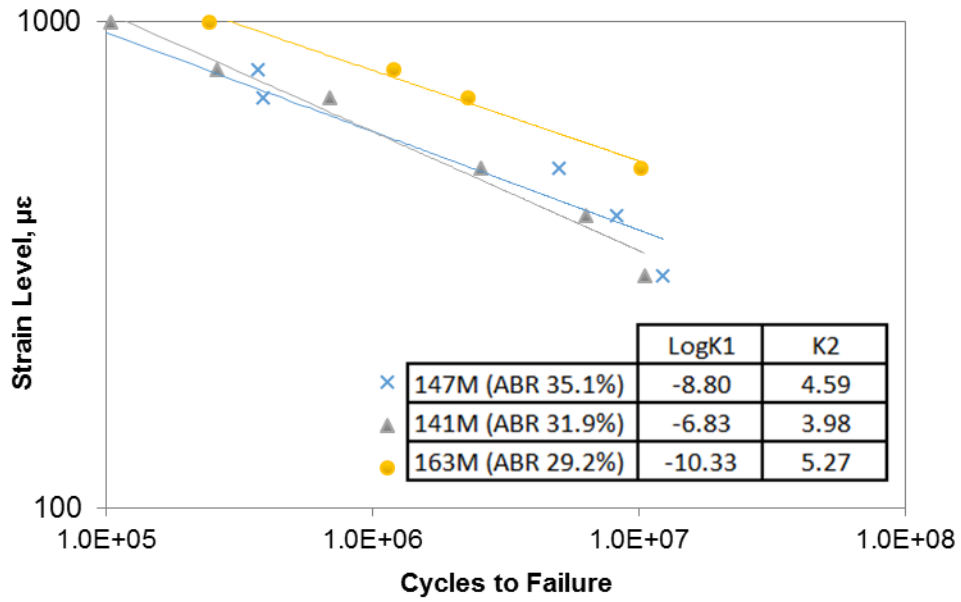
Figure 50. Four-point beam fatigue test results: Cycles to failure versus strain level.

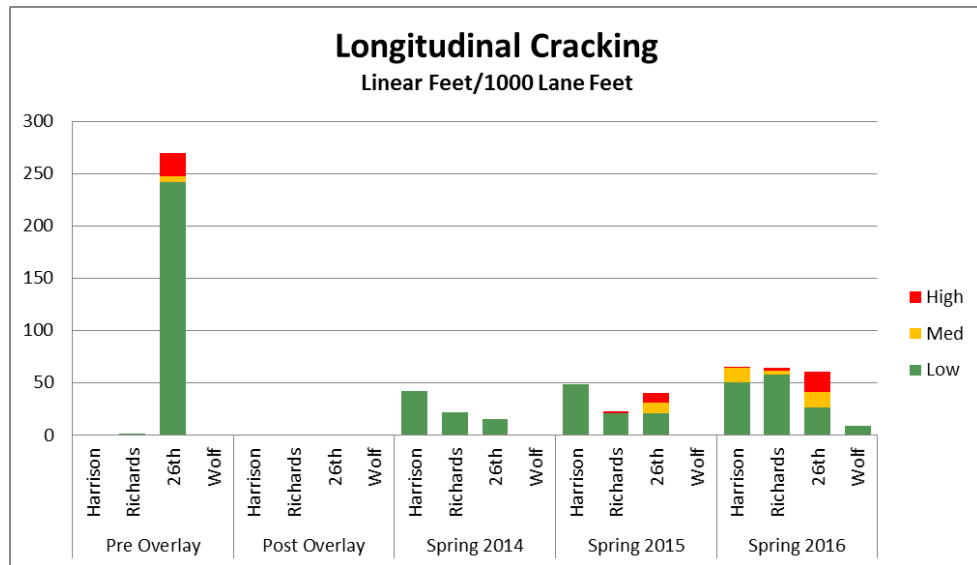
Figure 57. Longitudinal cracking by distress level for TRA projects.

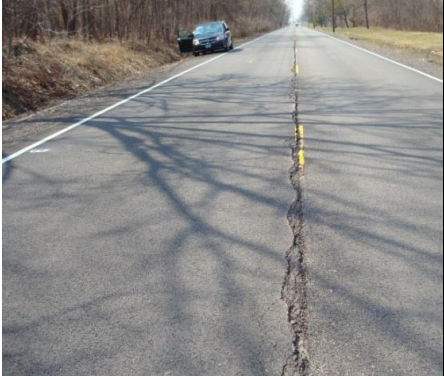
A photograph of a two-lane asphalt road with a yellow dashed center line. A dark car is visible in the distance on the left side of the road. The road surface shows some wear and a crack running down the center.

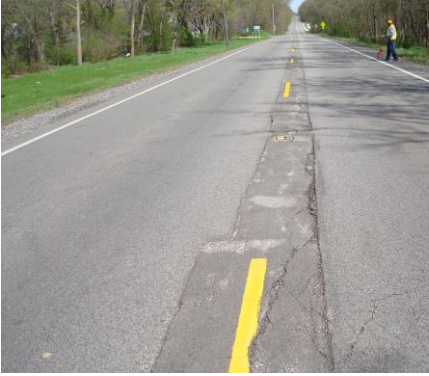
A photograph of the same road section, showing a worker in a yellow safety vest on the right shoulder. The road surface has a prominent longitudinal crack and some surface distress.

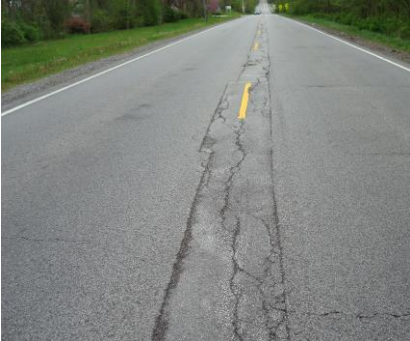
A close-up photograph of the road surface, highlighting a significant longitudinal crack and surface irregularities.

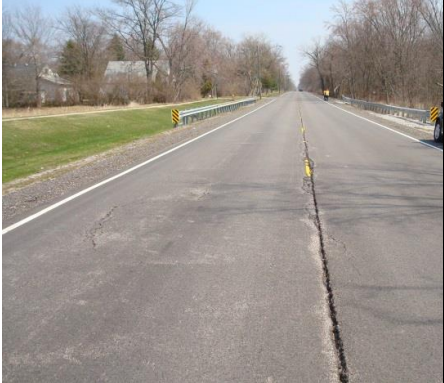
A photograph of the road from a different angle, showing a guardrail on the left side and a crack in the asphalt.

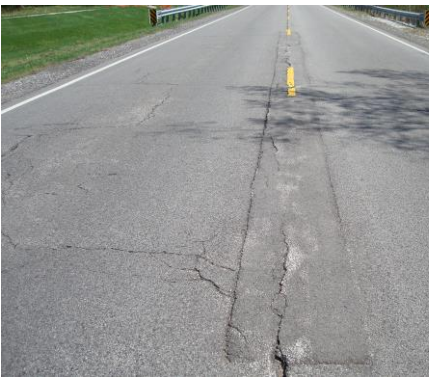
A photograph of the road showing a large, irregular surface crack and some dark patches on the asphalt.

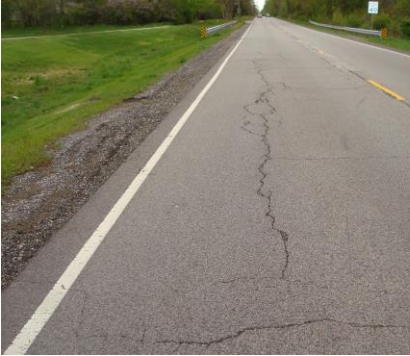
A photograph of the road showing a crack and a white line on the left side of the road.

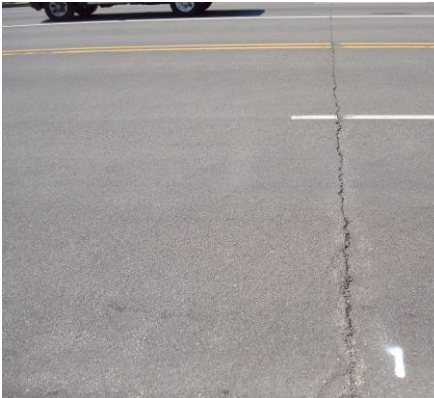
A photograph of a road surface showing a vertical crack. A white line is painted across the crack. A white number '1' is marked on the pavement to the right of the crack. A portion of a vehicle is visible at the top left.

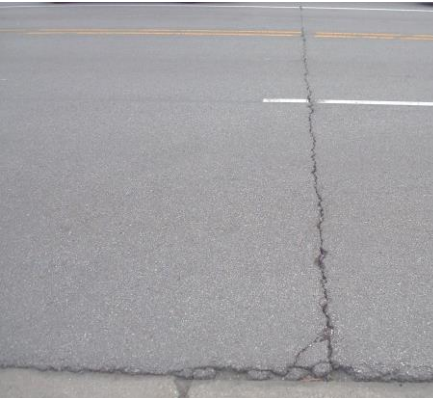
A photograph of the same road surface as in 2014, showing the vertical crack and white line. The crack appears slightly wider and more irregular.

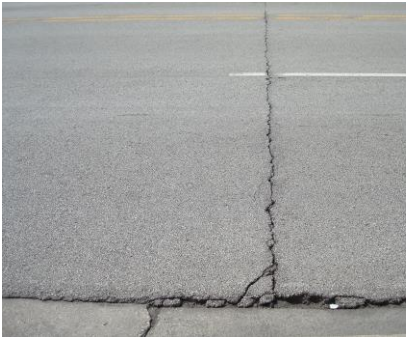
A photograph of the same road surface as in 2014, showing the vertical crack and white line. The crack is significantly wider and has branched out at the bottom.
