CIVIL ENGINEERING STUDIES

ESTABLISHING PROCEDURES AND GUIDELINES FOR PEDESTRIAN TREATMENTS AT UNCONTROLLED LOCATIONS

Research Report No. FHWA-ICT-17-016

ICT PROJECT R27-167

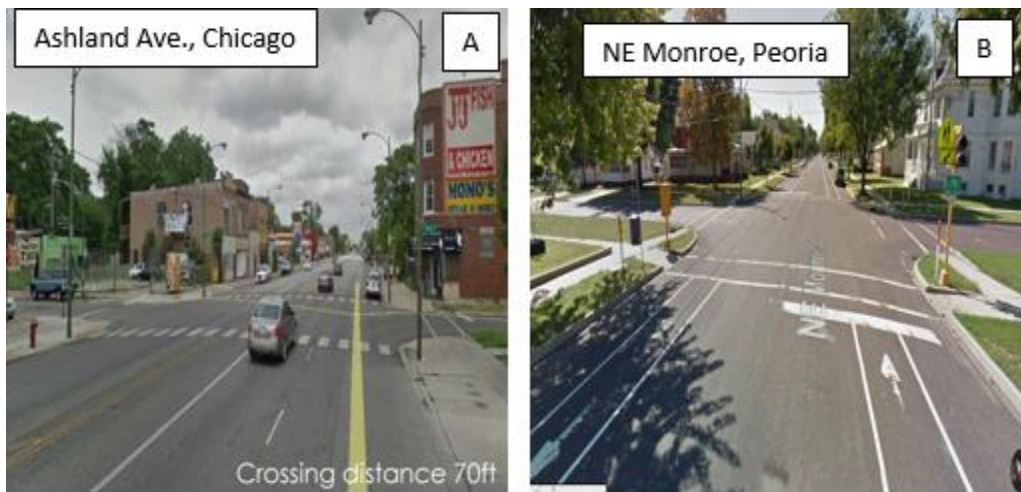
Two major cases of lengthy crossings were observed that may have contributed to unsafe pedestrian conditions. These include locations with multiple-lane crossings (more than three lanes) without a refuge island and locations with on-street parking and bicycle lanes on both sides of the roadway. Both cases increase the exposure time of pedestrians to traffic (Figure 30).

Figure 30. (a) Wide crossing distance with no median; (b) parking lane increasing the crossing distance.

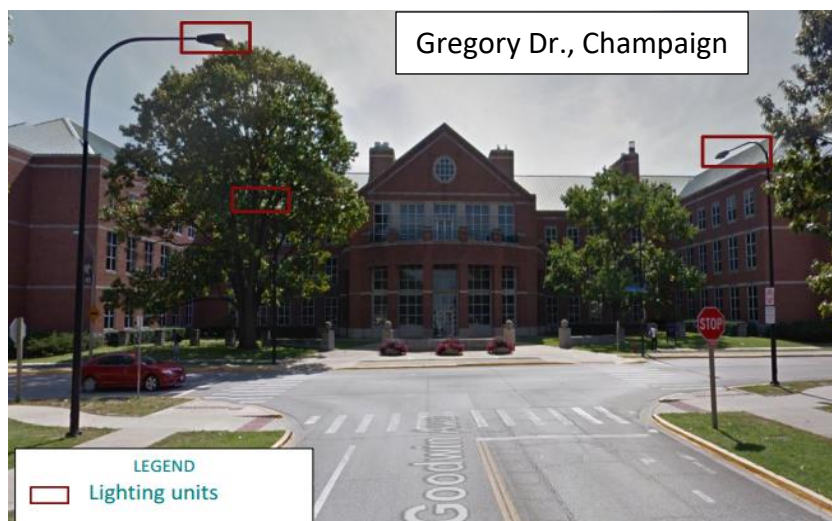
Figure 32), bad weather conditions, or noncontrasting clothing. Safety is further compromised when motorists do not expect pedestrians to be crossing. For example, an unexpected pedestrian crossing could occur at undesignated crossing points, at night, or during severe weather conditions.

Figure 32. Example of inadequate street-lighting location.

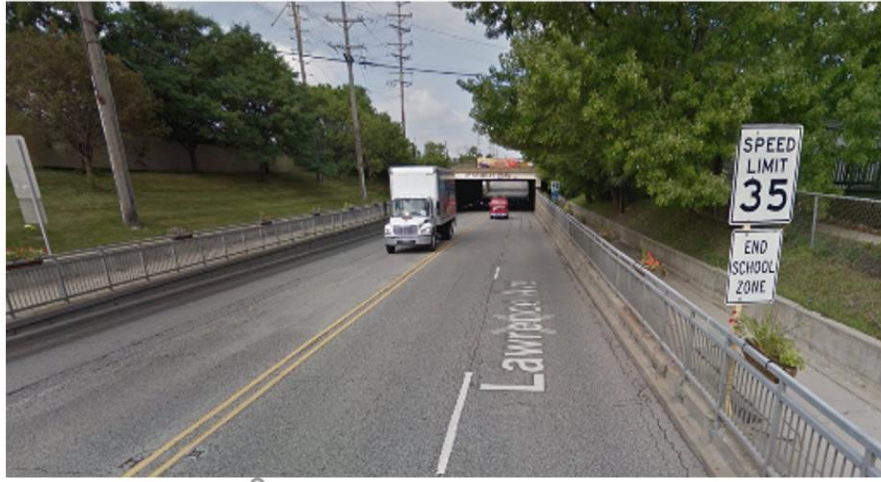
- To prohibit pedestrians from crossing roads with high speed limits or more than four lanes, pedestrian channelization is recommended. In addition, pedestrian channelization can be used to prohibit jaywalking between two adjacent crosswalks. Figure 42 shows an example of pedestrian channelization in Cook County, Illinois, that guides pedestrians to adjacent crosswalks.

Figure 42. Example of pedestrian channelization, Cook County, Illinois.

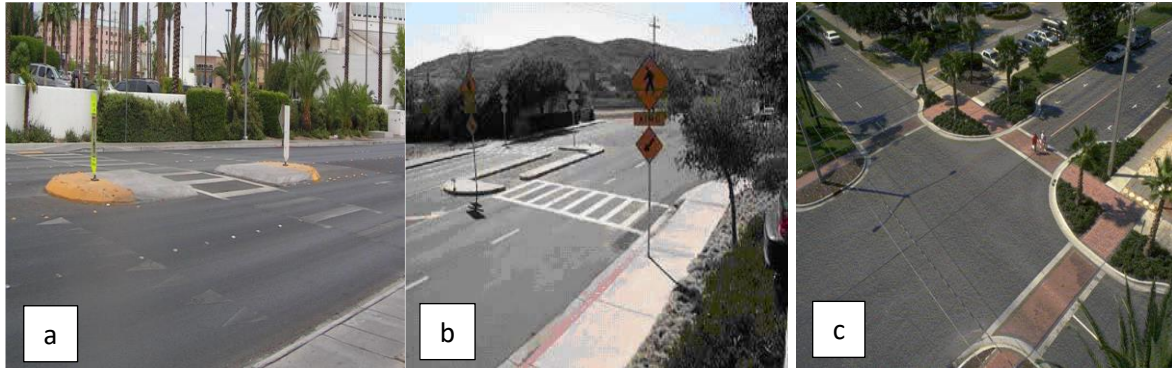
can ensure that pedestrians face oncoming traffic. A curb extension is effective to reduce the pedestrian's exposure to traffic and reduce the crossing distance. Another safety benefit of a bulb-out is that pedestrian-crossing signs placed there are more visible, as compared to those placed on the roadsides. A road diet is a traffic-calming measure to reduce speed through reducing the number of travel lanes or narrowing the travel lanes.

Figure 51. (a) Raised median (Pulugurtha et al. 2012); (b) split pedestrian crossover (VDOT, 2004); and (c) curb extension (Turner and Carlson, 2000).

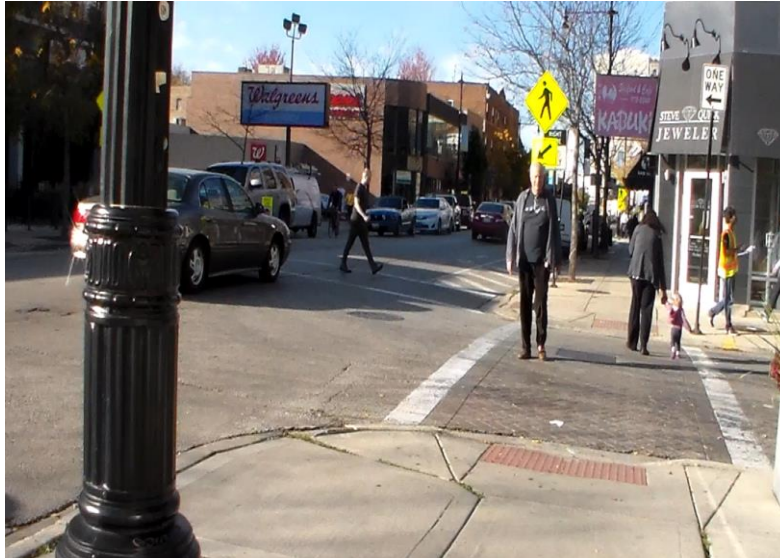
Figure 57. Brick-textured crosswalk on N. Clark St., Chicago.

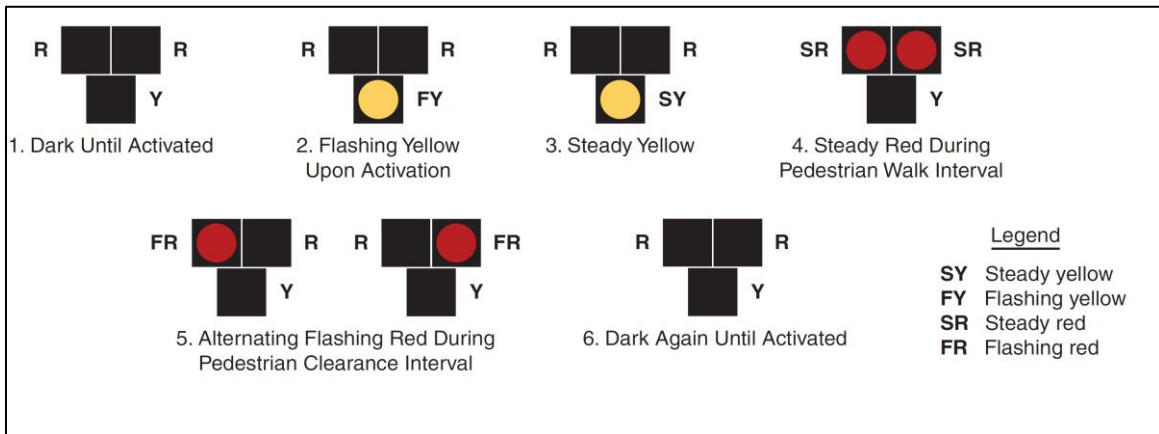
Figure 61. Sequence for a pedestrian hybrid beacon (FHWA, 2009).

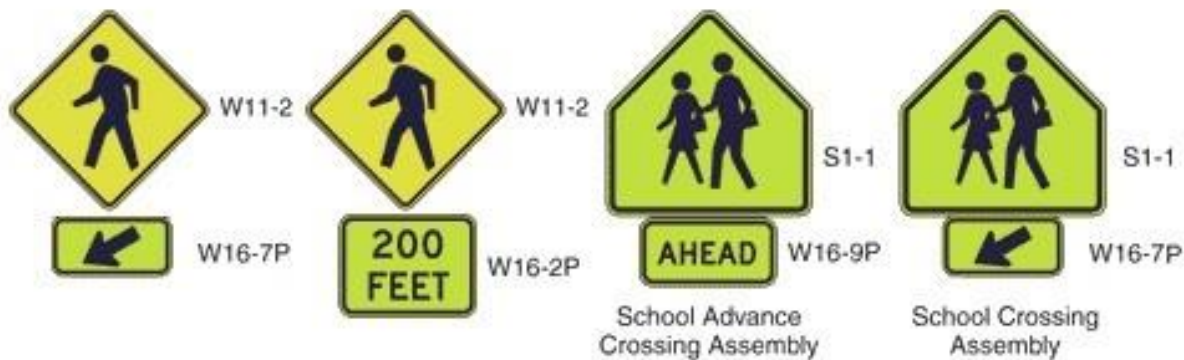
Figure A- 1. Pedestrian crossing and warning signs (FHWA, 2009).

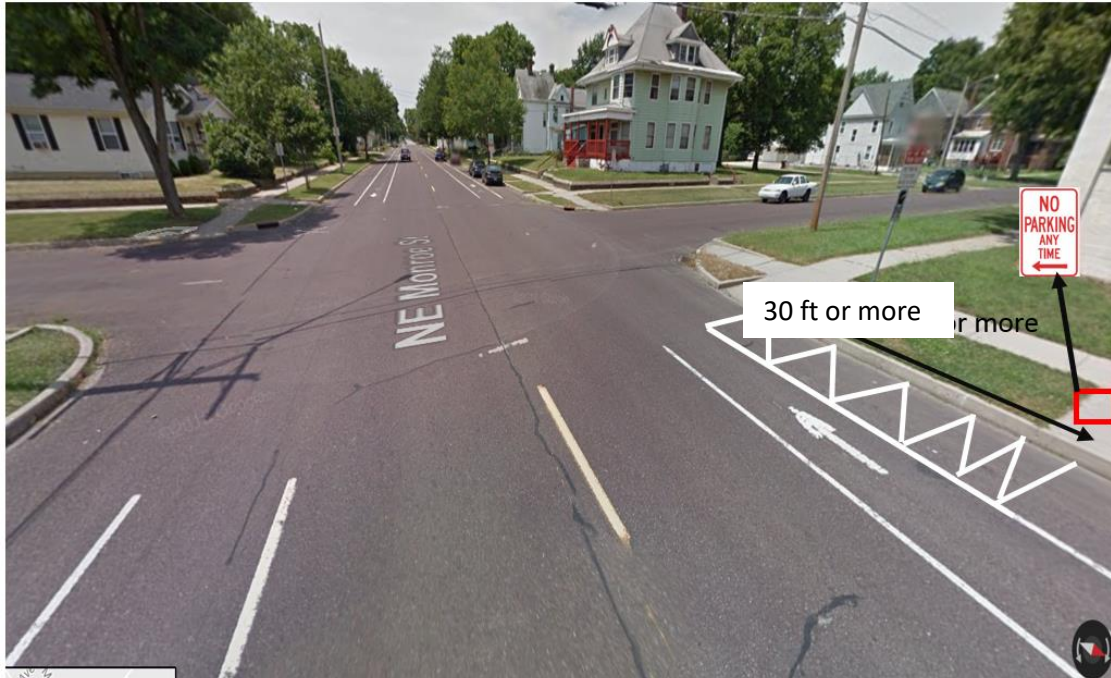
Figure E-6. Parking prohibition close to crosswalk.

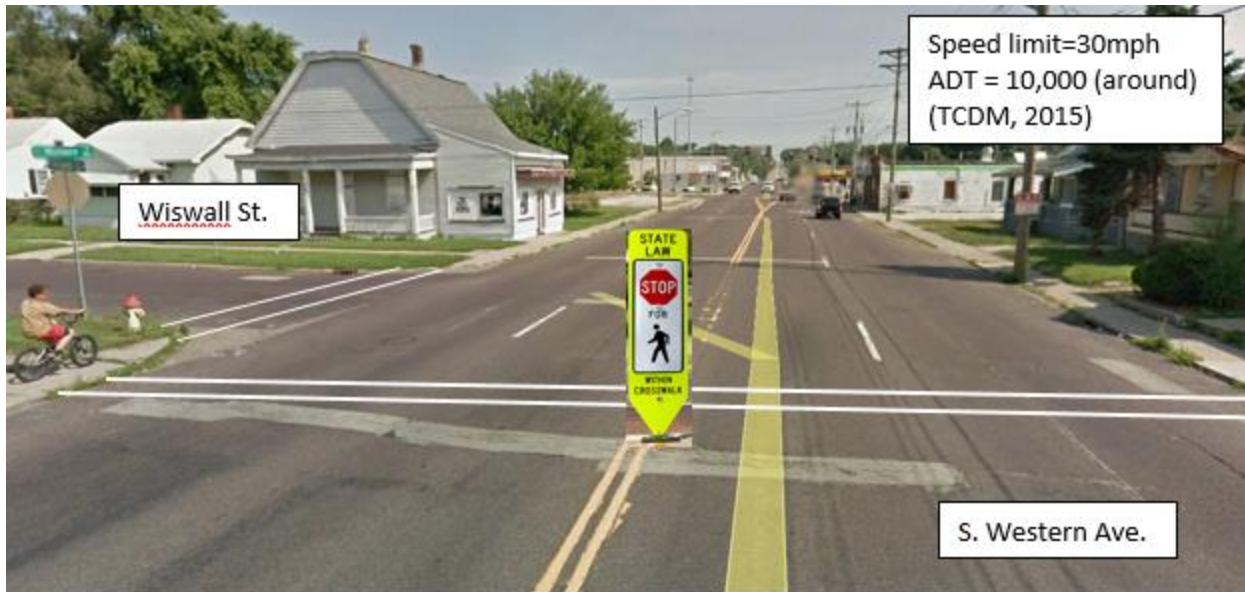
Figure E-19. Proposed crosswalk and other improvements at the intersection of W. Wiswall St. with S Western Ave.

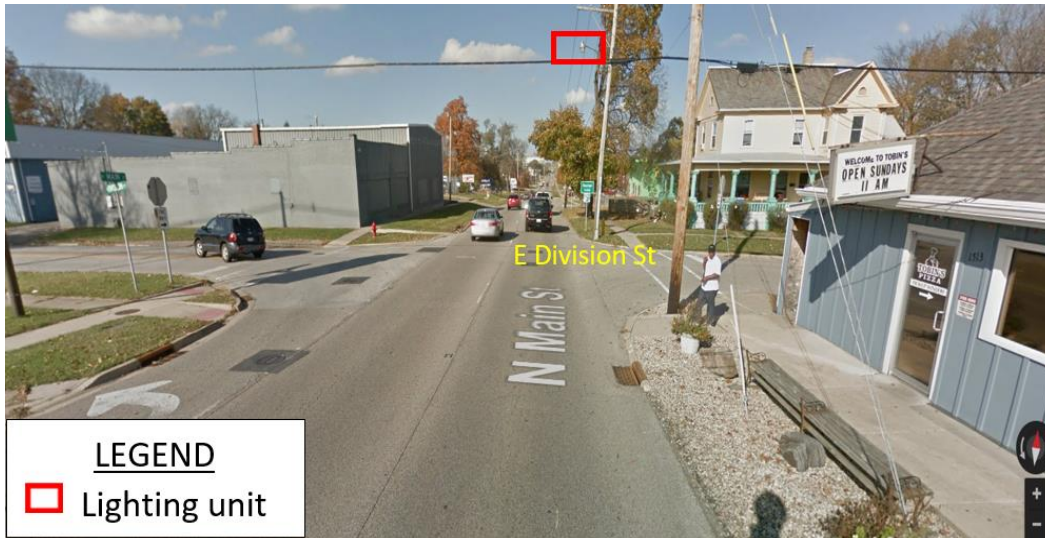
Figure E-32. Unmarked crosswalk with stop control on minor-street.

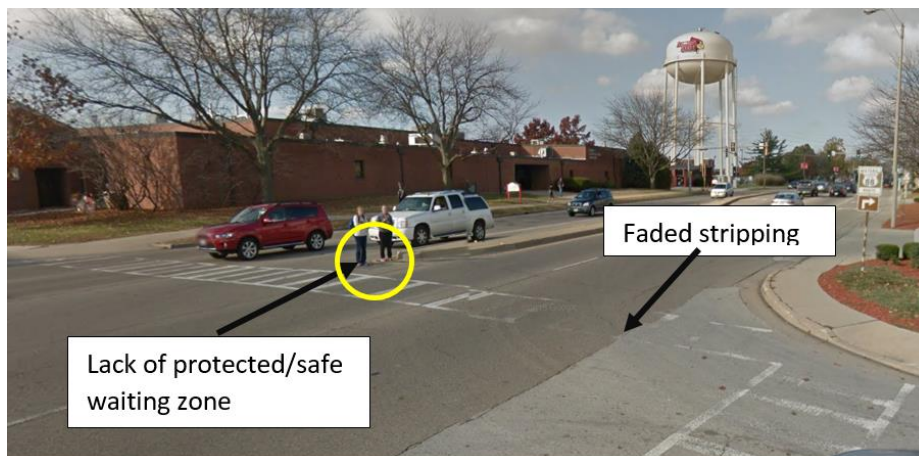
Figure E-33. Faded marking and lack of refuge island at US Business 51 and W. Locust St.

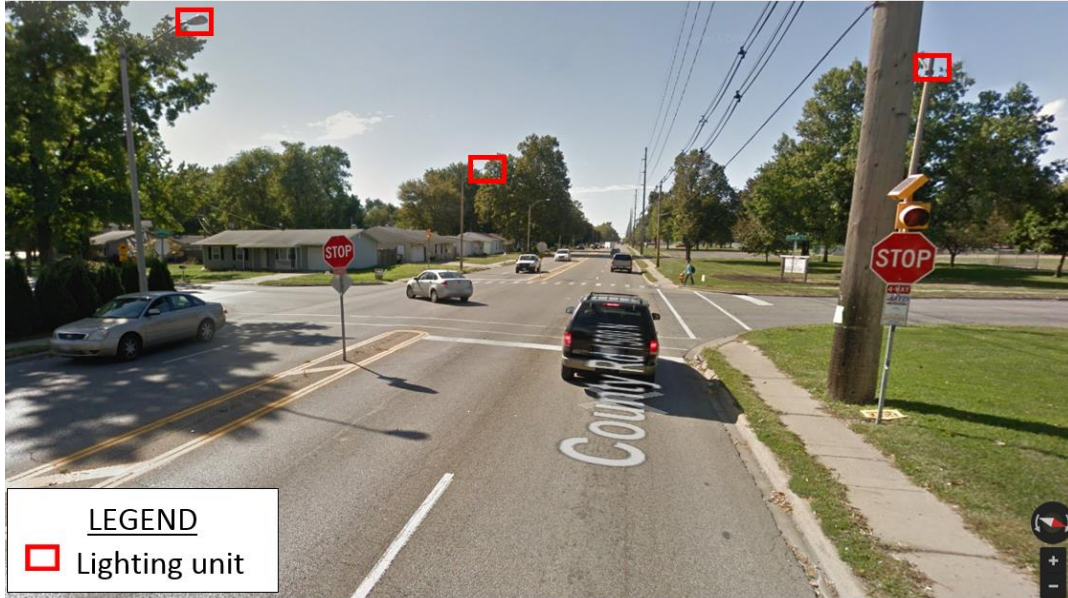
Figure E-42. Existing pedestrian treatment at intersection of Kirby Ave. and Crescent Dr.

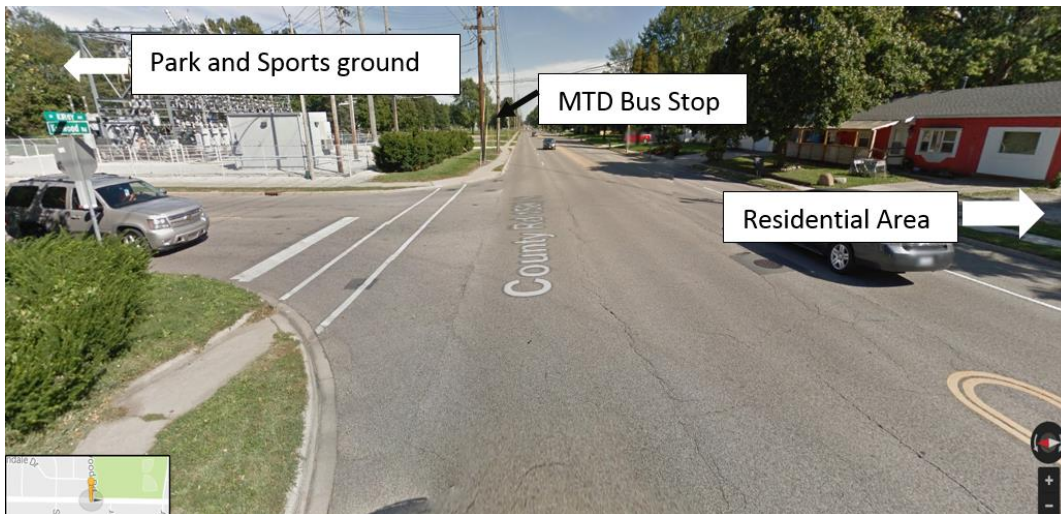
Figure E-43. Existing pedestrian treatment at intersection of Kirby Ave. and Kenwood Rd.

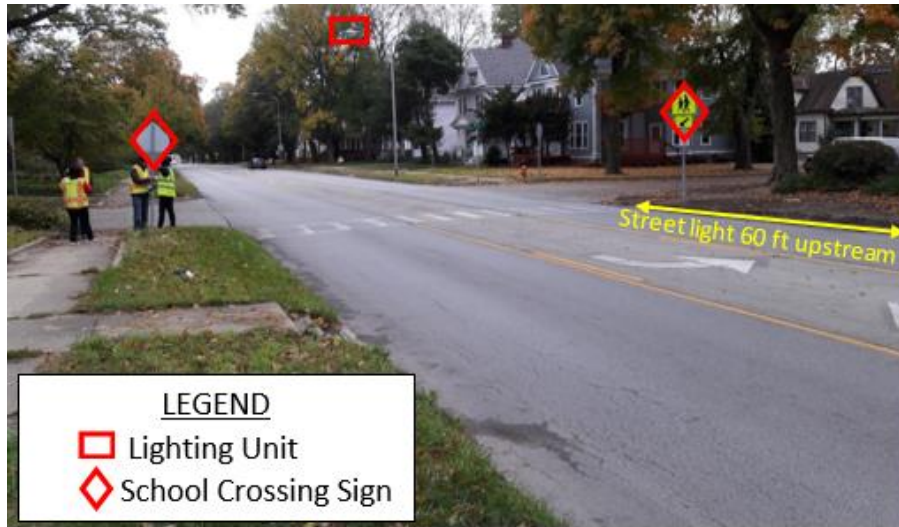
Figure E-46. Current treatments at the intersection of Springfield Ave. and S. New St.

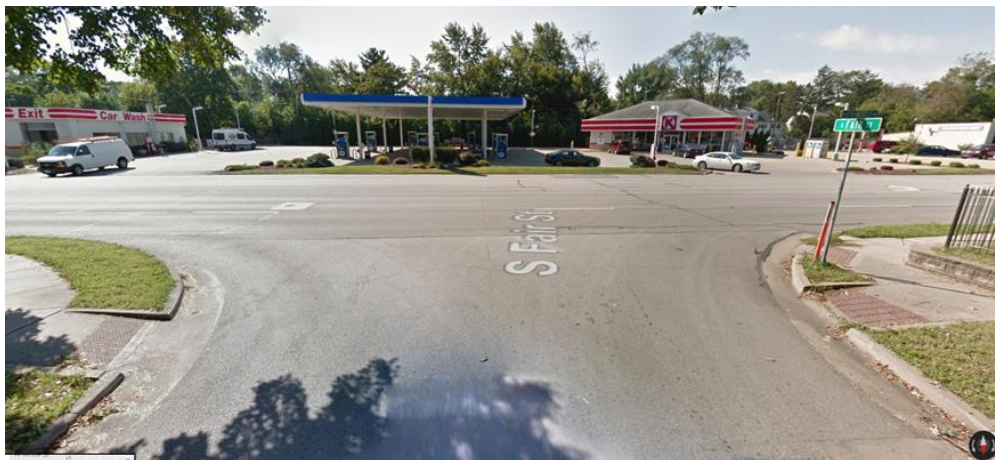
Figure E- 47. Current treatments at intersection of Springfield Ave. and S. Fair St.

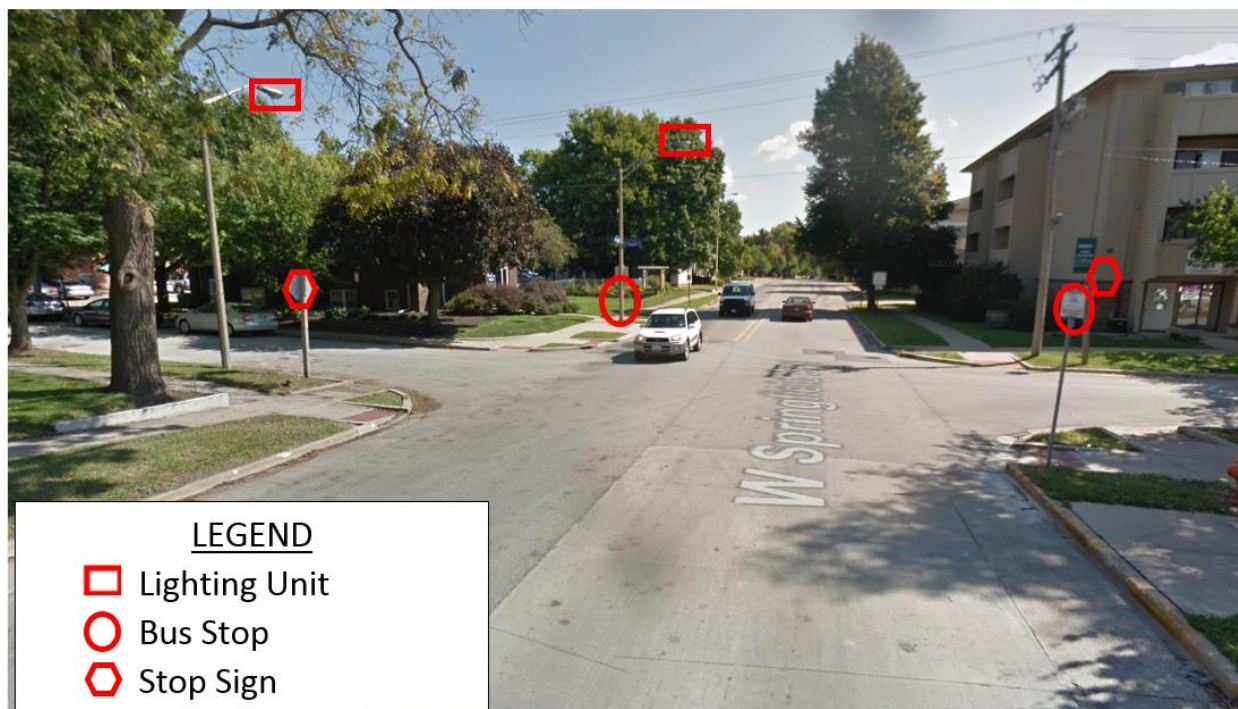
Figure E-49. Unmarked crosswalk at intersection of W. Springfield Ave. and S. Gregory St.

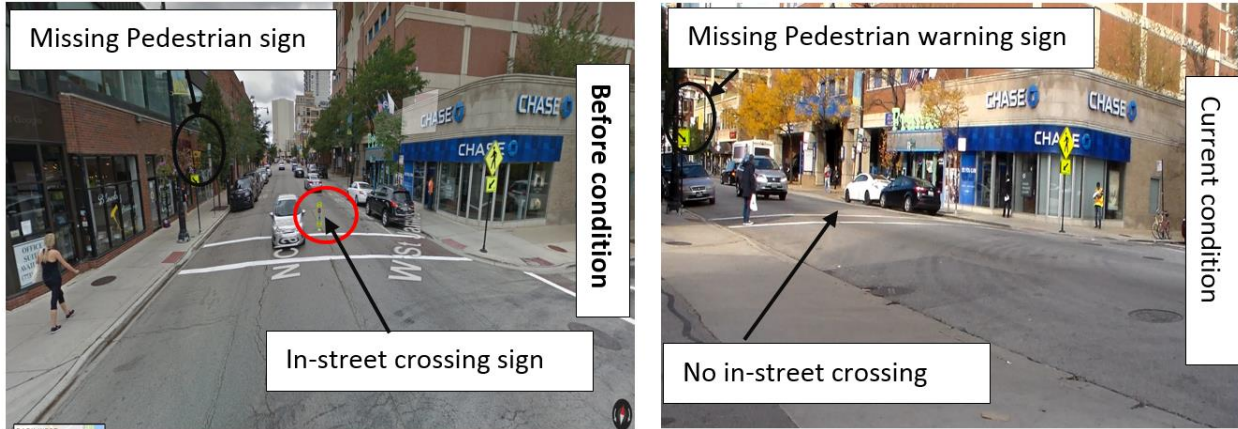
Figure E-54. Past and present condition at the intersection of N. Clark St. and W. St. James Pl.

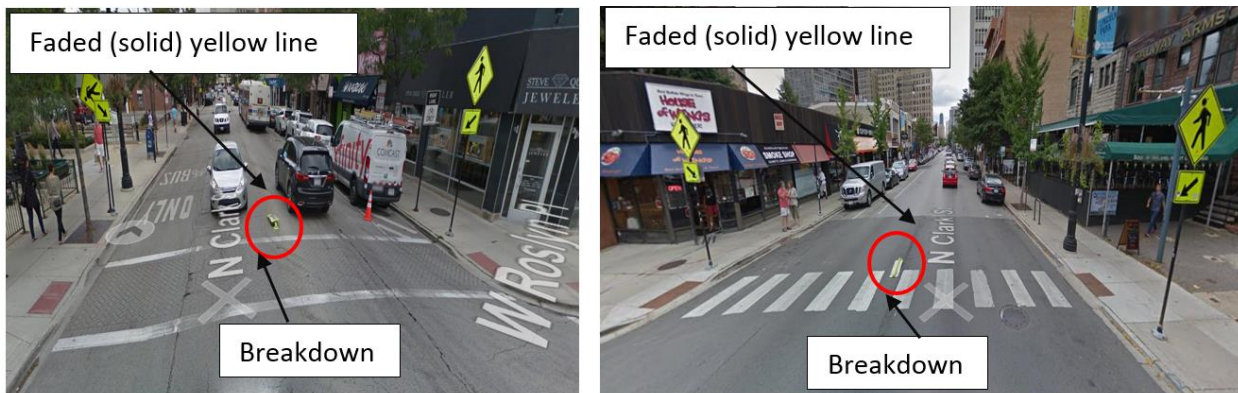
Figure E-56. Breakdown of In-street crossing sign along N. Clark St.

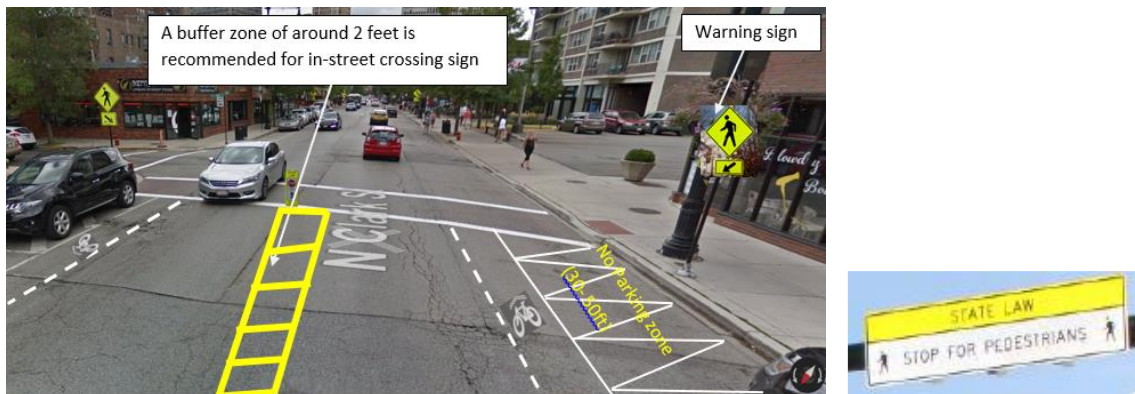
Figure E-57. Proposed improvement for the un-signalized crosswalks along the corridor.

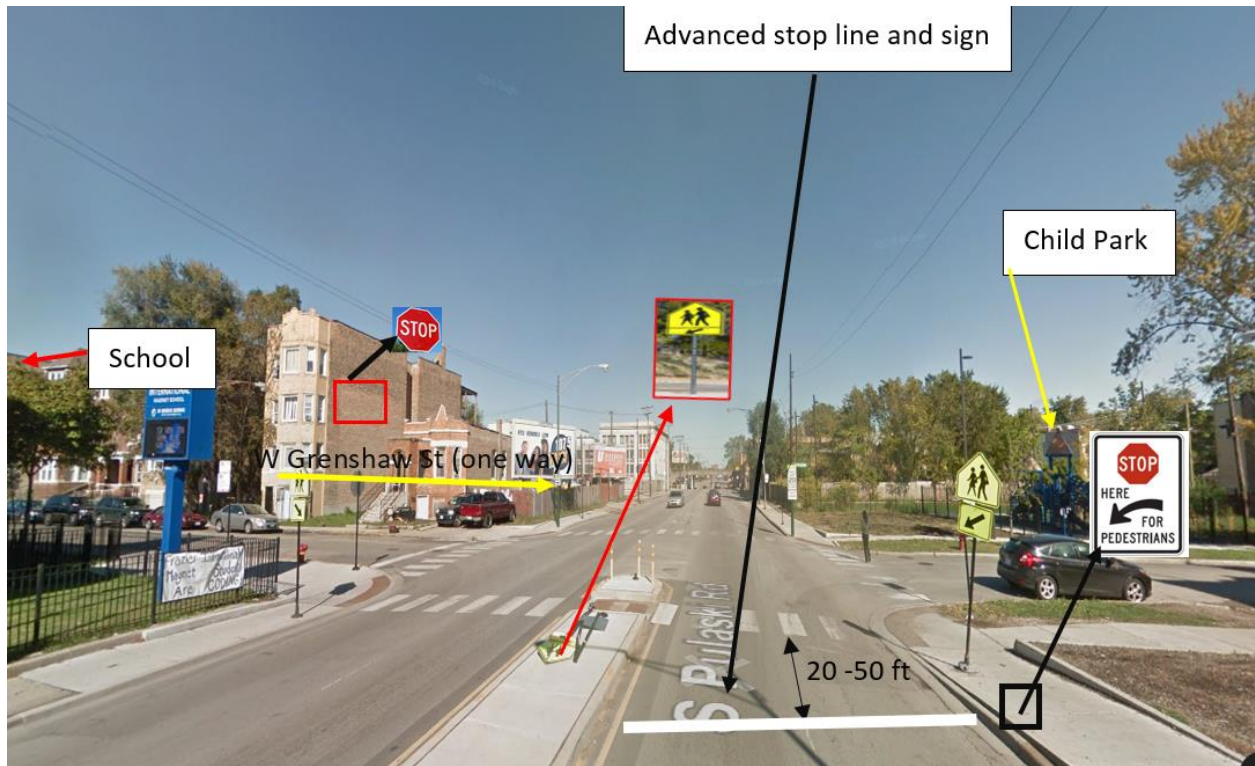
Figure E-71. Refuge island with warning sign and advanced stop line (four lane roads).

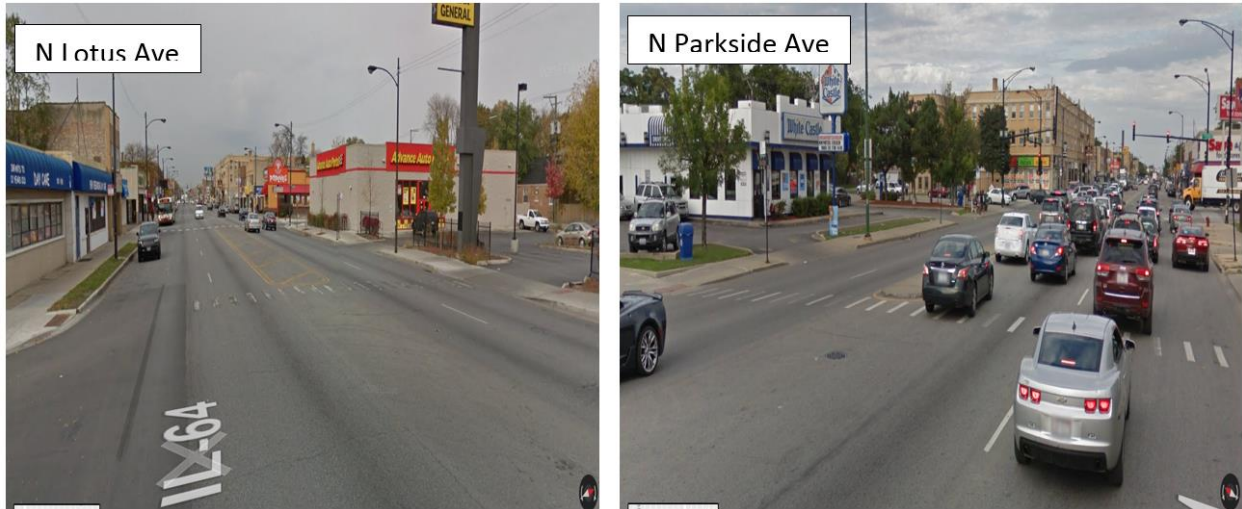
Figure E-77. Example of crosswalk markings at the intersections of W. North Ave. and N. Lotus Ave. and N. Parkside Ave.

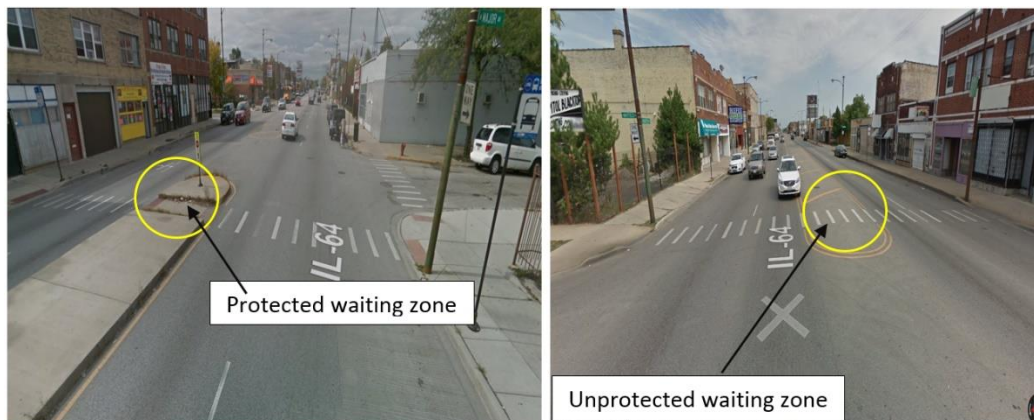
Figure E-78. Protected and unprotected waiting area along W. North Ave.

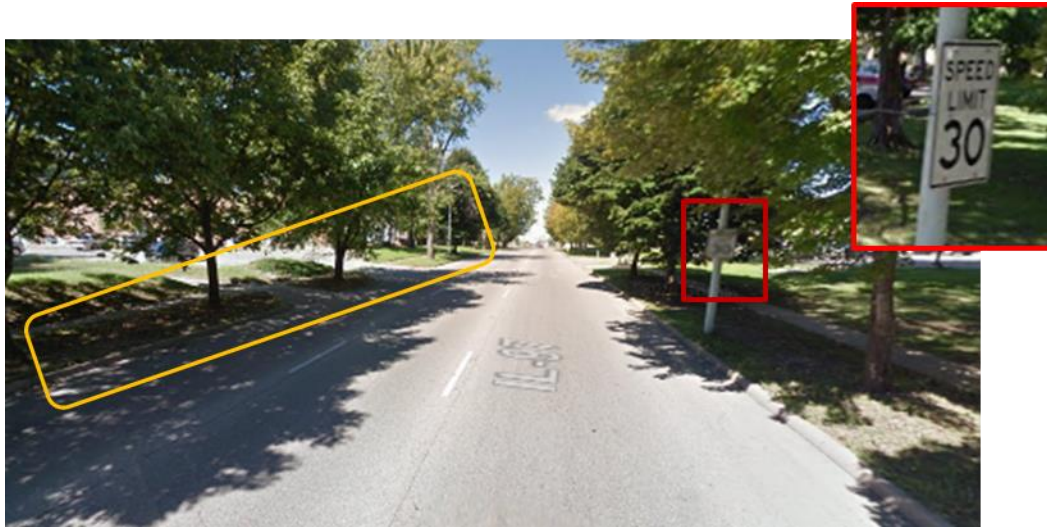
Figure E-100. Trees cover speed limit sign and crosswalk at W. Jefferson St., residential area.

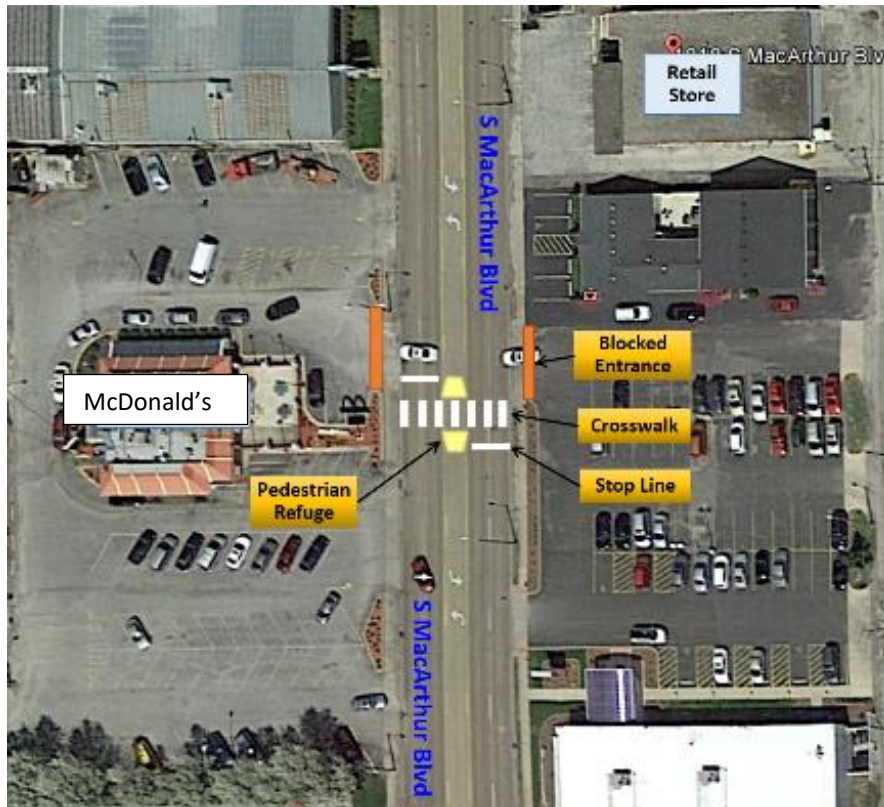
Figure E-105. Recommended mid-term treatment, installing crosswalk along S. MacArthur Blvd.

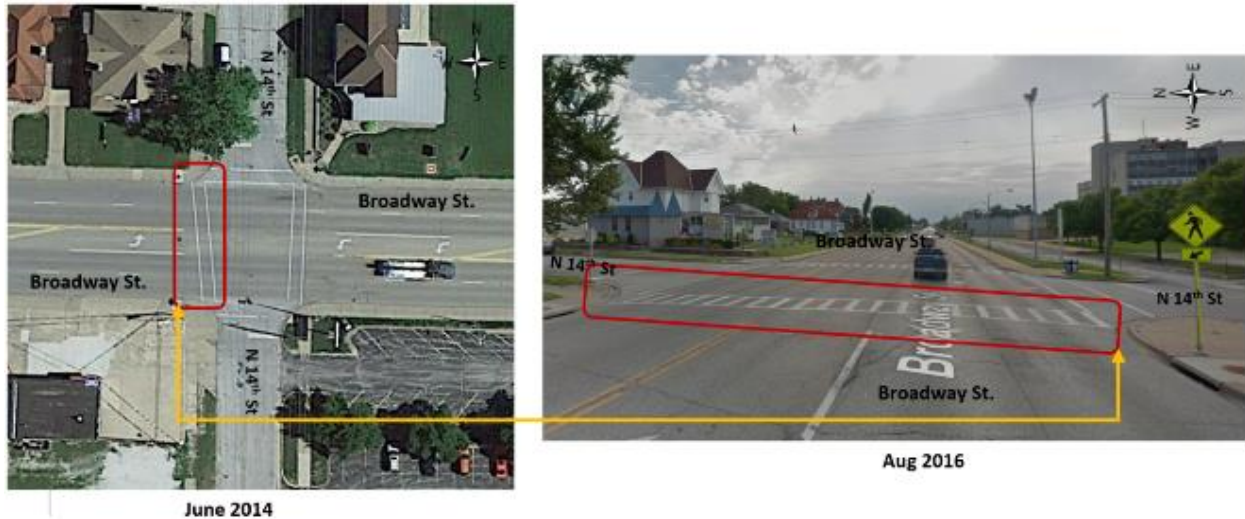
Figure E-112. The type of crosswalk striping across Broadway St. (in 2014 and 2016).
