UTILIZING LAB TESTS TO PREDICT ASPHALT CONCRETE OVERLAY PERFORMANCE

Research Report No. FHWA-ICT-17-020

**CONSTRUCTION AND PERFORMANCE
MONITORING OF VARIOUS ASPHALT MIXES**

December 2017

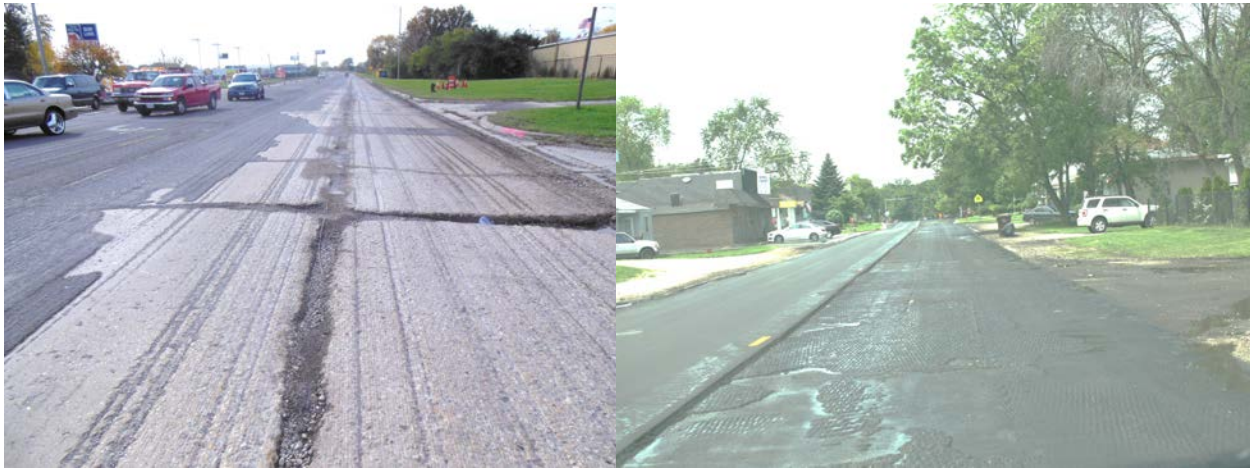
For projects constructed in 2015 [US 52 (60N07 and 60N08) and Washington (60Y04)], excessive grooving from the milling head was not a problem. The milling was performed in a uniform manner producing the desired milled texture. What was seen as a problem in the 2015 construction projects was the depth of milling resulting in very thin layers of an AC lift remaining in place above a lift interface. Where the remaining AC layer thickness was below approximately 0.75 in, traffic tended to cause the layer to be lost. This problem was most evident on the Washington Street (60Y04) project. Uniformity of mill texture and loss of AC layer across the pavement lane are shown in Figure 4.1b.

(a) Crawford/Pulaski Road after milling (2014)

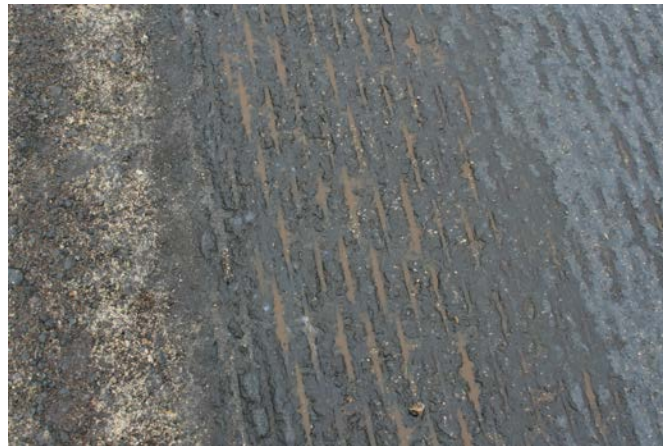
Figure 4.2. Brown, “unbroken,” emulsified-asphalt prime coat on US 52 Laraway Road to Gougar Road—contract 60N08.

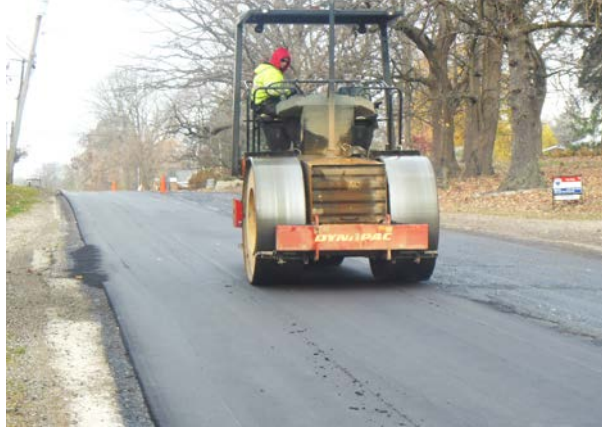
Figure 4.6. US 52 (60Y02) level binder construction with exposed, milled 12 in at edge.

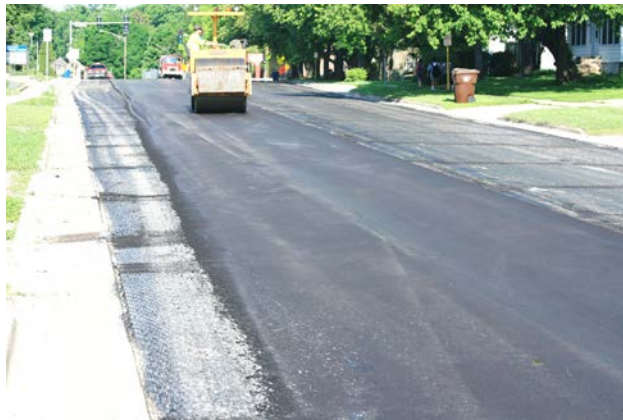
Figure 4.7. Curb-and-gutter section of Washington St. (60Y04) level binder construction and milling at gutter edge.

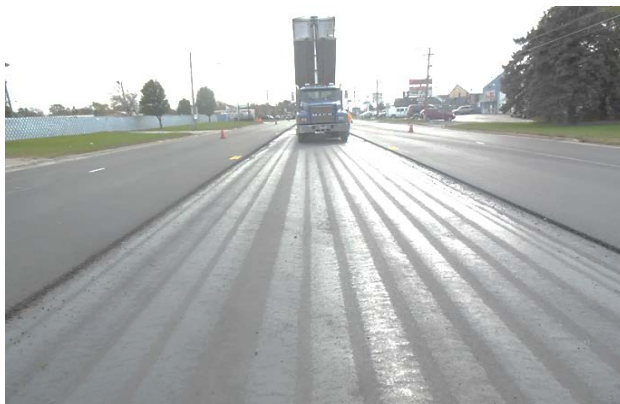
Figure 4.8. Crawford Avenue/Pulaski Road (60Y03) tack coat of level binder in center lane without traffic.

Prior to placement of the surface course, the level binder was cleaned and then tacked. Figure 4.8 shows Crawford Avenue/Pulaski Road (60Y03), where traffic was not allowed on center-turn lanes, and resulting “zebra” stripes. This case of striping was the most extreme observed, traffic at other projects spread the tack coat to some degree by the time of paving. Figure 4.9 shows US 52 (Gougar Road to Second Street—60N07), which was under traffic and had a fairly uniform tack coat application.

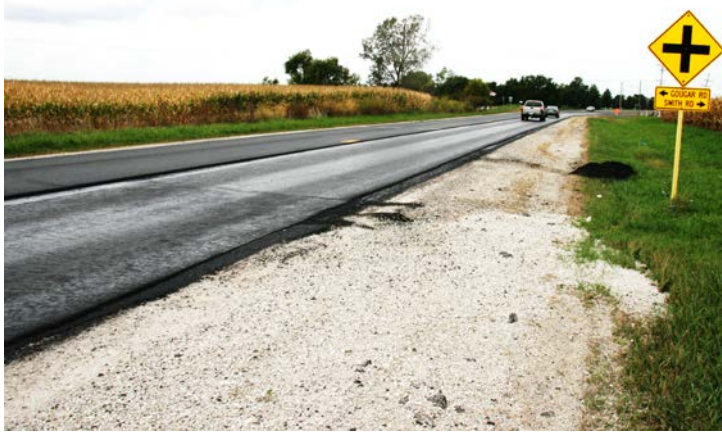
**Figure 4.9. US 52 (Gougar Road to Second Street—60Y07)
tack coat of level binder under traffic.**

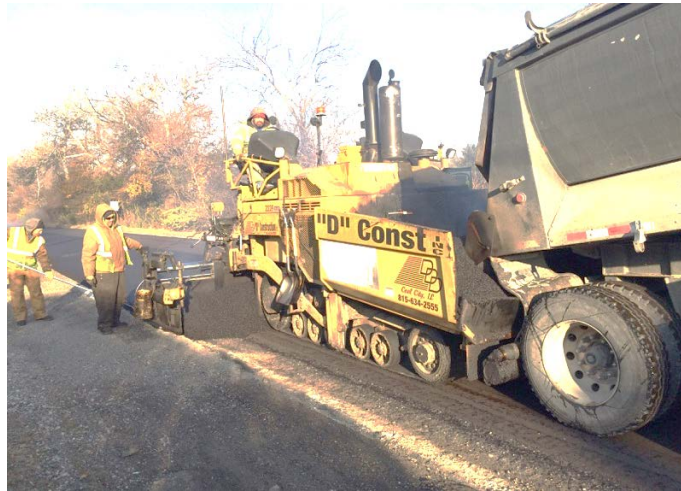
For all projects, the surface course thickness was 1.5 in, using typical paving equipment and procedures; however, it was noted that the paver used a 24-ft reference ski rather than a 30-ft ski as a leveling reference. The ski was located on the left side of the paver for the construction of all lanes under study. The right side of the paver did not have a reference and was adjusted from time to time to control material yield. After mat laydown, compaction was achieved with two dual-drum vibratory rollers, followed by a dual-drum vibratory roller operated in static mode as the finish roller. All the projects followed this general paving-train pattern.

Figure 4.10. Surface course paving of rural cross-section on US 52 (US 53 to Laraway 60Y02).

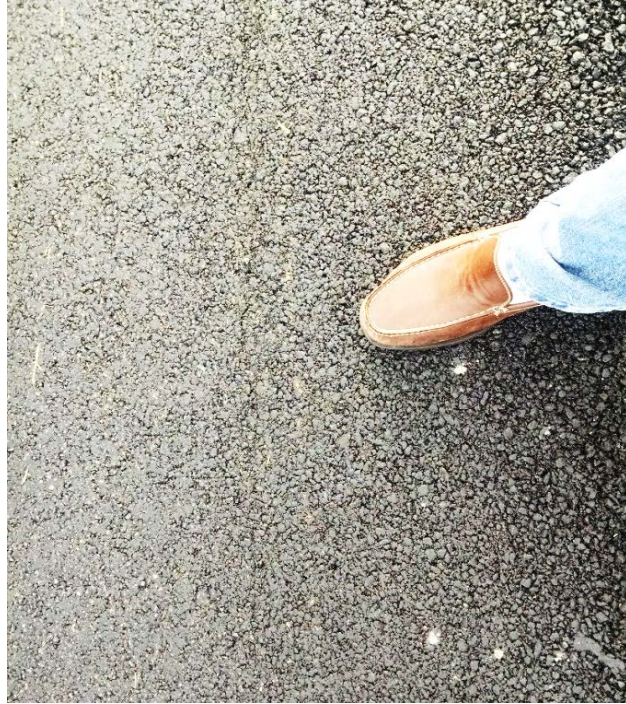
The surface was a nominal 1.5 in, the level binder detail (shown in Figures 4.3 and 4.5 above) resulted in the surface layer having a transverse “step” detail in the level binder. This detail seemed to be the cause of limited hairline cracking at the location of the “step” and slight segregation where additional material is supplied to the area at the outside edge of the screed, as seen in Figure 4.11. Additional surface course construction details were previously presented in the interim reports for each project (Lippert et al. 2016, 2017).

Figure 4.11. Evidence of hairline crack at underlying transition from level binder to no level binder. Level binder (4.75 mm) to left of crack and milled surface to right of crack. Increased segregation also at pavement edge (right side of photo).

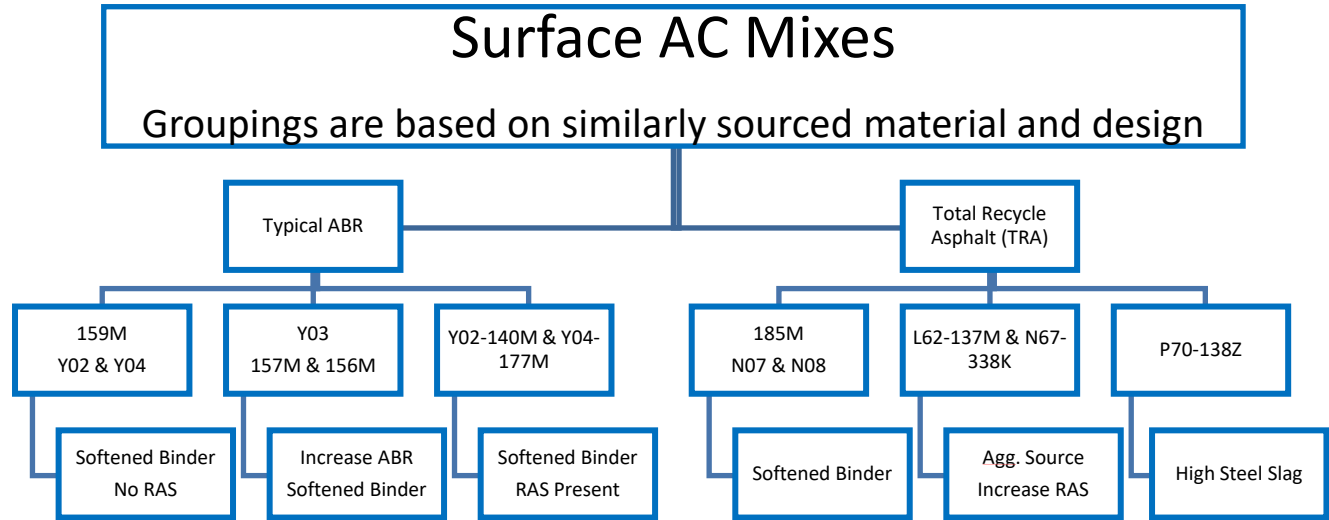
Figure 6.1. Grouping of surface AC mixes.

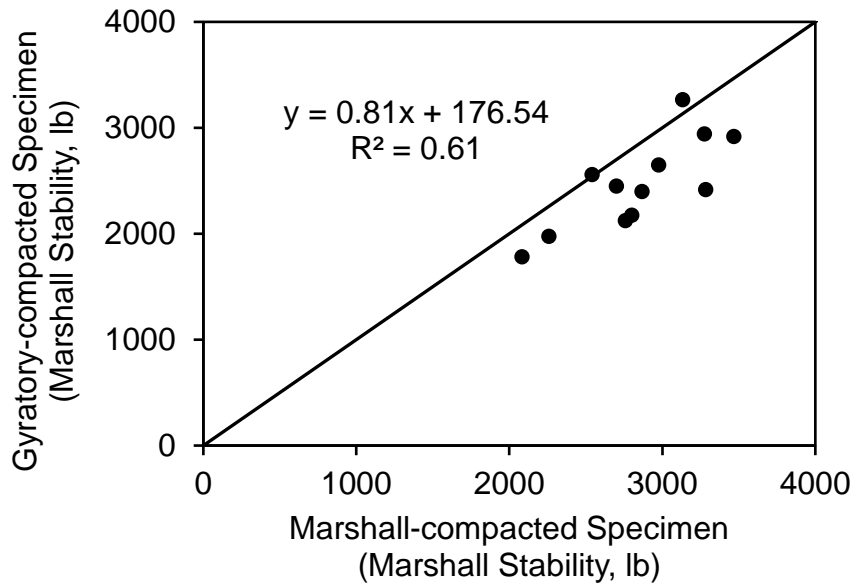
In general, all AC mixes met the Marshall stability requirements. The level binder mix was expected to have a lower stability value but because of using RAS and PG70-28, the values were the highest.

Figure 6.3. Marshall stability between Marshall-compact and cored gyratory-compact specimens at 4+/- 0.5% air voids.

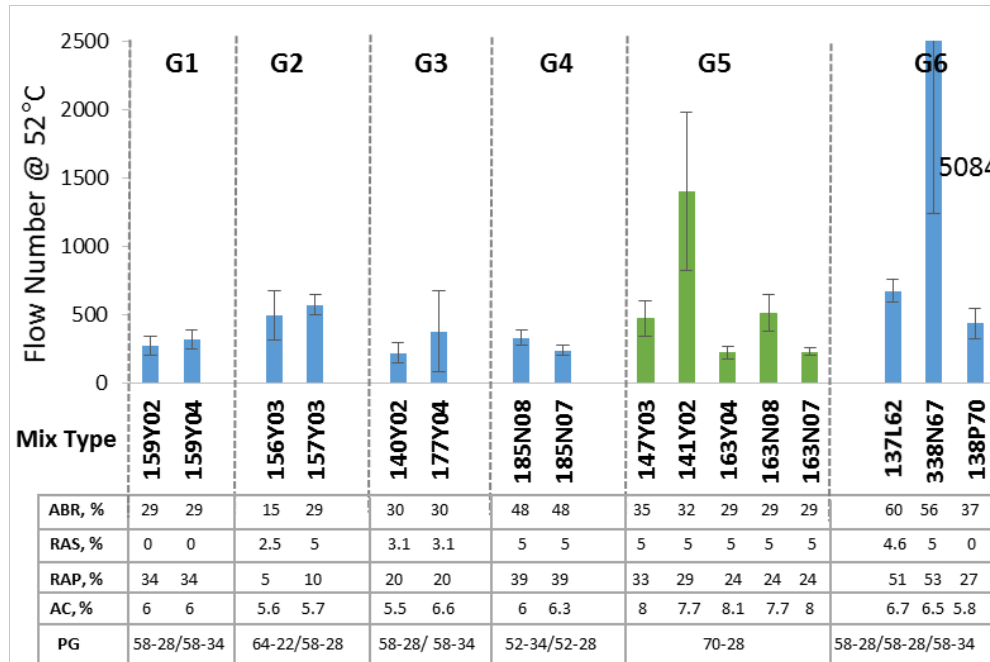
The 338N67 mix in Group G6 had an extremely high flow number, which is consistent with the Hamburg wheel-tracking test results that its rut depth was lowest among all mixes because of its highest ABR and RAS content. The mix is very brittle and it experienced higher severity cracks than any other section tested.

Figure 6.10. Flow-number test results for plant mix.

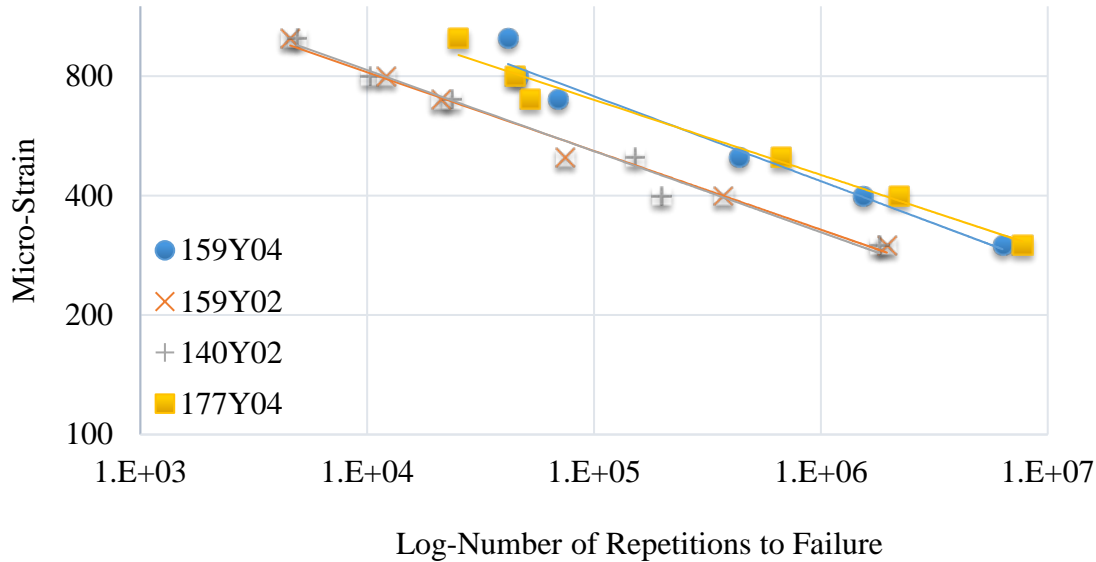
improved performance against fatigue cracking. Moreover, the results of mixes 140Y02 and 177Y04 showed that mix 177Y04 is more resistant to fatigue cracking. This improvement in fatigue life performance comes as a result of two main factors: a softer binder and a higher asphalt content.

Figure 6.11. Fatigue curves of mixes 159Y02, 159Y04, 140Y02, and 177Y04.

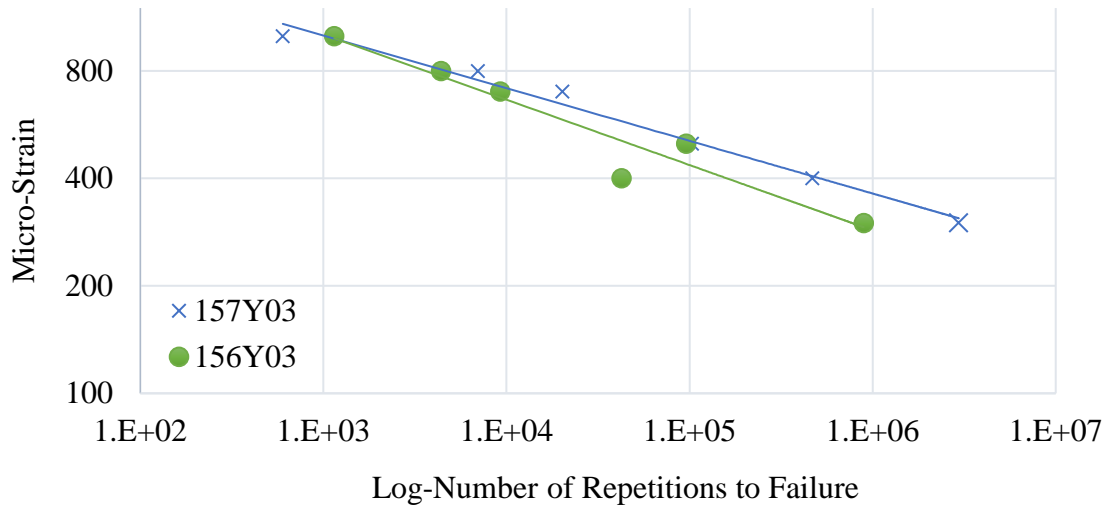
Figure 6.12. Fatigue curves of mixes 156Y03 and 157Y03.

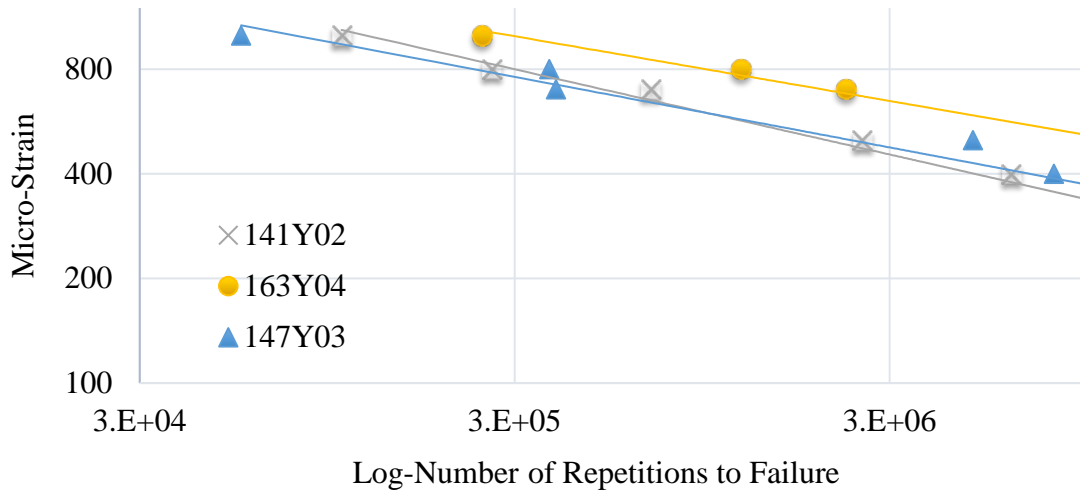
With a lower percentage of RAP and a higher asphalt content, mix 163Y04 exhibited a good fatigue resistance compared to the other AC mixes with the same PG (Figure 6.14). Mixes 141Y02 and 147Y03 showed a relatively similar performance. The effect of the higher percentage RAP in mix 147Y03 was counterbalanced by the increase in asphalt content. The aforementioned mixes also showed a more pronounced effect of the percentage of RAP at high strain.

Figure 6.14. Fatigue curves of mixes 141Y02, 163Y04, and 147Y03.

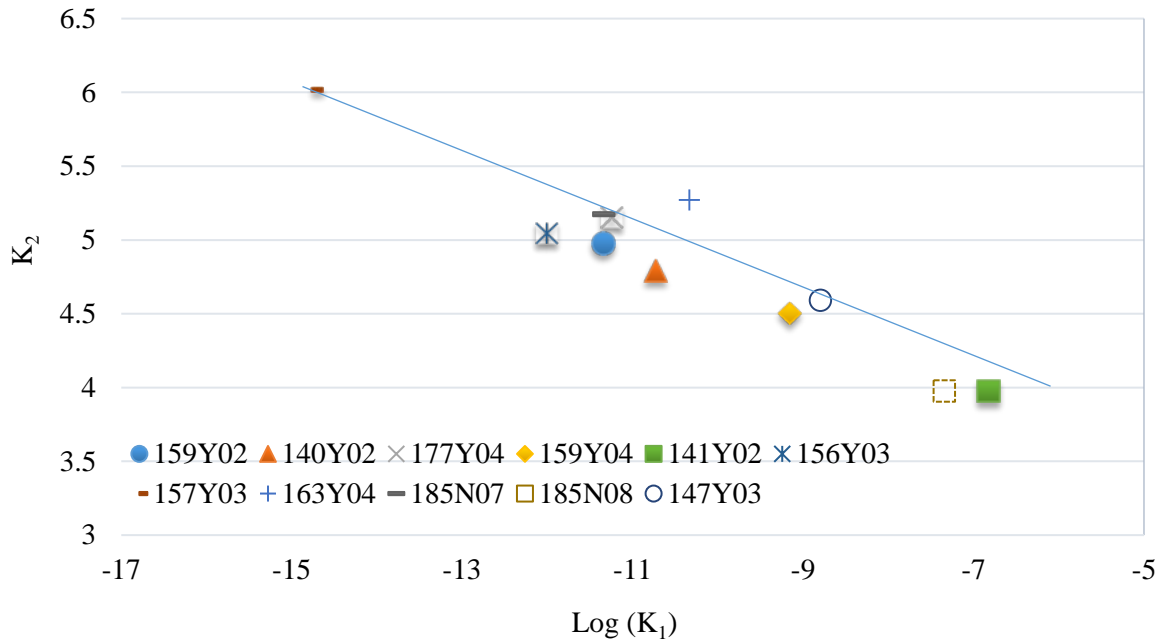
The slope and intercept of the fatigue curves are plotted in Figure 6.15. The slopes and intercepts of the fatigue curves (K_1 and K_2) were found to be following the same trend for other Illinois mixes (Carpenter et al. 2003). K_2 values range from 4 to 6, which is within the acceptable limits (3 to 6). As expected, $\log(K_1)$ values range over several orders of magnitude.

Figure 6.15. Plot of K_2 vs. $\text{Log}(K_1)$ for all the tested mixes.

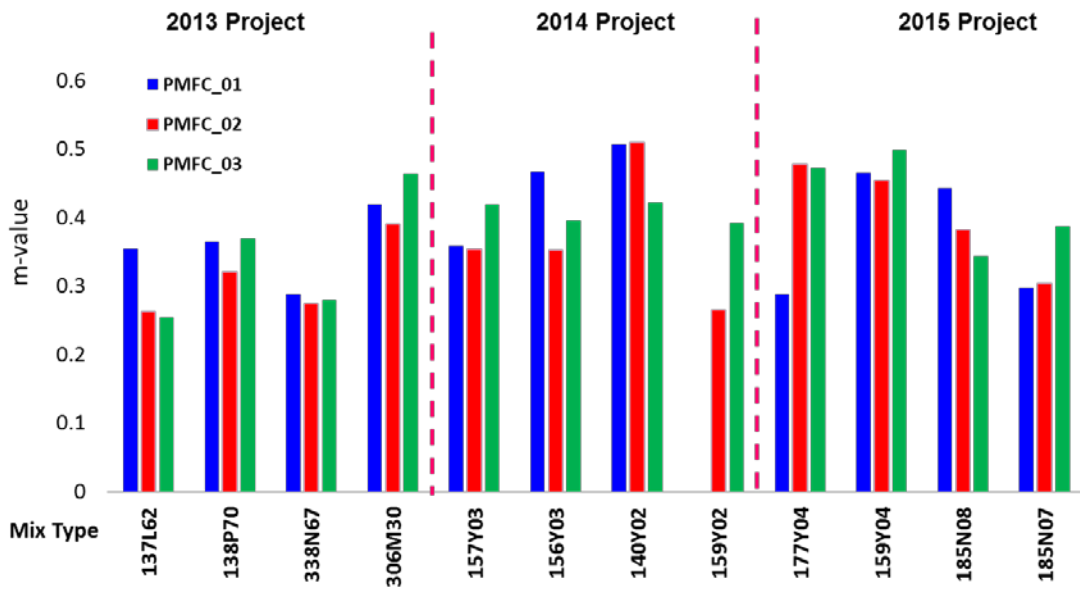
Figure 6.18. m-values from IDT creep compliance master curves.

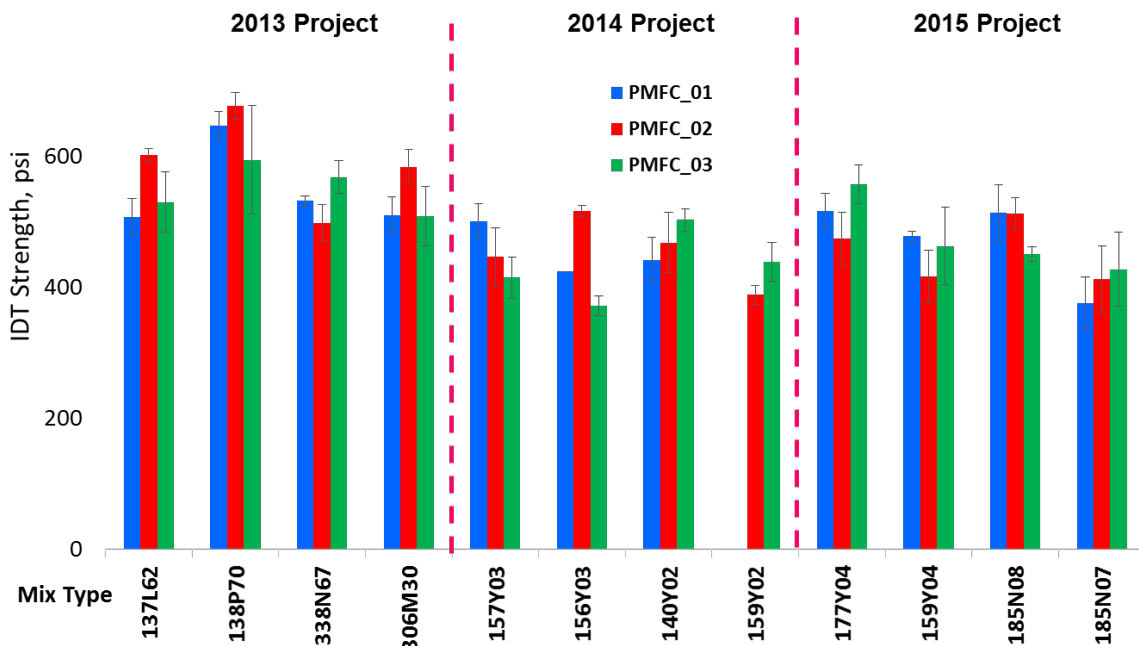
Similarly, tensile strength is another important component for the thermal-cracking prediction model of Pavement ME design. The IDT strength is statistically similar across PMLC at 95% confidence interval. Thus, at 14°F (-10°C) all AC mixes show very brittle behavior; and IDT doesn't distinguish the effect of recycled materials. It was shown that testing only at low temperature may not be sufficient to differentiate cracking resistance of AC mixes (Al-Qadi et al. 2015). Hence, there was a need to develop a fracture test at intermediate temperature such as I-FIT. In a few third field cores, a slight increase can be observed as compare to the first one, which might be due to stiffness induced with aging and air voids as shown in the Figure 6.19. However, generally IDT strength is statistically similar across the different field cores, and the effect of aging could not be observed.

Figure 6.19. IDT strength.

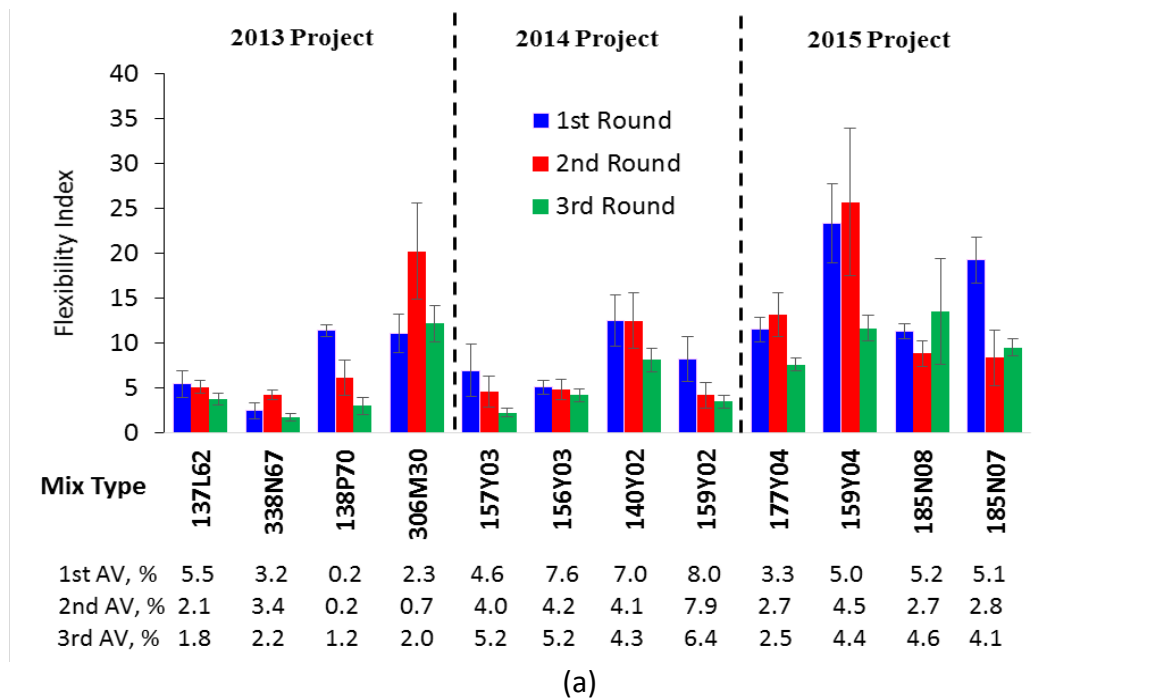
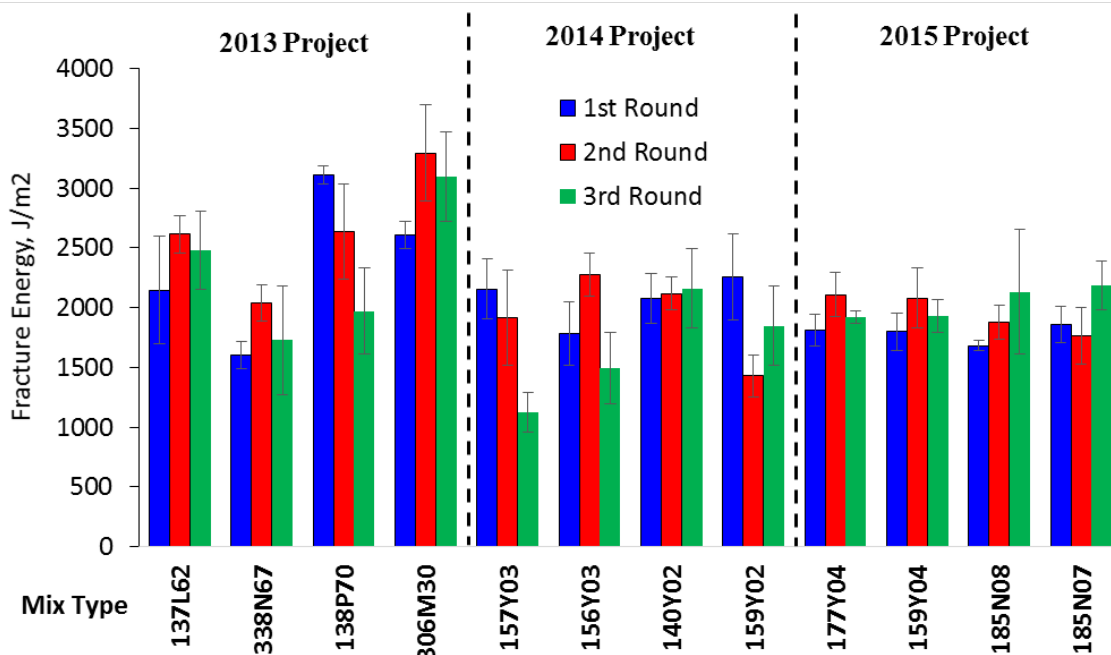
Figure 6.21(a) shows the FI values for third-round field cores. Only surface mixes had field cores. The averaged air void (AV) contents of tested specimens are also shown under each mix type. In general, the FI value decreases from first-round to third-round cores for all AC mixes,

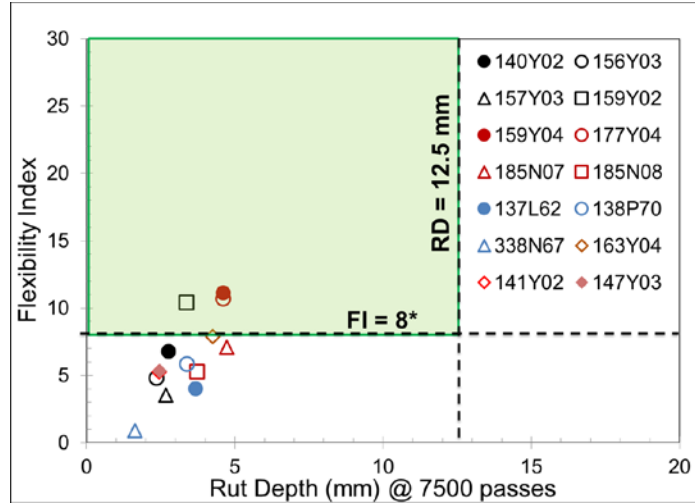
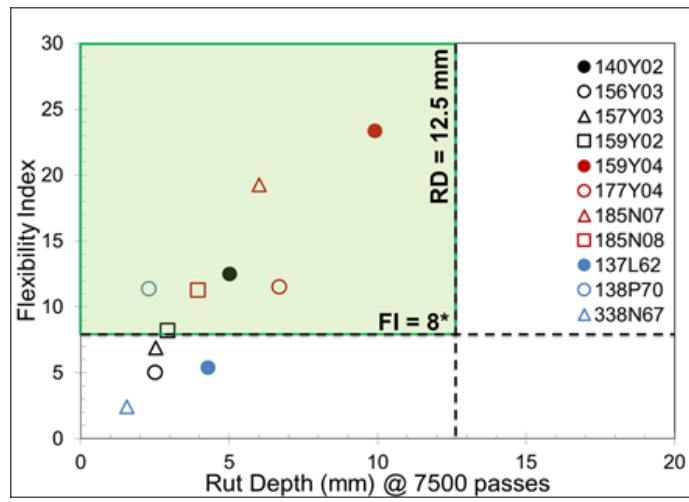
An alternative approach to evaluate laboratory performance of AC mixes is the balanced mix design approach. The approach has recently been used by several agencies to complement existing mix design specifications with a specific objective to relate the design to actual performance of the AC mixes. The initial version for the performance-space diagram was used to represent the interaction between the I-FIT and Hamburg test result parameters. The balance diagram for the AC mixes is presented in Figure 6.22 for PMLC and field cores.

Figure 6.22. Balanced AC mix for (a) PMLC; (b) Year 1 cores; (c) Year 2 cores; and (d) Year 3 cores.
