## Case report

# Subcutaneous emphysema during root canal therapy: endodontic accident by sodium hypochlorite

Department of Oral and Maxillofacial Sciences,  
"Sapienza" University of Rome, Rome, Italy

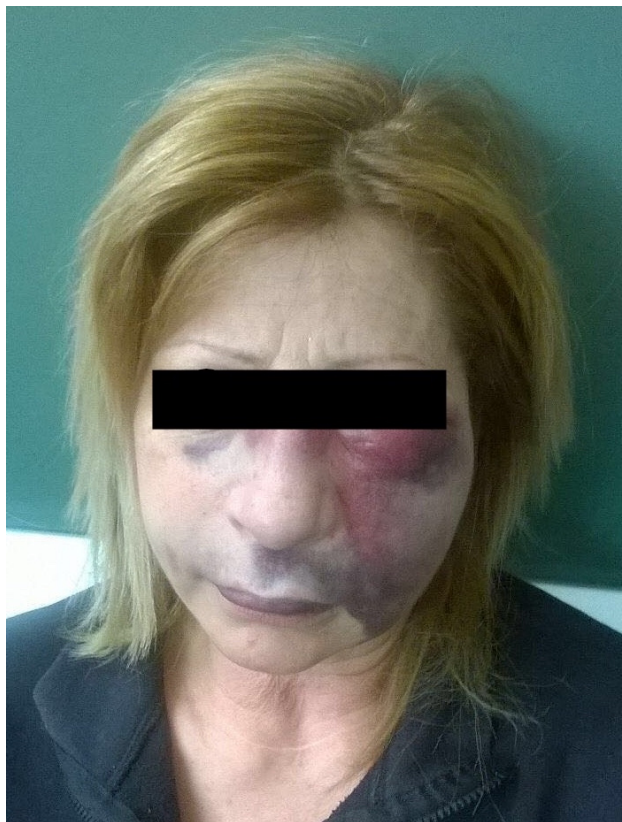
A 60-years-old woman had an abnormal swelling and pain during an endodontic treatment accompanied by her dentist to the emergency room and was referred to our observation for complaining of severe pain, ecchymosis and severe swelling on the left side of her face (Fig. 1). The aforementioned symptoms appeared after sodium hypochlorite irrigation and aggressive use of air spray for drying the root canal during the endodontic treatment of the upper left lateral incisor.

Figure 1. Woman with ecchymosis and severe swelling on the left side of the face immediately after the endodontic accident.

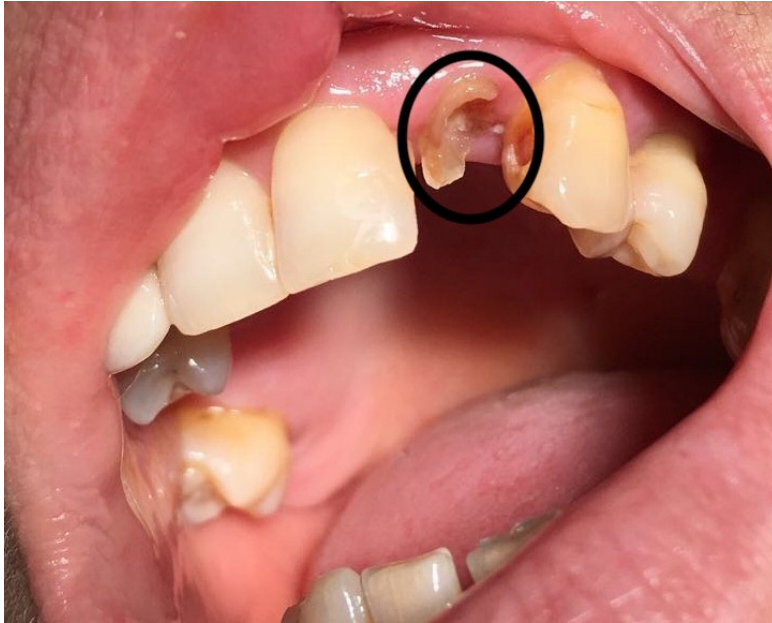
Intraoral examination revealed that the affected tooth had its own crown destroyed by decay processes. The part was slightly sensitive to vertical and horizontal percussion and palpation with a mobility of grade 2 was reported (Fig. 2).

Figure 2. The intraoral situation.

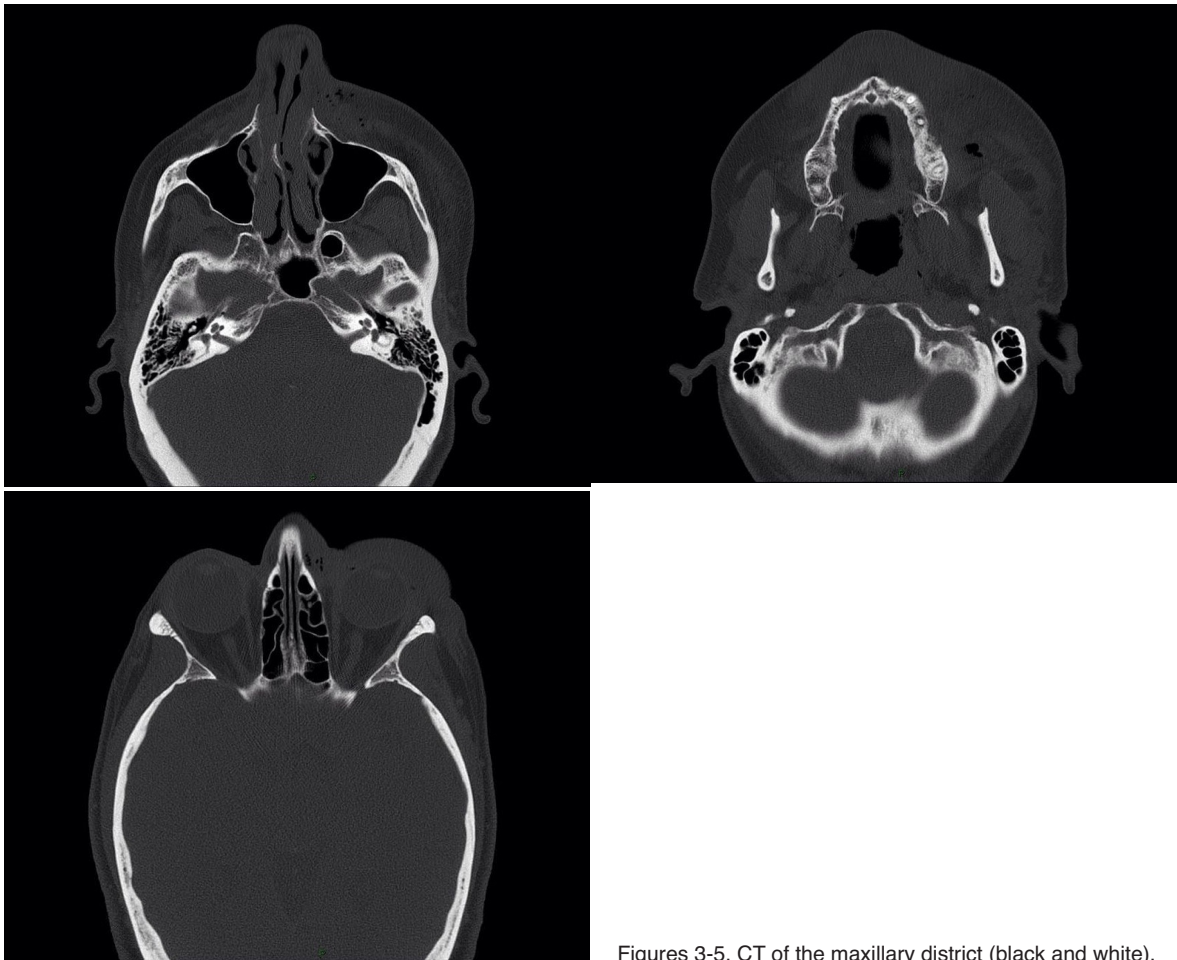
There was evidence of periapical swelling. A CT of the head and the maxillary district was prescribed (Fig. 3-5).

Figures 3-5. CT of the maxillary district (black and white).

The whole condition was diagnosed as air emphysema resulting from sodium hypochlorite solution extravasation during the endodontic treatment. Antibiotic and antiseptic therapy (ceftriaxone) and analgesic and antiedema therapy (betamethasone) were prescribed. Symptoms and the overall conditions of the patient improved three days afterwards (Fig. 6).
