Crack formation and damage evolution during consolidation in TBM driven tunnel linings in fine-grained soils

The paper deals with the numerical modelling of crack formation in segmental tunnel linings. A series of numerical analyses was conducted using the finite difference code FLAC2D. The primary aims of the analyses were to back-analyse the damage pattern observed in a TBM driven hydraulic tunnel excavated in clayey soils and to evaluate the safety level of the excavation assessing the stress and strain state of the lining.

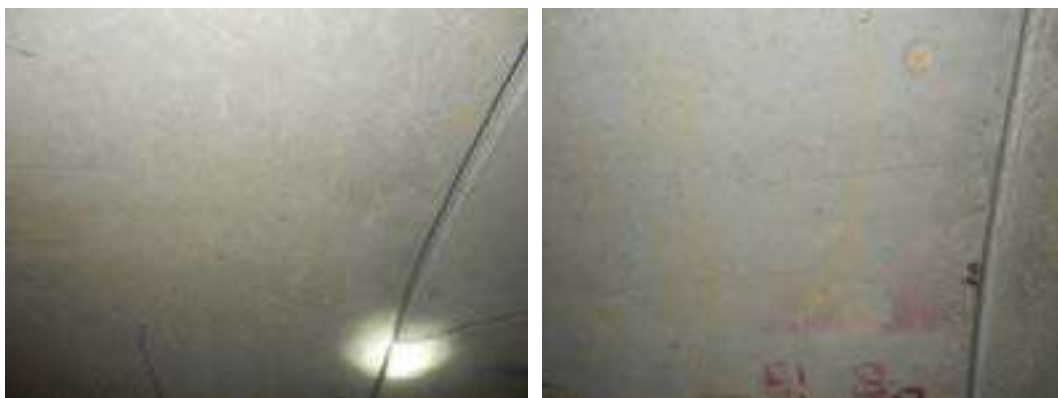
Under low cover depths, the construction proceeded normally and no problems were detected. As the cover depth increased towards its maximum value, a stretch of about 40 meters of the tunnel, near the excavation face, developed significant damage: sub-horizontal cracks were found at the intrados of the lining, roughly at the sides of the tunnel wall (see Figure 1), while at the crown some portion of concrete were detached, as showed in Figure 2. The workers reported hearing noises and noticing appreciable displacements of the lining segments in the damaged area. Through the erector pin holes, it was found a centimetric residual gap between the crown of the tunnel and the surrounding soil; at the springline and below, the soil was adherent to the lining.

Figure 1. Sub-horizontal cracks at the sides of the tunnel. Misaligned segments.

The depicted damage pattern was associated to a strongly asymmetrical closure of the surrounding soil onto the lining. In ordinary excavation condition, the ground closure onto the lining is practically symmetrical; in fact, even though the convergences are slightly different along the tunnel wall (the only exception being an isotropic geostatic stress state of the surrounding soil), the automated tail void grouting “fixes” the position of the surrounding soil before it experiences significant deformations. This ensures a globally compressive state of the lining and low variability of the normal forces along the wall.

The reported damaged was induced by the combined effect of two causes: a) the anisotropy of the geostatic stress state ($K_0 = 0.6$), which, in cases of large deformations as the ones allowed by design in the problem at hand, induces a strongly plastic behaviour near the springlines and, consequently, higher convergences on the horizontal diameter than on the vertical one; b) the downward movement of the lining, which was not co-axial to the excavation profile because of i) the lack of proper application of the hydraulic jacks’ thrust on the lining segments during every phase of the construction and ii) the absence, or at least the significant delay, of the tail void grouting.

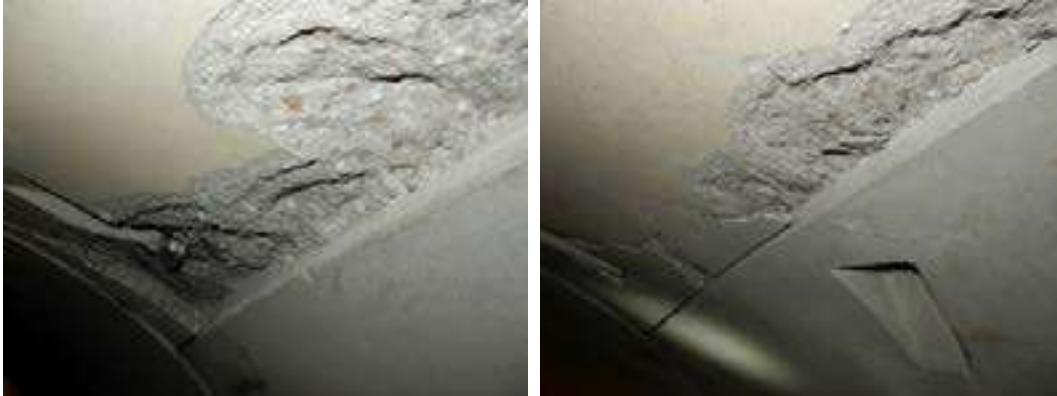
Figure 2. Concrete detachments in the upper part of the lining ring.

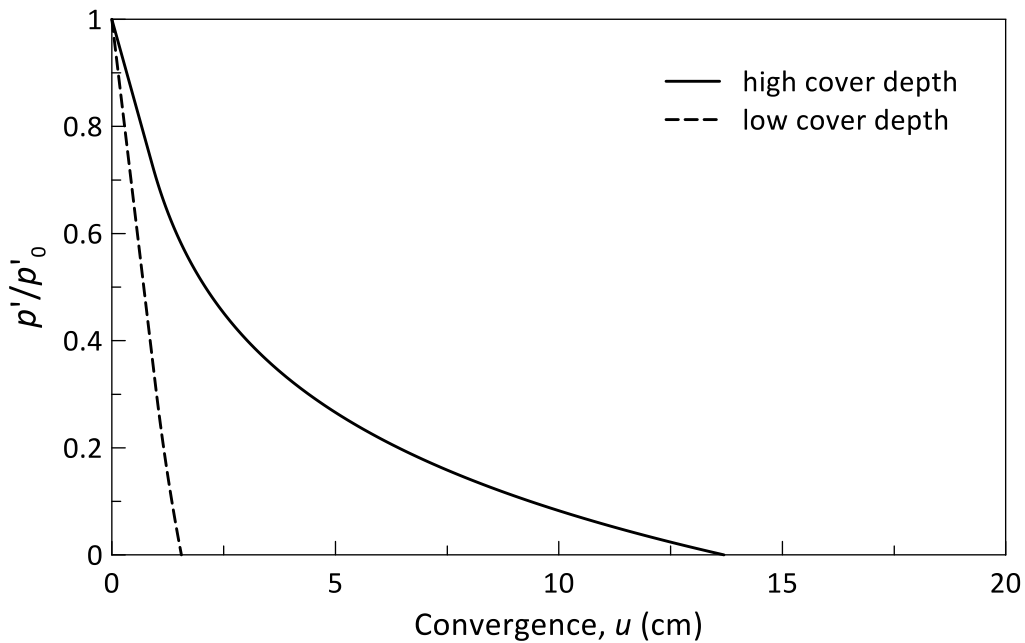
These improper construction procedures were not detected earlier because under low cover depths the convergences were very little, as the internal forces on the lining. In that situation, a delay in the tail void grouting doesn’t have a significant influence on the interaction mechanism. In Figure 3 are reported the so-called ground reaction curves, obtained assuming an isotropic geostatic stress state equal to the mean pressure. The curves show that, when excavating under high cover depths, the convergences in undrained condition were relevant. In such a case, delaying the grout injection of the tail void allows the surrounding soil to undergo significant deformations. This, in conjunction with the improper application the jacks’ thrust induced an asymmetrical interaction mechanism, as detailed in the following.

Figure 3. Undrained ground reaction curves.

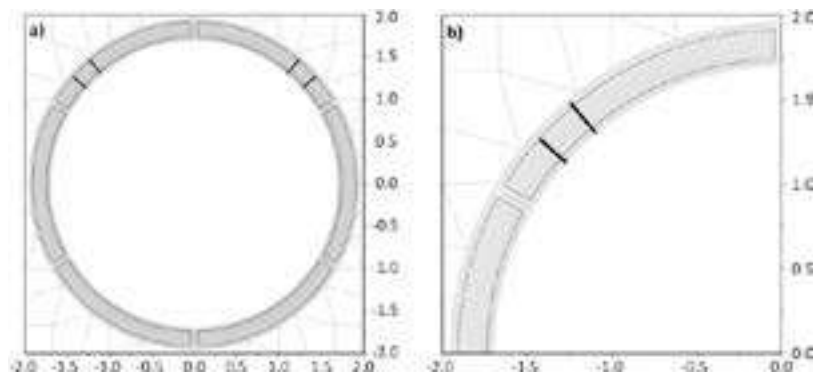
In Figure 9 the development of cracks in the numerical model is showed: a main and a secondary set of cracks can be seen. Their position is roughly the same of the maximum eccentricity tending the intrados fibres found in the beam analysis, and similar to the observed damage pattern. The main cracks resulting from the analysis have a width of 2.8 mm, comparable to those observed on site. At the extrados of the crown, no cracks are formed because of the presence of the joint.

Figure 9. a) formation of cracks in the lining b) mesh detail.

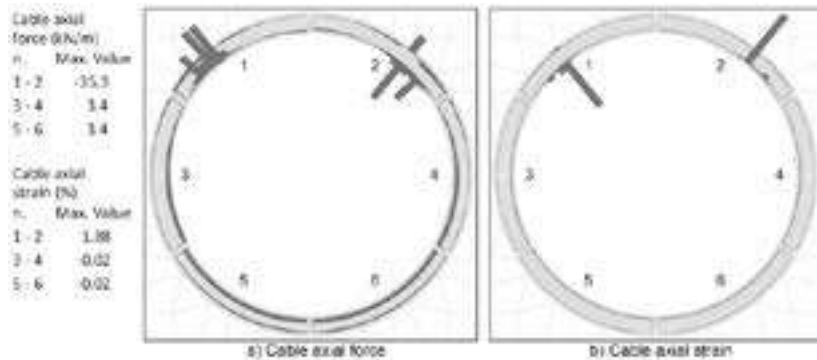
In the damaged area, the cracking induces a higher work rate of the steel bars near the intrados, which are strongly elongated (1.9% maximum axial strain) and subject to a tensile stress equal to the yield stress, as shown in Figure 11. The steel bars at the extrados are subject to a tensile stress of about 190 MPa, thus are not yielded.

Figure 11. Axial forces and axial strains in the steel bars.

Even though the lining suffers a significantly plastic stress and strain state, the soil-lining system is globally stable due to the ductility reserves of the composite structural section.

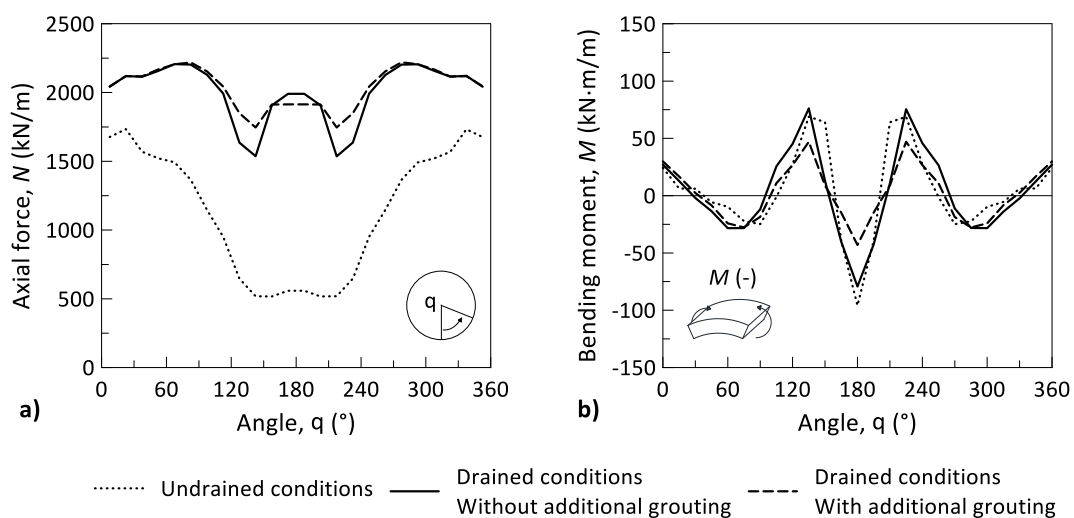
In the beam analyses, two scenarios were simulated: one in which the residual gap is still present at the crown and another in which the gap has been closed with an additional grout injection. The resulting internal forces in the lining are reported in Figure 12 and compared with the undrained results. The eccentricity of the stress state is reported in Figure 13.

Figure 12. Internal forces with and without additional grout: a) axial forces; b) bending moments.

In the scenario without additional grouting, the evolution of the stress state during the consolidation induces additional displacements at the crown, which comes into contact with the lining, restoring a more ordinary configuration. This increases the compressive state of the lining and has a significant confinement effect. In the scenario with additional injection, the beneficial effect of the consolidation is even more apparent, as showed by the greater homogeneity of the axial forces and the lower bending moments near the crown.

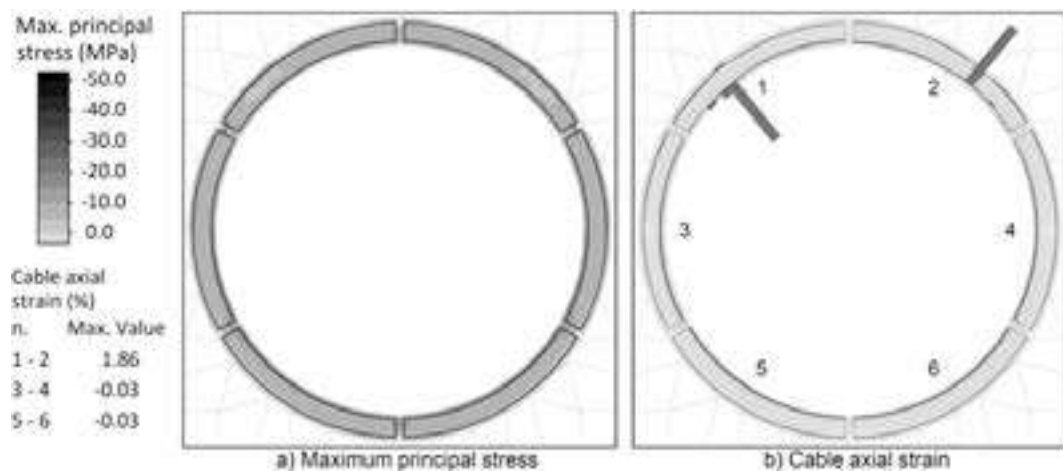
The results obtained assuming the second scenario are reported in Figure 15. The repair of the cracks impedes a significant shortening of the steel bars and the consequent turning of the tensile stresses into compressive ones. In detail, with respect to the undrained conditions, the shortening is limited to 0.02% and the tensile stress decreases of about 50 MPa. The concrete is subject to a compressive stress of about 10÷20 MPa, higher than that resulting from the first scenario.

Figure 15. Maximum principal stress contours in the concrete and axial strains in the steel bars with repair.
