It fits too well

The modern problems with CAD/CAM technology and resin bonded bridgework – A case study

by **Alaa Daud**, BDS MFDS RCS (Edin) MDTFEd; **Ken Snell**, RDT and **Claire Forbes-Haley**, BDS MJDF RCS (Eng) FDS RCS (Eng)

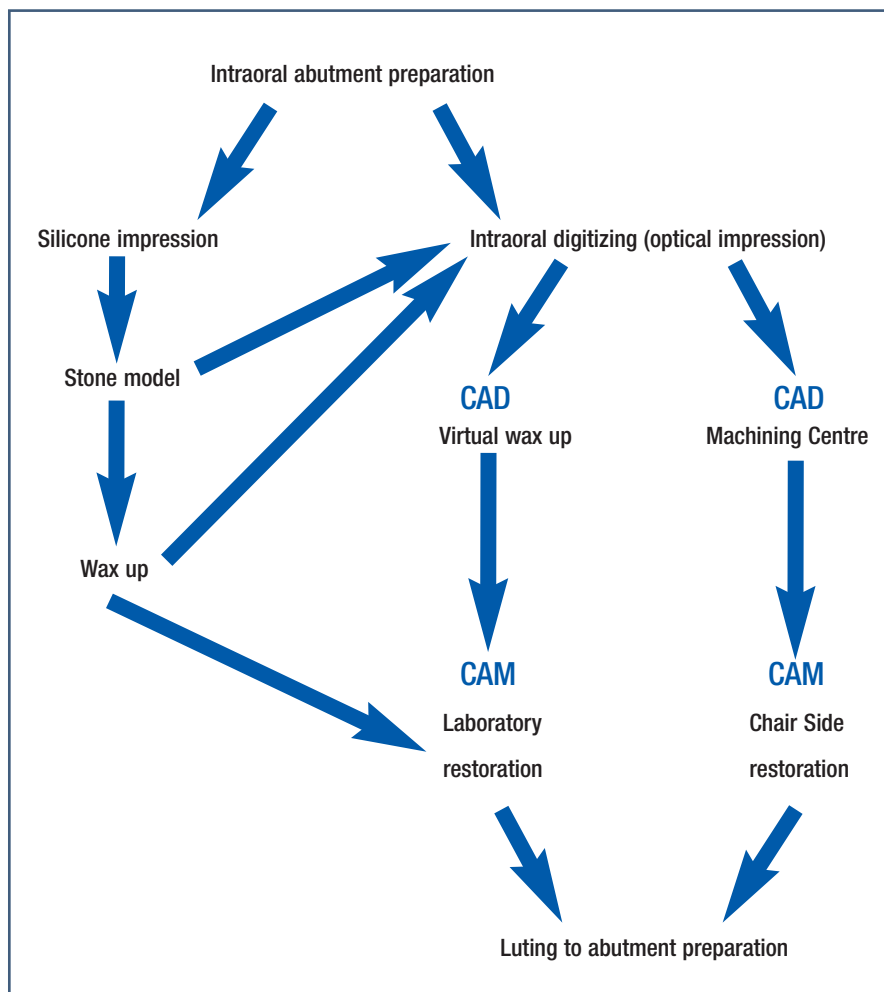
Fig.1:

There are multiple combinations of information acquisition available. The common methods for producing indirect restorations still regularly involve classical impressions, as intraoral scanners are expensive commodities. After impressions or scanning, conventional laboratory fabrication or dental CAD/CAM (computer aided design, computer aided manufacturing) is used, as shown in *Figure 1 (overleaf)*.

The conventional laboratory process Following the preparation of the

abutment/s, a silicon impression is obtained. A stone model is prepared at the laboratory as a replica. Wax patterns are then manually fabricated for metallic restorations, followed by the precision casting and porcelain veneering if required. The conventional powder build-up firing process of porcelain is still technically sensitive.

The dental CAD/CAM process

With the fourth generation CAD/CAMs available, the prepared abutment is scanned by an intraoral digitiser to obtain an optical impression. This image is recognised on the monitor and transferred to a 3-D graph using CAD software. Finally, the restoration is processed by a computer assisted milling machine (CAM).

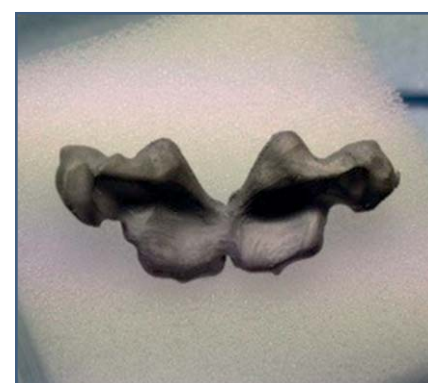
The final agreed restoration was a double abutted resin retained bridge supported by UR1 UL1 to replace UR2 UL2 as one whole unit. This design allows for retention of the UR1 UL1 following orthodontics and takes into consideration the de-rotation and movement of the UR13 UL13 and their chance of relapse (Image 1).

Image 1: Metal framework for resin retained bridge

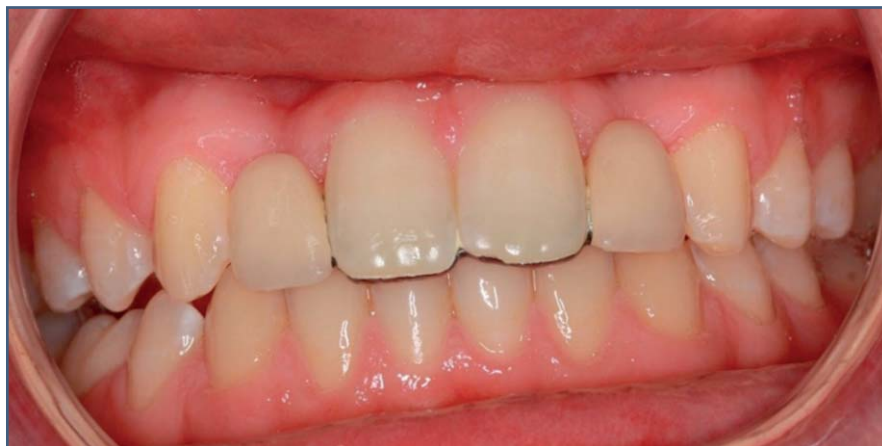
The patient returned two weeks later as he had noticed that the front teeth appeared greyer than the surrounding dentition. It appeared that the metal of the bridge was showing through as a grey discoloration on the incisal edges of the central incisors (Image 3 – overleaf). Since the invention of opaque Panavia™, we no longer had any issues with metal shine through using this style of restoration. Therefore, we investigated what the differences were in this case causing metal to shine through.

The patient did have a higher level of translucency on the incisal edges of UR1 and UL1 with deep palatal cingulum. This means these teeth could more easily show decoloration, but again following normal protocol using opaque cement, this would not usually be an issue.

Therefore, due to the accuracy of CAD/CAM, there was insufficient space for cement. This meant that even with opaque cement, the film of cement was too thin, allowing the metal retainer to show through the translucent incisal edges. Despite the retainers having a 'perfect' fit, luting agents must maintain a minimal film thickness necessary for long-term retention of the restoration and sufficient opacity. Therefore, the setting

Image 3: Grey area of the bridge

on the CAD/CAM software was intentionally changed to accommodate enough space for the luting agents. A new RRB was constructed via CAD/CAM with a space of '30 μm ' between the tooth and retainer to allow enough thickness for the cement.

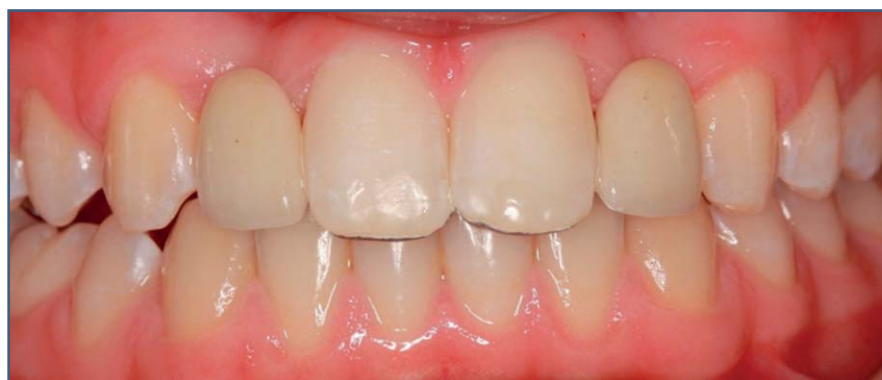
The new RRB was cemented using the same cement. A difference was noted aesthetically as no metal was showing through the incisal edges of the central incisors (*Image 4*).

Image 4: Final bridge
