Effects of Head Formation and Heat Treatment on the Mechanical Properties of Connecting Rod Bolts

A Senior Project

The Faculty of Materials Engineering
California Polytechnic State University, San Luis Obispo

June 11th, 2018

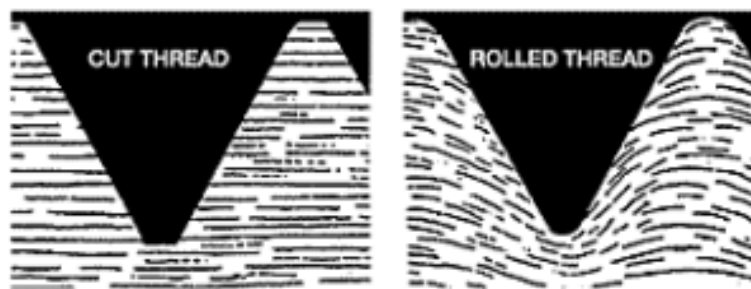
Figure 3. A representation of the difference between thread cutting and thread rolling. Thread rolling deforms the grains, increasing the strength of the threads [5].

The threaded portion of the bolt is produced by a process called warm rolling. In this process, the threaded section is induction heated to a relatively low temperature and then passed through a series of dies. The warm rolling process produces stronger threads than a thread cutting process due to the cold working of the grains during processing [4]. Figure 3 shows a comparison between the microstructure of thread rolling compared to thread cutting.

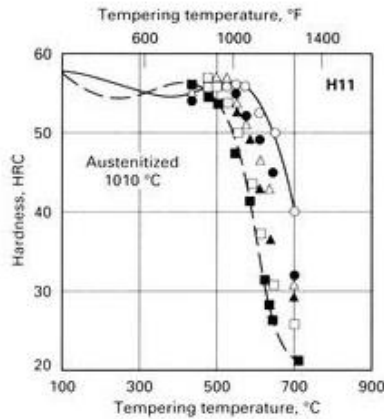
Figure 5. Tempering temperature vs HRC, showing the influence of austenitizing temperature, tempering time, and tempering temperature [9].

While it is possible for H11 to achieve full hardness through air cooling, typical quenching occurs either in a nitrogen gas atmosphere or oil. This is done to prevent embrittlement during air cooling. After quenching, most of the martensite has formed in the alloy. Retained austenite is a risk with high dissolved alloying element concentrations, so the austenitizing temperature is carefully chosen to balance maximizing alloying element concentration in the material and minimizing retained austenite. Typical austenitizing temperatures range from 995 to 1025°C, with hold times around 15 to 40 minutes [9]. Tempering follows austenitizing, and transforms martensite into a ferrite matrix with carbide precipitates known as tempered martensite. Multiple tempers can be used to reduce the amount of retained austenite. Mechanical properties are influenced by a combination of tempering temperature and time (Figure 5). Ideal heat treatment involves austenitizing above 1000°C, with a tempering temperature of 540°C to allow for flexibility in tempering times depending on processing requirements.

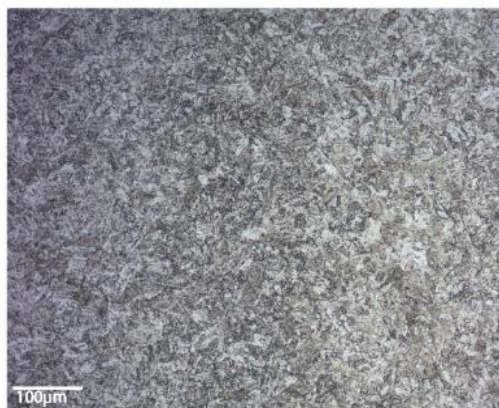
Figure 6. Microstructure visible under optical microscopy, showing martensitic matrix [1].

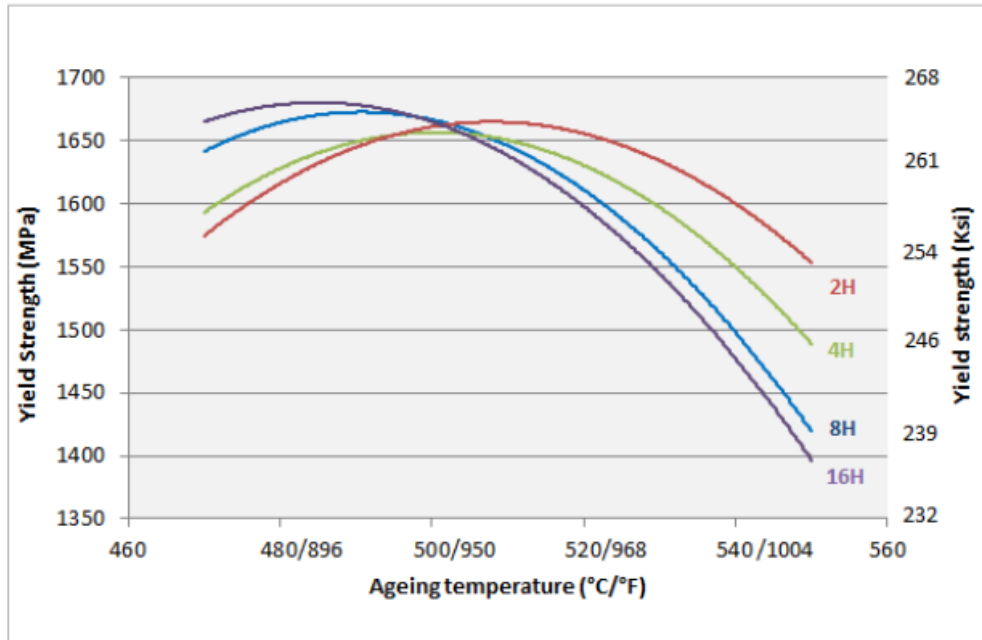
Figure 7. Aging temperature and time, and resulting yield strength for MLX17 stainless steel. A lower aging temperature held for longer will produce the highest strength possible [1].

Heat treatment of MLX 17 starts with solution treatment at 850°C, held for 2 hours, followed by quenching in oil or water. After, it is cooled to -73°C or lower and held for 8 hours to allow for complete transformation to martensite [1]. Aging follows which produces the end microstructure (Figure 6). Mechanical properties are influenced by aging temperature and time (Figure 7). Recommended aging temperatures from Aubert and Duval specify 510°C for aerospace components, and 540°C for components requiring high corrosion resistance, both held for 8 hours.

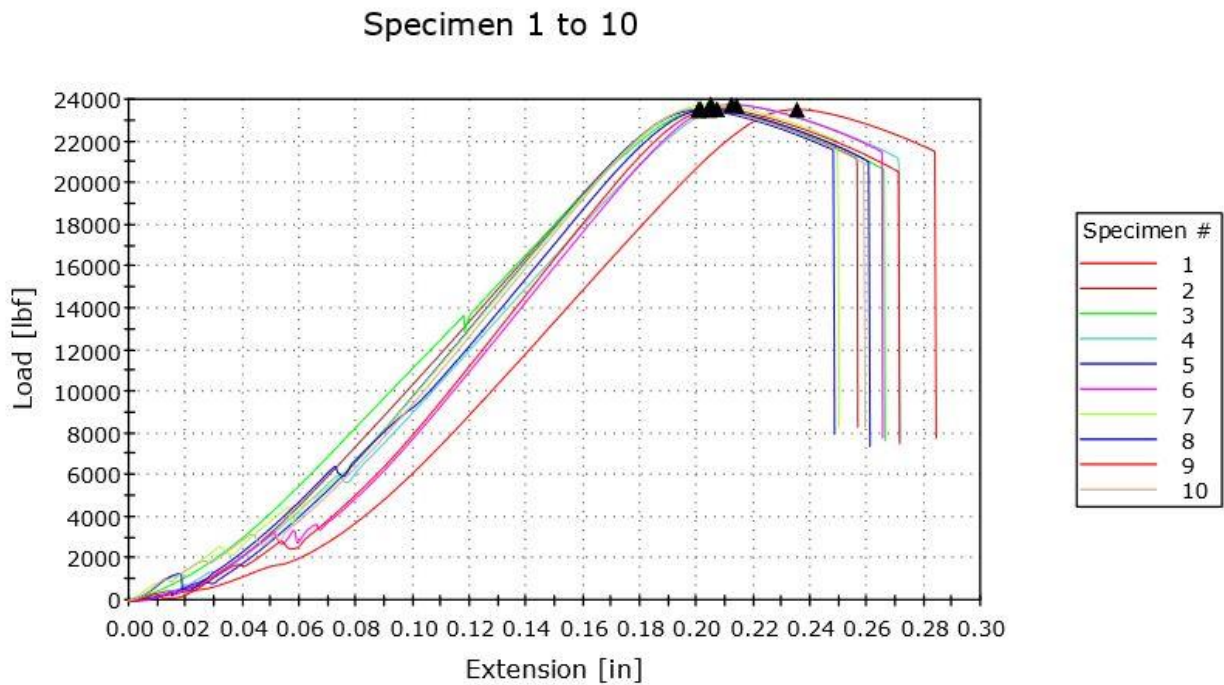
Figure 10. Typical raw data output from the Instron software, this graph showing samples 1-10 of H11. Complete results are available in the appendix.

Tensile testing gave the relationship of load and extension for each bolt, and by dividing load over cross-sectional area of the relief the relationship of stress and extension can be determined. Raw data from the Instron software was received as graphs of 10-sample groups (Figure 10) and as an excel file with time, load, and extension data in increments of 0.05 seconds. The raw data graphs show noise in the first 30% of the data, which is associated with the bolt, nut, and collar settling in to the fixture.

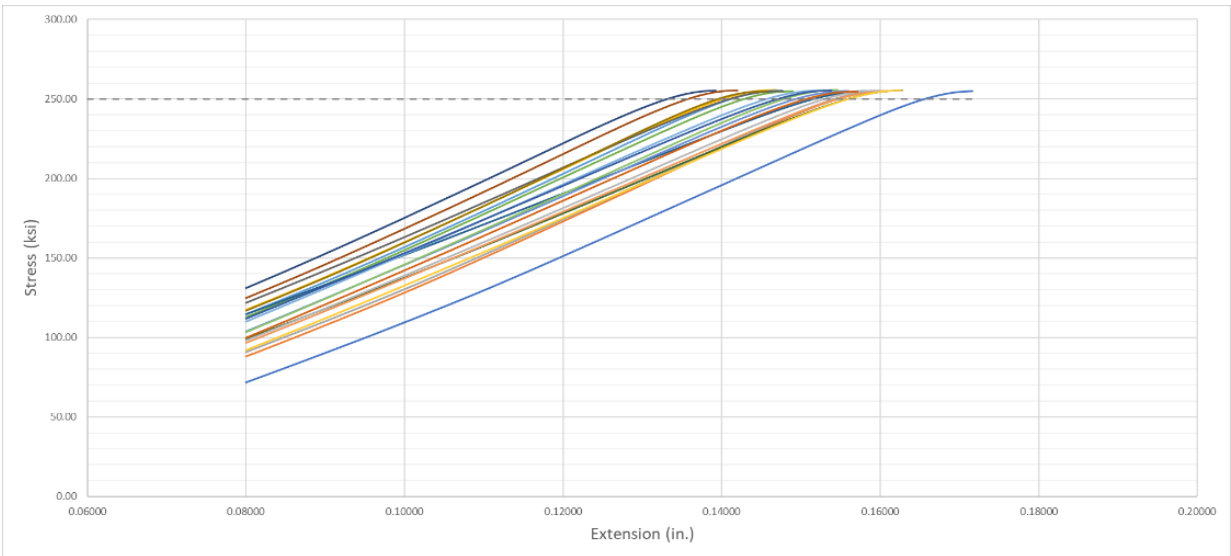
Figure 12. Compilation of MLX17 Re Solution Annealed data. The dashed line represents the estimated yield strength of 250 ksi.

Figures 13 through 15 show that consistency within each sample group was high, and all samples within a group had nearly the same elastic modulus, or slope of the elastic region. It is also significant to note that some settling noise was still present in the H11 data (Figure 11). While this is less than ideal, any second derivative peaks associated with this noise was disregarded when performing yield strength calculations. The two samples in Figure 13 which are shifted to the right are associated with samples where some extra extension was recorded initially, but had no significant load applied. This could have come from either the fixture shifting slightly in the Instron jaws during the first test of a group, or with the bolt being loose within the fixture at the beginning of testing. This should not be taken too seriously, since these samples still showed the same yield and tensile strength properties despite the additional recorded elongation.

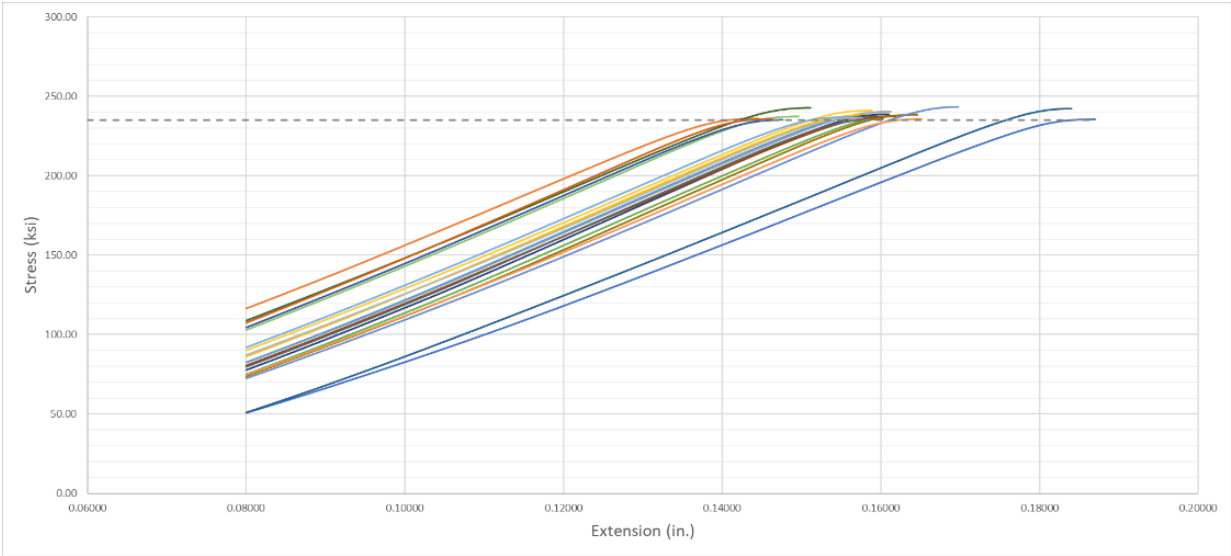
Figure 13. Compilation of MLX17 As Received data. The dashed line represents the estimated yield strength of 235 ksi.
