Accelerated UV Testing and Characterization of PV Modules with
UV-cut and UV-pass EVA Encapsulants

A Thesis Presented in Partial Fulfillment
of the Requirements for the Degree
Master of Science

ARIZONA STATE UNIVERSITY

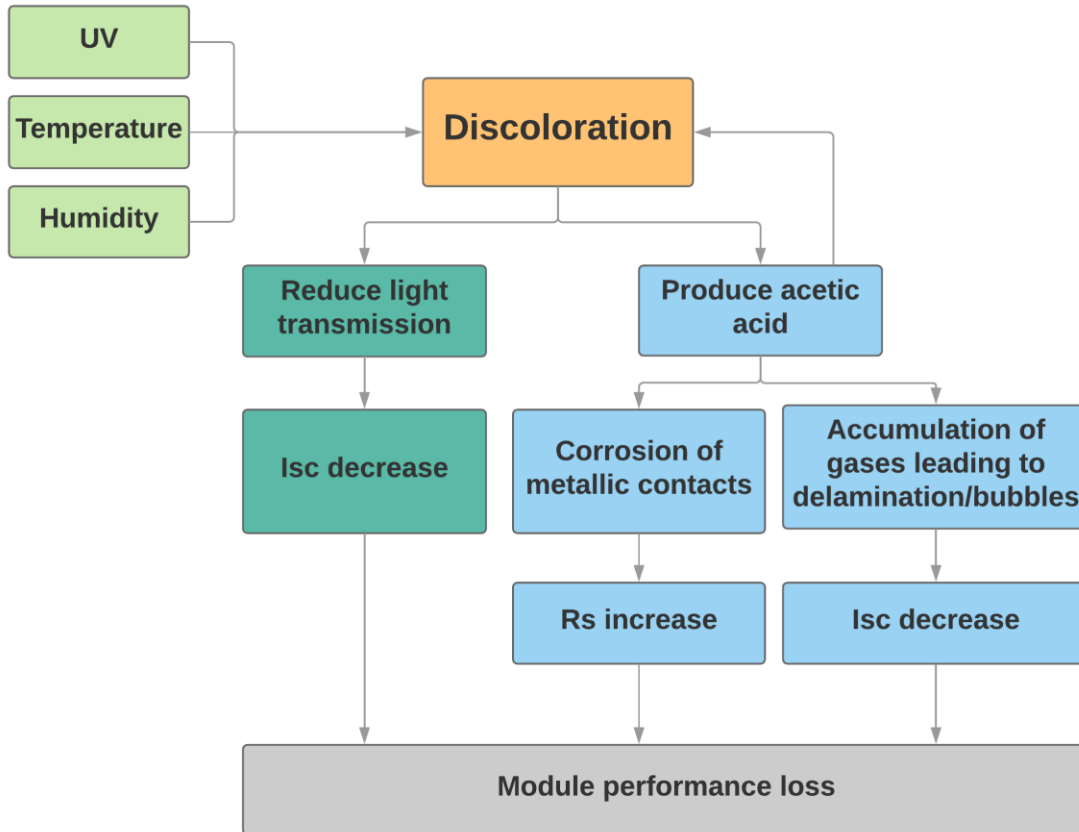
Figure 1.1: Causes and effects of encapsulant discoloration

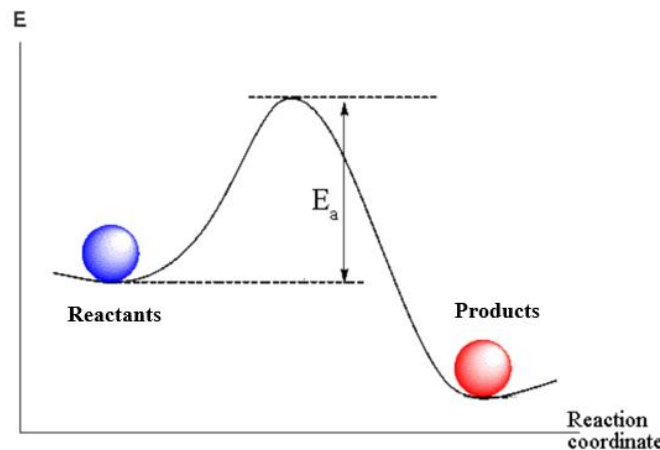
Figure 1.2: The chemical reaction process indicating the activation energy [8]

In PV reliability context, the activation energy (E_a) refers to the minimum amount of energy required to initiate the temperature accelerated degradation. The focus of this thesis is to find out the activation energy for encapsulant browning. But, as both photobleaching and browning reaction occur simultaneously, some changes were made in the setup to eliminate photobleaching reaction so that primarily only browning reaction could occur.

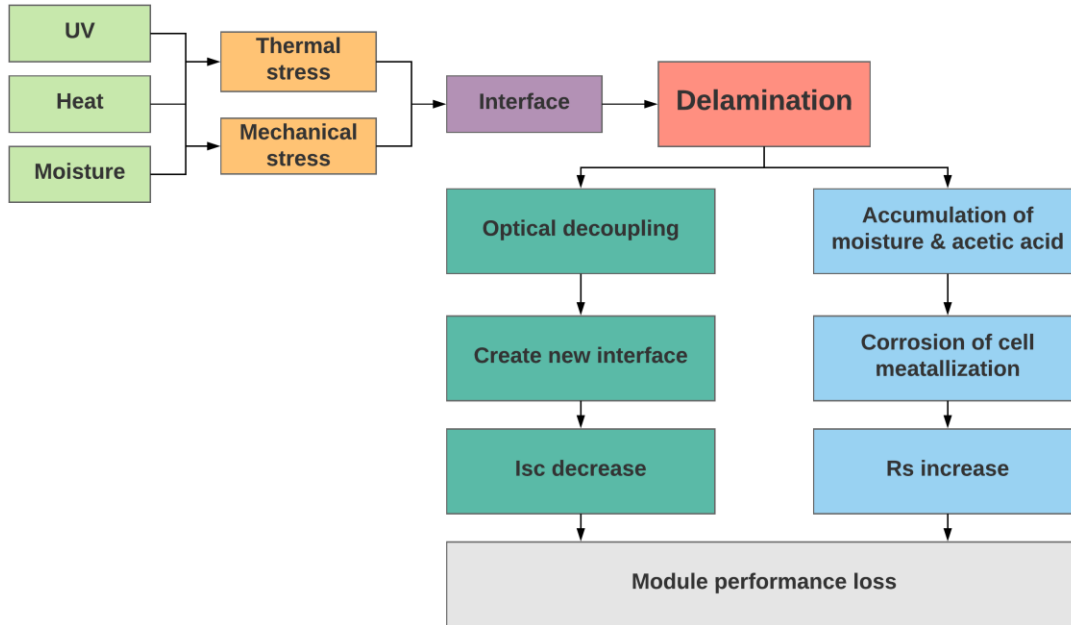
Figure 2.3: Causes and effects of delamination

Delamination is another major degradation mode observed in the field deployed PV modules. The major drivers for the delamination are- 1) the stress exerted at the interface from residual thermal stresses or from external mechanical stress applied on the module, 2) the deteriorated interfacial bonding due to attack from heat, UV and moisture. Delamination creates new interfaces- a) glass/air and air/EVA in case of glass/EVA delamination, b) EVA/air and air/cell front in case of cell front/EVA delamination[6]. Delamination causes the optical decoupling between the solar cell and encapsulant which reduces I_{sc} . It also allows more accumulation of moisture and acetic acid which leads to corrosion of cell metallization. Sánchez-Friera et al. observed power loss of 11.5% in 12 years exposed PV modules due to delamination[23].

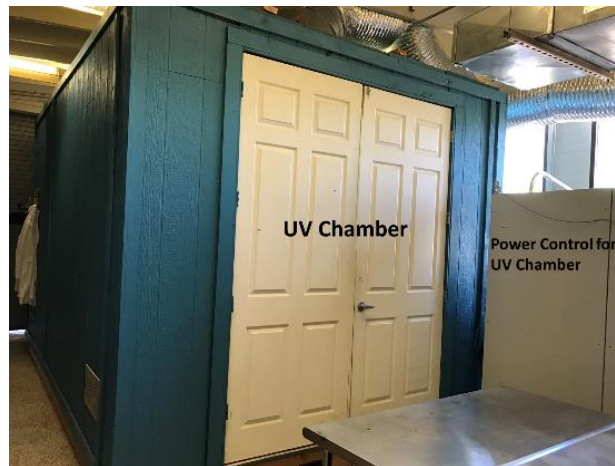
Figure 3.1: Outside view of the UV chamber

The accelerated UV stress testing was performed in a walk-in UV chamber equipped with rack housing for test samples. The UV chamber has a rack housing 144 UV tube lights in two rows and two fans on the roof for temperature control. The mini-modules were exposed to UV irradiance of 215 W/m^2 at a chamber temperature 50°C under dry heat. A UV sensor was placed inside the chamber in-plane to module surface to measure the UV irradiance intensity.

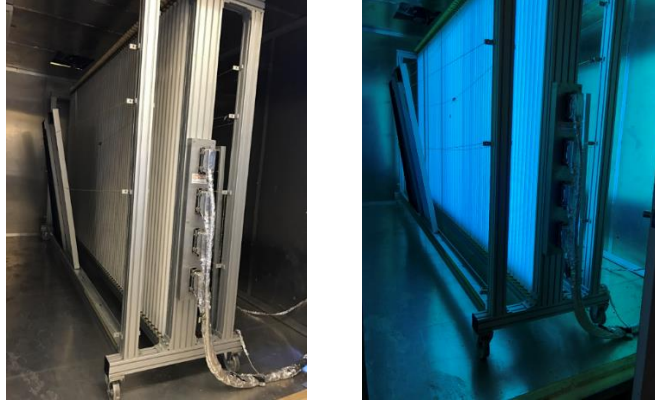
Figure 3.2: Inside view of a) unlighted UV chamber b) lighted UV chamber

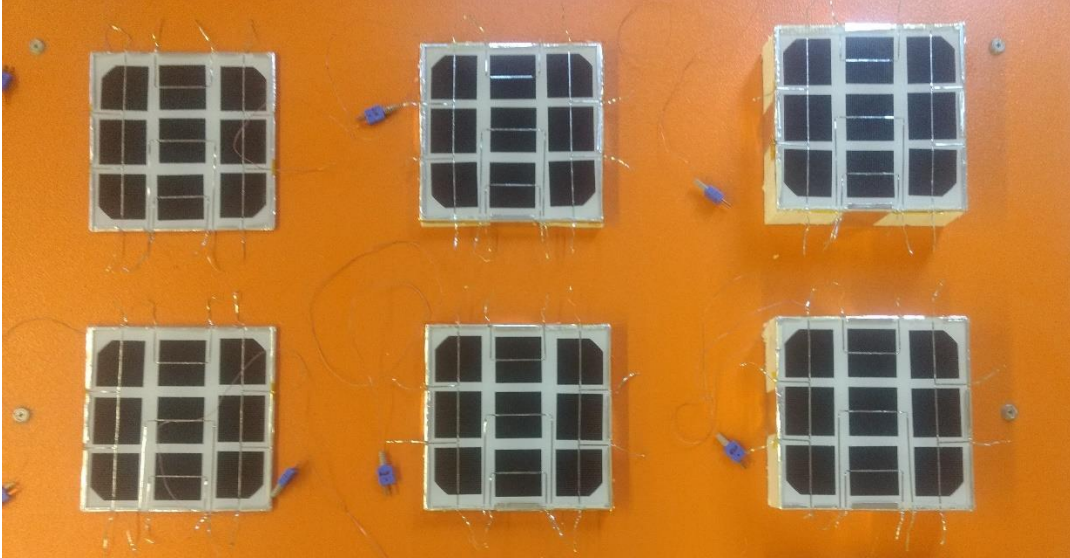
Figure 3.3: Top-view of the six mini-modules

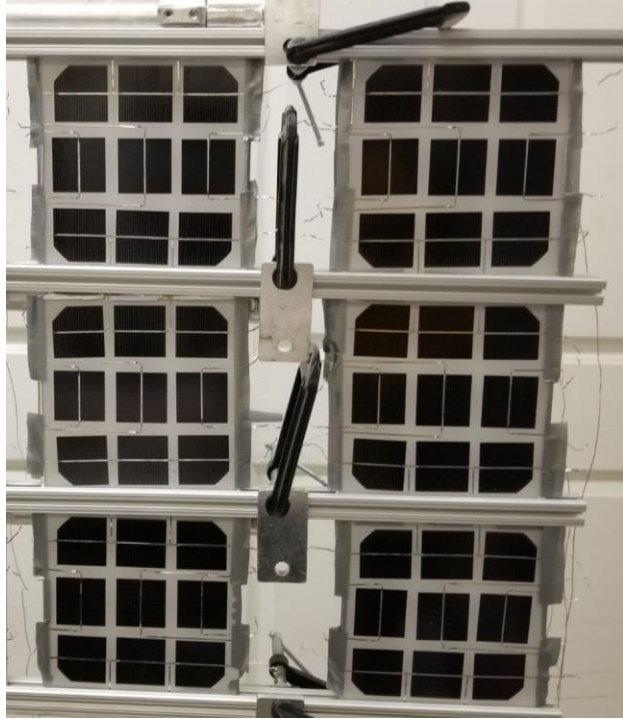
Figure 3.7: Mini-modules arranged on the rack placed inside the walk-in UV chamber

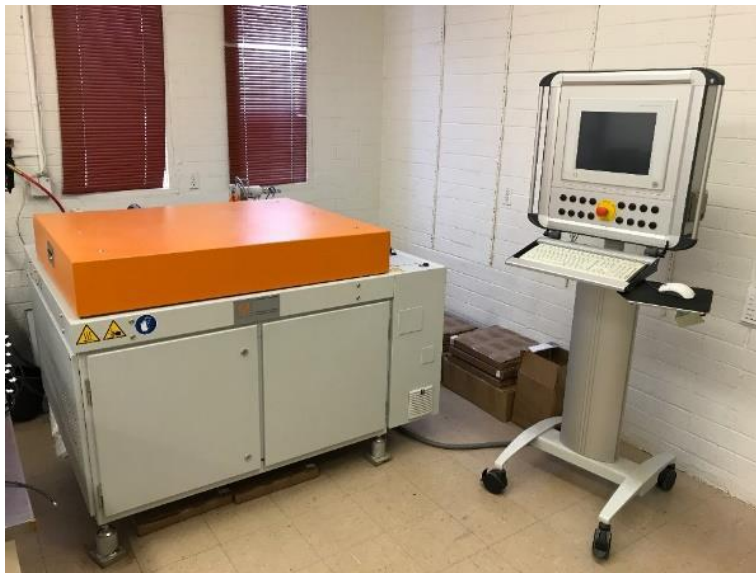
Figure 3.10: Laminator with the control system

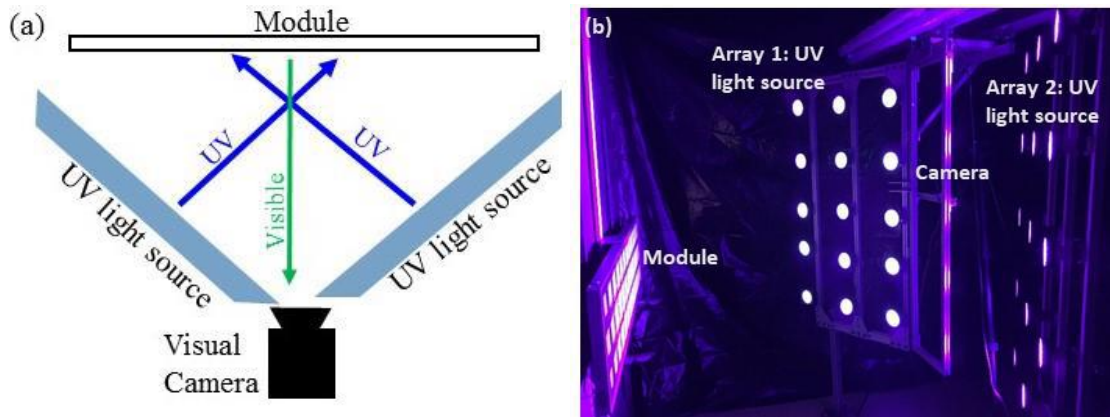
Figure 3.12: (a) Schematic of UVF imaging set-up with two UV light source arrays angled towards the module. The module emits visible light. (b) Photograph of the set-up with the UV arrays.

UV fluorescence imaging is a non-contact and non-destructive method that allows the fast and early detection of the discolored encapsulant, especially during the early stages of yellowing which is not visible to the naked eyes. The UV excitable chromophores present in the yellow region of encapsulant emit fluorescence when irradiated under black/UV light. The imaging setup consists of a visual camera and a UV illumination system comprising of two arrays of 15 UV lamps each inclined at an angle of 45° w.r.t. the module surface (*Figure Figure 3.12: (a) Schematic of UVF imaging set-up with two UV light source arrays angled towards the module. The module emits visible light. (b) Photograph of the set-up with the UV arrays.*Figure 3.12). This is done to minimize glare in the visual images due to UV light reflection. Nikon D3400 camera was placed on a tripod stand in between the two arrays and directly facing the module to get a clear image. The setup

provides uniform bright light on the module and this technique provides fast characterization results.

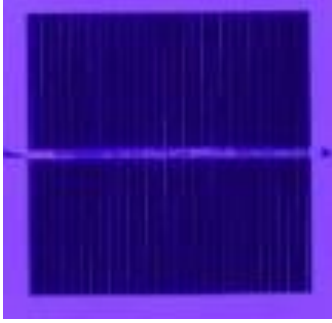
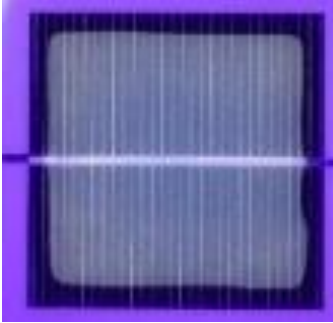
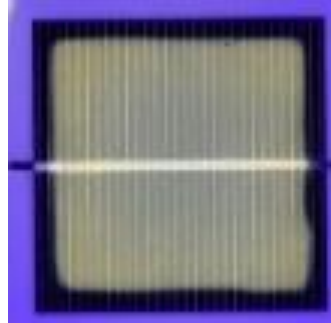
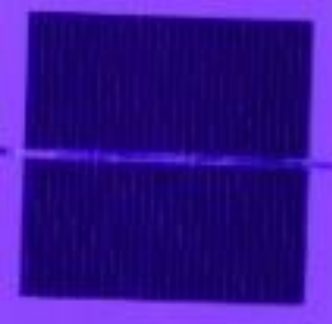
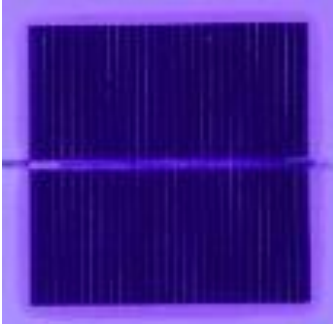
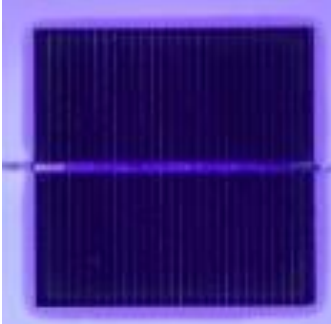
UV dosage		
0 kWh/m ²	200 kWh/m ²	400 kWh/m ²
Center cell from mini-module with UV-cut EVA (UVC-3) (high temperature)

Center cell from mini-module with UV-pass EVA (UVP-3) (high temperature)

Figure 4.3: Close-up UVf images of center cell from UVC-3 (high temperature) and UVP-3 (high temperature) modules

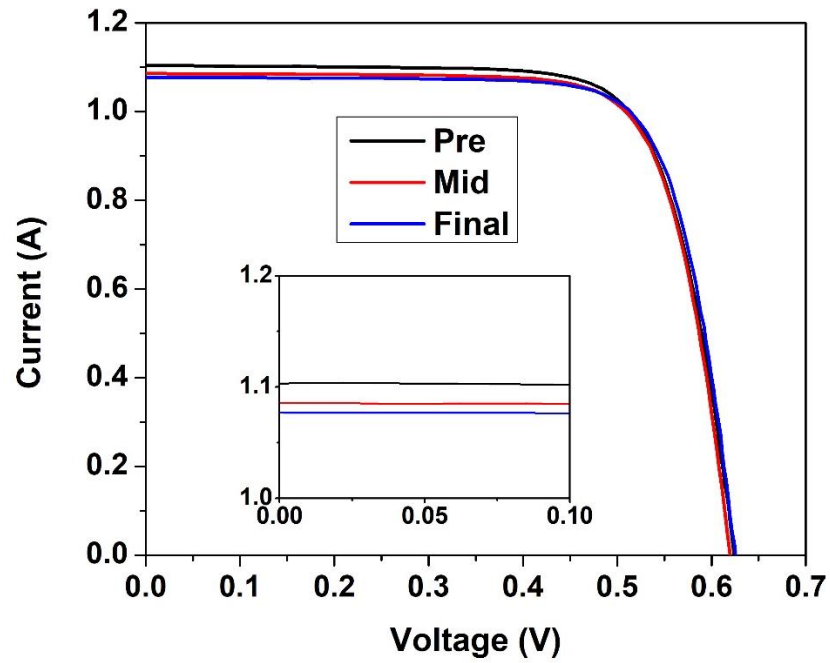
Figure 4.5: IV curve for UVP-3 cell 2 at various stages of accelerated stress test (0, 200 and 400 kWh/m² UV dosage)
