Sealing capacity of different materials for the reclamation of cracked concrete fish tanks

Eze, J. O. / Nnaji, J. C. / Okojie, L. A.

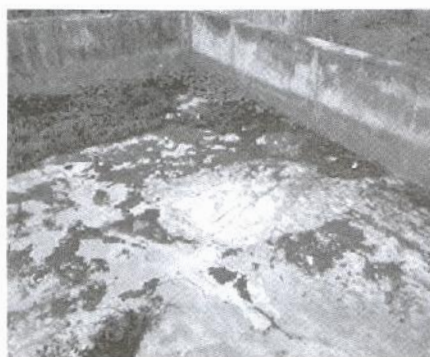
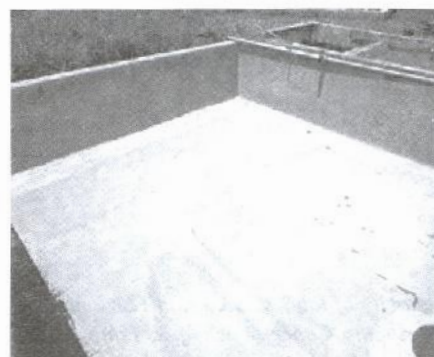
Plate 1: The nature of concrete tanks in T1 before and after application of sealant.

BEFORE

AFTER

Four concrete fish tanks (5m x 5m x 1m) were divided into two duplicate treatments and used for the study. Latex sealant (Dr. Fixit brand) was utilized in treatment 1 (T1) while normal Portland cement was utilized in treatment 2 (T2). The tanks (plate 1 and 2) were initially filled with water and the leakages and evaporation were determined. The surface of the four tanks were thoroughly cleaned (removal of loose materials, oils, grease, grasses, etc.) by wire brushing and the surface was dampened but in a touch dry manner. The sealant was mixed in ratio of 1:4:7 (super latex: water: cement) and was applied with brush on

the two tanks in T1. After the first coat (layer) was dried, the second coat was applied after 24 hours, when the second coat was dry, plaster (mortar) for protection and finishing was applied. Portland cement was also mixed in a ratio of 1:3 (cement: plaster sand) and applied on the other two tanks in T2. The tanks were cured for one week to flush away the toxic materials of the sealant and cement that may contaminate fish. After that, the tanks were filled with water to a level of 0.7m and *Clarias gariepinus* fingerlings were stocked in the treatments at a density of 10 fingerlings/ m² for three months and the seepage rates (decrease in water level per day) were determined.

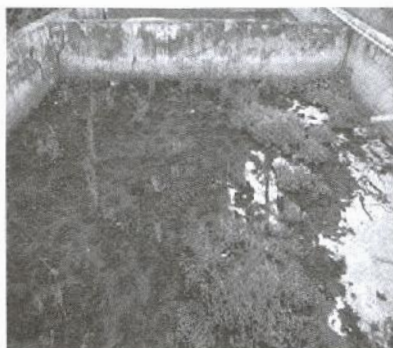
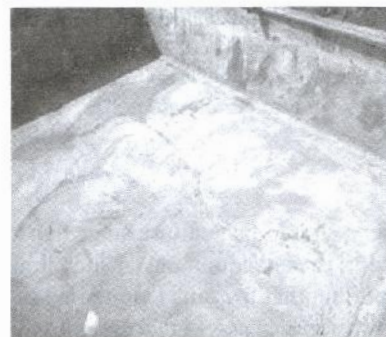
Plate 2: The nature of the concrete tanks in T2 before and after application of Portland cement.

BEFORE

AFTER

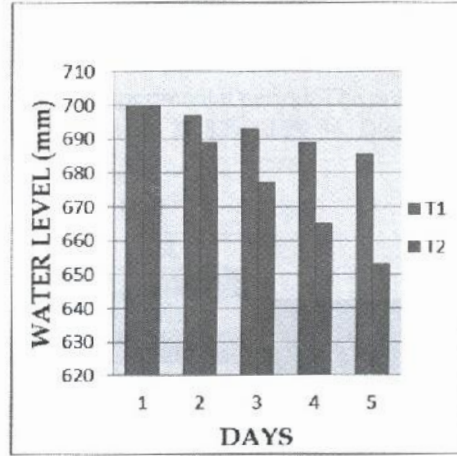
Fig. 2: Seepage after Application of Sealant and Portland cement.

The result obtained before the application of sealant and Portland cement (T1 and T2) is shown in figure 1. It was confirmed that seepage was very high and this led to abandonment of the tanks for several years. But after the application of latex sealant in T1, the seepage determined shows a slight drop (decrease in water level) of 4mm/day when the weather is clear (sunny) which may be as a result of water loss by evaporation while the seepage determined in T2 was 12mm/day and showed a continuous decrease irrespective of weather condition as shown in figure 2. Plate 1 and 2 shows the nature of concrete tanks in T1 and T2 before and after application of sealant and Portland cement. Tanks stocked with fish after treatments are shown in plate 3.
