# The Radon Gas in Underground Buildings in Clay Soils. The Plaza Balmis Shelter as a Paradigm

Carlos Rizo Maestre \*

and Víctor Echarri Iribarren

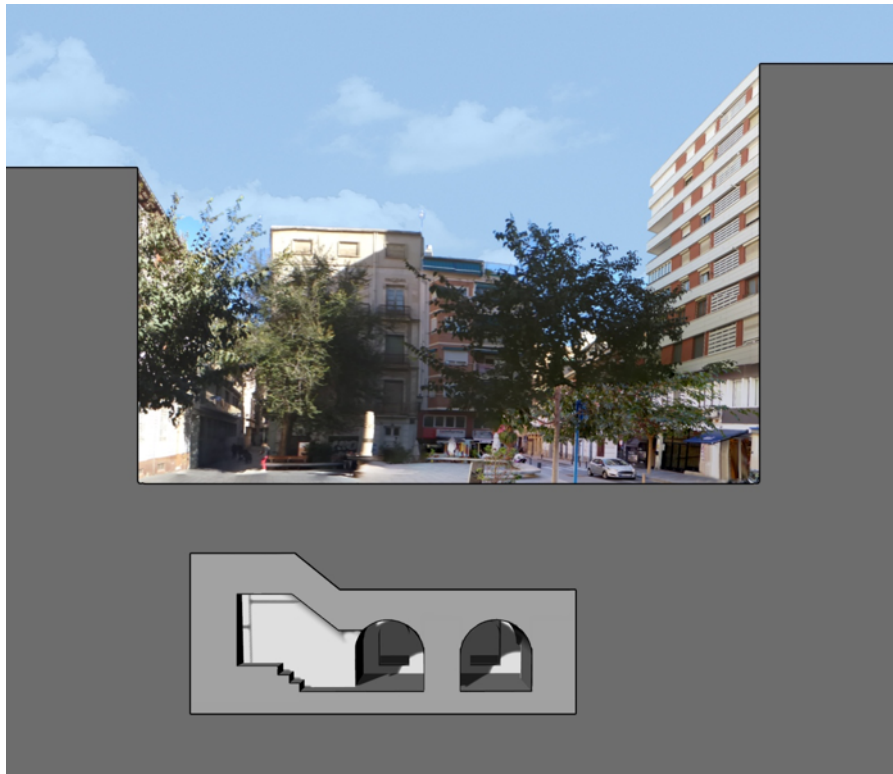
**Figure 2.** Photomontage of the Plaza Balmis section in its current state.

The shelter at Plaza Balmis is cellular, type 3, according to the characteristics of the municipal architect of the time, the shelter's body being buried two meters below the level of the square (Figure 2). The volumetric layout of the shelter (Figure 3) is composed of six rectangular cells with a surface area of approximately 7.5 m<sup>2</sup> in each one of them with a height ranging from 1.81 m to 2.33 m. The six rooms are connected by passages of approximately 1 m. The shelter complex has about 50 m<sup>2</sup> without accesses. The two central partitions are connected to the accesses and serve as a distribution for the other four that consisted of a stone bench. The galleries are separated by walls of 0.60 m width, made of cement mortar masonry and plaster up to half height. The lateral chambers are separated from the two central chambers by rings that brace the structure in its lower part and reinforce the upper part with semi-circular arches lower than those used in the vaults.

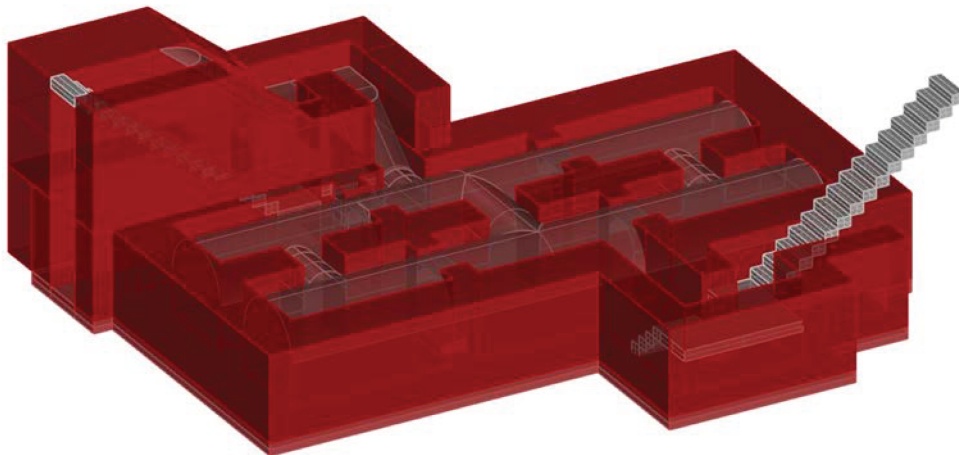
**Figure 3.** Image of the volumetry of the refuge of Plaza Balmis where the two entrances are shown. The right corresponds to that of the streets Limones and Cid, currently walled and the left corresponds to the only entrance available. The vaulted roofs are shown in a lowered semicircular arch. In the upper part there is a large concrete layer of up to 1.5 m, this side being the most protected.

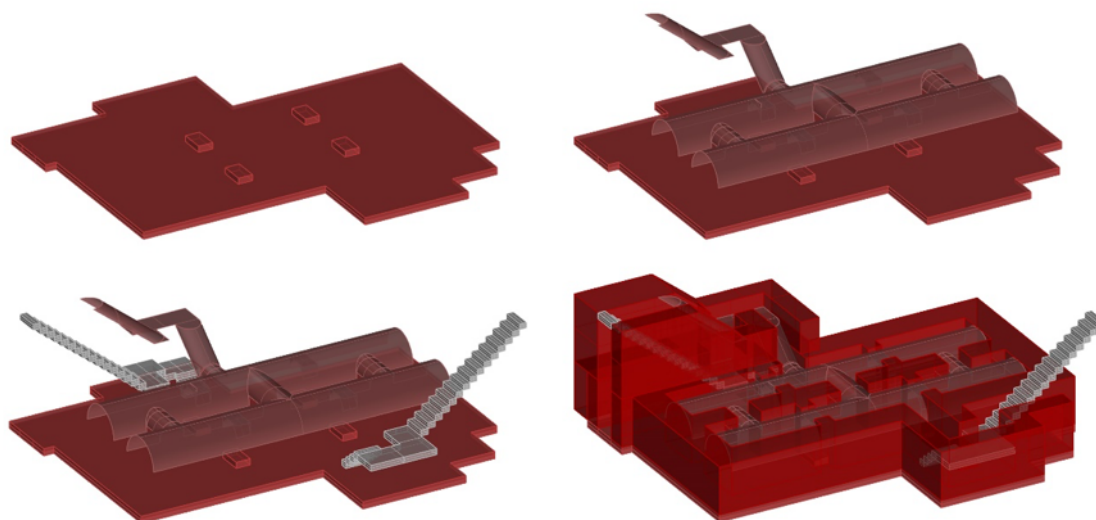
**Figure 5.** Images of the reconstruction in 3D of the refuge of Plaza Balmis, showing the two longitudinal naves that form three quarters each connected in both directions.

The construction, as shown in the Figures 4 and 5 has two zigzag accesses at the end of each stairway, to attenuate the effects of the shock waves caused by the bombs and in the event that one of them was not usable, the other was the escape route for the occupants of the shelter. The entrances are built on a base of mass concrete that serves as a support for the stairways built with hollow brick. The interior access to the square, corresponding to the intersections of Limones and Cid streets, is currently covered due to different developments that have been carried out in the square. The walled access was probably filled with rubble from the roof demolition carried out in 1946.

The upper enclosure is made of hollow brick, placed in the form of barrel vaults with lowered arches, ready for tambourine and plastered as shown in the sections in Figures 6 and 7. The upper top of the vaults is made of reinforced concrete, the pavement is made of mass concrete filled with compacted sand. In the original layout of the shelter, the roof contained the doorways to the enclosure and was the only direct contact to the outside, thus achieving greater protection.

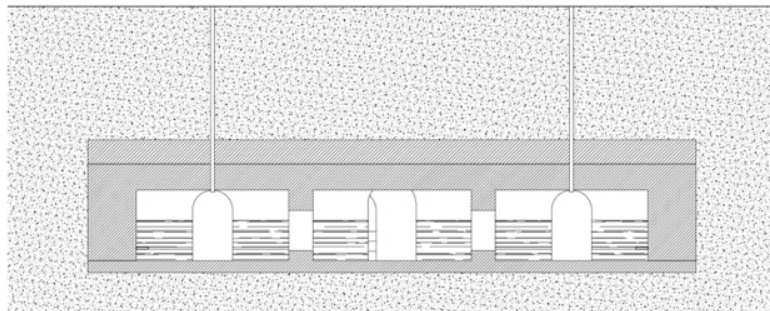
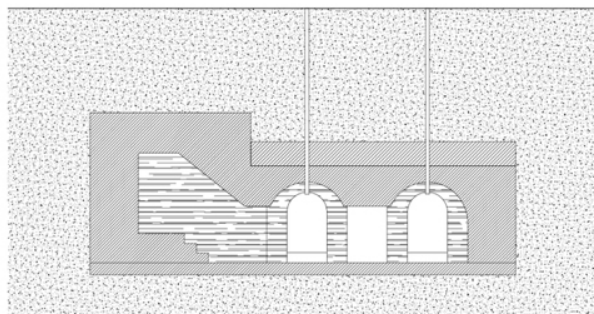
**Figure 7.** Section of the Plaza Balmis shelter with the three corridors connecting the three spaces that divide the two naves.

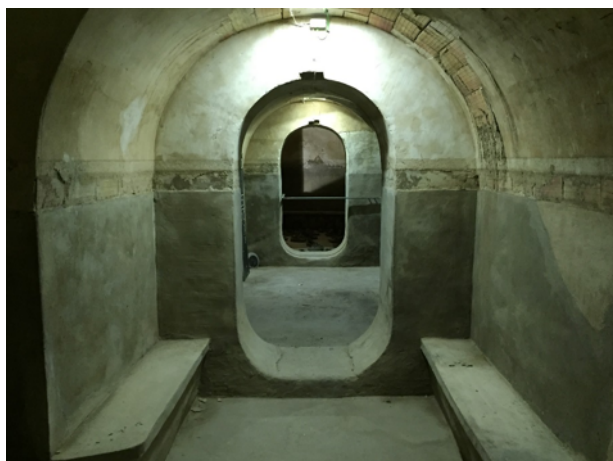
**Figure 8.** One of the two main halls, where the three cells of this one are distinguished, being the distribution center.

At present, the shelter has deteriorated due to the high humidity present in the interior (Figure 8) generated by the upper square and the poor ventilation, produced by the only available access.

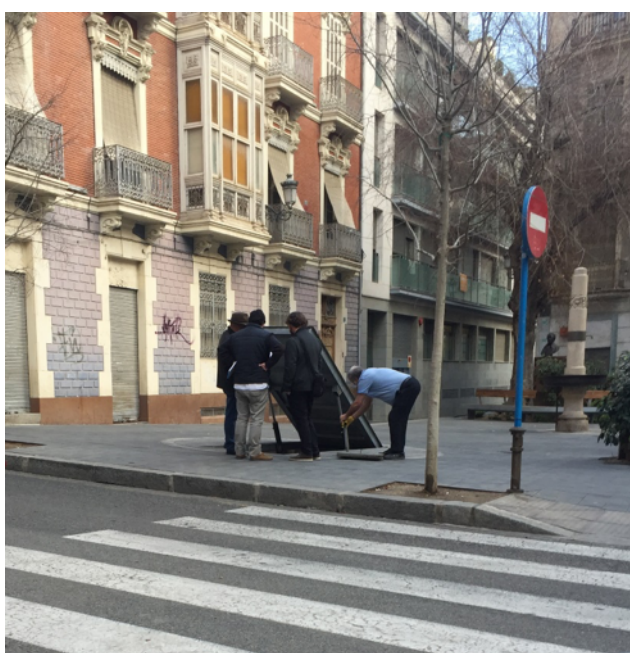
**Figure 9.** Image showing the opening of the hydraulic access to the Plaza Balmis refuge on Canalejas Street. This entry is being modified by a fixed type for greater security.

In 2007, the City Council of Alicante plans to remodel the square space in order to modernise it. This is great resistance among the inhabitants and the traders because they consider that the square is in good condition and that there are more important areas needing improvement. For this reason, the modernisation of the square was halted up to 2013 when the project was restarted. During the course of the work, the shelter appears and generates great expectation among the population. Finally, it was decided to respect and value it, and to add an access from Canalejas Street, which is integrated into the pavement and opens with hydraulic elements as seen in the Figure 9.

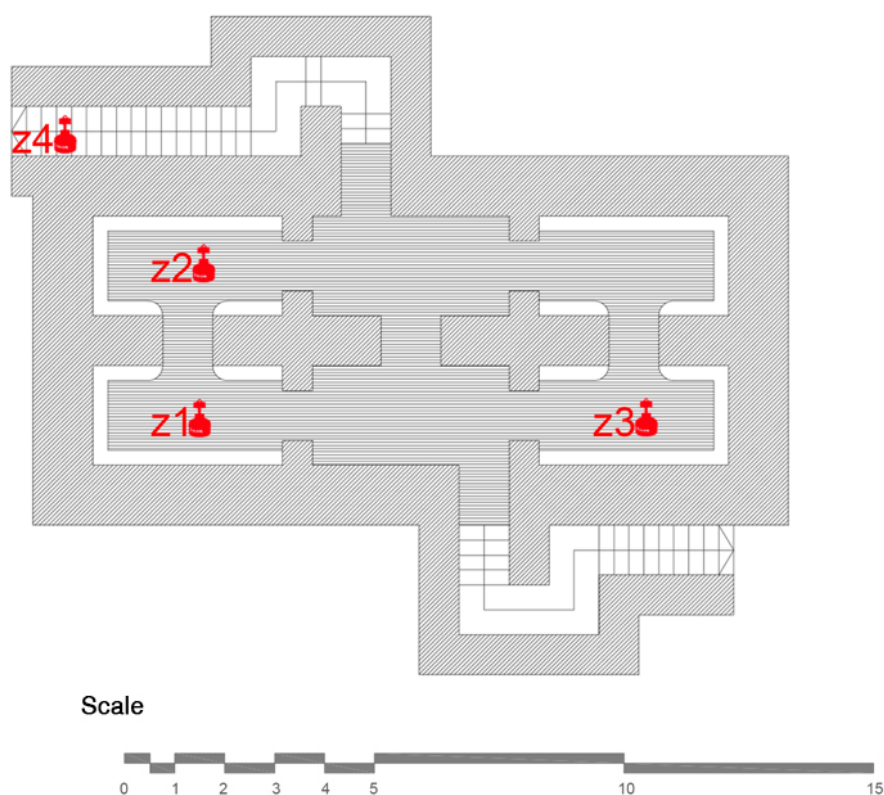
#### SHELTER PLANT

**Figure 10.** Arrangement of the zones chosen for measurements at the Plaza Balmis refuge.

The data collection of the shelter of the Plaza del Doctor Balmis was carried out over 22 days, from the 15th of March 2016, and it took place homogeneously throughout the shelter. The measurement zones of the study correspond to the cells, as shown in Table 1 and Figure 10.

Zone	Cell
Zone 1	Cell 4
Zone 2	Cell 1
Zone 3	Cell 3
Zone 4	Secondary entrance walled

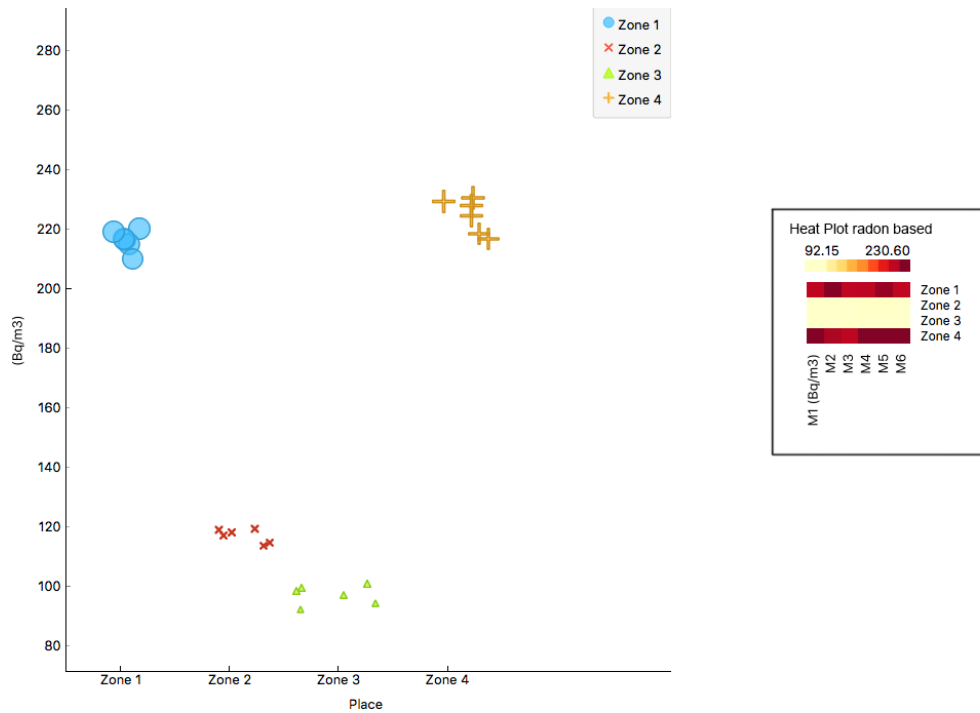
**Figure 11.** Scatte Plot. Symbol size propoortiona and Heat Plot, the different measurements in the coloured areas depending on the presence of radon obtained in each of theml.

In the views of the analysed data displayed in the Figure 11, the values obtained in the different measurement zones are below the threshold of 300 Bq/m<sup>3</sup>, established within this study as a value above which it is necessary to take corrective ventilation measures. Zones 1 and 4 are the only ones above 100 Bq/m<sup>3</sup>, a value above which the presence of radon gas in buildings used by people must be monitored.

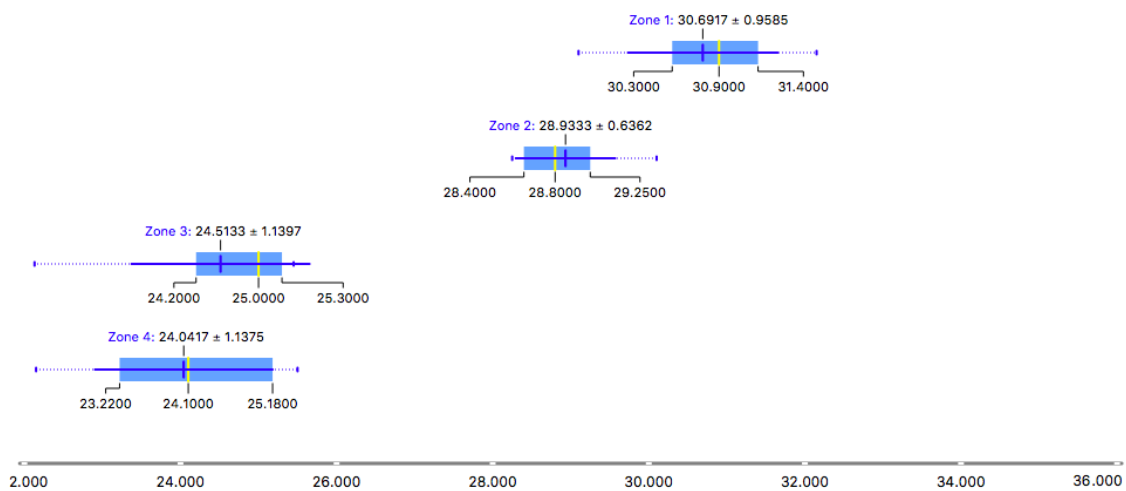
**Figure 12.** Box Plot zones measures on Plaza Balmis Shelter.

As it can be seen in the results representation Figure 12 all measurements are above 100 Bq/m<sup>3</sup>. The values of zones 1 and 4 are particularly relevant, with values close to 220 Bq/m<sup>3</sup>. The purpose of this research article is to demonstrate the hypothesis that the accumulation of radon gas in buried buildings is greater than that which can occur in unburied buildings, even on clay soils. Clay soils have traditionally been considered of low risk for accumulation of radon. In the early phases of the study and to test the results, measurements were made in unburied defensive buildings, built in concrete and from the same period as the Balmis shelter. In one of these constructions, 24 measurements were taken in four different zones. The results are shown in Figure 13. These values serve as a comparison of the two constructions, since they are above 25 Bq/m<sup>3</sup>, in constrast with values higher than 220 Bq/m<sup>3</sup>. The shelter of Plaza Balmis presents values five times higher than the similar one not buried, therefore, the non-granitic lands also favour the radon gas accumulation.

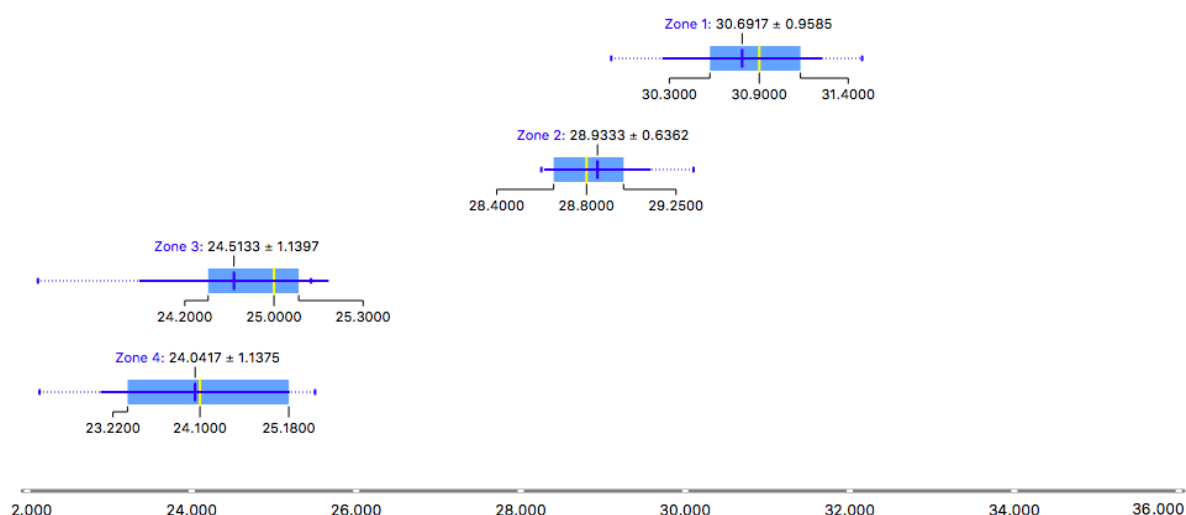
Figure 13. Box Plot zones measures on unburied building.
