**ENGINEERING SUSTAINABILITY & SUSTAINABLE ENERGY 2018  
(ESSE '18) CONFERENCE**

8<sup>th</sup> May 2018, Dolmen Resort Hotel & Spa, St. Paul's Bay, Malta

**MONITORING INDOOR TEMPERATURES OF PLACES OF WORSHIP: A FIRST STEP TOWARDS  
ENERGY SUSTAINABILITY**

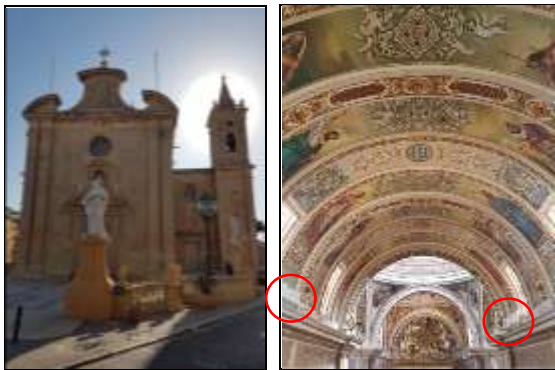
**Figure 1:** Photographs of the façade and nave with installed AC units of Balzan Parish Church.

Balzan became a parish on the 14th August 1655 and in December 1669 work started on the building of the existing Parish Church. Though it is reported that part of the building was in use after four years from commencement, works were completed by 1695, under the direction of architects Lorenzo Gafa and Giovanni Barbara. The church was built in the form of a Latin cross. A belfry was also added in 1708, which today includes 6 bells made in Annecy, France by Fonderie Paccard. The methodology of construction is mainly of load bearing masonry walls supporting a vaulted roof and dome structure, built with globigerina limestone blocks and roofed over by a composition of 'deffun' layer.

It is pertinent to mention that in 2006, the Balzan Heritage Commission was set up to establish the cause of the fallen Emvin Cremona Painting in the dome of the Rosary Lateral Chapel, within the Balzan Parish Church earlier on that year. The Commission was given the responsibility to undertake observation, recommend/undertake various studies and draft up a report on this case. The board remarked that a combination of causes may have affected the painting, one of which was the possible introduction of the air-conditioning system installed in the last decade, which may have caused climatic fluctuations that resulted in detachment.

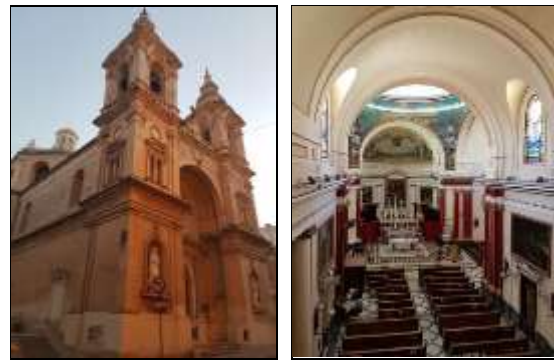
**Figure 2:** Photographs of the façade and nave of Stella Maris Parish Church, Sliema.

The methodology of construction is mainly of loadbearing masonry walls supporting a vaulted roof and dome structure, built with globigerina limestone blocks. The original roofing material, still present, include a 'deffun' layer with the adequate falls to eliminate ponding. The 'deffun' technique consists of various graded gravels (from rough and big grains to smaller thin grains), followed by a lime layer with

beaten crushed pottery (clay) powder over it, laid to falls.

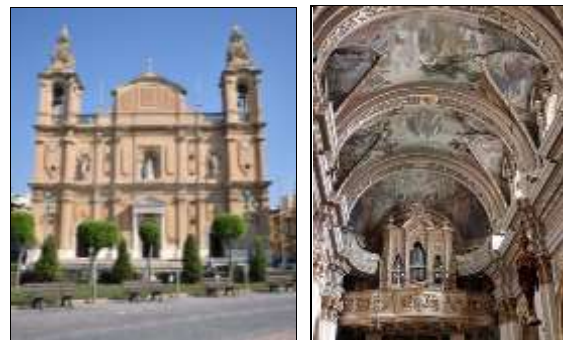
**Figure 3:** Photographs of the façade and nave (facing western end) of Msida Parish Church.

The plan is conventional and takes the form of a three-aisled Latin Cross, which was the most frequently adopted plan in the design of local Parish Churches. The façade comprises of a series of bays with the two outer bays surmounted by well-proportioned bell-towers. Lorenzo Gafa's design for St Catherine Parish Church of Żejtun appears to have been the source upon which the architect Andrea Grima based his design.

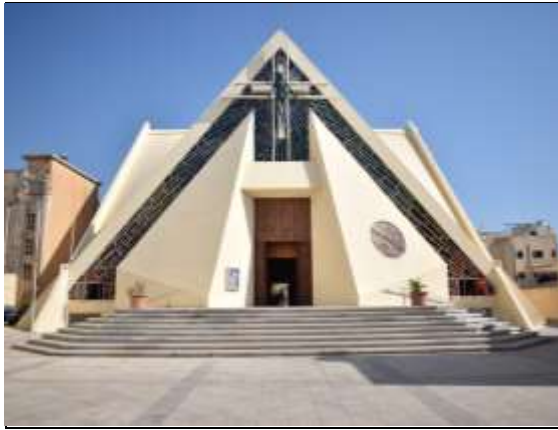
**Figure 4:** Photograph of the façade of Fgura Parish Church.

is based on a square plan roofed over by a concrete shell structure that is symmetric about both axis. The main material supporting the building is concrete and the strength of the structure is derived from its form rather than its sheer mass. The layout from the exterior is pyramidal, with a triangular opening on each four sides, which gives the impression of a floating building.

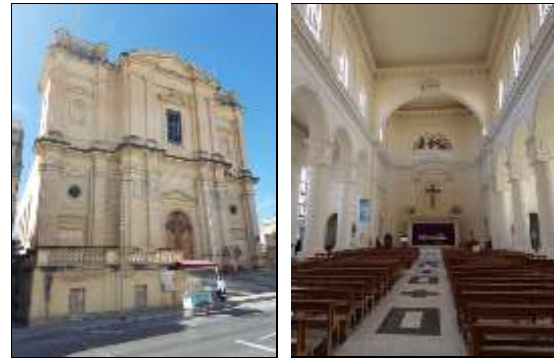
**Figure 5:** Photographs of the façade and nave of Santa Venera Parish Church.

Santa Venera Parish Church was constructed at various stages between 1954 and 2005, although the building is still incomplete, lacking bell towers and external finishing. Construction of the church began on 19 April 1956, to Romanesque Revival (Neo-Romanesque style) designs of Joseph D'Amato. After excavation works, the crypt was completed by June 1967 and was used as a provisional church. Due to this fact and the construction of other three churches in Malta by the Order of the Brothers of the Blessed Virgin Mary of Mount Carmel (Carmelites), construction works at Santa Venera were brought to a halt. On the twentieth anniversary since the opening of the crypt, Perit Louis A. Naudi, assisted by Godwin Aquilina and Lino Bartolo, were commissioned to continue works. The original plan was redesigned by Ġużeppi Galea from Rabat and works were executed by Attard Bros. Co. Ltd. The methodology of construction is mainly of loadbearing masonry walls supporting reinforced precast planks. The foundation stone was laid down on 6 October 1990 and works were brought to completion after fifteen years, with the last interventions seen by Perit Innocent Centorrino. The building was blessed and opened for veneration on 17 July 2005 [58]. This Church has yet to be consecrated.

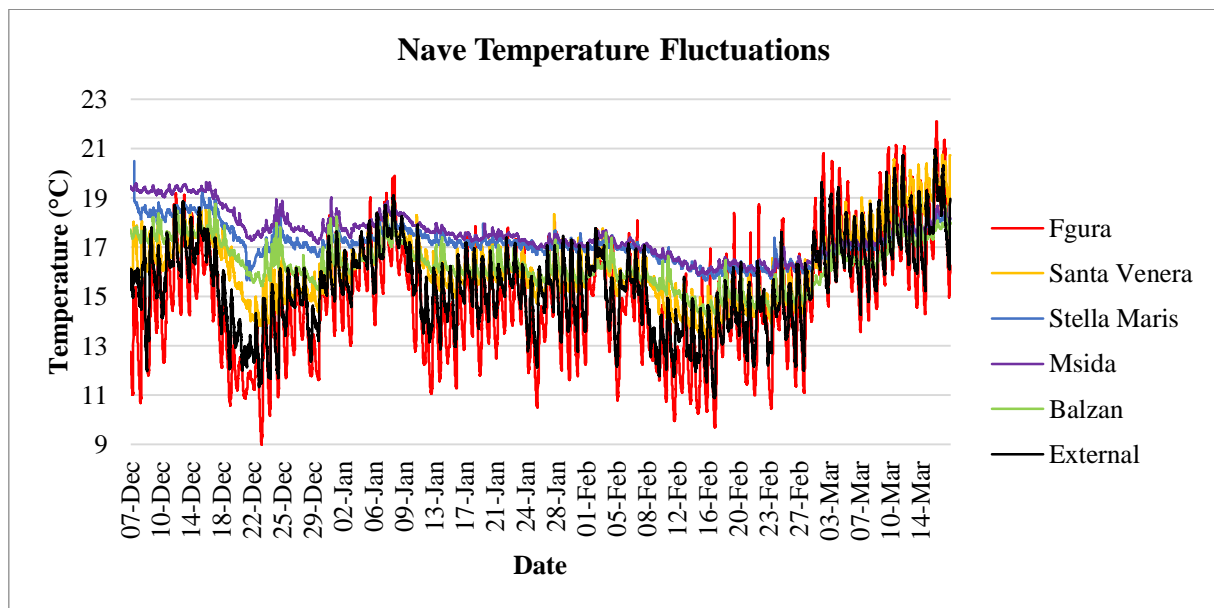
All the remaining churches are much better in terms of indoor climate conditions. Unlike the Fgura Church, there is also evidently a marked time lag for the outdoor temperature to affect the indoor temperatures, especially during consecutive days when the outdoor temperature plummets.

The best performing church is the Msida Parish Church, where indoor temperatures remain stable for much longer and only drop below 17 °C towards the beginning of February. However, within one month the temperature climbed again to a more comfortable value.

**Figure 6:** Comparative Analysis of Nave Temperature (T °C) Fluctuations of the five churches under study.

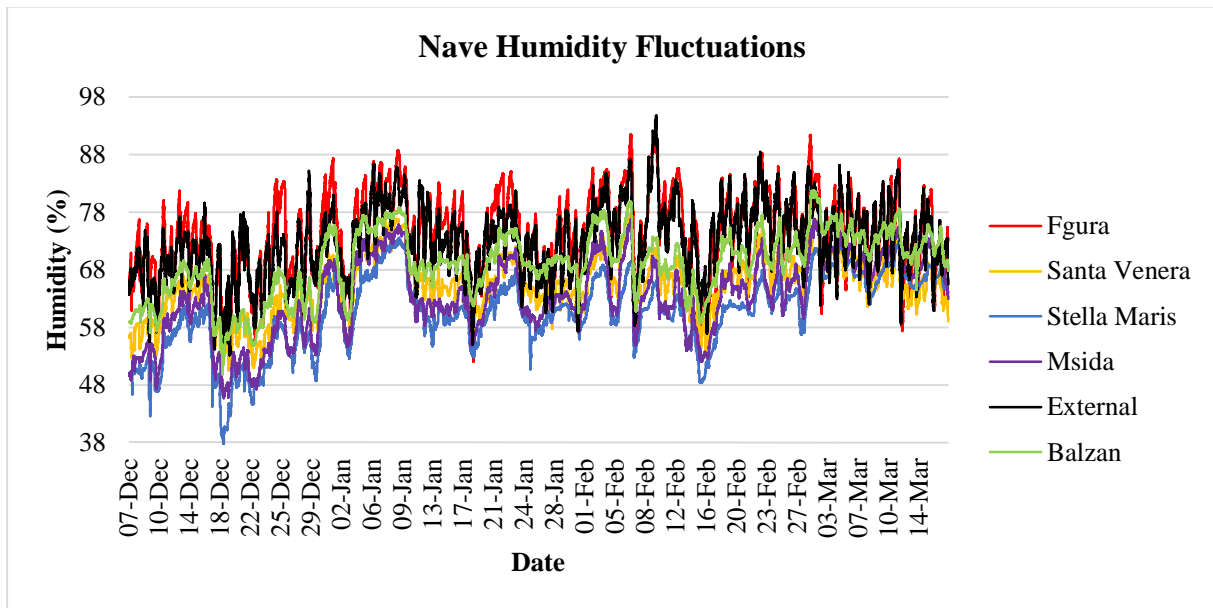
Balzan is the furthest away from the sea and is assumed to be least affected by outdoor RH. However, this is not the case. It is to be noted that this Church has a huge subterranean water reservoir and this could be a reason for creating a colder atmosphere due to evaporative cooling from the floor, thus affecting RH. This will be verified at a later stage of this on-going Ph.D. study.

It is to be noted that although the Balzan church has an air-conditioning system, it is not used for heating at all, despite the fact that its air temperature is about 2 °C lower when compared to the Msida and Stella Maris churches. This gives an indication that the congregation is more resilient to sustain colder rather than hotter temperatures outside the comfort zone.

**Figure 7:** Comparative Analysis of Nave Humidity (RH %) Fluctuations of the five churches under study.

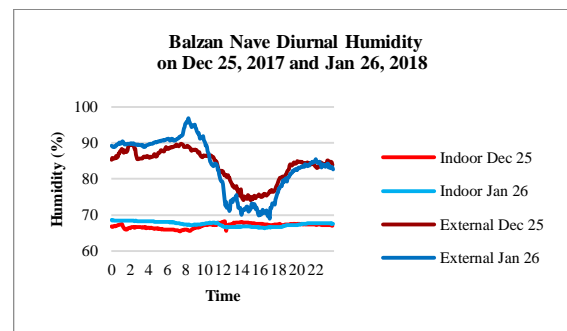
With regards to humidity, it is noted that it is stable for both days, despite changes in the outdoor RH. One explanation could be that the indoor RH is dominated by the effect of the underground water reservoir. The presence of people on Christmas day had very little effect.

**Figure 9:** Comparative Analysis of Nave Diurnal Humidity (RH %) Fluctuations of Balzan Parish Church.

Note: Humidity for days post-Jan 26 up to Feb 12 was recorded at 100% and thus could not be used for interpretation.
