**Failure Characteristics of All Polyethylene Cemented Glenoid
Implants in Total Shoulder Arthroplasty**

PhD Thesis

Sarah Junaid

2010

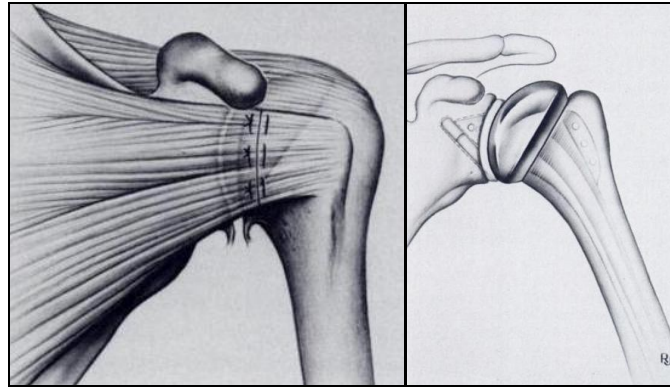
Figure 1.15: Neer Hemiarthroplasty (left) and non-constrained total shoulder arthroplasty (right). Figures reprinted with permission from Journal of Bone and Joint Surgery American, 1974, 56A, 1, Replacement Arthroplasty for Glenohumeral Osteoarthritis, Neer, 1-13.

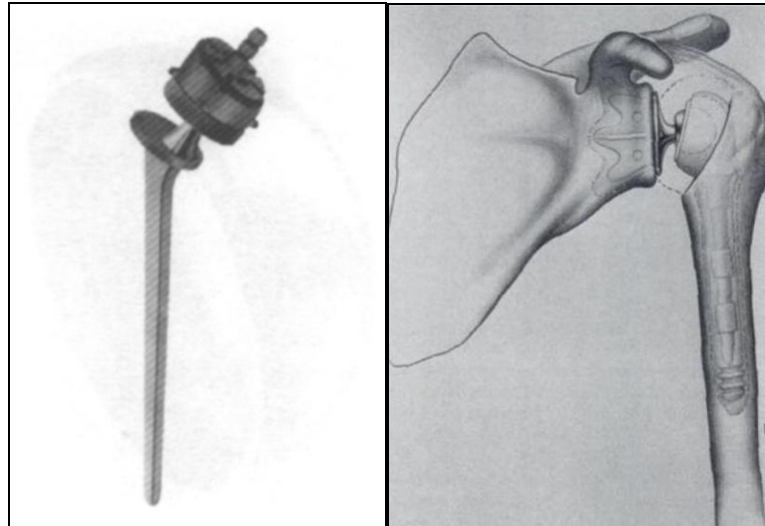
Figure 1.16: The Michael Reese shoulder (left) and Neer Mark III reverse shoulder (right), two examples of a fixed-fulcrum TSA design (Williams et al. 2004; Zadeh & Calvert 1998). Figure reprinted with permission from Surgical Disorders of the Shoulder, Watson, M (Ed), Michael Reese shoulder implant, p 132, Copyright (1990).

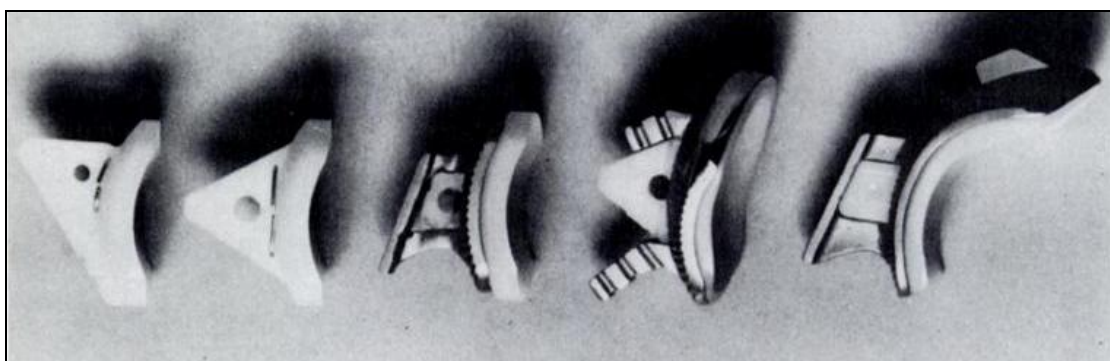
Figure 1.17: Glenoid designs showing non-constrained PE (two left), non-constrained metal-back (middle), and two semi-constrained metal-back glenoids (two right). Note: semi-constrained implants were designed to prevent upward head migration (Neer et al. 1982). Note: figure reprinted with permission from Journal of Bone and Joint Surgery American, 1982, 64A, 3, Recent experience in total shoulder replacement, Neer, 319-337.

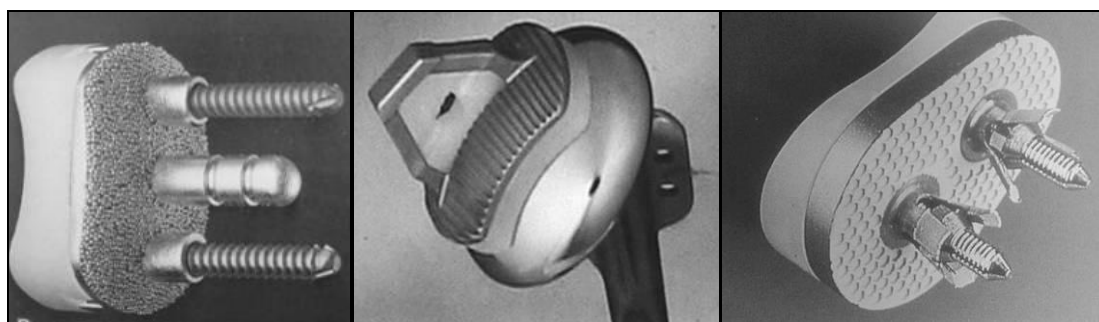
Figure 1.18: (Left to right) Metal-back Cofield, Neer and Tornier implants that are no longer in use (Katz et al. 2009). Images used with permission from Tornier, Inc., and Smith & Nephew, Inc., February 2010.

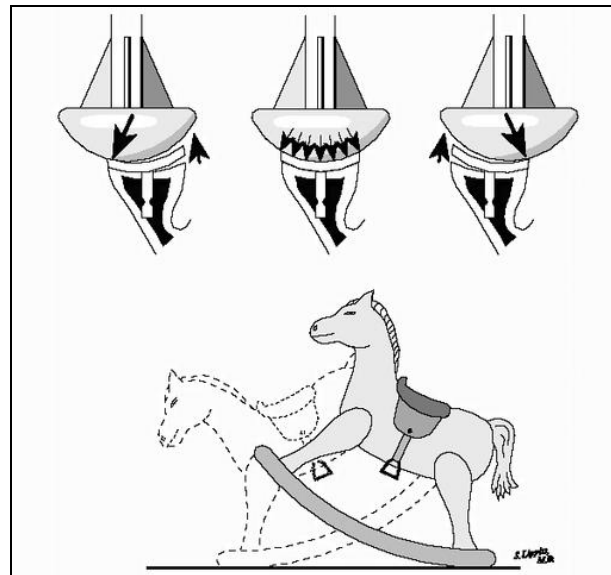
Figure 1.19: Eccentric loading of glenoid implant, leading to “rocking horse” mechanical loosening (Matsen III & Lippitt 2004). Image reprinted with permission from University of Washington website, <http://www.orthop.washington.edu>.

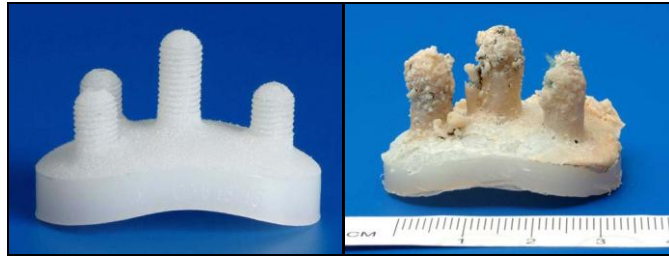
Figure 2.1: Before implantation (left) & retrieved threaded implant (right) showing partially intact cement at the pegs (Yian et al. 2005). Figure reprinted with permission from Journal of Bone and Joint Surgery American, 2005, 87A, 9, Radiographic and Computed Tomography Analysis of Cemented Pegged Polyethylene Glenoid Components in Total Shoulder Replacement, Yian, 1928-1936.

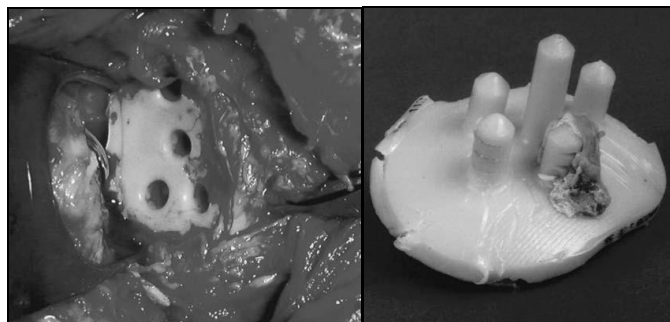
Figure 2.2: Revision surgery showing cement intact with the glenoid bone (left) & retrieved glenoid showing failure occurring at the implant/cement interface (right) (Nyffeler et al. 2003). Figure reprinted with permission from Journal of Bone & Joint Surgery-British, 2003, 85B, 5, Influence of peg design and cement mantle thickness on pull-out strength of glenoid component pegs, 748-752.

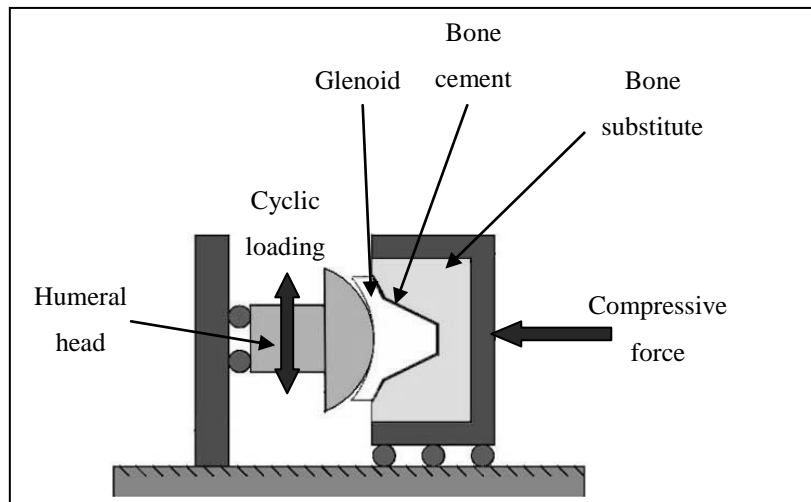
Figure 2.3: Mechanical fatigue testing of glenoid fixation (Reprinted and annotated from Journal of Shoulder and Elbow Surgery, 9 /2, Anglin, C. et al., Prosthesis Subluxation: Theory and Experiment, 104-114, Copyright (2000), with permission from Elsevier and C. Anglin).

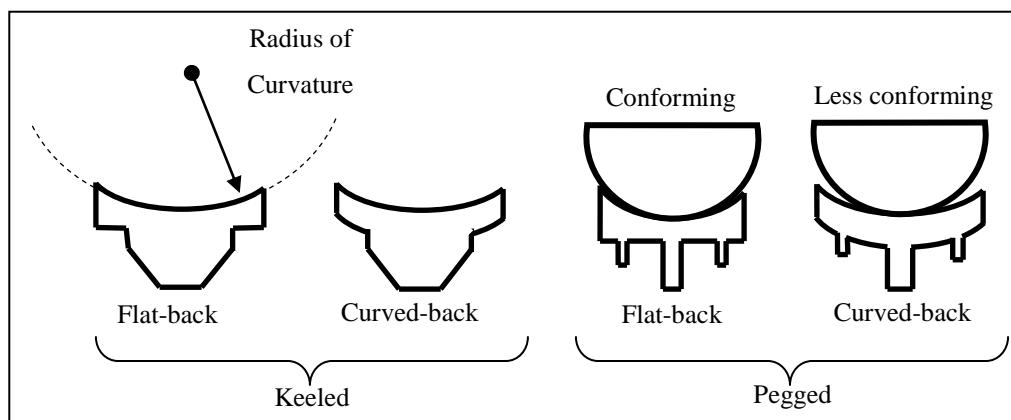
Figure 2.4: Main glenoid design parameters; keel/peg, curved/flat-back, conforming/less conforming.

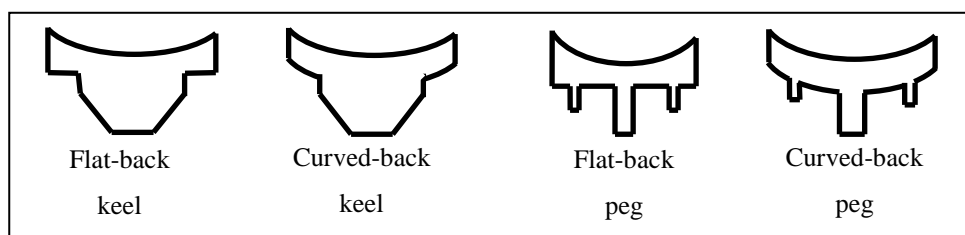
Figure 3.1: Four glenoid designs with two radius of curvatures, making a total of 8 designs.

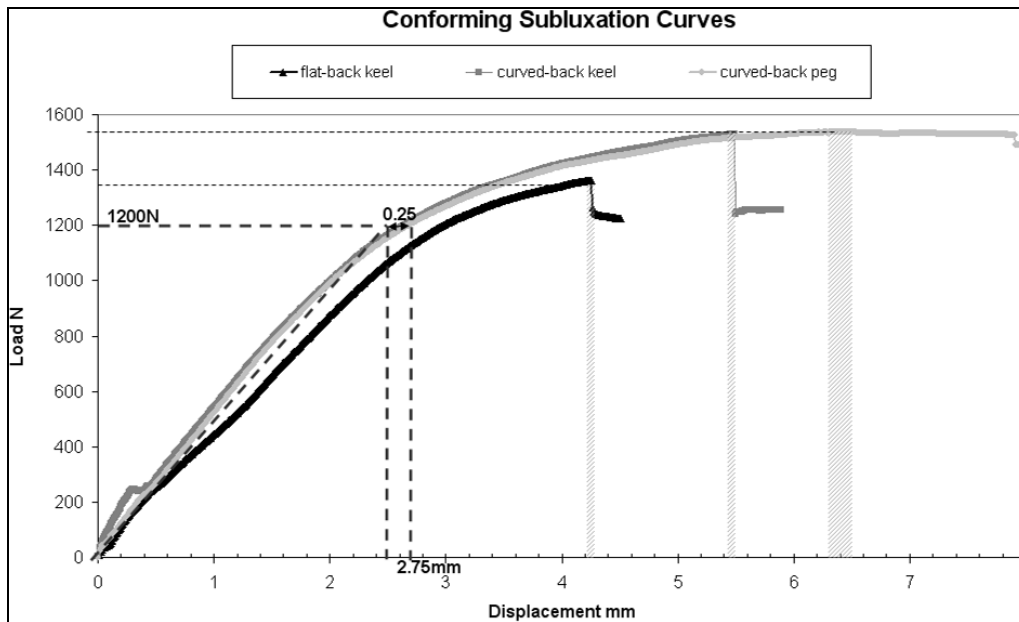
Figure 3.4: Subluxation curve of three conforming specimens with loading point derived at the linear section of the curve (dotted) using an average offset of 0.25 mm. Note: displacement range (shaded) at point of subluxation.

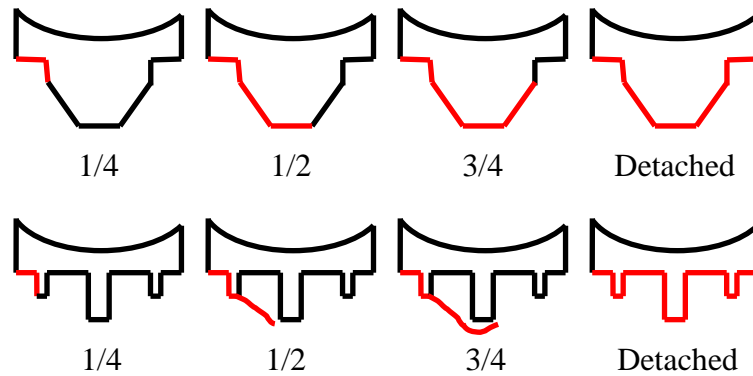
Figure 3.5: definition of failure where red represents failure at the implant/cement interface, where the literature mentions failure, this refers to 3/4 failure. Note: diagonal red lines in the pegged glenoid indicate failure in the bone substitute.

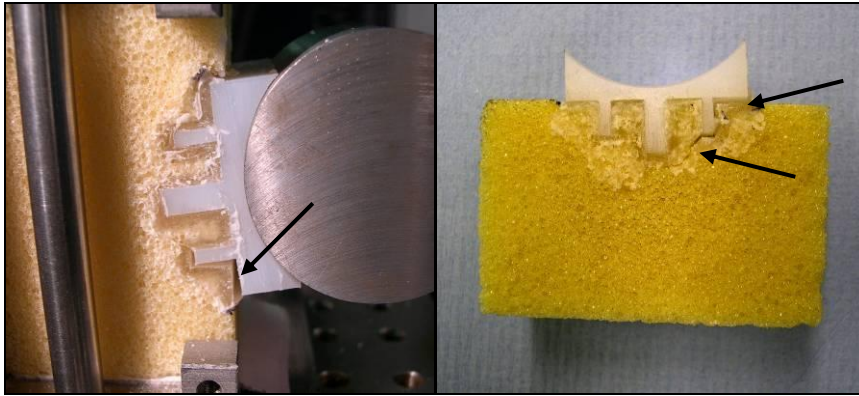
Figure 3.6: In all cases failure was observed in the implant/cement interface and initiated in the inferior part of the fixation (arrows).

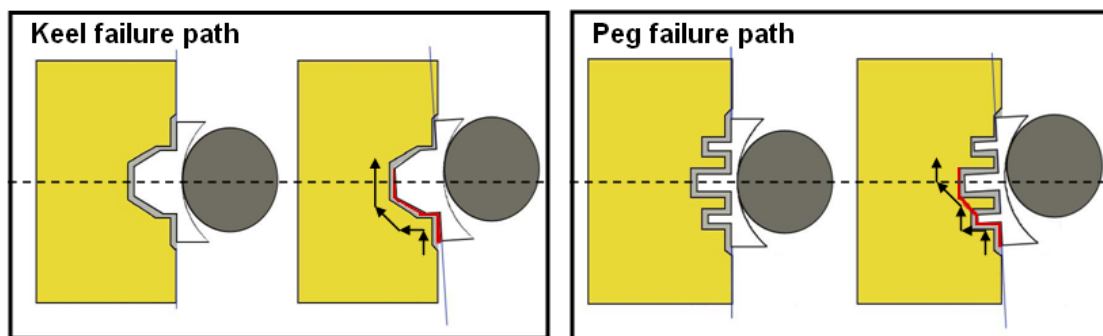
Figure 3.7: Failure pathway in keeled (left) and pegged glenoids (right). A similar failure path was observed for all design configurations.

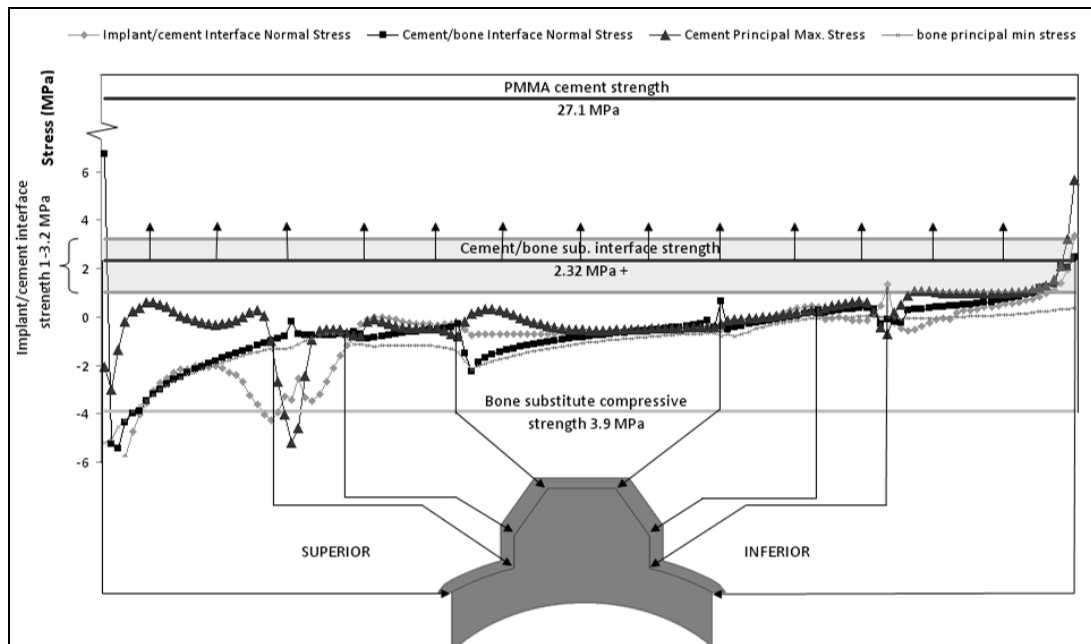
Figure 3.8: Plot of the predicted stresses in the fixation of the curved-back keel specimen. The plotted stresses are at: the two interfaces, in the bulk PMMA bone cement and in PU bone substitute. The strengths of the two interfaces, of the cement and of the PU bone substitute are also shown. The implant/cement interface strength is only known within a range and this range is indicated by the hatched area. Only a minimum value of the cement/bone-substitute strength is known (2.32 MPa) and the arrows indicate that the strength is likely to be higher than 2.32 MPa.

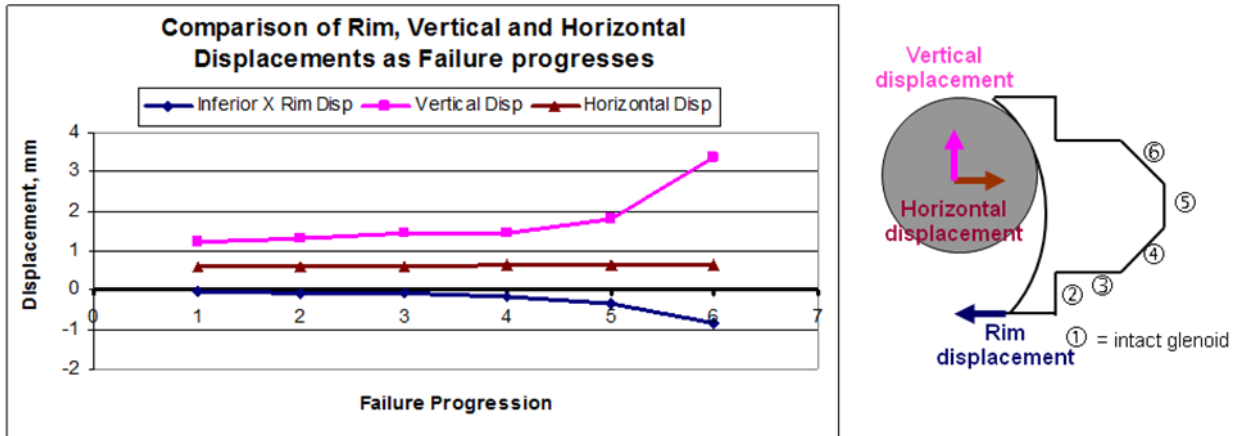
Figure 4.1: FE predictions showing a correlation between vertical head and inferior rim displacements with failure progression at the implant/cement interface.

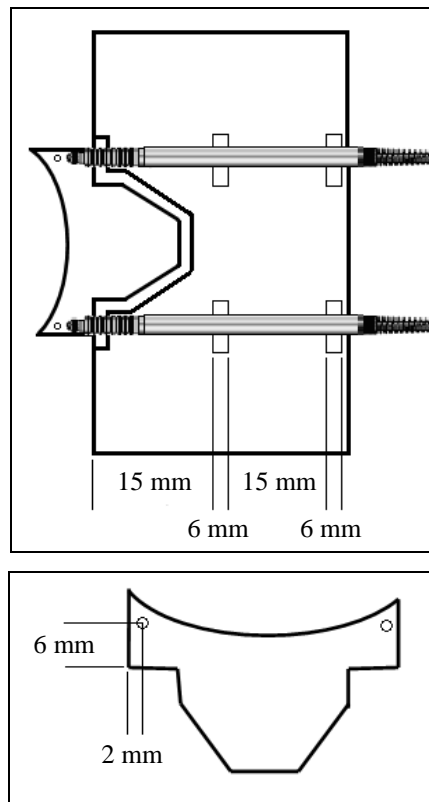
Figure 4.2: Schematic of the LVDTs fixed to the bone substitute (above) and location of reference pins at the superior and inferior rim (below).

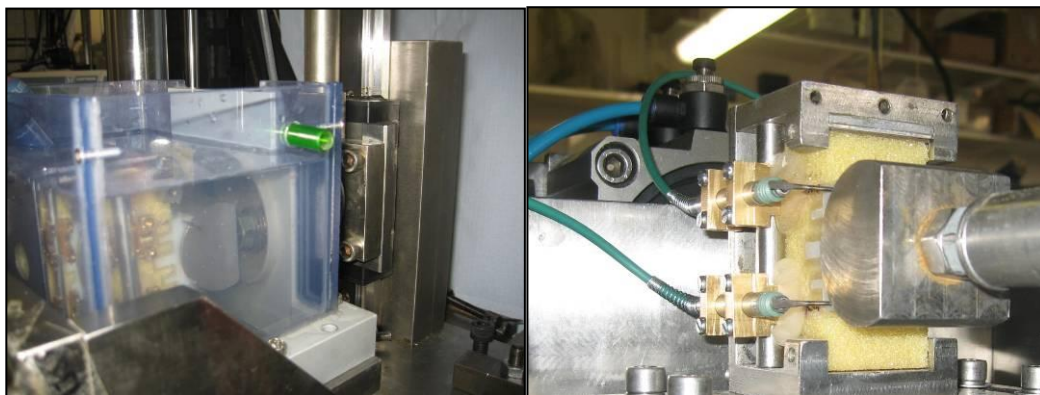
Figure 4.3: Specimens tested in a $37 \pm 2^\circ\text{C}$ water bath (left) and horizontal rim measurements were taken using LVDTs every 2000 cycles (right).

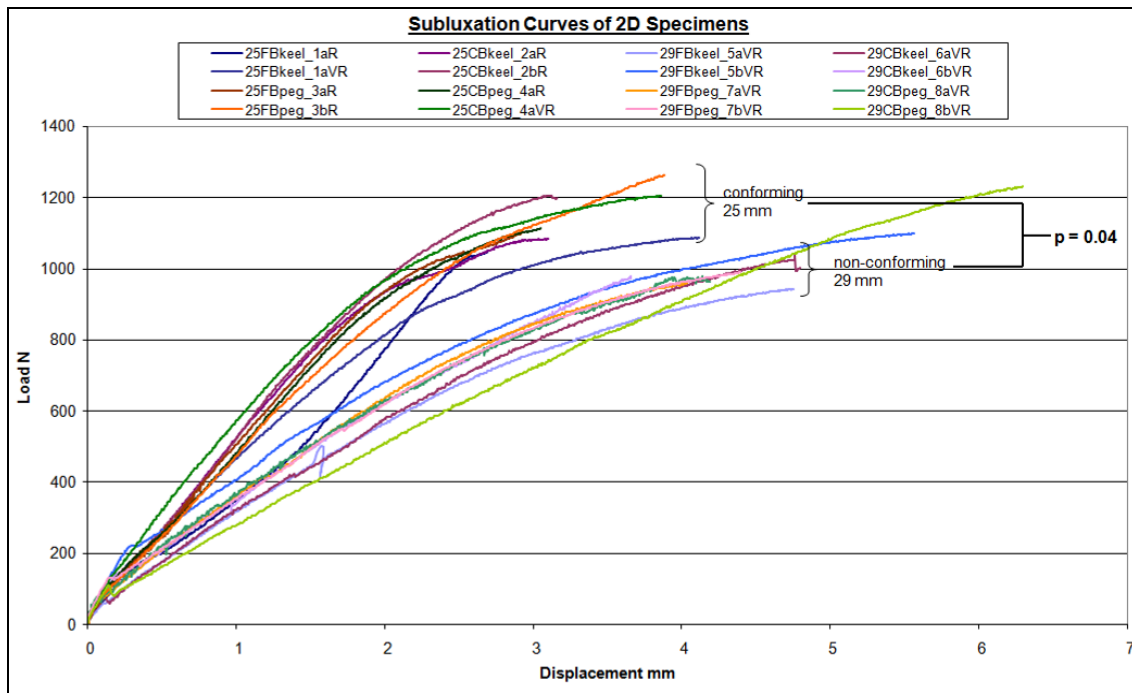
Figure 4.4: Subluxation curve of 8 designs (n = 2), a significant difference in subluxation loads was found between the two conformities (p = 0.04).

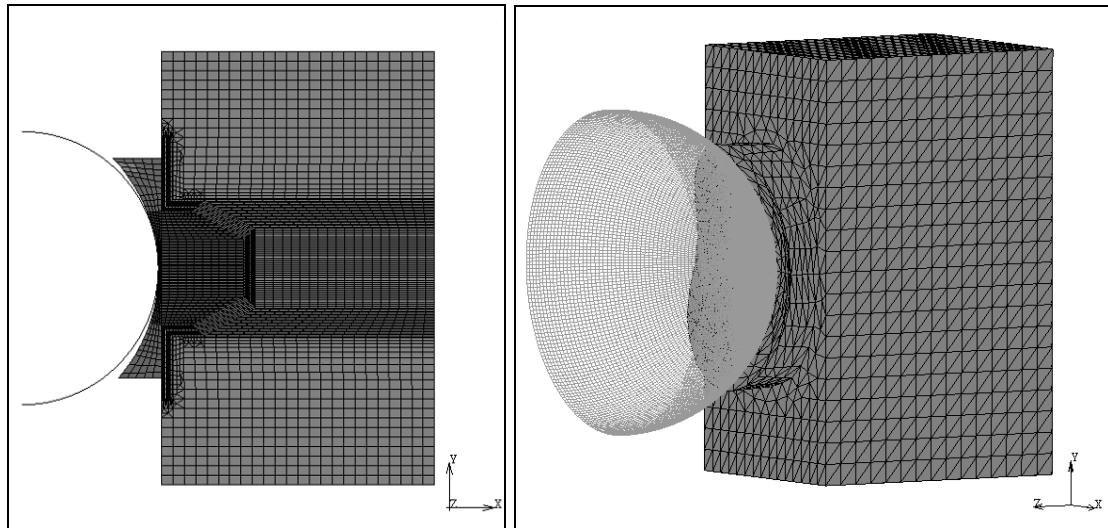
Figure 4.5: 2D (left) and 3D (right) non-conforming 29 mm flat-back keel FE models.

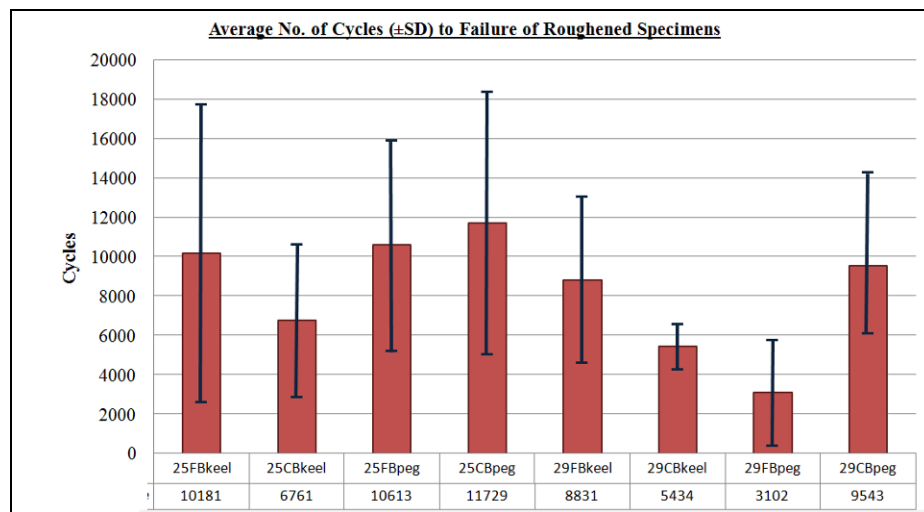
Figure 4.6: Average number of cycles in roughened specimens at failure for each design.

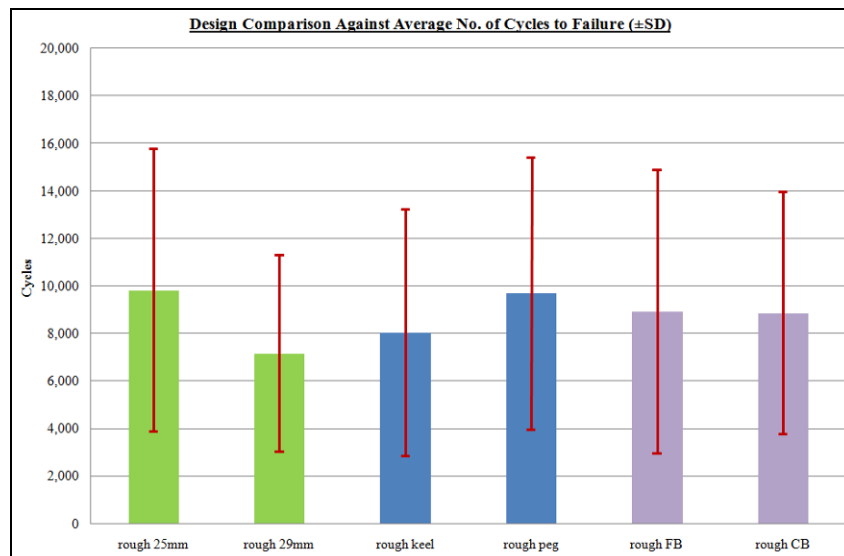
Figure 4.7: Comparable results between less (29 mm) & more (25 mm) conforming, keel & peg and flat & curved-back.

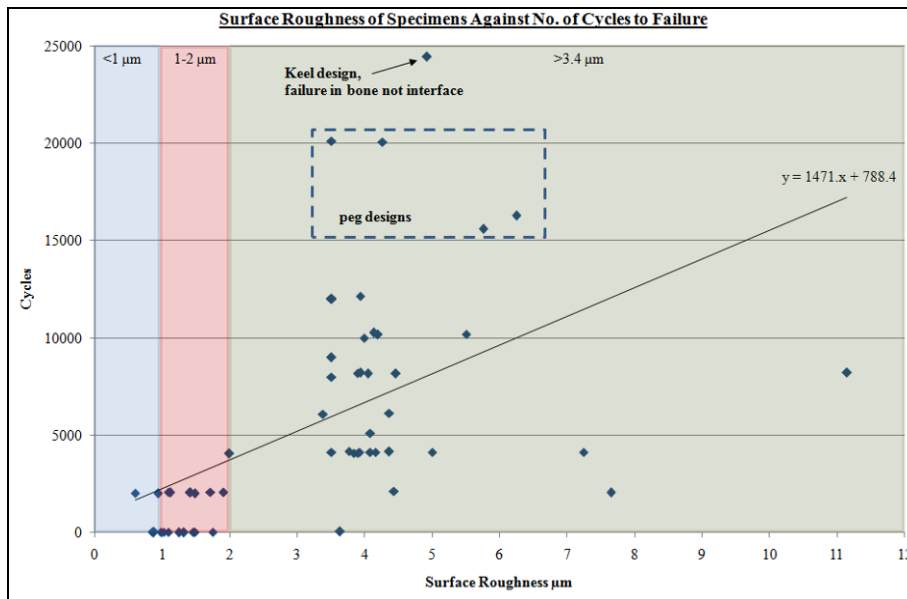
Figure 4.8: Increase in number of cycles to failure and surface roughness was proportional.

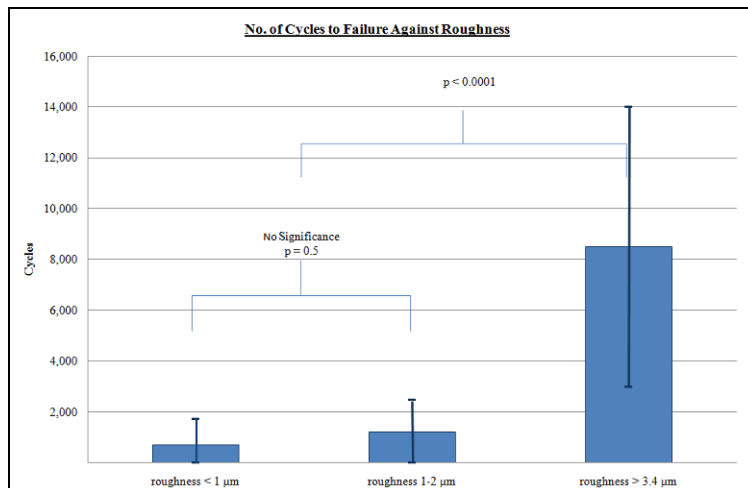
Figure 4.9: A significant difference was found between roughnesses 0-3.4 μm and > 3.4 μm ($p < 0.0001$).

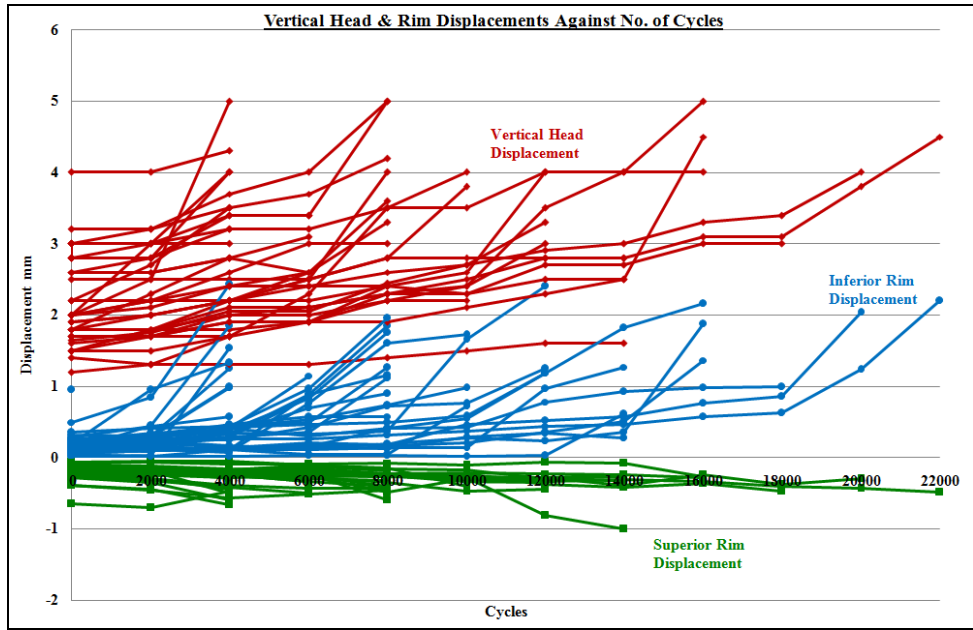
Figure 4.10: A positive correlation was found with number of cycles in both vertical head and inferior rim displacement.

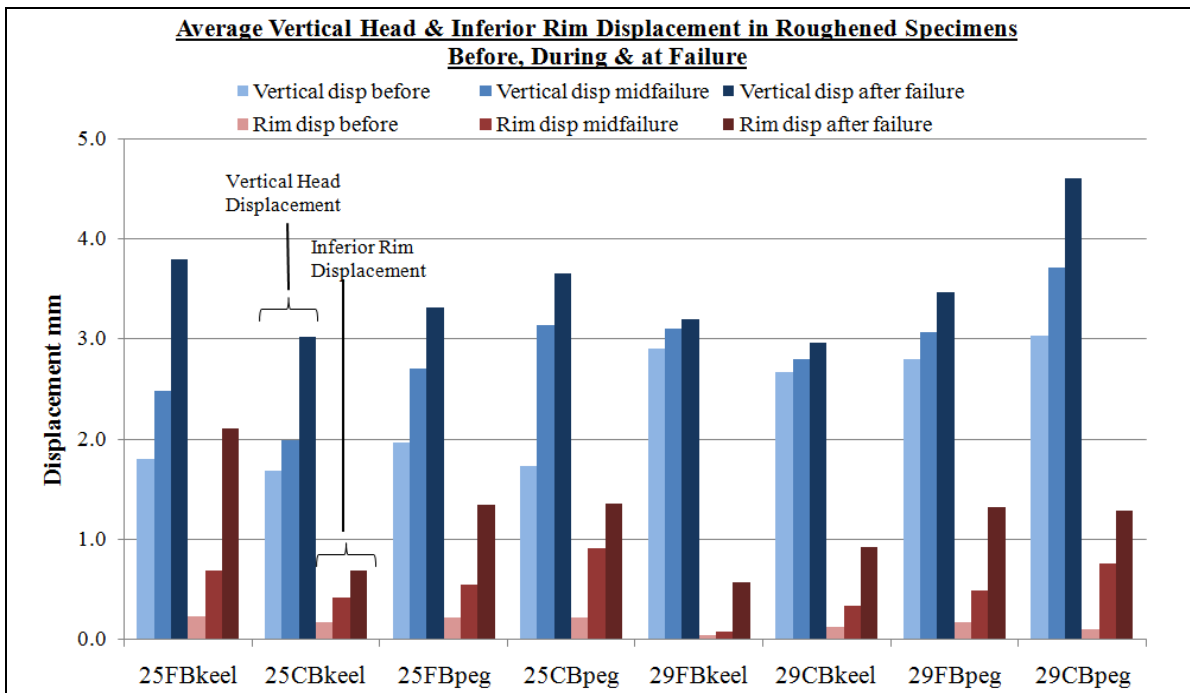
Figure 4.11: Bar chart showing a positive correlation between average vertical head displacement, average inferior rim displacement and progressive failure.

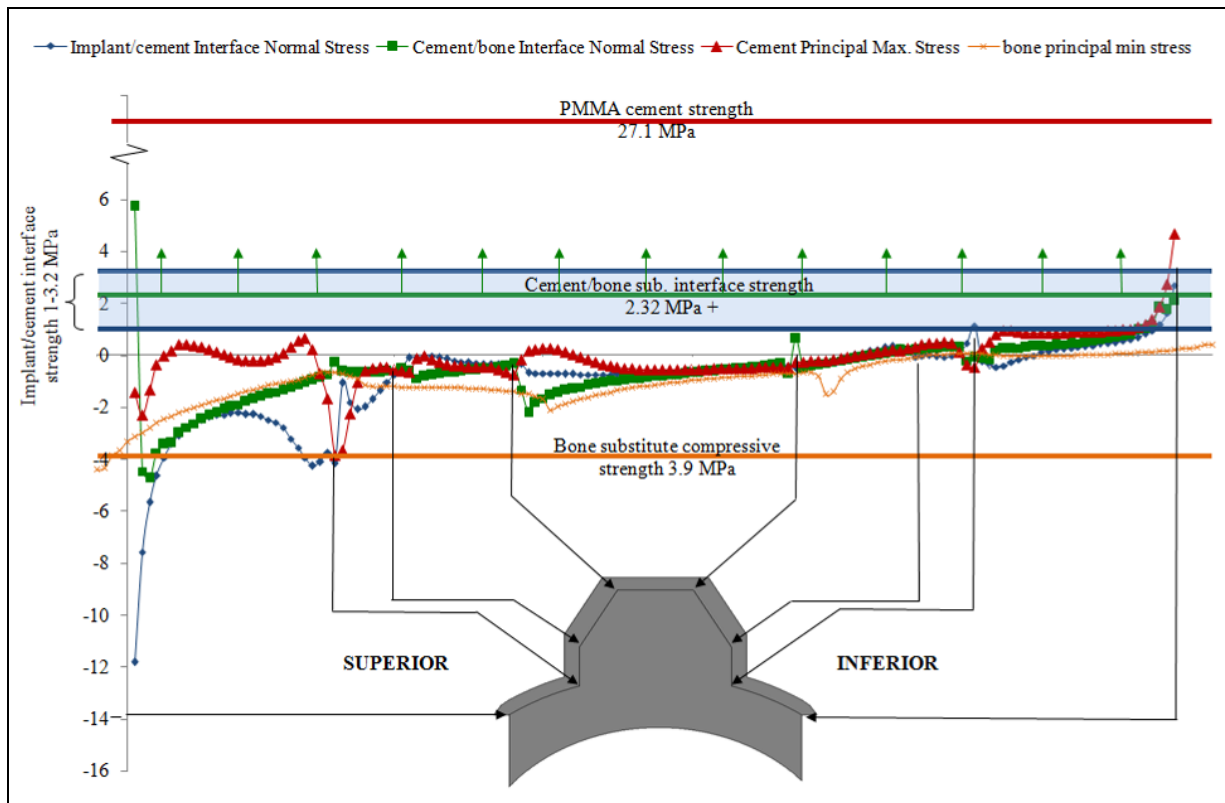
Figure 4.14: Colour plot of the predicted stresses in the fixation of the conforming curved-back keel model. Note: plot is the same as Fig. 3.8.

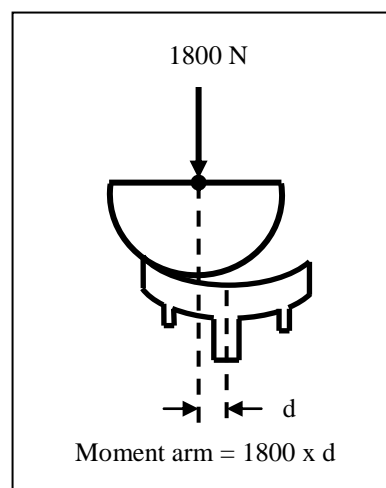
Figure 4.15: The moment generated by loading the glenoid is defined as the product of the compressive load (1800 N) and vertical head displacement (moment arm).

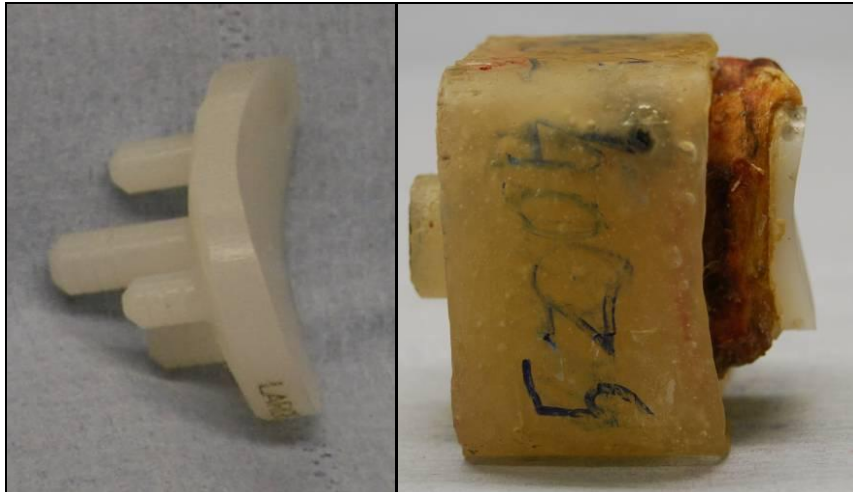
Figure 5.1: Aequalis Tornier curved-back cemented glenoid implant (left). NB2 specimen cemented and potted for testing (right).

The 10 scapulae were implanted with a Tornier Aequalis all-polyethylene curved-back pegged glenoid (Fig. 5.1). Three small, six medium and one large glenoid with radial curvatures of 27.5 mm, 30 mm and 32.5 mm respectively were implanted by an experienced shoulder surgeon (T.G.). The soft tissue and labrum were excised, the glenoid surface was reamed, removing the cartilage layer, and care was taken to maintain the subchondral layer. The glenoid implants were cemented using Simplex[®] bone cement (Stryker Europe, Montreux, Switzerland). The scapulae were cut to size using an Exakt 310 CP diamond-tipped high precision saw (Exakt Technologies Inc., Oklahoma City, USA) and cemented using Simplex[®] bone cement into the specimen holder. Care was taken to ensure the glenoid surface was correctly aligned with no implant tilt (Fig. 5.1). Two holes were drilled into each glenoid implant to accommodate a 2 mm diameter rod at the superior and inferior edge of the glenoid, 2.5 mm from the corresponding rim. Two rods were prepared as reference points to measure the corresponding rim displacements via the LVDTs (Fig. 5.2).

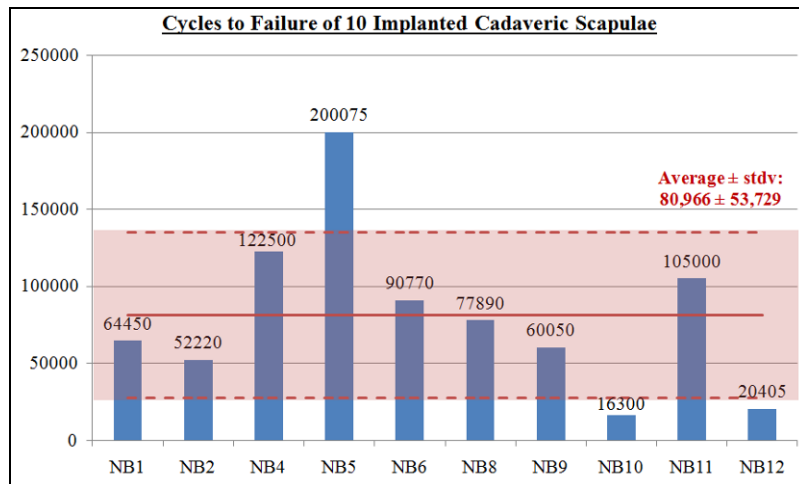
Figure 5.4: Number of cycles to failure. Red solid and dotted lines represent average and upper/lower standard deviations respectively.

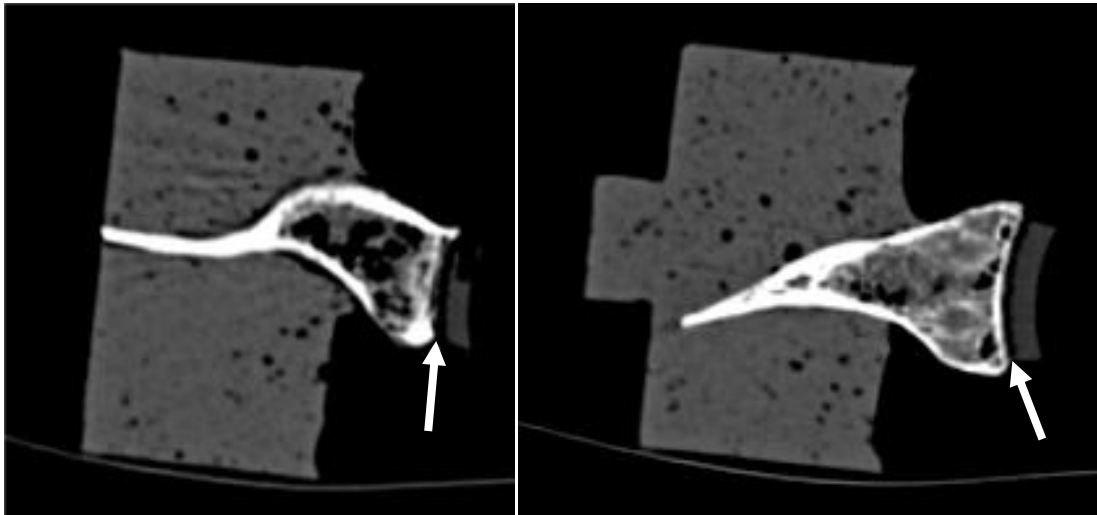
Figure 5.5: CT slices of the transverse plane showing an example of superior (left) and inferior (right) failure at the implant/cement interface in the specimen NB1.

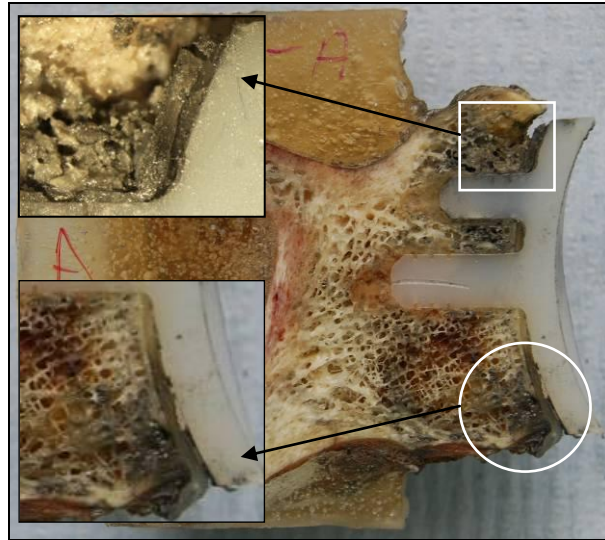
Figure 5.6: Cross-sectional slice of NB1 after failure. Note: inferior failure of the implant/cement (circle) and superior bone crushing (square).

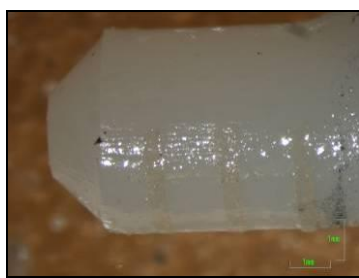
Figure 5.7: One implant detached completely at the implant/cement interface (NB12), the pegs show the cement still intact in the peg grooves.

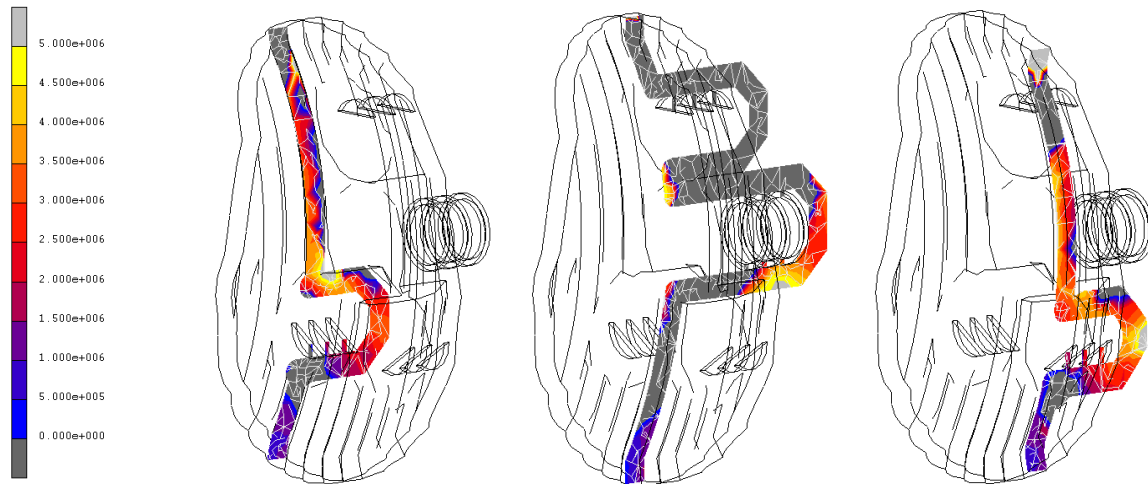
Figure 5.12: Colour plot slices through the pegs of the cement mantle showing principal stress maximum. Note: Dark grey denotes compressive stresses and light grey areas have exceeded 5 MPa.

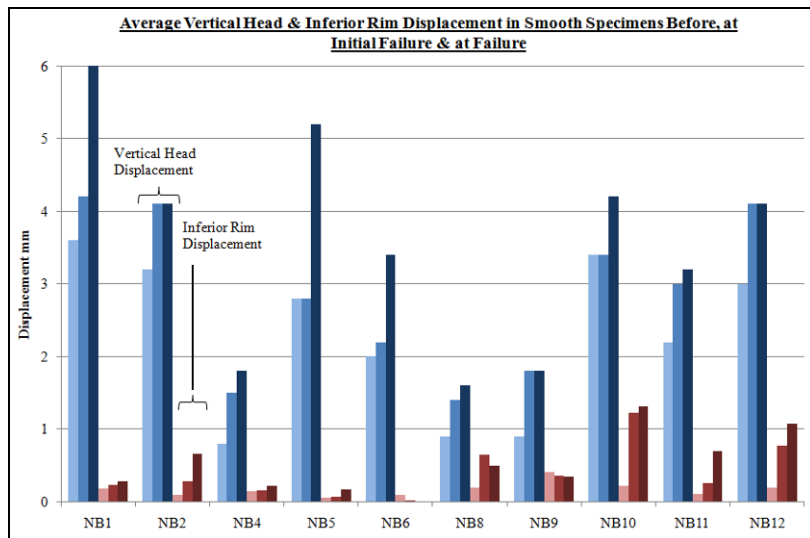
Figure 5.14: Comparison of vertical head displacement and inferior rim displacement with progressive failure.

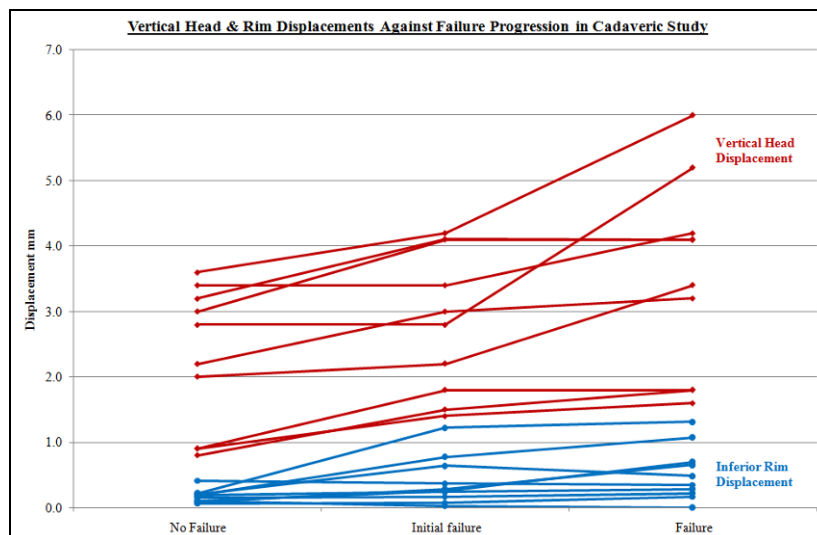
Figure 5.15: Positive correlation between vertical head displacement ($p = 0.04$) and inferior rim displacement ($p = 0.005$) before, at initial failure and at failure.

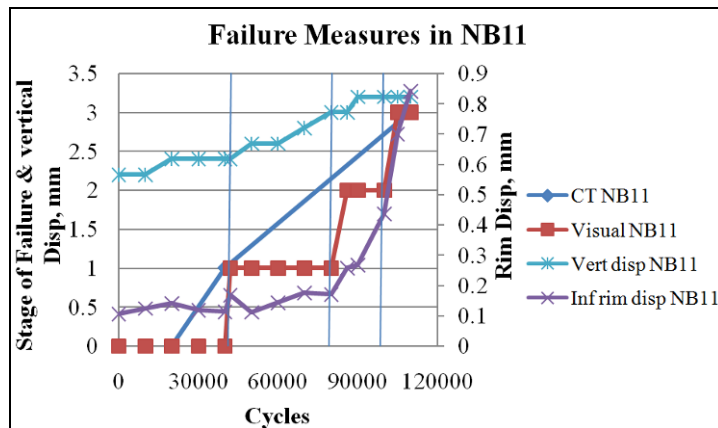
Figure 5.16: A specimen plot of visual and CT failure with inferior rim and vertical head displacement, showing correlation between CT and visual failure and correlation in displacements with CT and visual failure. Note: see Appendix F for failure key.

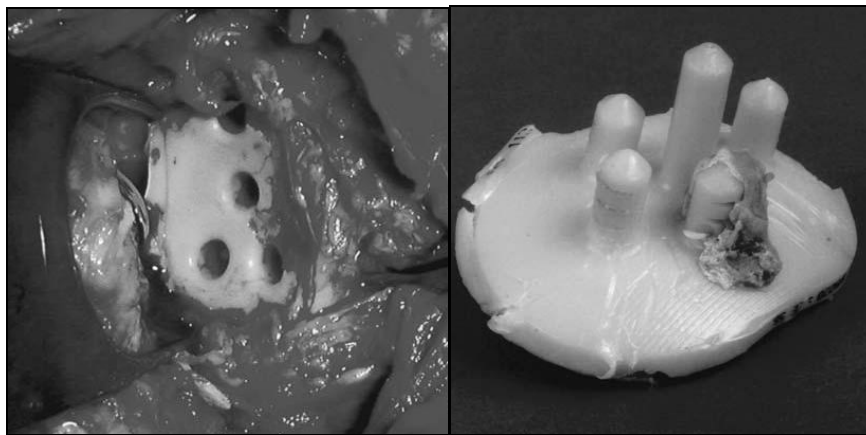
Figure 5.17: Retrieved smooth pegged cemented implant showing clear failure at the implant/cement interface (Nyffeler et al. 2003). Figure reprinted with permission from Journal of Bone & Joint Surgery-British, 2003, 85B, 5, Influence of peg design and cement mantle thickness on pull-out strength of glenoid component pegs, 748-752.

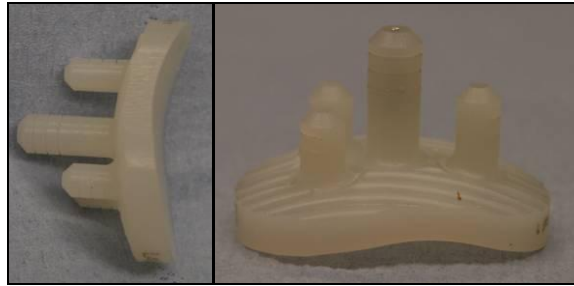
Figure 6.1: TOPEL smooth pegged design with macrostructures.

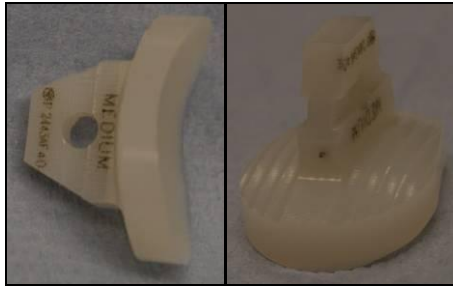
Figure 6.2: TOKL smooth keeled design with macrostructures. Note: Only large sized implants were tested.

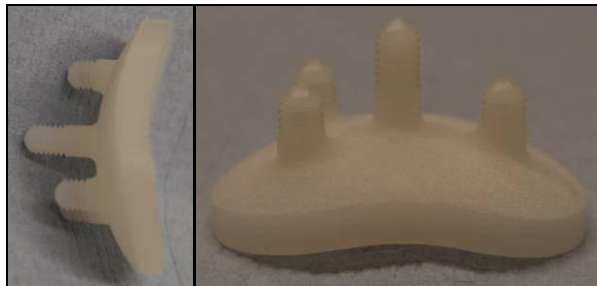
Figure 6.3: n-S/n-R rough pegged design.

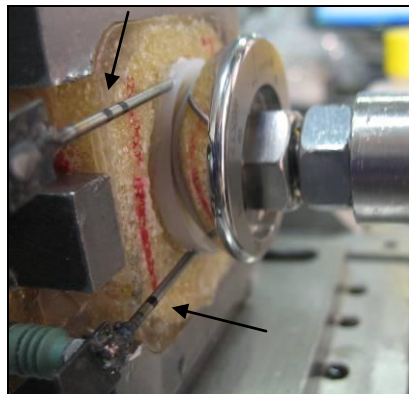
Figure 6.4: Glenoid fixation fatigue testing in bone substitute foam. Reference pins for rim displacement measure indicated by arrows.

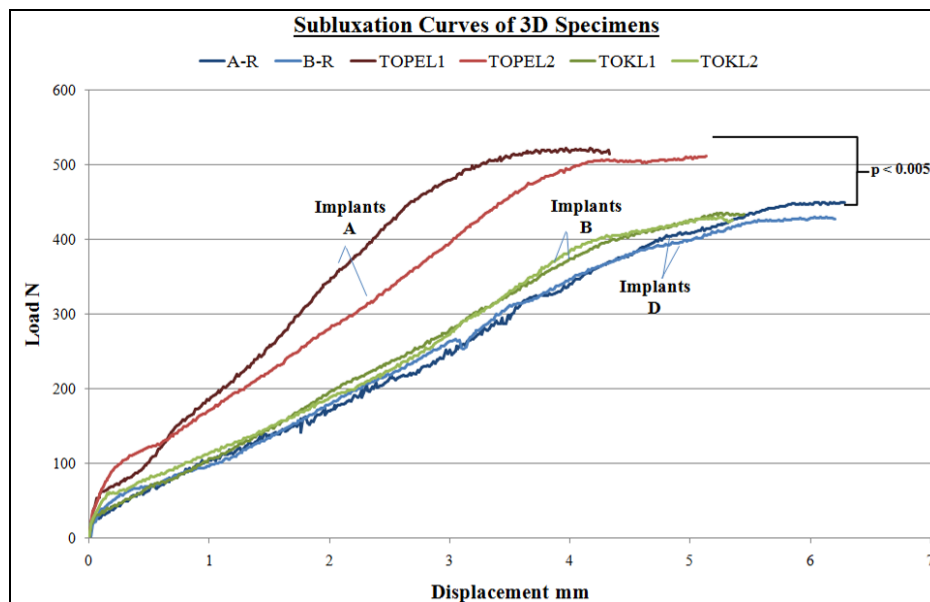
Figure 6.5: Subluxation curve of 3 designs (n = 2), a significant difference in sublaxation loads was found between the smooth peg (TOPEL) and both the smooth keel and rough peg (TOKL and n-R respectively) ($p = 0.005$). Note: TOPEL and TOKL are identical except for the anchorage with peg and keel components used respectively.

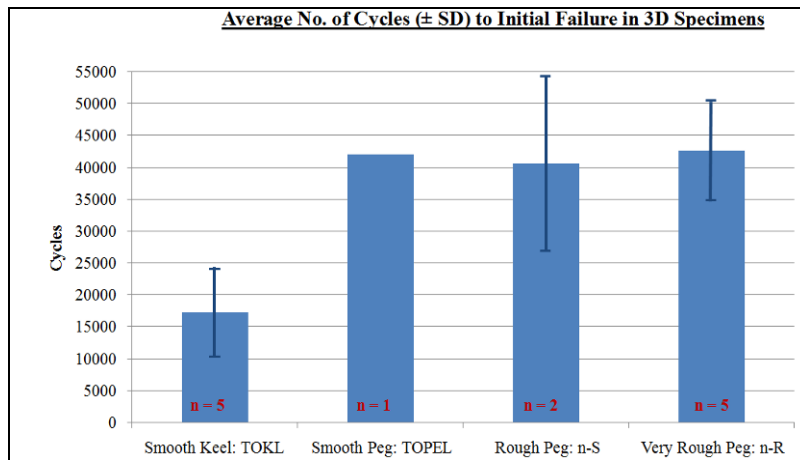
Figure 6.6: Average number of cycles at initial failure, showing a marked difference between the smooth keel specimens to all three peg groups.

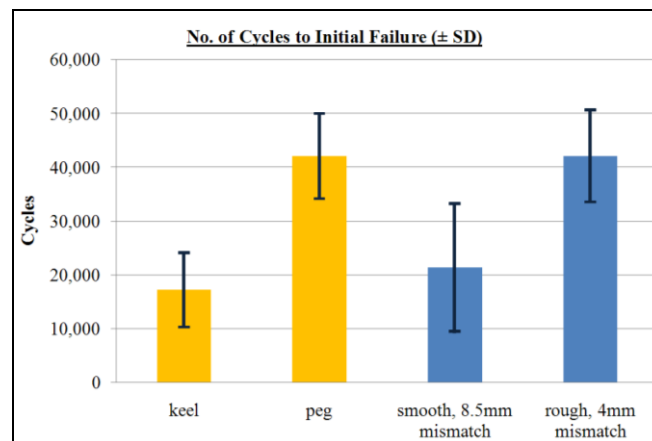
Figure 6.7: Design comparison shows marked differences between the keel & peg, the smooth, 8.5 mm mismatch & rough, 4 mm mismatch.

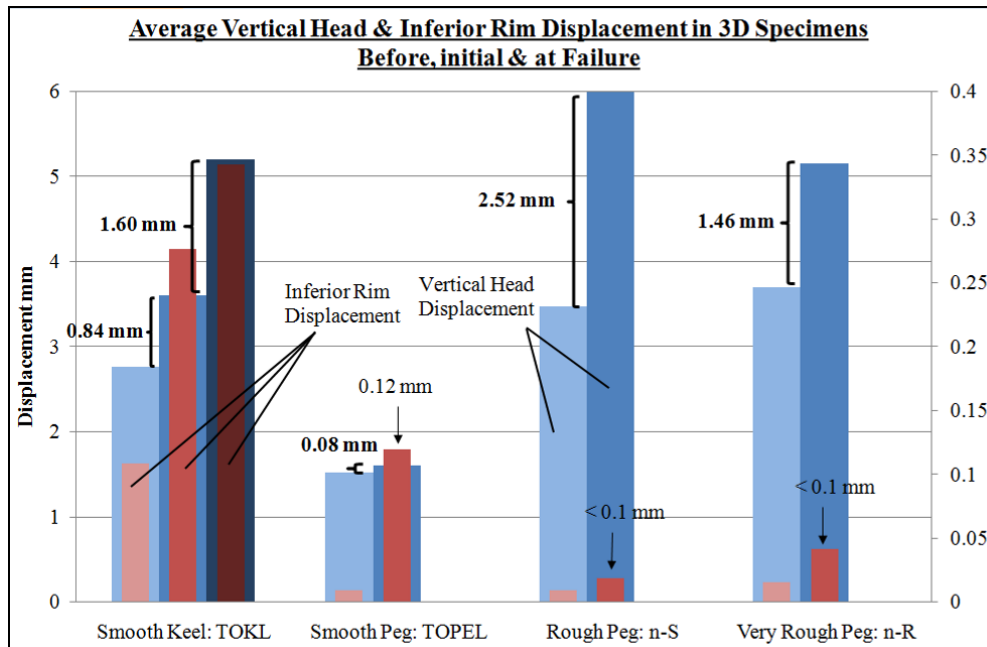
Figure 6.8: An increase in both vertical and inferior rim displacement with progressive failure in the smooth keel (TOKL) group. Note: the remaining groups did not reach complete failure.

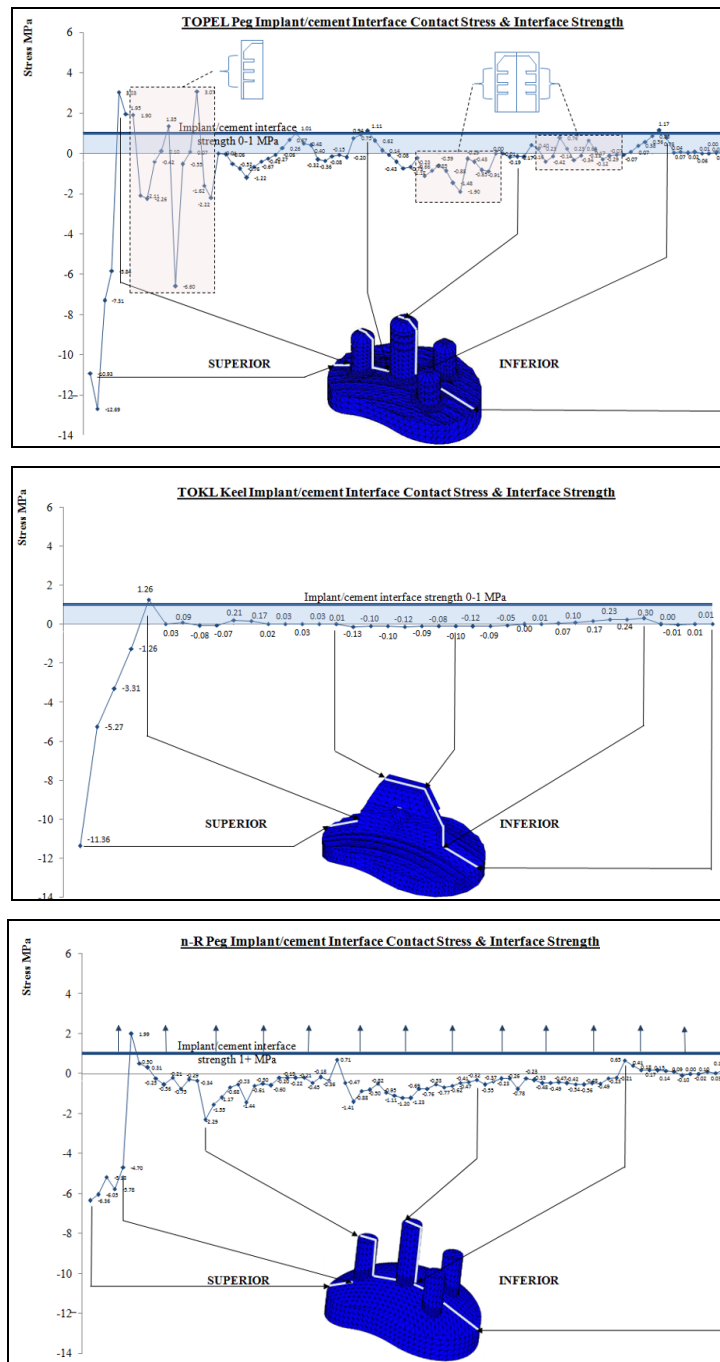
Figure 6.10: FE contact stresses in the superior/inferior direction at the implant/cement interface for TOPEL, TOKL and n-S/n-R implants respectively.
