**Failure Characteristics of All Polyethylene Cemented Glenoid
Implants in Total Shoulder Arthroplasty**

PhD Thesis

Sarah Junaid

2010

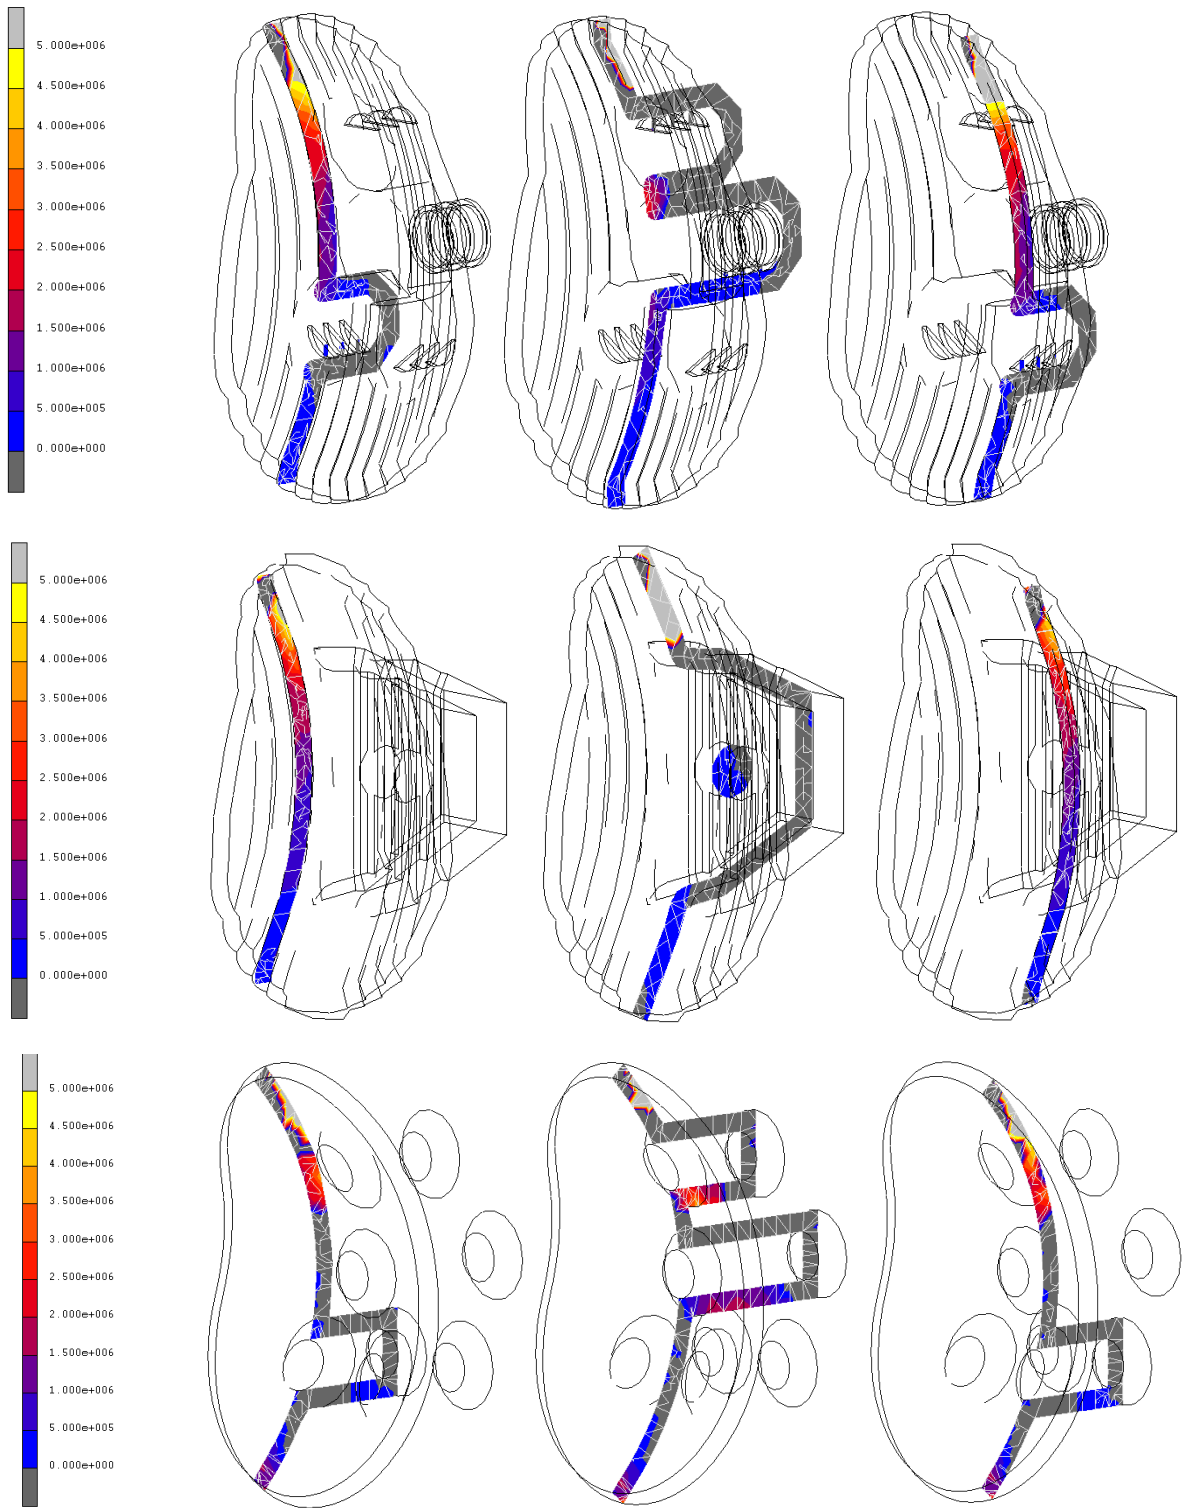
Figure 6.14: Colour plot slices of the cement mantle for TOPEL (left), TOKL (middle) and n-S/n-R (right) implants showing principal stress maximum (tensile stresses). Note: Dark grey denotes compressive stresses and light grey areas have exceeded 5 MPa.

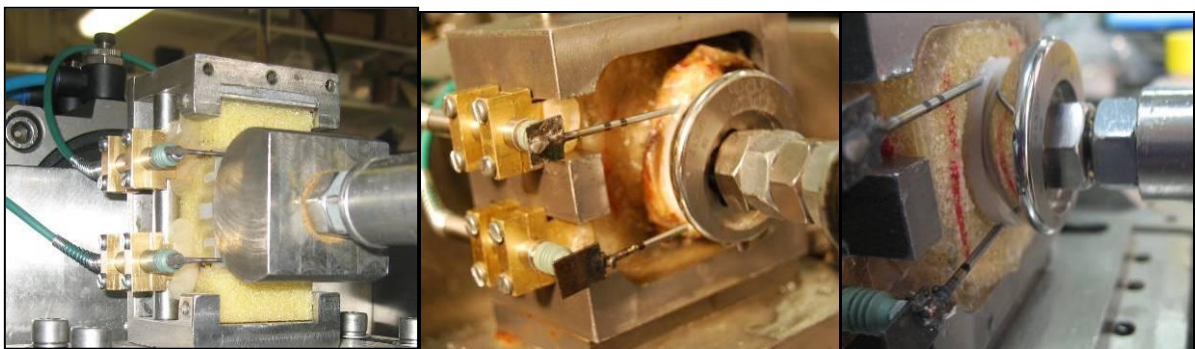
Figure 7.1: superiorly and inferiorly aligned LVDTs for rim displacement measures in 2D (left), cadaveric (middle) and 3D (right) studies. Note: figures are the same as Fig. 4.3, 5.2 and 6.4 respectively.

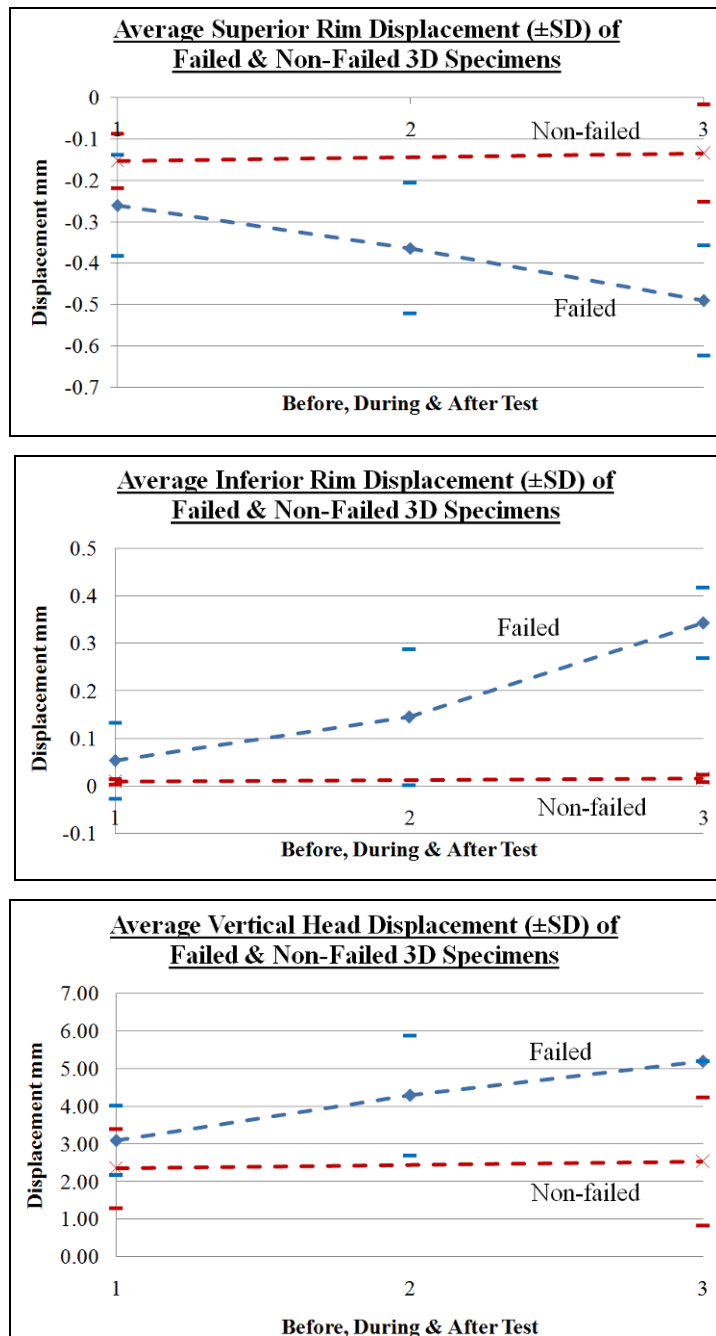
Figure 7.3: Superior, inferior and vertical displacements before, during and after testing in the implants that did not fail in the 3D study (n = 7), compared to the implants that failed (n = 5). Note: no significance was found before and after testing in the non-failed implants, whereas significance was found in the failed (p < 0.05).

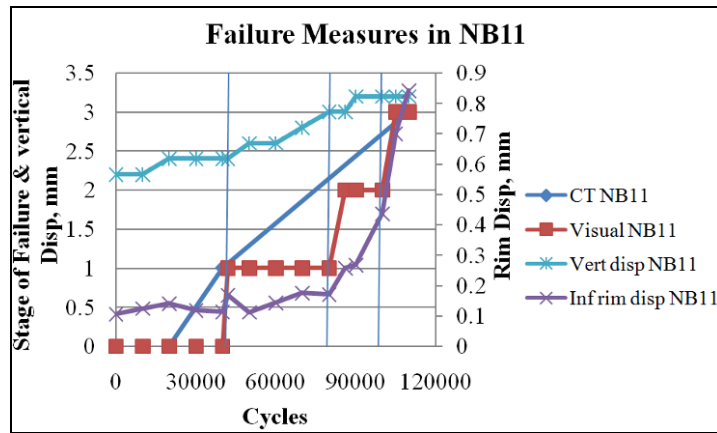
Figure 7.4: Plot showing vertical head and inferior rim displacements correlating to both CT and visual failure. Note: same figure as Fig. 5.16.

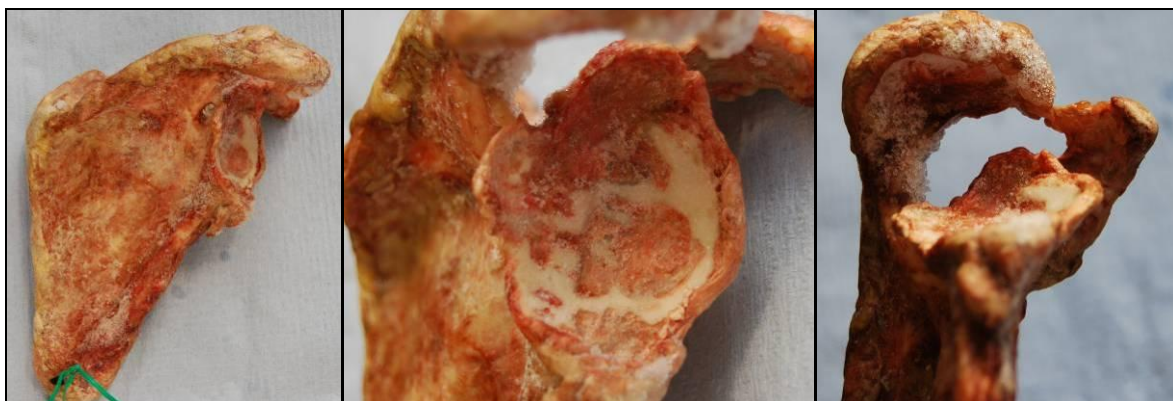
Figure 9.1: Poor quality scapula bone. Note: excessive posterior wear of the glenoid surface (right).

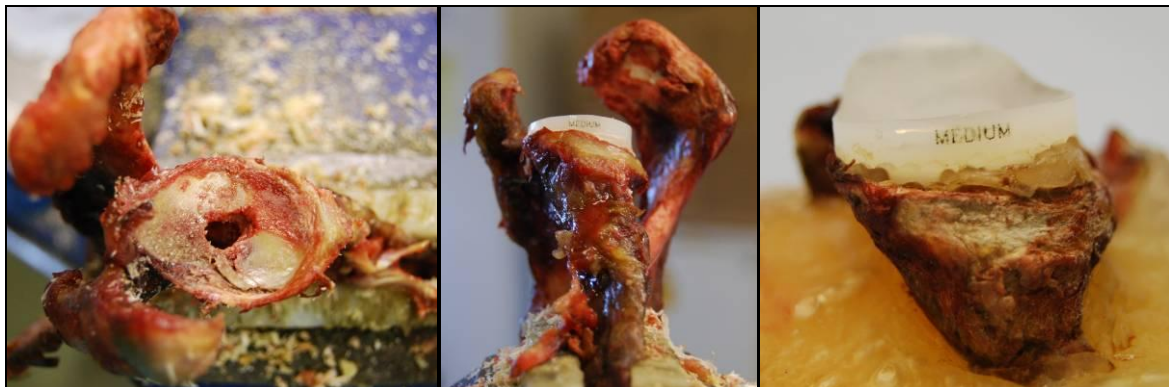
Figure 9.2: Sclerotic, poor quality bone. Note: poor implant seating and excessive posterior wear (middle) and failure at the implant/cement and cement/bone interface (right).

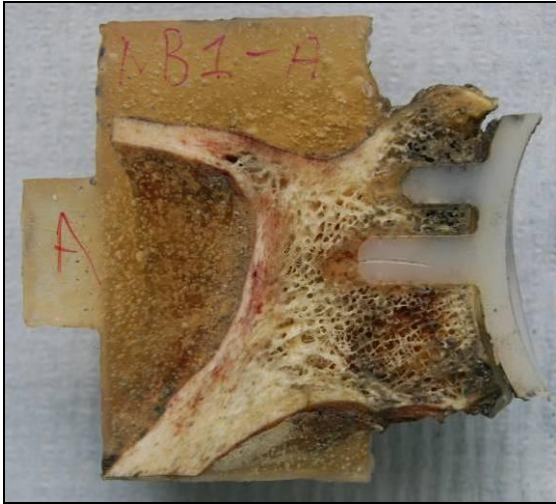
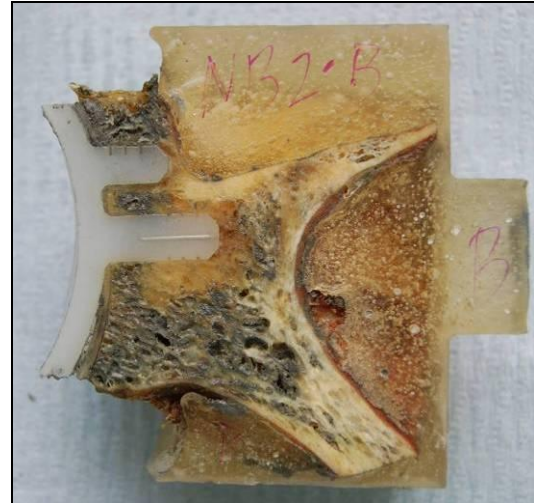
NB1 & NB2

Appendix E: Cross-sectional photos of the cadaveric specimens after fatigue testing
