SEISMIC VULNERABILITY ASSESSMENT OF EXISTING MASONRY BUILDINGS: CASE STUDY OF THE OLD CITY CENTRE OF FARO, PORTUGAL

Romeu VICENTE¹; Tiago FERREIRA²; Rui MAIO³; Humberto VARUM⁴;
Alexandre A. COSTA⁵; Aníbal COSTA⁶; Carlos S. OLIVEIRA⁷; João ESTÊVÃO⁸

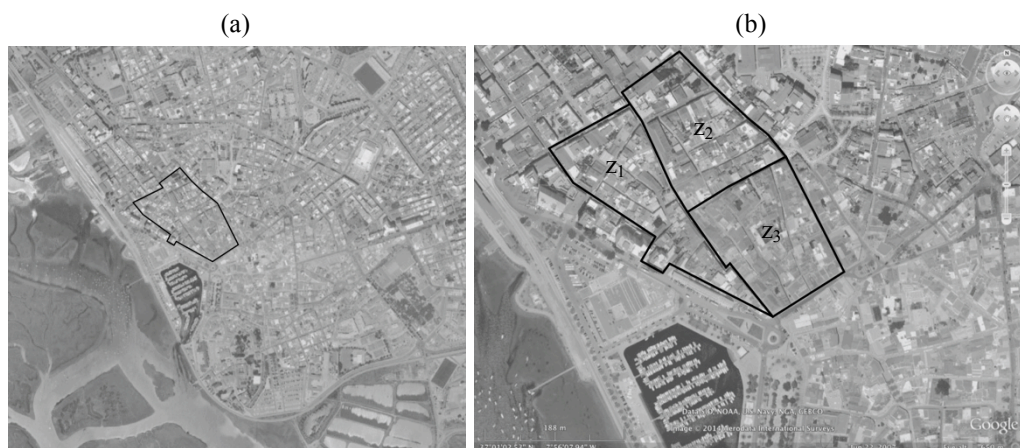
Figure 1. Project area (a) and zone delimitation (b) of the Ribeirinha area within the city of Faro.

Faro, formerly named as Ossónoba and having appeared about the 8th Century before Christ, is the Capital of the southernmost city of mainland Portugal. In the present case study it was given particular attention to the ARU (Urban Rehabilitation Area) Ribeirinha (see Figure 1), in which the higher amount of both old masonry and residential buildings was found, and thus with increased interest for the purpose of this research. Originally associated to agriculture and fishing commercial activities, this area still preserves some of those traits by the existence of countless warehouses at the ground floor level of residential buildings. As documented in several historical documents related to its historical evolution, Faro has been victim of countless invasions and transformations throughout the centuries. One of the most significant catastrophes happened during the 18th Century, with the well-known 1755 earthquake followed two years after by a hurricane and also by the devastating wars occurred in the early 19th Century. The knock-on effect that these events have had, led to collapse the majority of the existing building stock. Once the reconstruction process was understandably long and complex and naturally realised new construction technologies, which were implemented over the ruined buildings, during this period Faro witnessed a densification of its building stock, supporting the complex architectural nature recurrently found in the majority of the surveyed building's backyards.

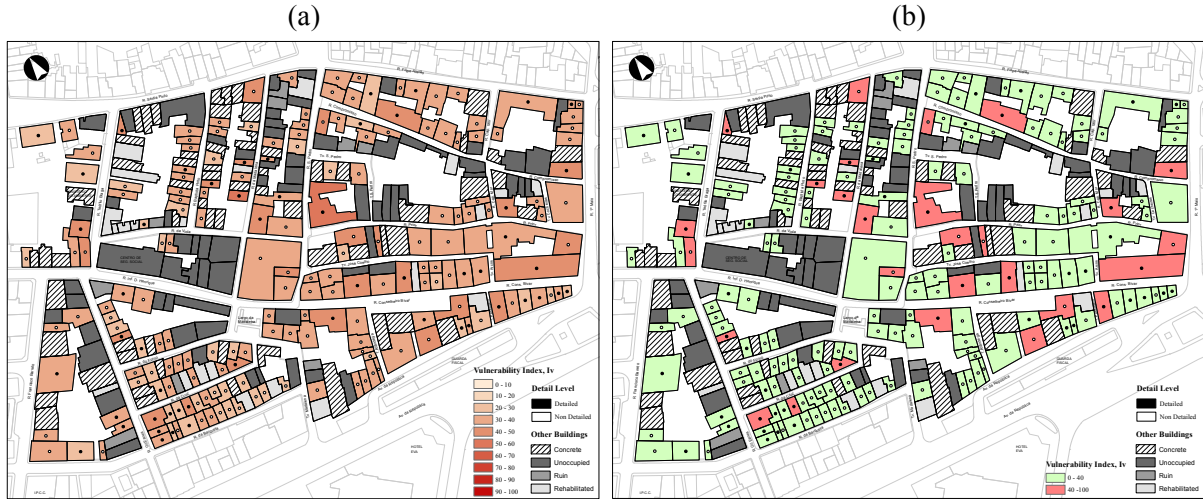
Figure 4. Vulnerability index mapping of buildings within the Ribeirinha area (a) and the identification of buildings with $I_v \geq 40$ (b)

Figure 4 shows the spatial distribution of building stock's seismic vulnerability in zones Z_1 , Z_2 and Z_3 of the Ribeirinha area. These results allowed for the identification of areas where more vulnerable buildings were located and also to identify the most vulnerable buildings or typologies. From analysing this figure one observes that Z_3 was the most vulnerable of the Ribeirinha area. Also from the right side of Z_1 resulted significant vulnerability indexes. Once more, it is important to refer that unoccupied and "in ruin" buildings (78 buildings out of 354) will seriously exacerbate this scenario.
