COMPDYN 2017
6th ECCOMAS Thematic Conference on
Computational Methods in Structural Dynamics and Earthquake Engineering
M. Papadrakakis, M. Fragiadakis (eds.)
Rhodes Island, Greece, 15–17 June 2017

DISCUSSION ON THE RESPONSE OF UNREINFORCED MASONRY TO LOW-AMPLITUDE RECURSIVE LOADS: CASE OF GRONINGEN GAS FIELD

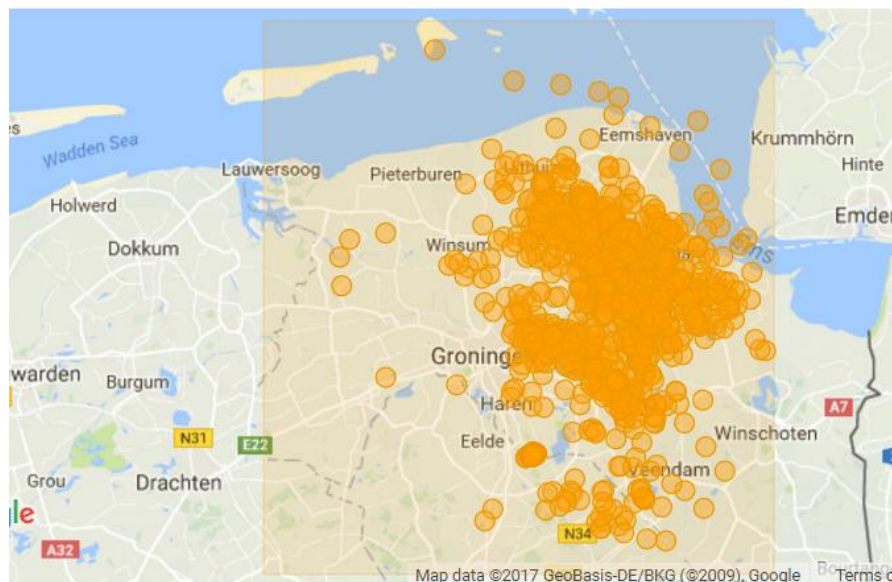
Figure 1: The seismic events obtained from the KNMI Seismic Database for the Groningen region for the time period between 2003 – 2016.

In Figure 1, the seismic events between 2003 and 2016 in the area can be seen. Distribution of the events in terms of magnitude ranges can be seen in Figure 2. The sudden increase in seismic events between 2011 and 2013 can clearly be observed in that figure.

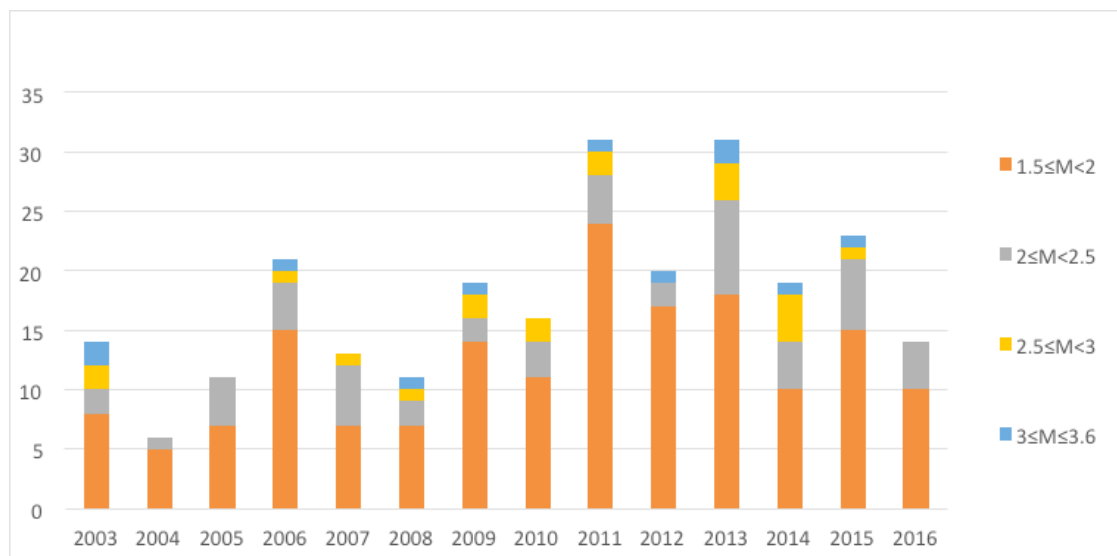
Figure 2: The distribution of the seismic events in a year basis for Magnitude 1.5+.

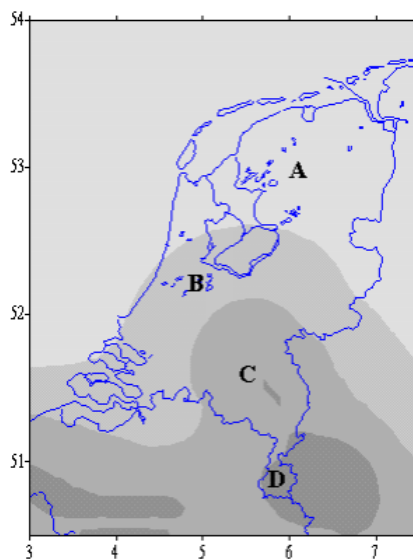
Figure 4: The seismic zonation map of the Netherlands is based on a seismic hazard study with a 10% of exceedance in 50 years (return period 475 years, and A means 0.01g PGA).

In Figure 3, the seismic zonation map of the Netherlands is given in accordance with the Eurocode-8. Specifically, the region of Groningen is classified as Seismic Zone A, which corresponds to PGA 9.81 cm/s^2 (0.01 g). This value was exceeded by far during the strong ground motion that was recorded at the Huizinge event on the 16th of August 2012 (Middelstum station). More detailed research on the seismicity of the region, as well as the characteristics of the strong ground motion records can be found in Bommer et al (2015) [3].

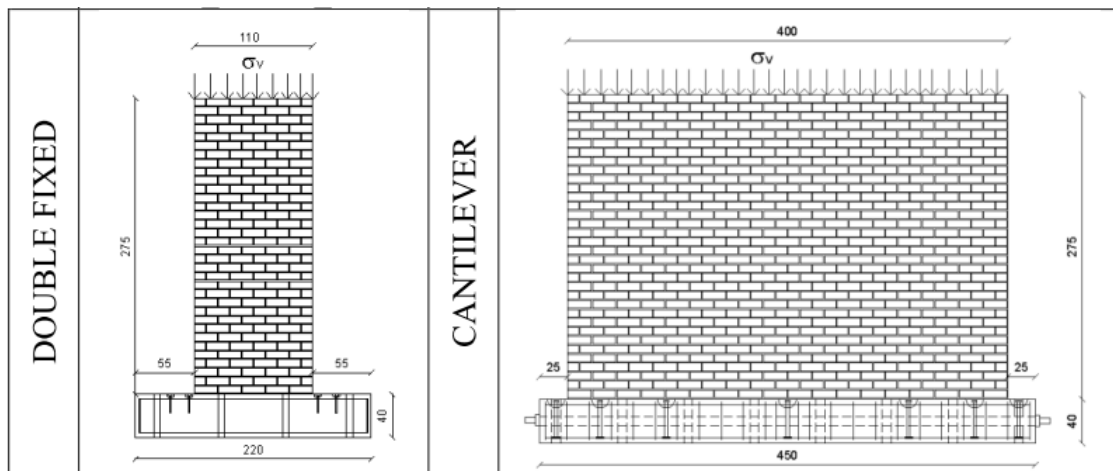
Figure 5: Experimental configurations considered, Slender Wall (left) and Squat Wall (right) (Pavese et al, 2015 [4]).

Experiments sponsored by NAM (Nederlandse Aardolie Maatschappij) and conducted by EUCENTRE (Pavia, Italy) were carried out on full-scale wall specimens resembling the typical calcium-silicate unreinforced masonry walls that can be found in the Groningen region. Specifically, two wall specimens representing a slender and a squat wall, correspondingly, were investigated under in-plane cyclic shear-compression tests. Their characteristic and dimensions are given in the Table 1, and their experimental configurations are shown in the Figure 4. These two specimens were chosen to account for different types of wall that can be traced in real structures are characterized by flexure or shear dominated type of failure.

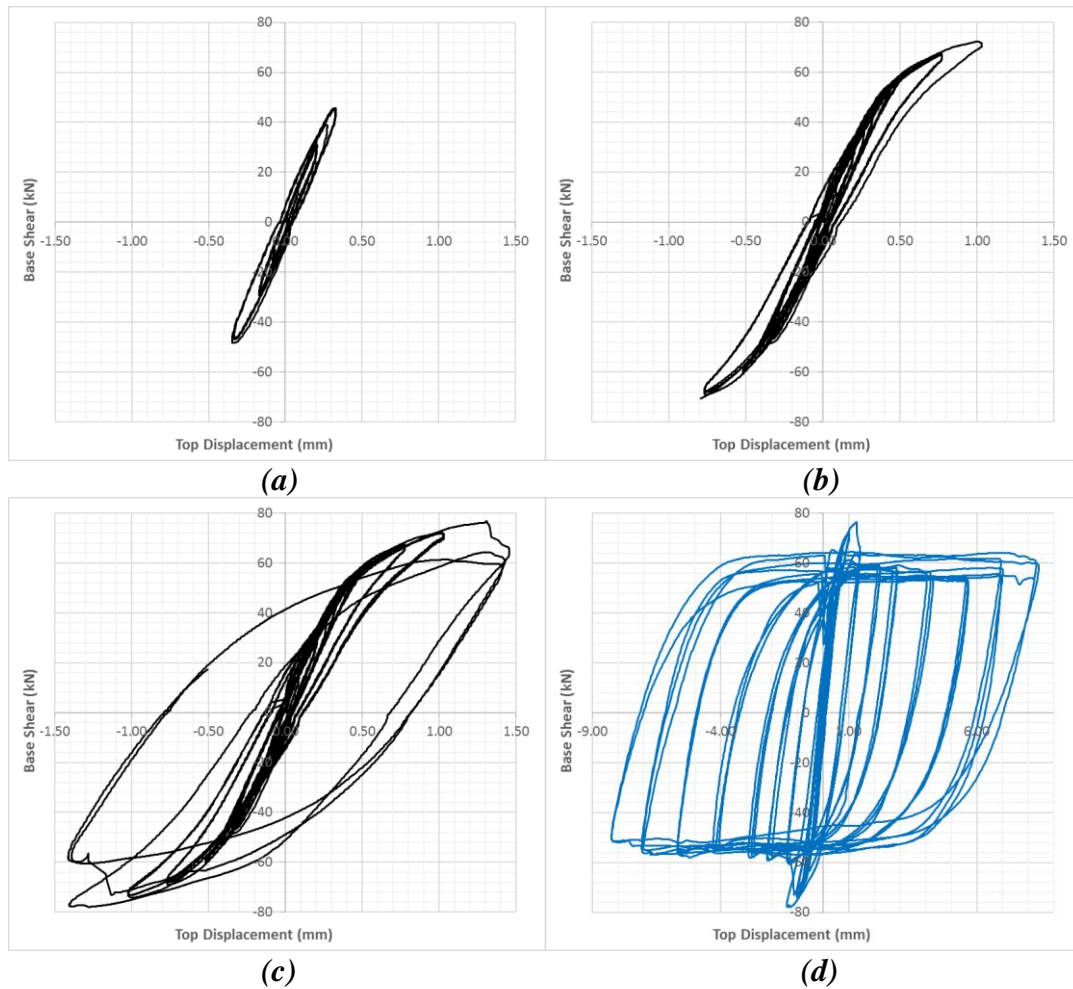
Figure 6: Experimental load deflection curve of the same EUCENTRE specimen (the squat wall specimen) focusing on different displacement ranges: (a) The first 3x3 cycles, up to 0.4mm top displacement, (b) The first 3x6 cycles up to 1mm top displacement, (c) The first 7x3 cycles up to 1.5mm top displacement, and (d) the full experimental hysteresis curve (modified from Pavese et al., 2015 report, and please note that the displacement scale of the first three plots is the same)

In order to better understand the response of the Groningen-type URM to cyclic loads, focus on the load-deflection curves are presented here in Figure 6. In evaluating the load-deflection curves in earthquake engineering practice, it is more common to concentrate on the post-yield phase of the response. In the case presented here, however, the response in the very small cycles becomes important. It can be seen in Figure 6a that the very first cycles of the squat wall (see Figure 6 for the squat wall specimen), there is a considerable amount of hysteretic energy consumed, as well as residual displacements remained on the system. In this case, the top displacement is extremely small, in the range of 0.4mm, translating into 0.01% top drift. The response becomes slightly different in Figure 6b, where the top drift ratio goes up to 0.015%, and a pinching type response is observed. The reason for this response may be either rocking of the specimen as it is, or failure of bed joints and partial rocking of the wall on one or multiple bed joints. In Figure 6c, on the other hand, ductility starts to build up leading to fatter hysteresis

loops and obvious damage. When focused out to the overall response, as shown in Figure 6d, the response in the very first cycles gets invisible.

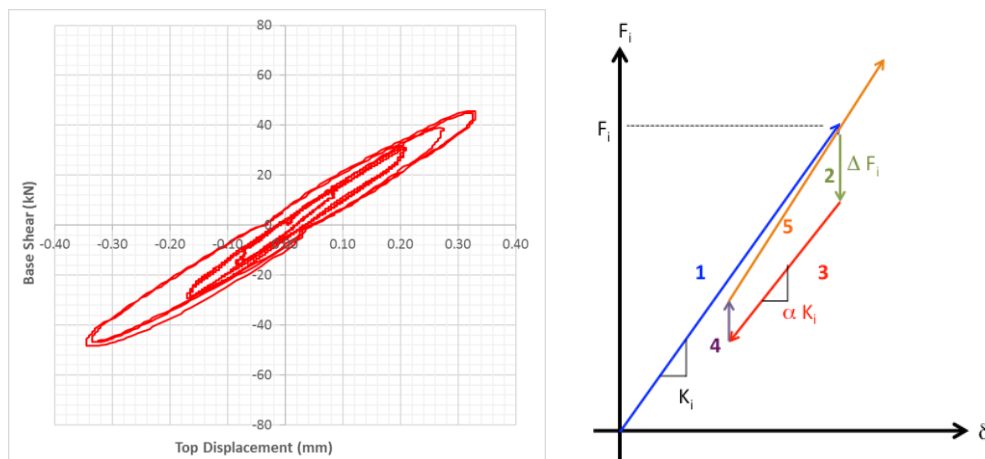
Figure 7: Focus on the experimental load deflection curve for the first 3x3 cycles (left) and an idealized hysteresis backbone (right)

Zoom into the very first 3x3 cycles, as shown in Figure 7 (left), provides insights regarding the extremely low amplitude response of the URM walls in question. The hysteresis loops of the first cycles is quite fat, leading to residual displacement and energy consumption, so damage, in the very beginning of their response. After analyzing several cycles in the experiments, the initial backbone curve suggested for the very low amplitudes can be seen in Figure 7b. It should be noted that the main issue in this behavior, at the very beginning of the response, is the force drop when the cycles reverse. As opposed to bi-linear response, for instance, the constant is the displacement but not the load. This created practical problems in modeling these URM walls since none of the available and suitable models can consider a strength drop under constant displacement, since the hysteresis loops are mostly set for large deformations and the case is the increasing displacement under constant or slightly increasing/decreasing loads. More insights are provided on this issue in the rest of the paper.

In Figure 7 (right), in line with the experimental results, there are two characteristic behaviors that need to be addressed in a suitable hysteresis loop, which are i) at the beginning of every unloading, there is a force drop of ΔF_i , and ii) the unloading stiffness is always smaller than the initial loading stiffness, thus the initial stiffness K_i is multiplied with a coefficient α , that is smaller than or equal to 1.0.

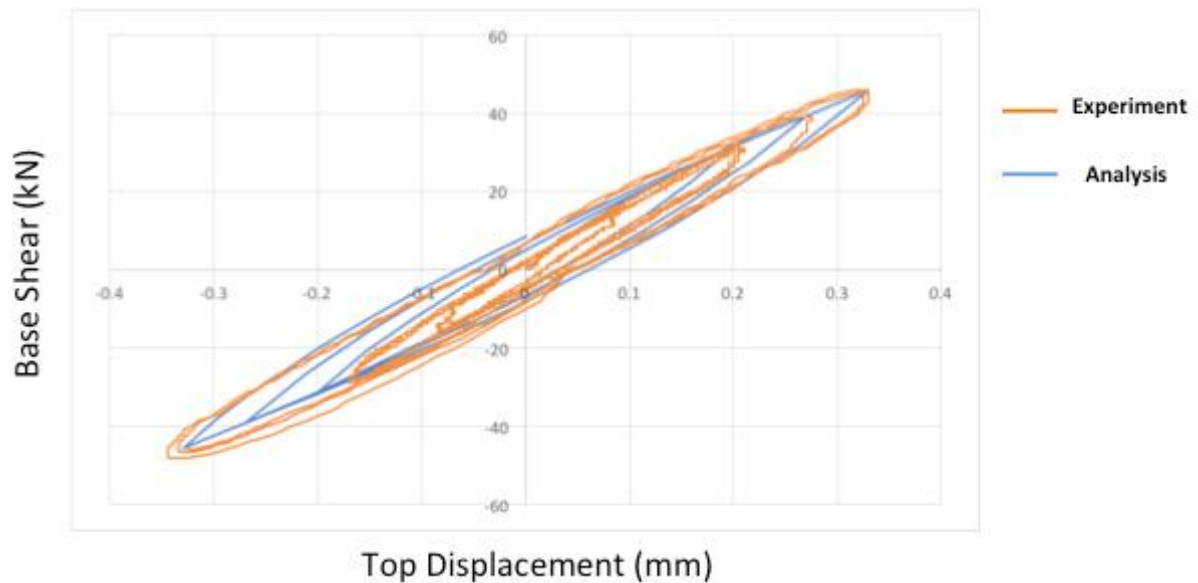
Figure 8: Calibration of the numerical model with the response of the tested specimen in terms of base shear versus top displacement for the first 3x3 cycles of the conducted experiment.

At this point, a simple numerical model was created in the SeismoStruct software to simulate the response of the tested specimens for the very first cycles of the conducted experiments which seem to be of major importance. The Ramberg–Osgood [5, 6] constitutive model was applied on a link element, taking into consideration also the physical characteristics of the tested specimens, such as the mass, stiffness, and strength. The response of the utilized numerical model is presented in the Figure 8, comparing with the response of the corresponding specimen. Their comparison yields to a reasonable match in terms of horizontal force – top displacement response.

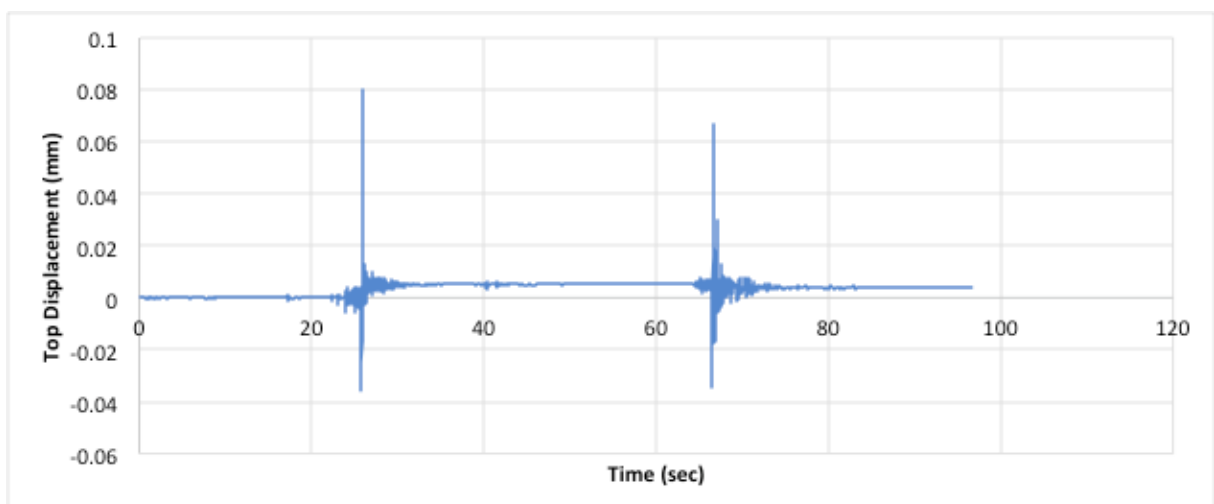
Figure 9: Top displacement time history of the squat specimen for scenario #2

By using the calibrated Ramberg-Osgood model, and by applying several recursive seismic actions, it was found that the residual top displacement is approximately 0.05mm after 2014 event, and it goes down to approximately 0.025mm after the 2012 Huizinge event. Repetition of the 2014 event for 5 or 10 times does not alter this response.
