RIPARIAN VEGETATION SUSCEPTIBILITY TO WIND AND FLOODING IMPACTS OF HURRICANES

An Undergraduate Research Scholars Thesis

CHRISTY ATTAWAY

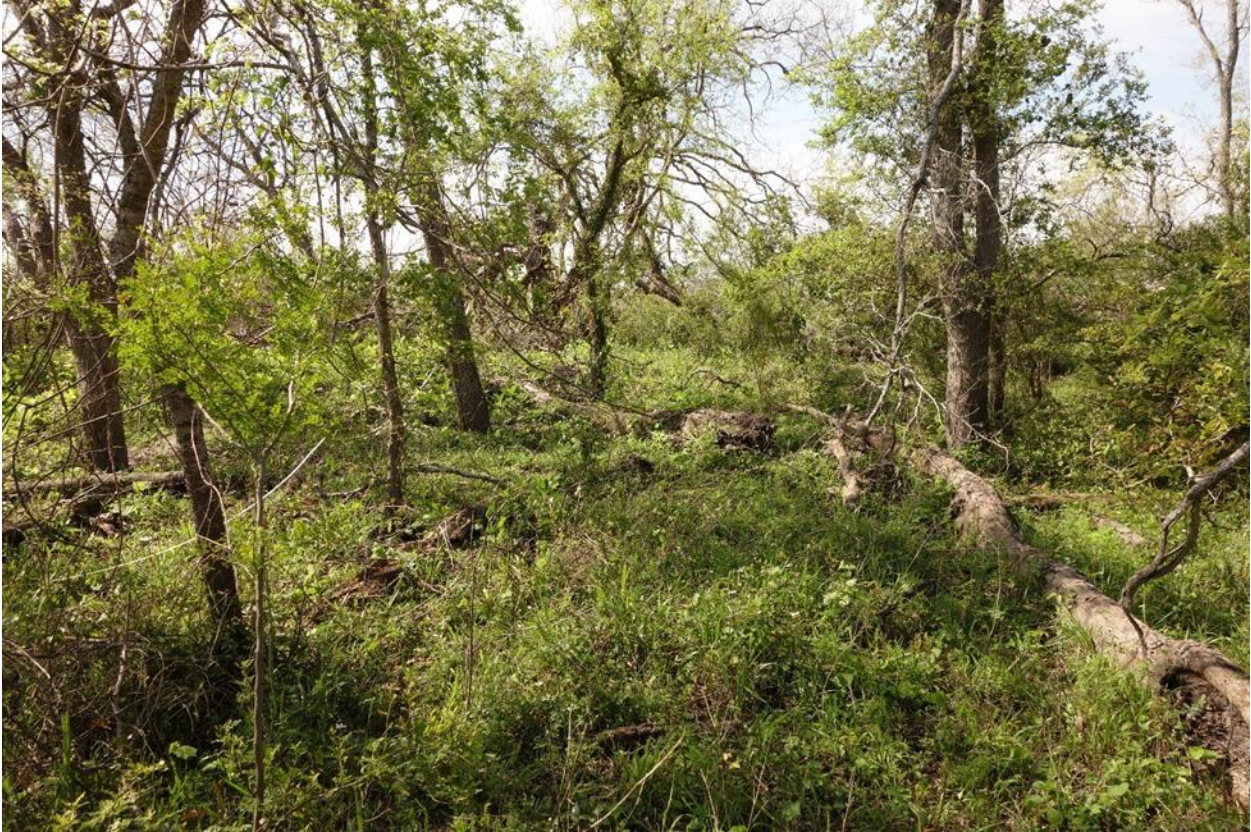
Figure 4: Plot G6 was characterized by many more mature tree species that were spaced relatively far apart. In order to get a detailed representation of the area, the plot was extended to 10 m x 30 m, an area equal to 10 plots when compared to the other plots.

For G6, the southernmost plot (Figure 3 and 4), 10 plots were simultaneously created by establishing a grid of 10 m x 30 m. Surveying one plot at the location of the previous study's starting point would not have accurately portrayed the composition of the site. Few species were growing within the 3 m closest to the riverbank, but many more individuals were scattered within the 30 m that we recorded. For this plot, we marked the location of each DBH measurement with the GNSS.
