GUIDEBOOK NO. 6

GUIDE TO THE BUILDING STONES OF DOWNTOWN COLUMBUS: A WALKING TOUR

prepared for the 1992 Annual Meeting
of the Geological Society of America

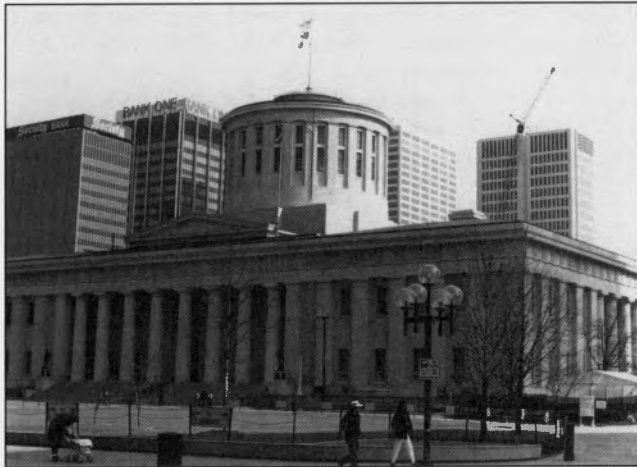
FIGURE 3.—The Ohio State House. View from the southwest.

The Ohio State House, or Capitol (fig. 3), occupies a whole city block (Capitol Square) in the center of downtown Columbus. The original capitol on the site was brick and was occupied in 1816; the current capitol was completed in 1861. The cornerstone was laid at the northeast corner on July 4, 1839, but it took 22 years and the installation of steam-operated machinery at both the yard and the quarry as well as a railroad for transportation to bring the building to completion. According to a brochure on Ohio's capitols (Anonymous, n.d.), it is considered "one of the purest examples of Greek Doric architecture in the United States."

near the Central Hospital" (Bownocker, 1915). The original building commission "decided on native stone as the material and contracted with William Sullivan, who had a quarry on the west bank of the Scioto, about three miles from the square" (Anonymous, n.d.). Bownocker describes it as a high-grade building stone; "the columns were supplied by the five and one-half foot-course, which at that time formed the base of the quarry." The steps came from the 6- to 9-inch-thick "sheepskin" course, which was regarded as superior to the more popular Salem Limestone of Indiana. The structure demonstrates how well the rock withstands the Ohio climate. Abundant fossils are evident in the columns, including **corals**, **brachiopods**, and **mollusks**. The outside steps also show many fossils, including a coiled **cephalopod**, **gastropods**, **colonial corals**, and **stromatoporoids** (Mayer, 1962; Hannibal, 1990).

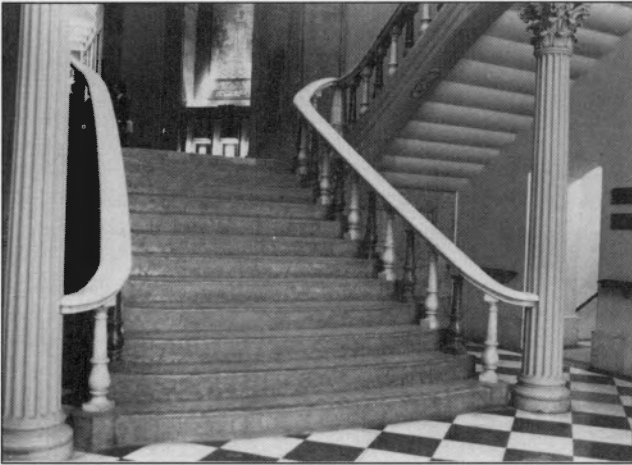
FIGURE 4.—Interior steps of Ohio State House showing stairs of Columbus Limestone, balustrades of *Tennessee marble* and white *Italian marble*, handrails of *Italian marble*, and floor of *Champlain Black marble* and white *Italian marble*.

Stairs in the north and south halls are Columbus Limestone. The turned balustrades are dark *Tennessee marble* (Holston Formation) alternating with white *Italian marble*. The handrails and newel posts are also white *Italian marble* (fig. 4). Some of the statues in the State House are probably *Carrara marble*.

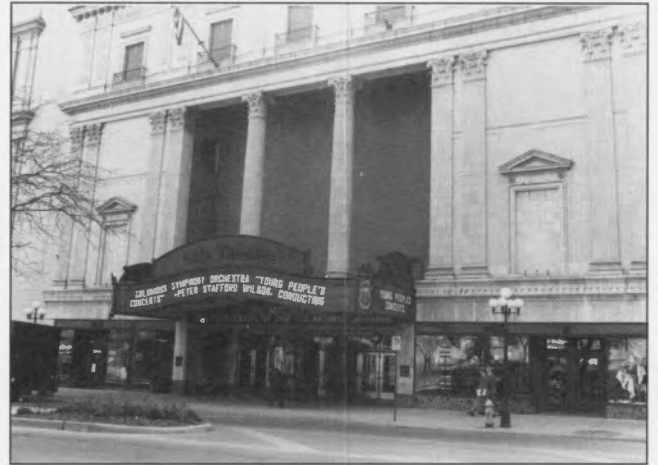
FIGURE 5.—Ohio Theatre.

This ornate “movie palace” (fig. 5) on State Street, south of the State Capitol, was opened in March 1928. Designed by Thomas Lamb, a major theatre architect of the 1920’s, as one of Marcus Loew’s theatres for silent films, the Ohio Theatre was considered to have the richest interior in the country (Anonymous, 1978). By 1969, with its original decorations still intact, it was destined for destruction. The efforts of a community-based citizens’ organization resulted in its restoration.

The walls of the entry, both inside and outside the main doors, are covered in white *Vermont marble*. Just above the floor is a green marble. The ticket booth is *Verde Antique*. The floor of the entrance was white marble; it was replaced after one year because it was too slippery when wet. Most of the interior floors that are not covered by carpet are **terrazzo**.

The interior is mainly plaster, stucco, and other materials characteristic of the “rococo” style. A salmon-colored marble, *Etowah marble* (Murphy Marble), was used beside the sinks and in the partitions of the washrooms in the addition on the east side. This Cambrian-age stone was quarried in the Tate area of Georgia and supplied by the Georgia Marble Company (Joseph Hannibal, personal communication, 1992). Original glass tiles and glass partitions may be seen in the washrooms in the old section. A countertop in the south end of the ground floor of the new east wing is artificial marble, and the west wall of this wing is pink terracotta from California. This terra-cotta wall looks like a wide curtain. This look was achieved by using molds for horizontal parapet parts.

The exterior of the east entrance has large columns that look like limestone from a distance; however, they are concrete, poured as one unit on site by injection from the base into a mold that contains reinforcing iron.

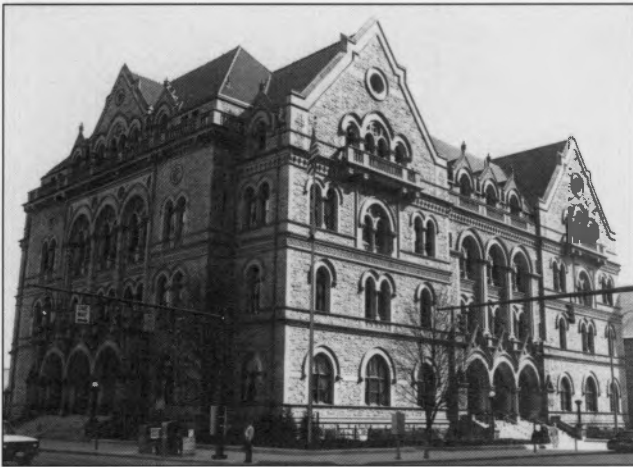
FIGURE 6.—Old U.S. Post Office and Courthouse. View southeast from Capitol Square.

This building (fig. 6), at 121 East State Street (now fronting on 100 South Third Street), is sometimes described as the Old, Old Post Office, and was the first federal building in Columbus. This Romanesque Revival style building, completed in 1887, was enlarged in 1912 when it was converted to High Victorian Gothic. The pointed arches (fig. 7) and red clay tile roof are evidence of the change. The exterior is golden-tan **rock-faced** Berea Sandstone. This stone is Devonian-Mississippian in age (about 360 million years old). It is composed mostly of pure quartz grains which are interpreted as river or beach deposits and sand dunes. It was early termed “Berea Grit” because it was quarried in great quantities in the 1800’s at Berea, Ohio, and used for grindstones because of its coarse quartz grains. The stone in this building may have been quarried at South Amherst, Ohio, a location which has some of the deepest sandstone quarries in the world. (See

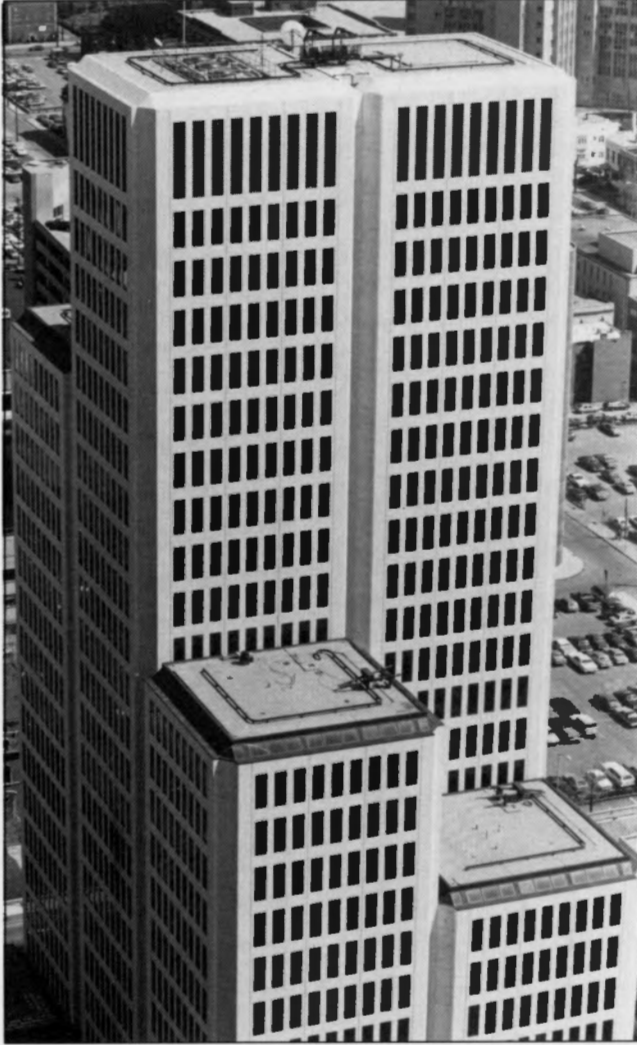
FIGURE 9.— BancOhio National Plaza. Five of the six connected towers are visible in this view east-southeast from the Rhodes Tower.

Located at 155 East Broad Street, the BancOhio National Plaza (fig. 9) consists of six connected towers rising to various levels. It was dedicated in 1976. This building makes striking use of *Italian travertine* from Tivoli, Italy, where it is quarried extensively. Ninety percent of the exterior and 20 percent of the interior, including the lobby, are faced with the travertine, a light-colored, porous, calcium carbonate rock. Travertine is used extensively within some buildings, but this structure is the only one on this tour that uses it as an exterior building stone. Chafetz and Folk (1984) give more information on travertine.

The building is of "bundle-tube" construction, placed on a 5-foot slab footing, with poured-concrete reinforcing obtained from local sources. Trees and numerous other plantings, together with sculpture and photography, complement the design-with-nature theme of this building.

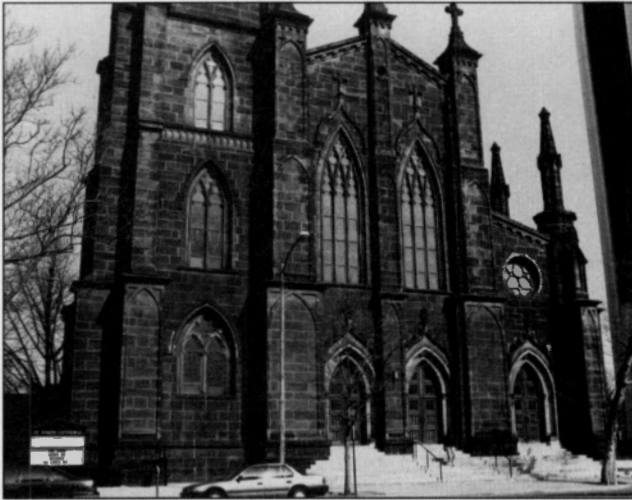
FIGURE 10.—Saint Joseph Cathedral.

This building (fig. 10), an outstanding landmark in Columbus for more than 100 years, is located at 212 East Broad Street. Construction began in 1866 and was completed in 1872. It followed the trend, set by the Capitol, of being constructed from stone close to the

Inside the cathedral, the early pillars of the vaulted nave were cast iron. They were replaced by Salem Limestone pillars when the building was renovated in 1914. The altars and 12 crosses embedded in the walls around the church are *Italian marble*. The cathedral was designed to have a spire 250 feet high, but it was never built. Together with the rectory, the cathedral gives a sense of space and timelessness amidst the surrounding utilitarian buildings.

Stop 6. SAINT JOSEPH CATHEDRAL. The exterior of the cathedral was cleaned and restored in 1994. The change can be seen by comparing the current appearance with Figure 10. A chemical was used to clean the stone because sandblasting would have removed too much of the stone.

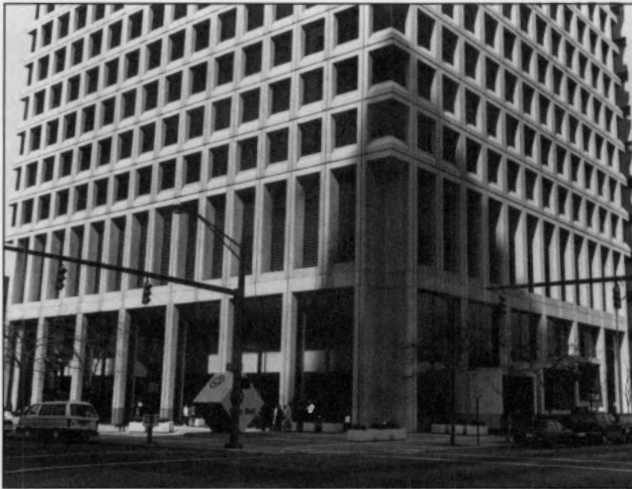
FIGURE 12.—Ohio Bell Building. View from the southeast.

Located at 150 East Gay Street, one block north of Broad Street, this high-rise office building (fig. 12) was completed in 1973. The lower part of the building and the outside plaza at first appear to be slate or **phyllite** because of their shiny, **micaceous** surface. A sample in cross section, however, shows that this stone is **quartzite**. It was quarried in Sweden and brought as ballast to the United States. The upper part of the building is enclosed with modular units of precast concrete, some of it from local sources, and solar bronze plate-glass windows. The floors and walls of the two-story lobby are quartzite. A beautiful desk in the lobby is made of rock termed "black granite" by the builders; it is a gabbro showing large feldspar crystals. A large cube structure of concrete bearing the Ohio Bell logo decorates the southeast area of the plaza.

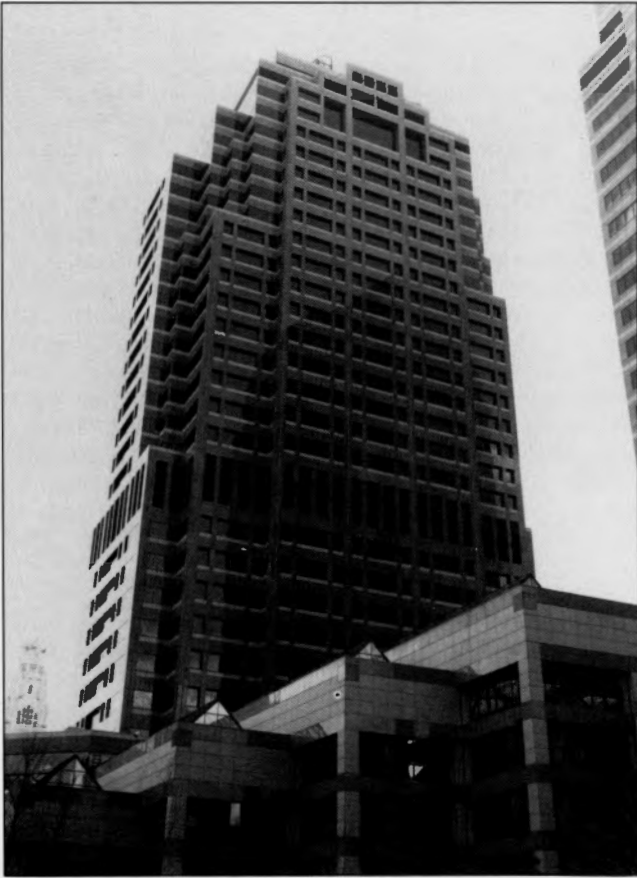
FIGURE 13.—William Green Building. The Atrium is in the foreground and Three Nationwide Plaza is on the right.

The William Green Building (fig. 13), on the north side of Spring Street between Front and High Streets, houses the Ohio Bureau of Workers' Compensation and the Industrial Commission of Ohio. The pre-assembled exterior stone walls use a steel truss system that backs several sections of granite in each unit. Although it was built in 1991, about the same time as the Riffe Center (Stop 16) and Three Nationwide Plaza (Stop 10), all three buildings use different systems for fastening stone to the frame of the building (Bernard Costantino, personal communication, 1992). The stone for this building was supplied by Moliterno Stone Sales of Rhode Island. The exterior is primarily (90 percent) polished *Cardinal Red granite* of Precambrian age from Finland. This dark-red porphyritic granite is described as being "softer" than most granites used in this country. It tests at 1290-1460 **psi** (pounds per square inch), whereas

most stone used has a strength of at least 1500 psi. Deer Isle Granite, used for the other 10 percent of this building, is about 1850 psi (John Ward, personal communication, 1992). According to Dale (1923), *Cardinal Red granite* contains some phenocrysts of potassium feldspar up to 2.5 cm in length, smoky quartz, and milk-white **oligoclase** in addition to biotite.

The lighter colored, polished Deer Isle Granite makes up the banding in the columns, the window trim, and other highlights of the building. This coarse-grained, white to gray biotite granite was mined on Crotch Island, Stonington, Maine. On the walkways surrounding the building, *Cardinal Red granite* is used beneath the overhangs and on the handicap ramps. *Cardinal Red granite*, brick, and another dark-red granite, similar to *Agate granite* of Three Nationwide Plaza

(Stop 10), are used for the sidewalks. The dark-red granite trim on the sidewalk at the southwest corner of the Green Building has a wider range of textures (**migmatitic** to **pegmatitic**) than other granites used in the plaza and sidewalks of the Nationwide-Green block.

The interior floor of the building contains a dark and a light travertine from Italy. Inset at the junctions of the travertine tiles are tiles of flamed and polished *Cardinal Red granite*. The north lobby has two colors of travertine on the ceiling and walls. Reddish-orange *Breccia Pernice marble* and light-colored *Italian travertine* are found in some of the walls of the north lobby adjacent to the Atrium at Three Nationwide Plaza.

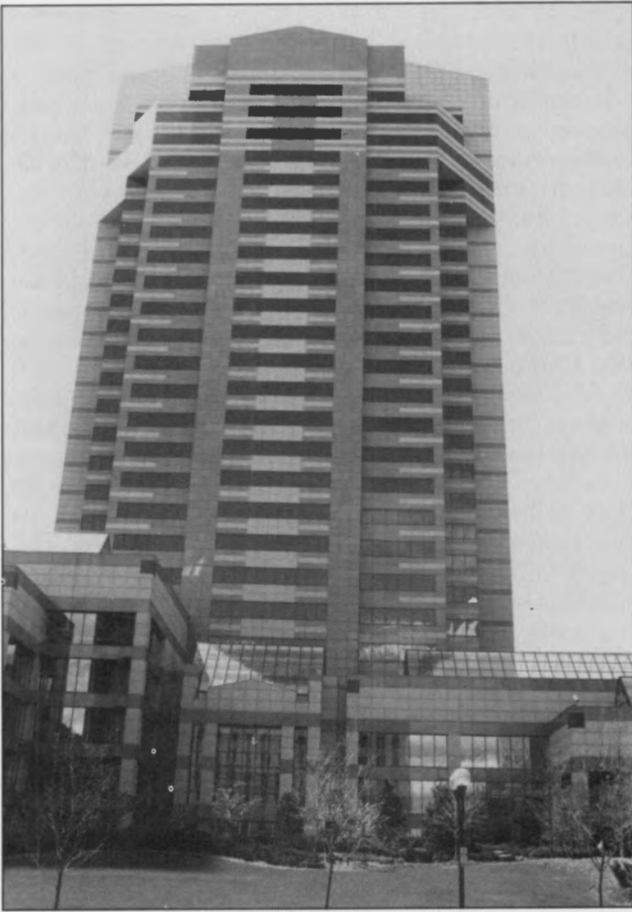
FIGURE 14.—Three Nationwide Plaza and the Atrium.

Three Nationwide Plaza and the Atrium at Three Nationwide Plaza (fig. 14), at 250 North Front Street, is the third office building in the Nationwide Insurance group of buildings completed since 1978. Three Nationwide is between One Nationwide Plaza (Stop 11) on the north and the William Green Building (Stop 9) that parallels Spring Street between High and Front Streets on the south. Parts of Three Nationwide opened in 1988; the Atrium was completed in 1989. The State of Ohio and Nationwide Insurance planned, designed, and constructed Three Nationwide, the Atrium, and the William Green Building in the largest coordinated office-building construction project undertaken in the United States by government and private business.

Polished *St. Peter travertine* of Tertiary age is used on the walls and columns of Three Nationwide Plaza as trim. This stone is from Tivoli, Italy. Polished *Trani travertine* (*Perlato Royal Svevo*) from Trani, Italy, on the Adriatic coast, is the beige rock in the floor of the building.

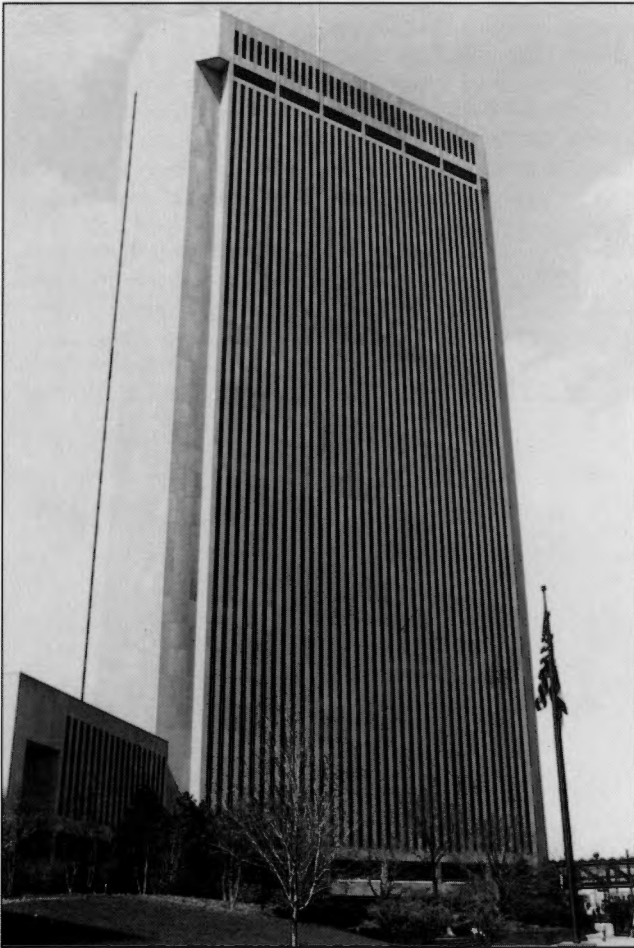
FIGURE 15.—One Nationwide Plaza. View north from the Atrium adjacent to William Green and Three Nationwide Plaza buildings.

This imposing building (fig. 15) is situated on the corner of Nationwide Boulevard and High Street four blocks north of Broad and High. Completed in 1977, it is 40 stories and 482.5 feet high, encompassing a total of 1,325,000 square feet. Anderson Concrete of Columbus furnished 64,000 tons of concrete for the structure. The exterior is faced with Salem Limestone (commonly known as *Bedford* or *Indiana limestone*), a limestone made up of sand-size grains cemented with calcite. The grains consist of **oolites** that have minute shell fragments as nuclei and fossils, including **foraminifera**, fragmental **bryozoans**, **crinoids**, corals, and brachiopods, as well as a minute amount of carbonate detritus of unknown origin (Bates, 1969; see also Thompson, 1990). It is a light-gray stone, Mississippian in age, deposited in a warm shallow sea about 325 million years ago. According to Bates (1969), in the 1960's at least 60 percent of the dimension limestone produced in the United States was Salem Limestone from south-central Indiana.

The interior lobby of the building has walls and pillars of beige *Italian marble* from Trani, Italy. The floor and exterior decoration on the plaza are *Agate granite* provided by the Cold Spring Granite Company from a quarry in Ortonville, Minnesota.

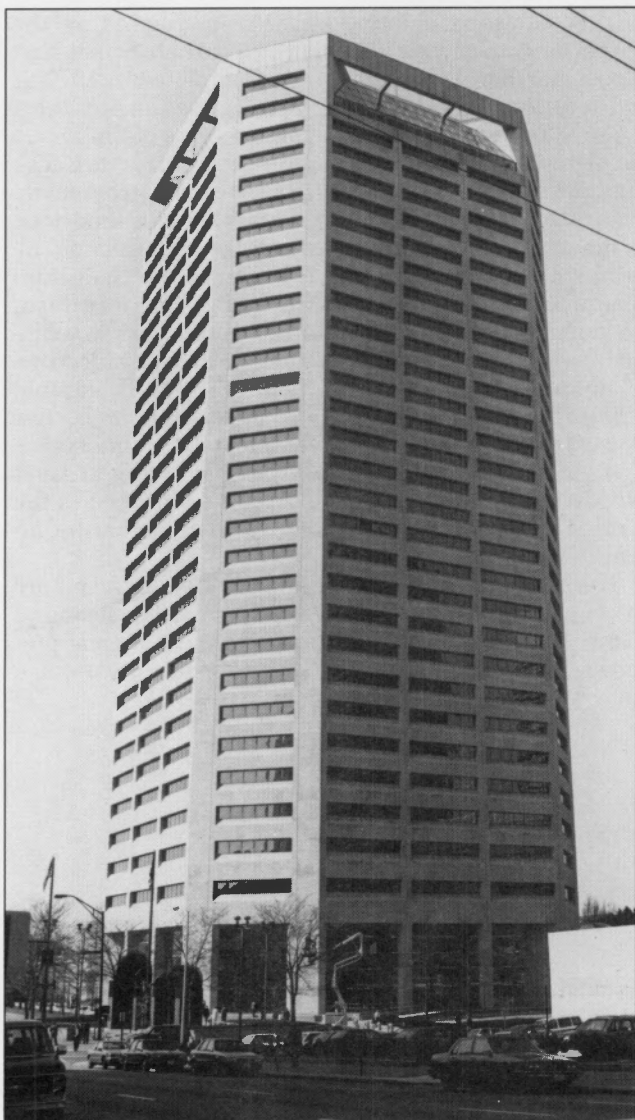
FIGURE 16.—American Electric Power Building.

This structure (fig. 16) is located at 1 Riverside Plaza west of Marconi Boulevard between Spring and Long Streets. The building, completed in 1983, was designed by the same architects as those who designed One Nationwide Plaza (Stop 11) and used the same stone (Salem Limestone) on the exterior. Three horizontal bands of light-pink granite, known as *Stony Creek Red granite*, from New Haven County, Connecticut, are used at various elevations to decorate the building. This stone is also used extensively in the lobby. It is coarse grained and has large pink feldspar crystals in a gray mass. This granite is actually a **migmatite**, consisting of biotite **gneiss** and granite, and in places is pegmatitic (Slagle, 1982). It is pre-Triassic in age. A turbine sculpture dominates the southeast corner of the building.

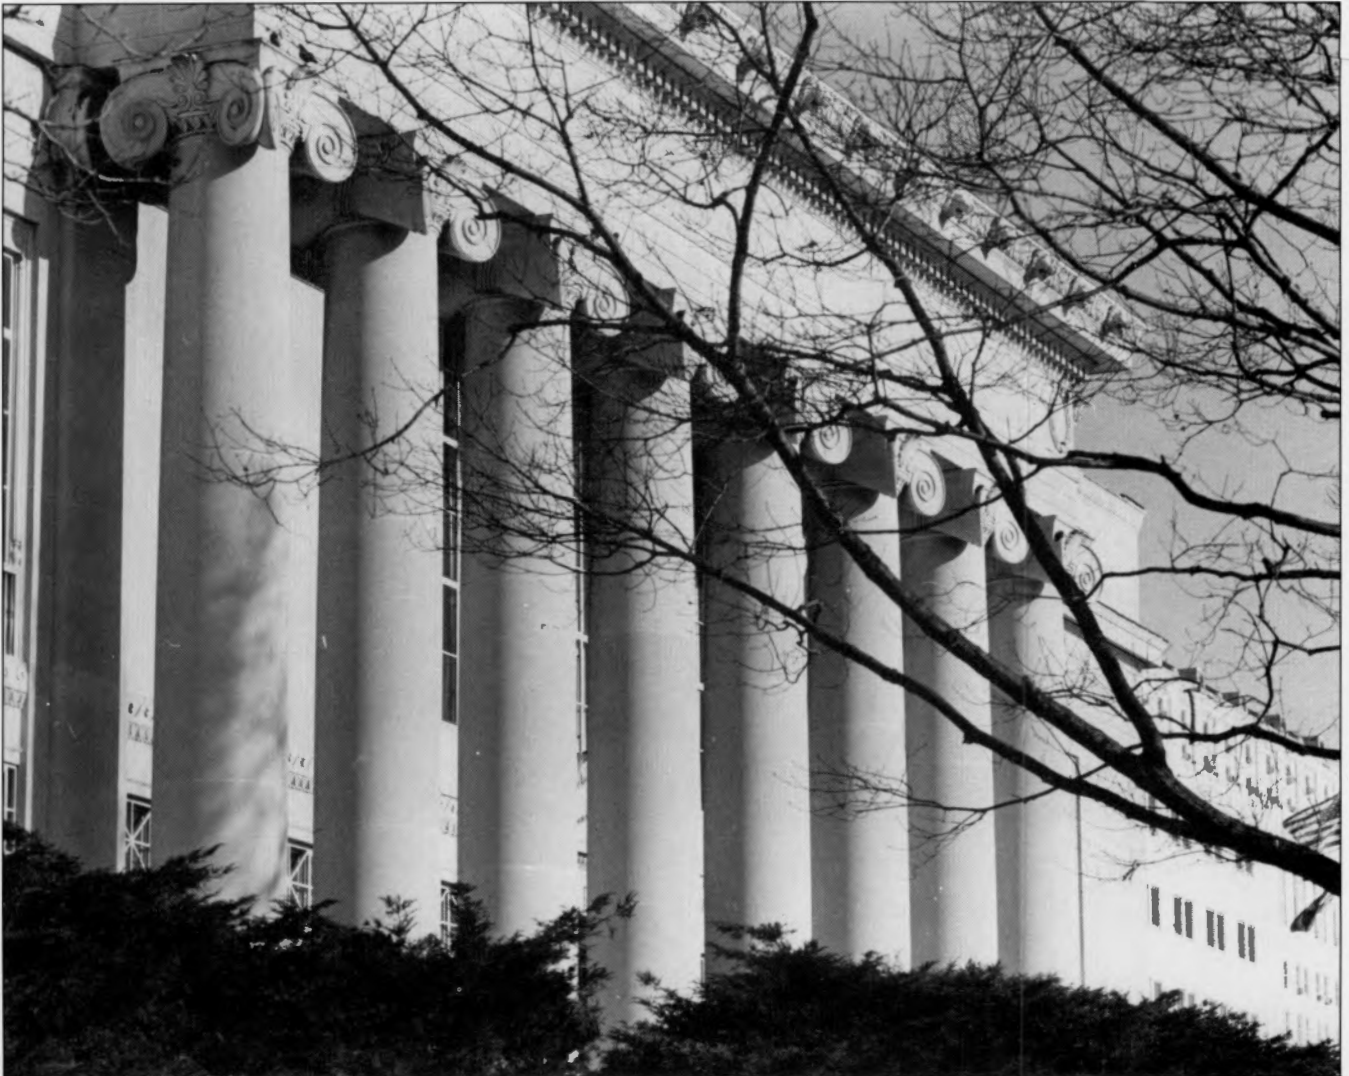
The sedimentary, igneous, and metamorphic rocks, ironwork, woodwork, statues, urns, and the colossal Ionic columns of Salem Limestone effectively decorate this otherwise plain and utilitarian building.

FIGURE 17.— Ionic columns of Salem Limestone on west side of Columbus City Hall.

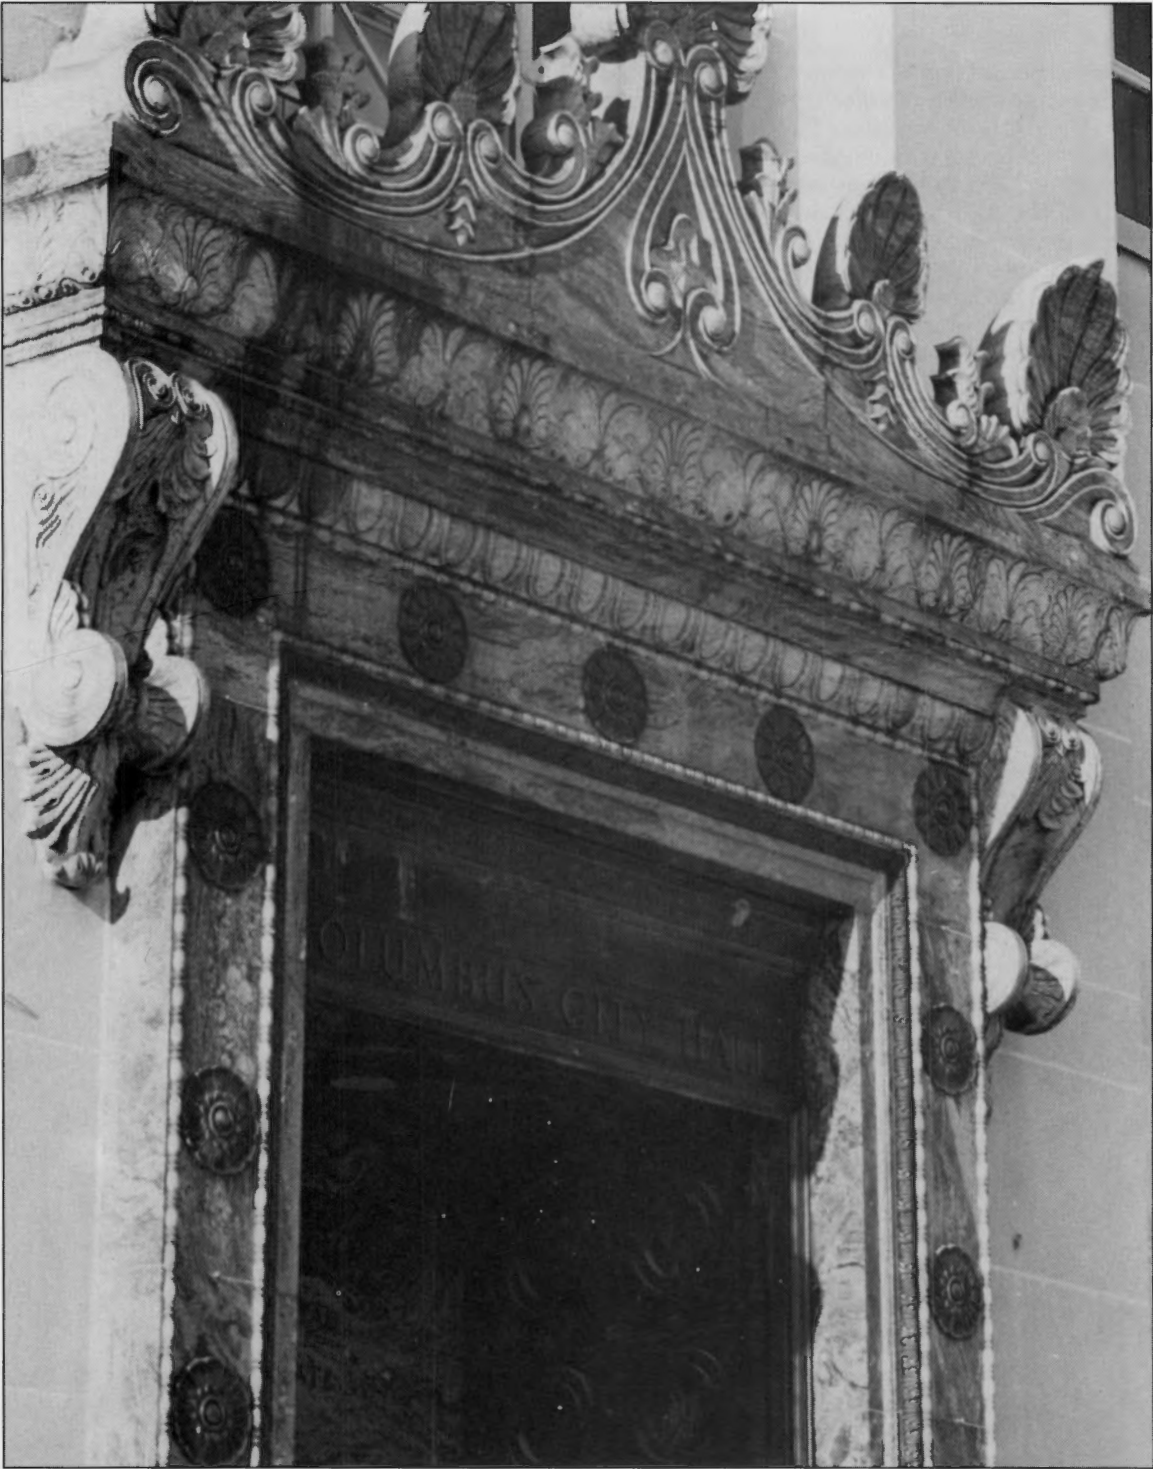
FIGURE 18.— Doorway of Morton Gneiss at Columbus City Hall.

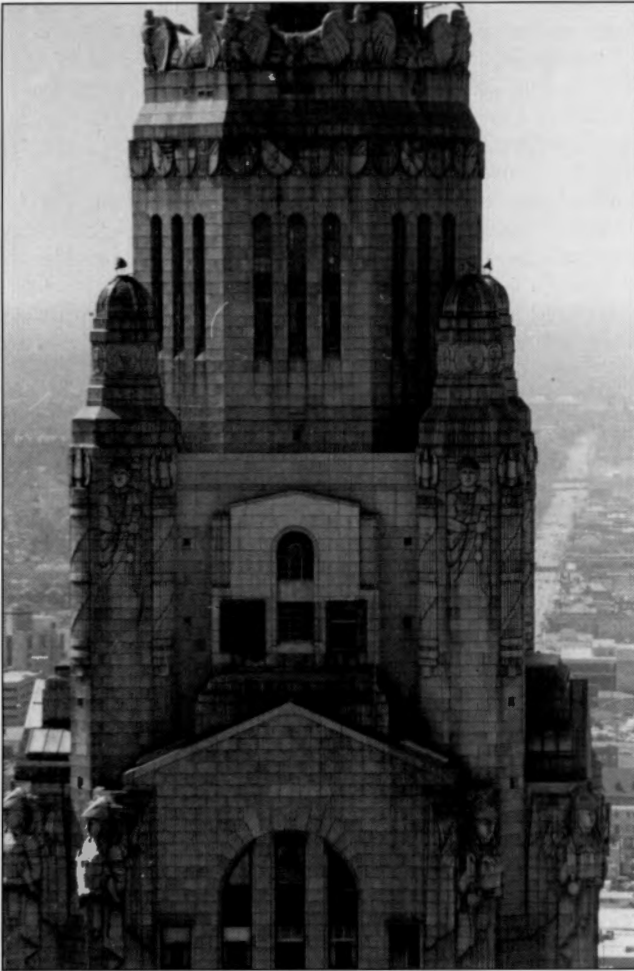
FIGURE 19.— Detail of terra-cotta sculptures on east side of LeVeque Tower. View from Rhodes Tower, 1986.

The 55-story LeVeque Tower (fig. 19), formerly known as the AIU (American Insurance Union) Building, at 50 West Broad Street, is as tall as the Washington Monument. The tower, built in 1924-27, is commonly called the first aerial lighthouse in the country because it served as a guide to aviators. For many years it was the only skyscraper in Columbus. It was the first to have a caisson foundation to bedrock. It is constructed of concrete; 10,000 tons were required to form the skeleton. Terra-cotta in a white oak pattern covers the concrete. Weathering through the years has made it necessary to remove some of the decorative terra-cotta and to replace some of the surface.

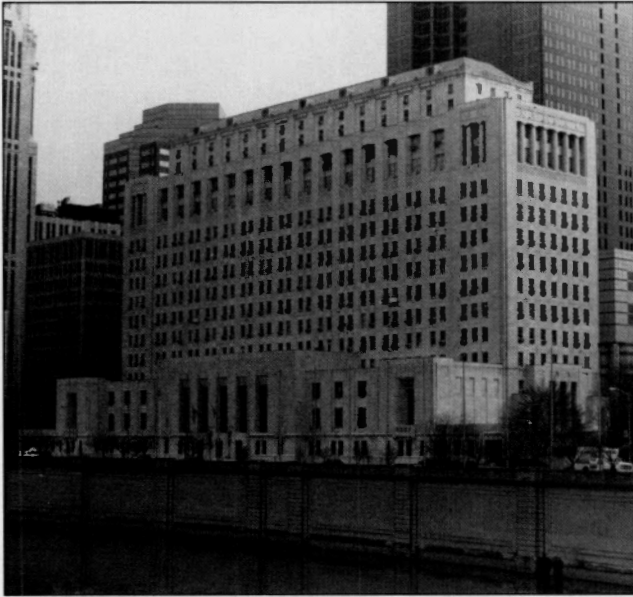
FIGURE 20.—Departments of State Building at 65 South Front Street. The Scioto River is in the foreground. In the background, the Riffe Center is on the far right next to the Huntington Center; at far left is the LeVeque Tower.

Three gleaming white *Georgia marble* (Murphy Marble) buildings constitute an important part of the Civic Center complex overlooking the Scioto River. The central building (fig. 20) is at the foot of State Street at 65 South Front Street. The Ohio Department of Transportation Building is to the north at 25 South Front Street;

The original (central) building was constructed from 1931 to 1933, at a cost of \$6 million, and was considered one of the finest state office buildings in the country. It was faced with gleaming white marble from the Georgia Marble Company of Nelson, Georgia. This coarse-grained, **metamorphosed** limestone (McCallie, 1907) of Cambrian age was installed with the Zibell Anchoring System, a new concept in marble application developed by the Georgia Marble Company. Construction was hampered by previously laid city water and sewer lines, and a gas leak caused a terrific explosion and devastation even before the building was completed.

At the time of its construction this building was large enough to house all the departments of state, but by the early 1960's it was too small. The two adjacent buildings were completed in 1967. The two newer ones are also faced with *Georgia marble*. Their plazas and the lobbies are decorated with white marble and sharply contrasting walls of so-called "black granite." This stone is larvikite, from Larvik, Norway. It is an attractive black igneous rock composed mainly of feldspar and augite. The blue crystals consist of two intergrown feldspars, oligoclase and soda microcline or **orthoclase** (Slagle, 1982).

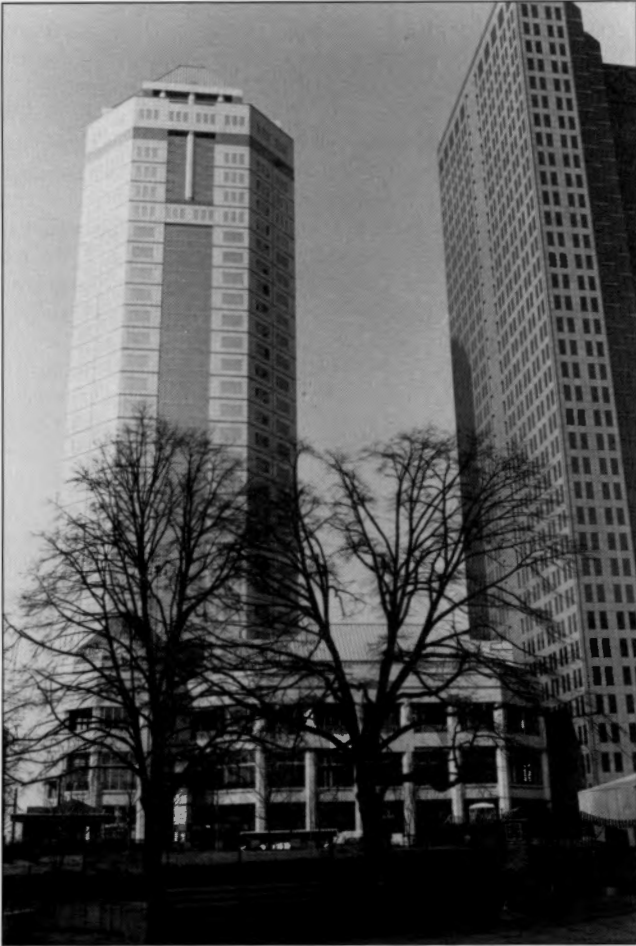
FIGURE 21.— The Vern Riffe Center for Government and the Arts. View west from Capitol Square.

The 503-foot-high Riffe Center (fig. 21), also called the Riffe Tower, was completed in 1988 at the northwest corner of State and High Streets. The building contains state offices, including the offices of the Governor and the House of Representatives, several theaters, an art gallery, a day-care center, and a restaurant. The architects, BOHM-NBBJ, used a stone-faced precast-concrete wall system. The stone was supplied by Formai and Mariani of Carrara, Italy.

The interior of the building contains limestone and travertine. The reddish-brown stone is polished *Rojo Alicante marble*, a limestone of Jurassic age from Alicante, Spain; it is used in the base of and in accent strips on the wall. Most of the wall is a buff travertine, *Geneva Creme*, which has either a honed or satin-smooth finish. The floors in the lower levels of the building are also *Geneva Creme travertine* (also known as *Classic Roman travertine*); slightly darker *Rojo Alicante marble* is used as insets. There are fossils, including cephalopods, in the *Rojo Alicante*.

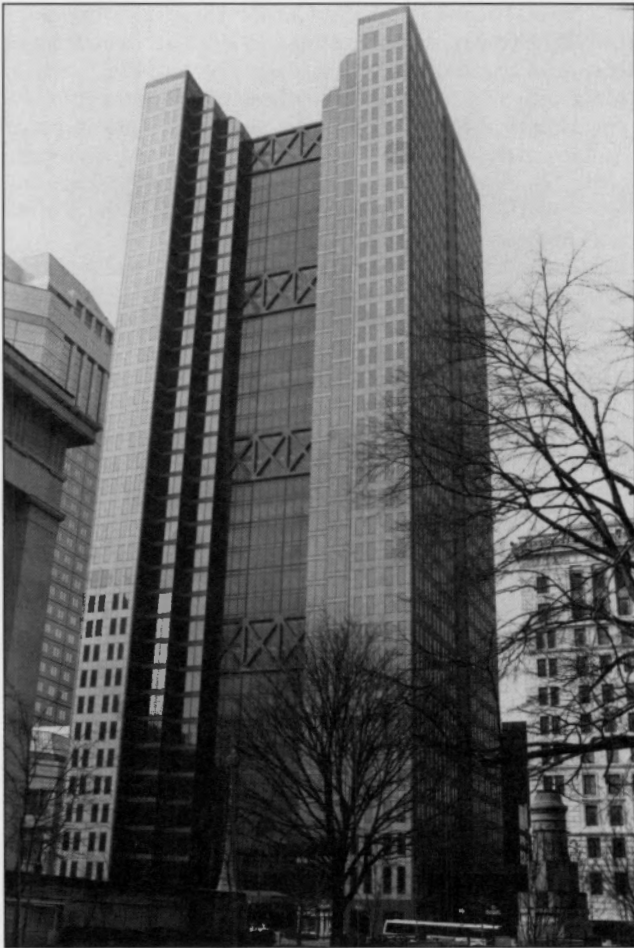
FIGURE 22.—Huntington Center. View from Capitol Square.

In 1984 the Huntington Center (fig. 22) was constructed on the site of the Neil House hotel at 41 South High Street, directly west of the axis of the Capitol rotunda. It has 37 floors and 1 million square feet of space.

The lower, street, and gallery levels feature travertine floors trimmed in the granite, accented with highly polished bronze escalators, revolving doors, and handrails. The gallery floor is white *Italian travertine* and *Colorosa travertine*. The latter is a Quaternary-age stone from Colorado.

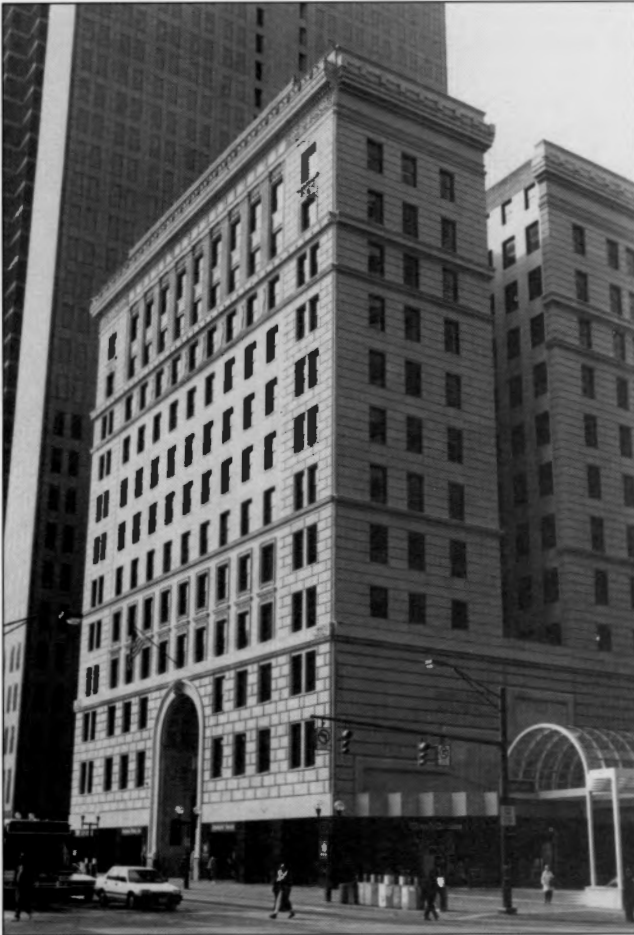
FIGURE 23.—Huntington National Bank.

This original building (fig. 23) of the Huntington National Bank, at 17 South High Street, was completed in 1926. It is constructed of buff brick and has a front facade of gray granite and sharply contrasting "black granite" (larvikite). This dark, highly polished rock contains large crystal faces of anorthoclase in a dark matrix; however, the blue luster is not as well developed as that of the larvikite in the Departments of State Buildings (Stop 15). *Tennessee marble* is used extensively on the interior floors and walls; the floor of the outer lobby is now covered with *Italian travertine*. Of special note in the spacious bank lobby is the ornate ceiling designed by Tiffany.

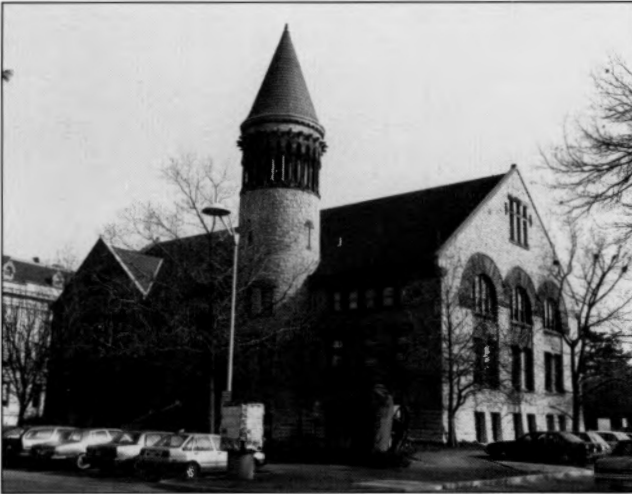
FIGURE 25.—Orton Hall at The Ohio State University. Five different Ohio building stones, arranged in stratigraphic order, were used on the exterior.

Orton Hall (fig. 25), on South Oval Drive on the campus of The Ohio State University, reflects Ohio's geological history. It was completed in 1893 at a cost of \$102,000 and was designed to house the Department of Geology, the Geological Museum, and OSU's main library. The building's structure and design were conceived by Dr. Edward Orton, the first president of the university and State Geologist of Ohio (1892-1899). About five different kinds of stone are used on the exterior and more than 30 in the interior, most readily visible as columns in the vestibule; all are native to Ohio. The design is Richardson Romanesque Revival, a style noted for its massive blocks of stone.

The front steps of Orton Hall, originally of highly fossiliferous Columbus Limestone from the Marble Cliff quarry on Trabue Road, were replaced in the 1960's with Salem Limestone (*Indiana limestone*). As Orton Hall was designed to use Ohio materials, from the clay in the floor tiles to the exterior building stones, this change was not appreciated by some local geologists. More recent renovation has received the assiduous attention of Charles Summerson of the OSU Department of Geological Sciences. Columbus Limestone can still be seen on the east margin of the steps and on the wainscoting of the front hall.

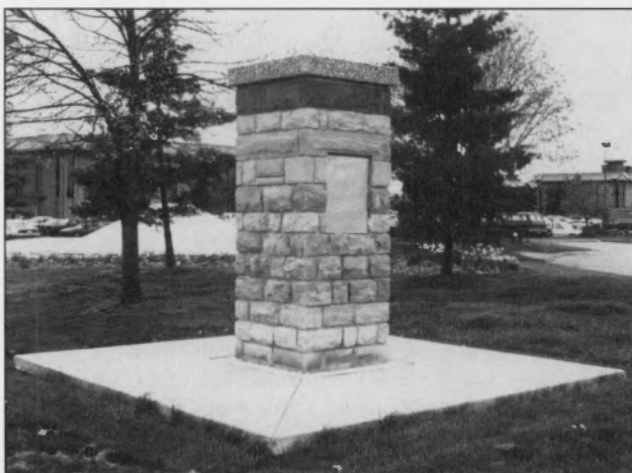
FIGURE 26.—Earth Day (1990) Monument at Fountain Square.

If time and transportation are available, take a side trip to see the Ohio Department of Natural Resources Earth Day 1990 Monument (fig. 26) at Fountain Square, south of Morse Road just east of Northland Mall. The monument is a geologic column consisting almost entirely of Ohio building stones (fig. 27). It was built with donations, including material, time, and labor, from the mining and construction industries and the geological and educational communities of Ohio. The monument was designed by Linda Gaertner and built by Ralph Styers. A time capsule in the monument commemorates the 20th anniversary of the first Earth Day.
