THE EROSION OF A CHANNELIZED STREAM
IN AN URBANIZED BASIN AT
WINDING HOLLOW COUNTRY CLUB, COLUMBUS, OHIO

A Senior Thesis

THE OHIO STATE UNIVERSITY
DEPARTMENT OF GEOLOGY AND MINERALOGY

1978

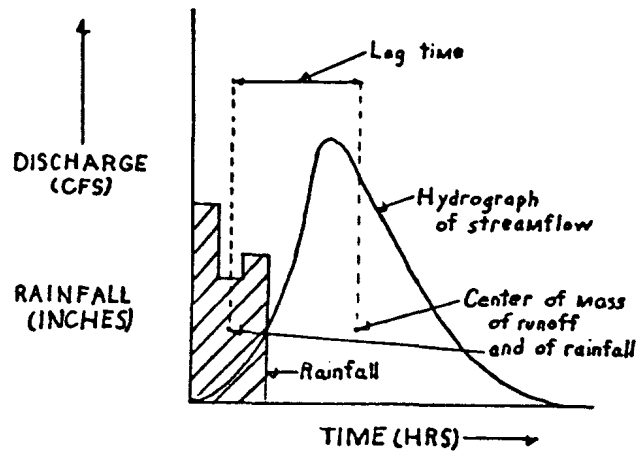
Figure 1. Hypothetical unit hydrograph of an undisturbed basin. (Leopold, 1963.)

Figure 1 is a hypothetical unit hydrograph taken from Leopold (1963) representing an undisturbed basin. One significant parameter which relates the storm and runoff is the lag time. Lag time is the interval between the center of mass of rainfall and the center of mass of the resultant hydrograph. Lag time is a function of the mean basin slope and basin length.

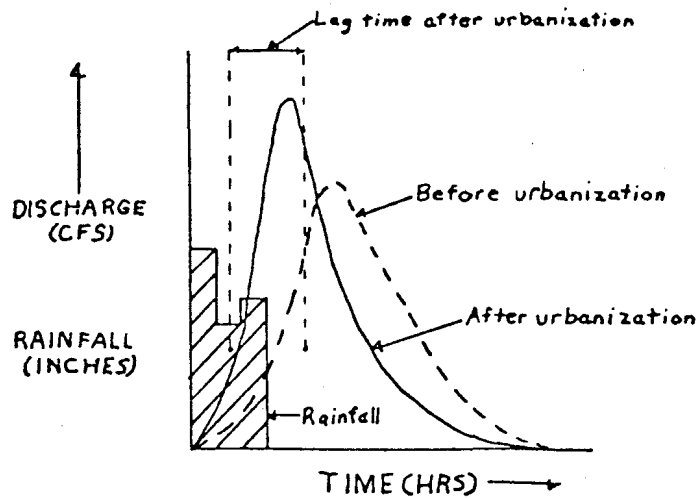
Figure 7. Hypothetical unit hydrograph of a basin before and after urbanization. (Leopold, 1963.)

With a great volume of runoff being channeled artificially, the current velocity increases, thus allowing more runoff to the stream in a shorter period of time. As Figure 7 of the unit hydrograph indicates, for any given storm the lag time is less and the peak discharge is greater within an urbanized basin.

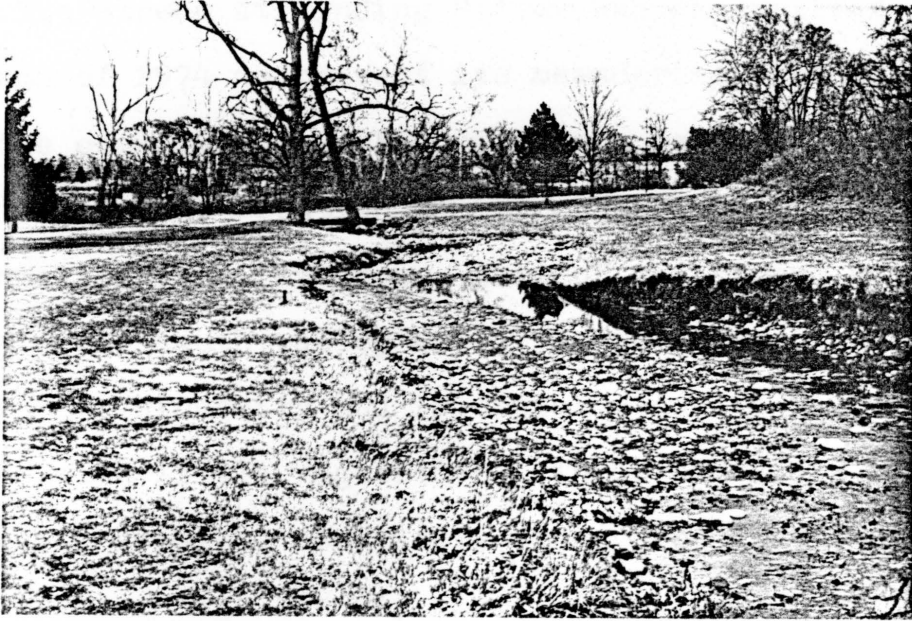
8A. Normal flow of stream before rainfall.

8B. Overbank flow of stream after heavy rainfall.

Figure 8. Flooding in the Winding Hollow Drainage Basin.

In recent years, there has been a significant increase of urbanization within the Winding Hollow drainage basin. Appendix I discusses the methods of determining percentage of urbanization and impermeable surfaces. For example, in 1955 the study area was estimated to be 10 percent urbanized with 2.16 percent of the surface being impermeable. Today the basin is estimated to be 69 percent urbanized with 14.9 percent impermeable surface. This increase in urbanization contributes to a greater amount of discharge in the basin for any particular storm by means of more runoff and a higher current velocity. Therefore the potential for increased erosion and more flood peaks has been intensified. Figure 8 shows an example of the more common place flooding which has recently occurred in the drainage basin.

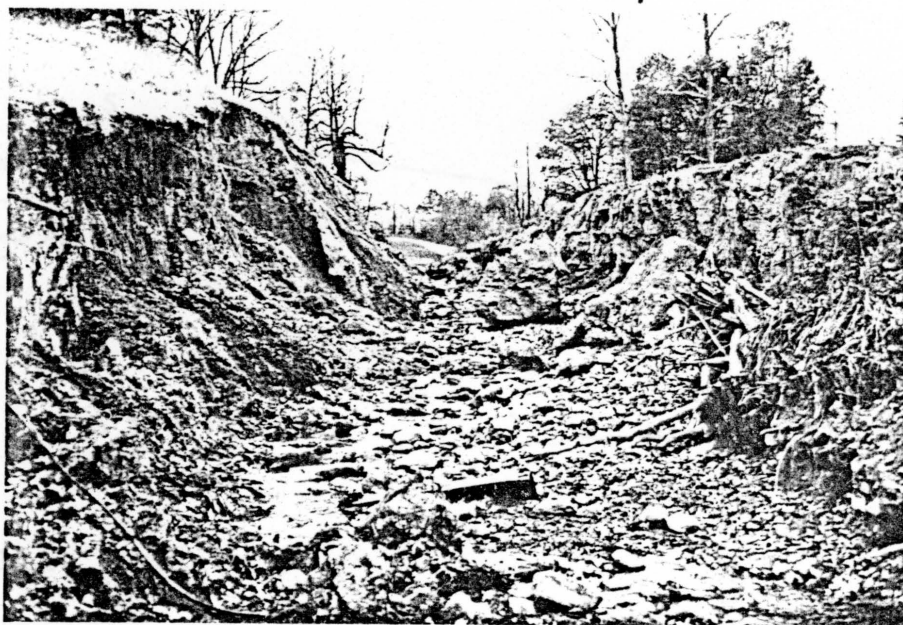
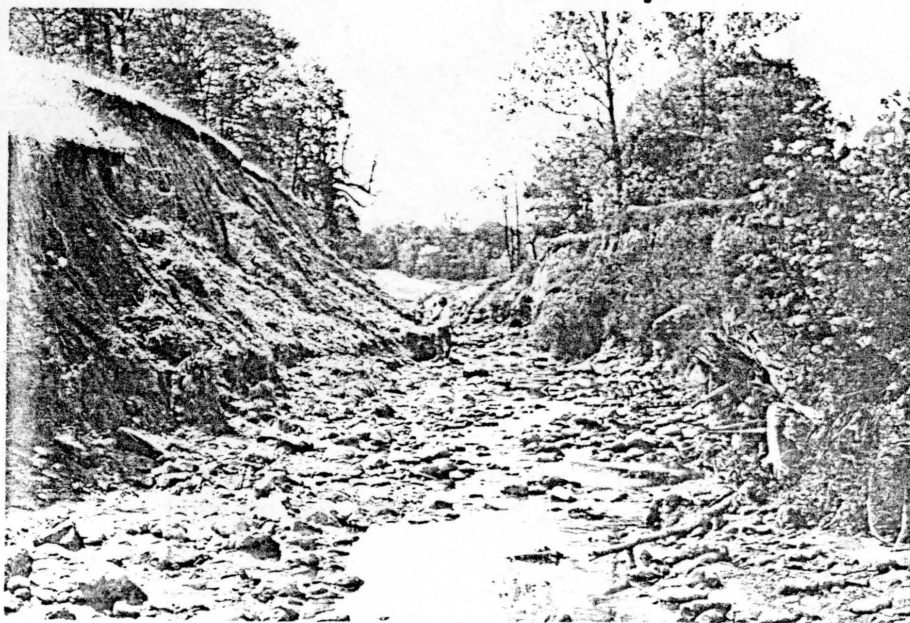
Figure 10A. Profile 5

Figure 10B. Profile 6

Figure 10. Changes in the Stream Channel in the Areas of Profiles 5 and 6.

Figure 10C. Upstream view of Profiles 5 and 6 in December, 1976. Banks are steep and large blocks of material have fallen into the stream.

Figure 10D. Upstream view of Profiles 5 and 6 in August, 1977. Banks are less steep and smaller material slides into the stream.

Profiles 5 and 6 (Figure 10) represent the two areas that exhibited the greatest amount of erosion. The volume of material that eroded between these two areas is estimated to be approximately 25,555 feet.³ A similar area, as shown in profile 3 (Figure 11) is located further downstream and has also lost a large amount of material. These areas have eroded greatly because of the stream channelization within the unstable south valley wall. At these locations, the till walls occur on a slope and are high and steep with little vegetation. Therefore the walls are very susceptible to hydraulic action and mass movement. Figure 12 reveals a slump structure that occurs in the area of profile 3. The structure was observed during the first Spring after channelization (1974) and was probably caused by saturation of

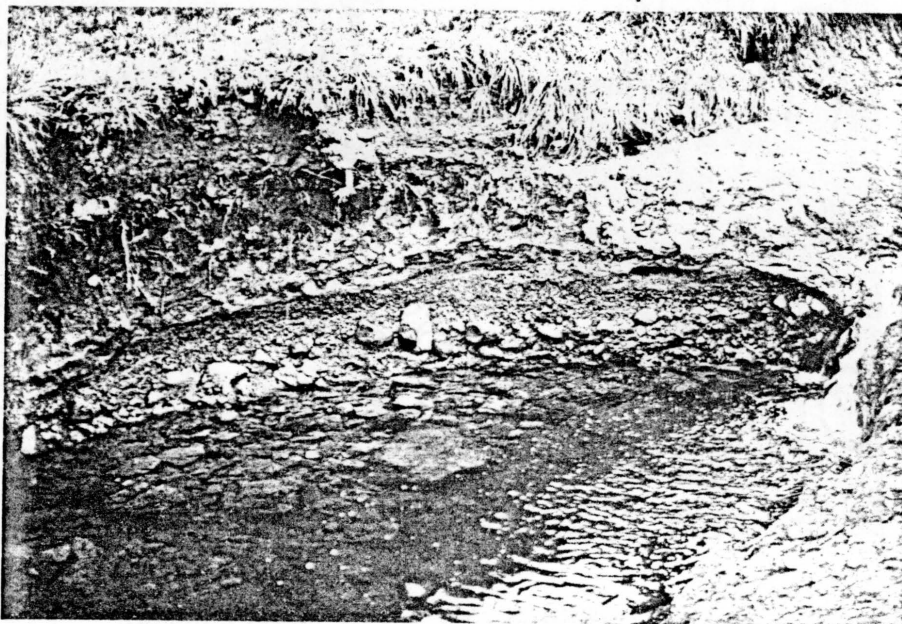
Figure 13A. Profile 7.

Figure 13. Changes in the Stream Channel in the Profile 7 Area.

Figure 13B. View of carbonate layer overlying an older bed of unconsolidated sand and gravel.

Areas which have been channelized, but are located in the valley, have also undergone erosion. These more stable locations have had less material removed. (Table 3) Profile 7, however, is an exception to erosion in the channelized valley areas. As shown in Figure 13, the carbonate till channel bottom is downcut to an older bed of unconsolidated sand and gravel. This underlying channel fill is easily eroded when exposed.

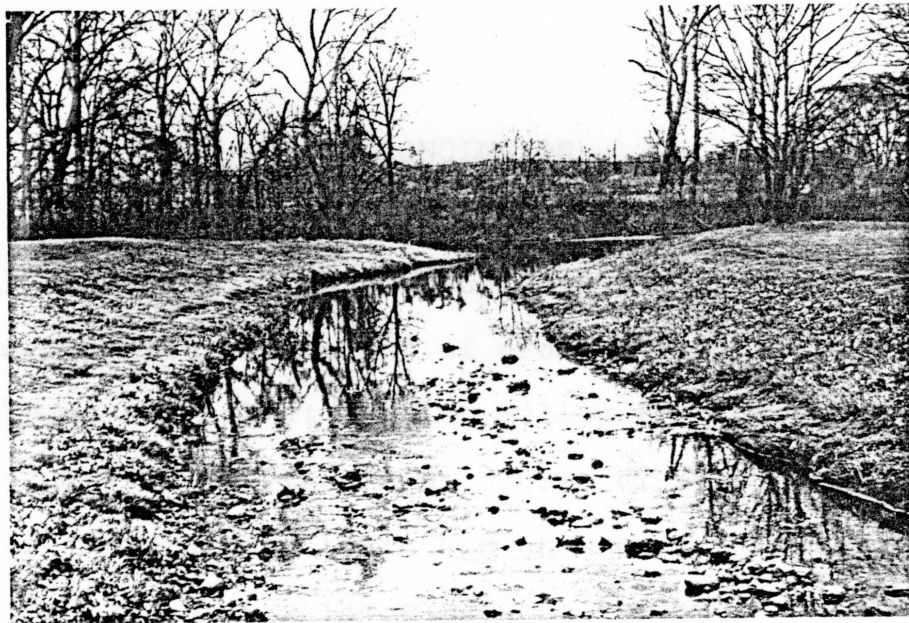
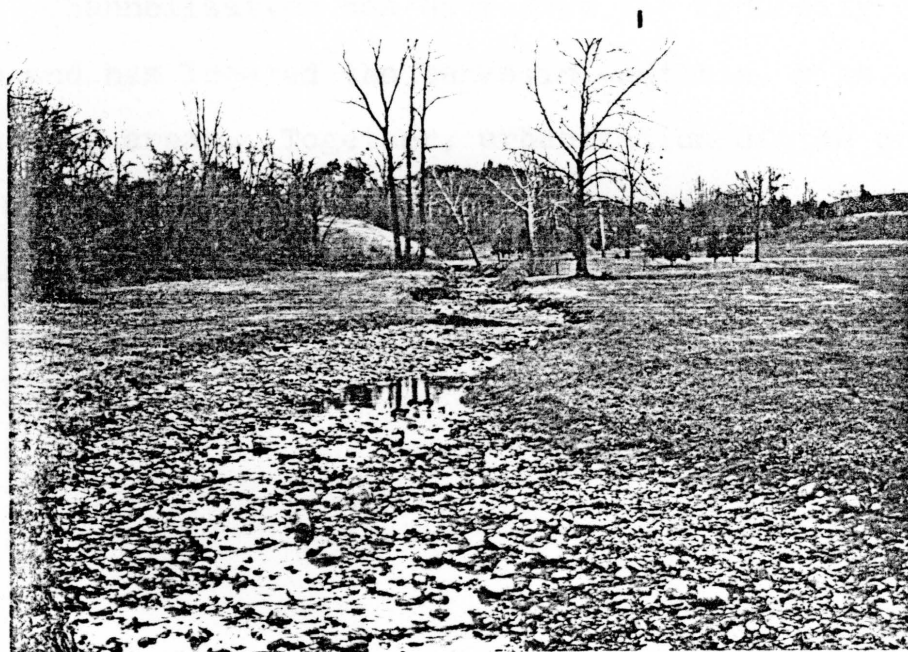
Figure 15A. Downstream view of the Profile 1 area.

Figure 15B. Upstream view of the Profile 2 Area.

Figure 15. Areas Downstream From Channelization.

The two profile areas downstream from channelization underwent little change during the monitoring period. Profiles 1 and 2 (Figure 15) exhibit the least amount of erosion in the study area. These low sloping vegetated banks, characteristic of the unchannelized areas, are more resistant to erosion processes.

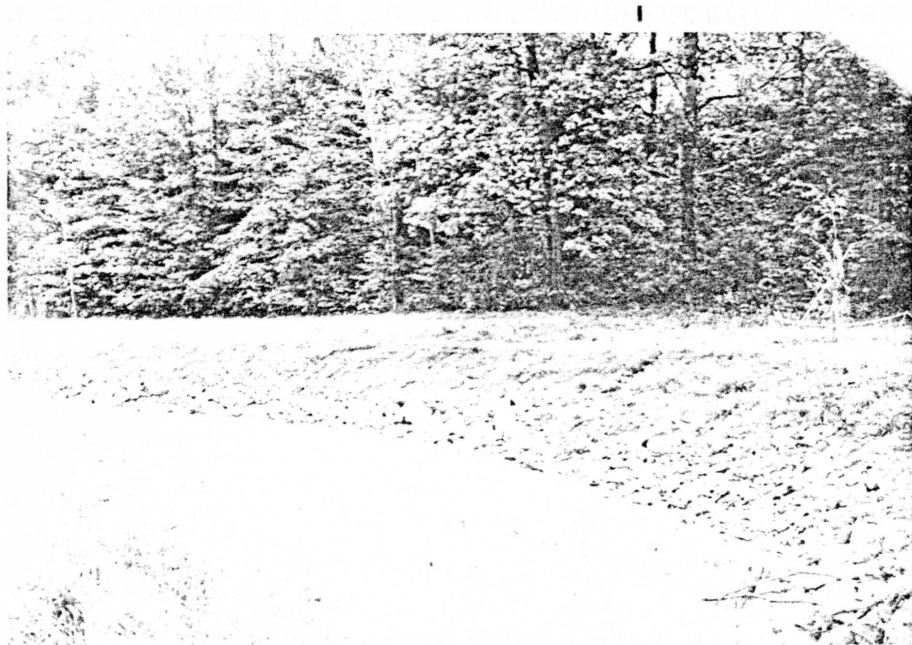
Figure 16. Reinforcement of banks and channel with limestone riprap.

The most economical and feasible way to reduce erosion in the channel is to pile limestone riprap along the banks and bottom such as in Figure 16.
