Geological Note No. 7

**MAPPING BEACH WIDTHS FOR THE OHIO PORTION  
OF THE LAKE ERIE SHORELINE ALONG COASTAL  
EROSION AREA PROFILE LINES, 1990 AND 2004**

by  
Erik R. Venteris, D. Mark Jones, and James McDonald

Columbus  
2012

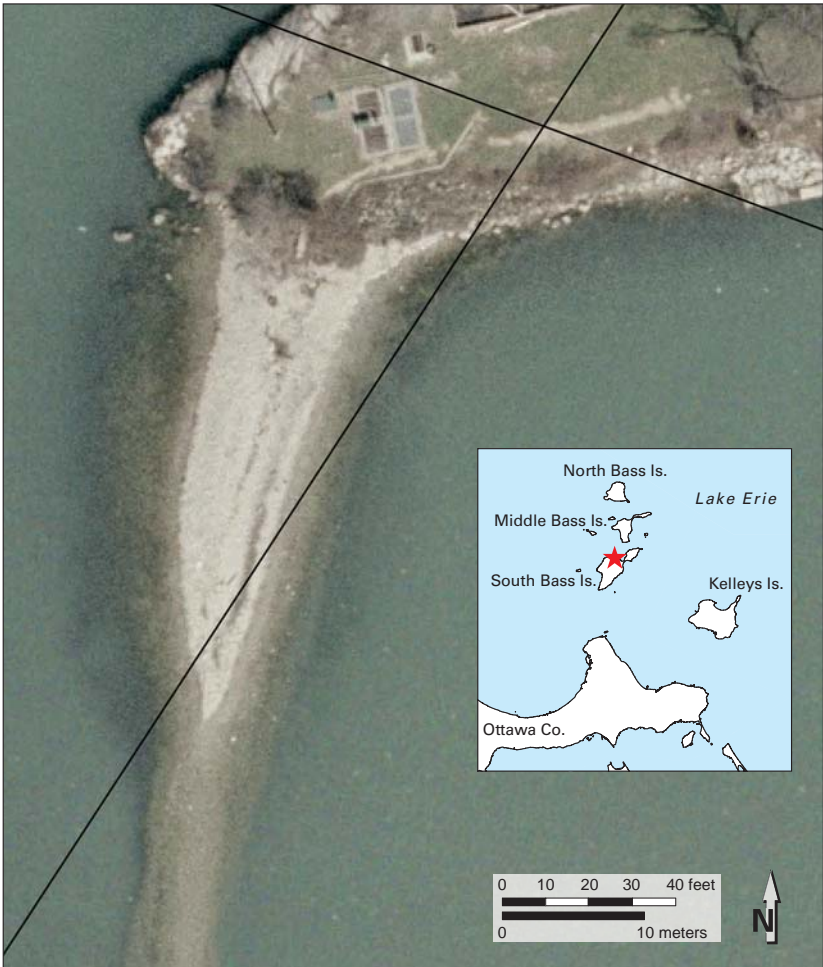
FIGURE 3.—Photo showing a Lake Erie Coastal Erosion Area transect that does not cross the beach in a meaningful way. Most such lines were established with a proper shoreline orientation, but later construction projects (in this case a jetty for a harbor) can render individual transects meaningless.

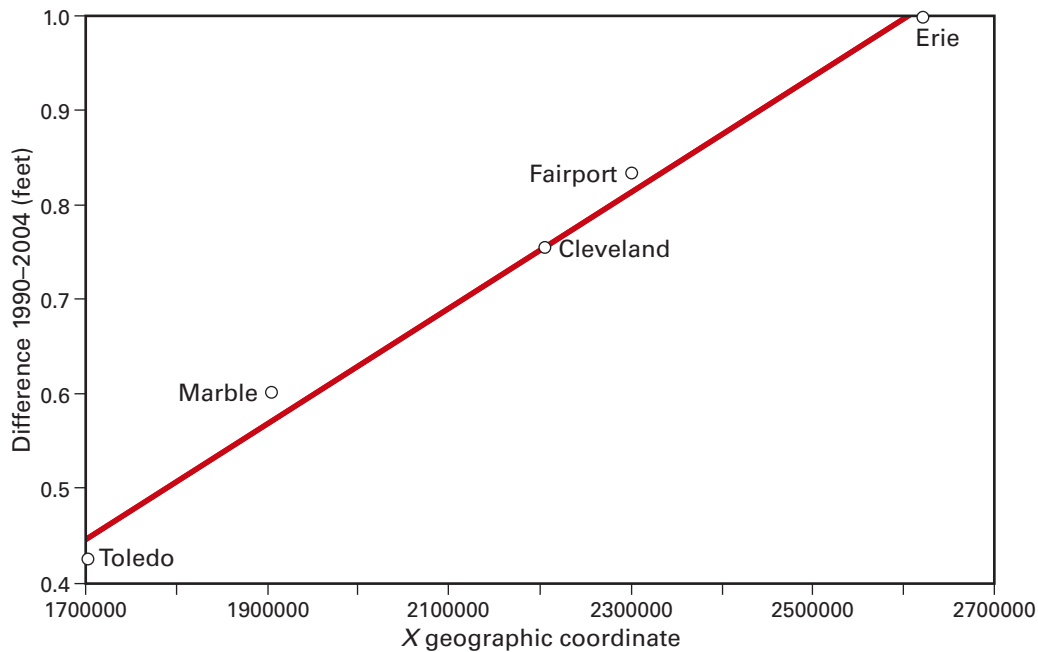
FIGURE 4.—Calibration curve predicting the difference in Lake Erie lake levels between 1990 and 2004, from the  $X$  geographic coordinate (Ohio State Plane North, feet). The lake did not undergo large changes in level from east to west during 1990. However, lake level increased towards the west during the 2004 photo dates, producing a clear trend in lake level change from east to west.

Changes in lake levels were determined using data from lake level gauges operated by the National Oceanic and Atmospheric Administration (NOAA, 2006), National Ocean Service and located at Toledo, Marblehead, Cleveland, and Fairport, Ohio. The Erie, Pennsylvania, station also was used because it is the closest station for a portion of the eastern Ohio shore. An average lake level was calculated for each station over the range of collection days for each year. (It is possible to correct only for differences in mean lake level and lake-wide, wind-driven events, not local wave conditions.) Lake levels were nearly constant from east to west for the 1990 data, but there was a wind-driven seiche event for 2004, with levels decreasing from west to east. The difference in lake levels between the dates—the lake level in 2004 ranged from 0.4 to 1.0 ft (0.1 to 0.3 m) less than in 1990—followed a very predictable west-to-east trend, allowing the lake level correction to be applied for each location using a linear regression based on the  $X$  geographic coordinate (fig. 4).

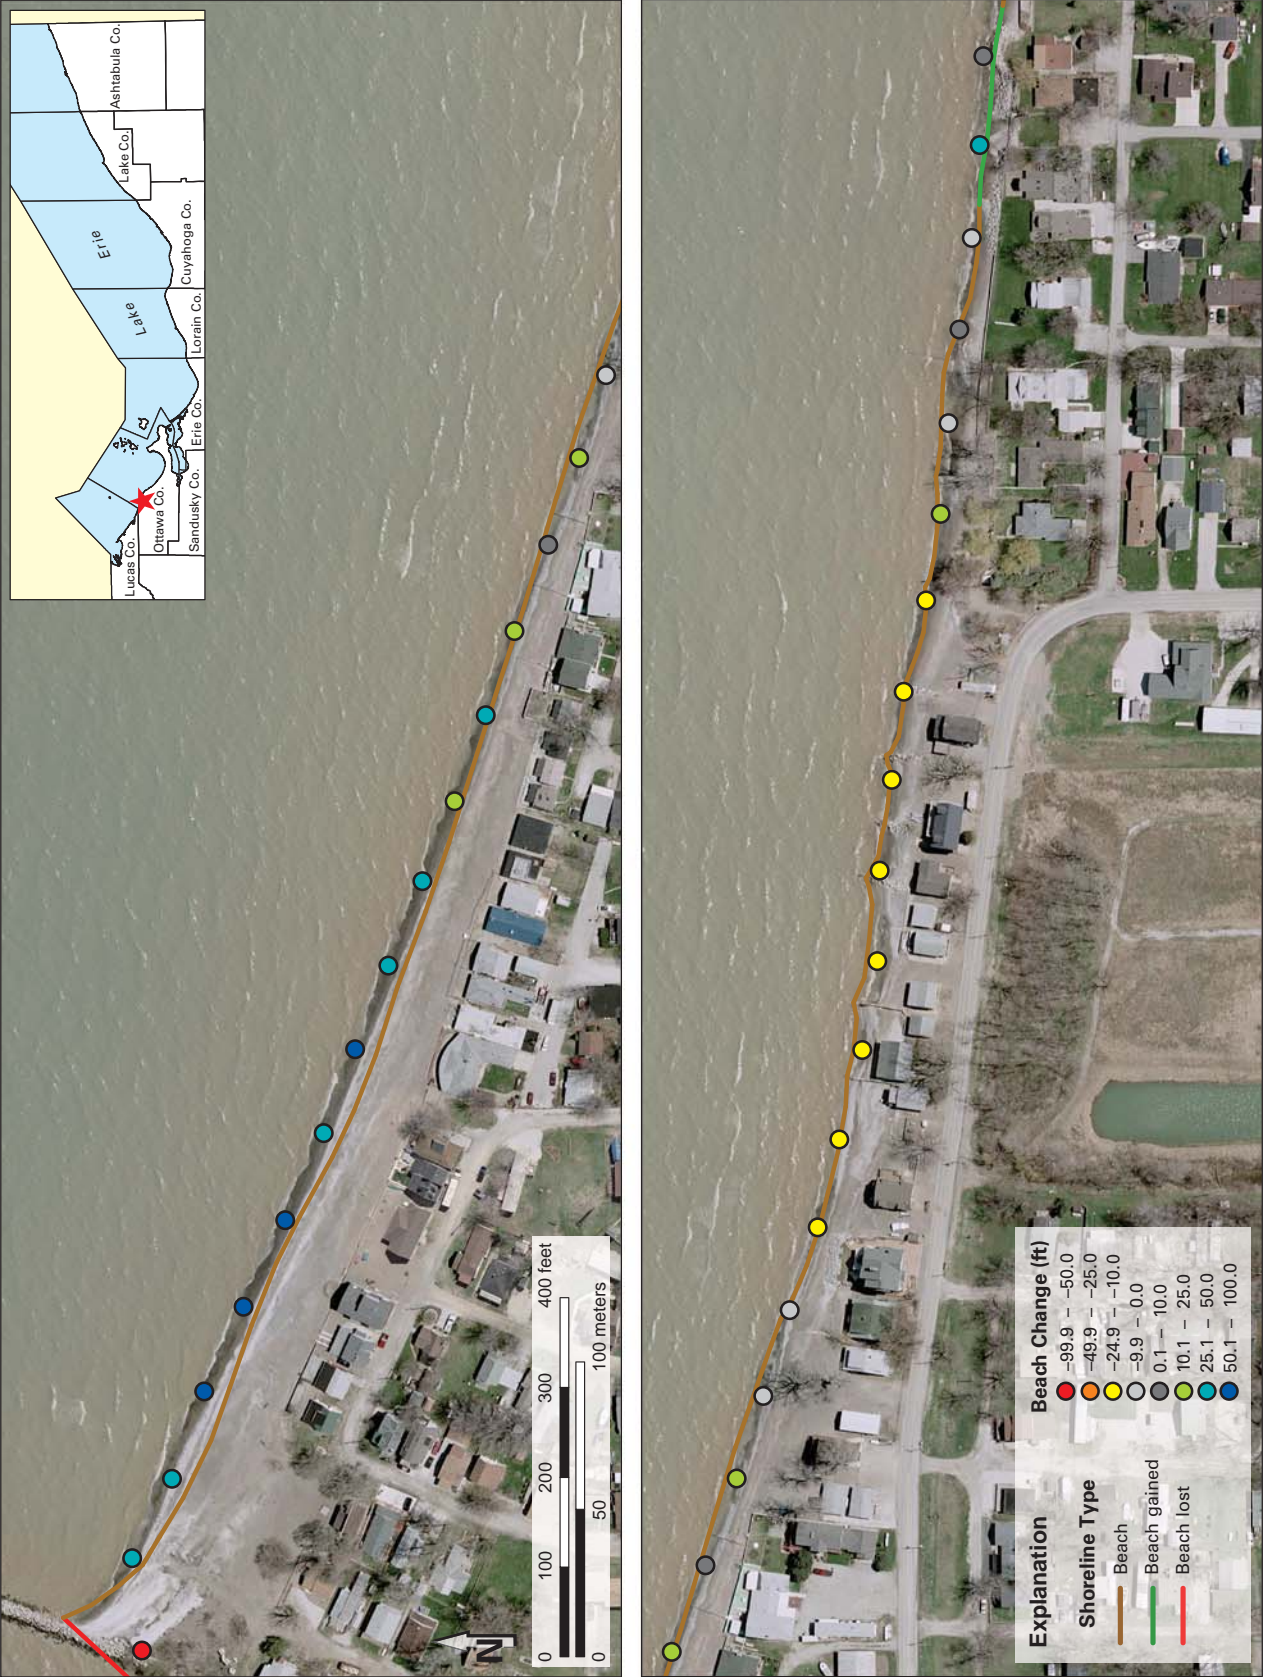
FIGURE 9.—Uncorrected Lake Erie beach width changes (in feet) and shoreline types superimposed on the 2004 color orthophoto, Ottawa County, Ohio. The panels should be read from left to right beginning with the top panel.

The second site is Locust Point in western Ottawa County (figs. 8–10). This location was chosen as a contrast to the Ashtabula County site, as it consists of a relatively wide, sandy beach and lacks a retreating bluff. Locust Point sits immediately west of a large and abrupt curvature in the shoreline (a surface expression of a bedrock high associated with the Findlay Arch). This curvature causes the longshore drift in the vicinity of Locust Point to diverge to both east and west, as suggested by published maps (Herdendorf, 1973; Mackey, 1996) as well as unpublished data on file with the Division of Geological Survey (Guy, 1994)<sup>3</sup>. Therefore, sediment transport is variable and may

occur to either the west or the east, most likely dependent on prevailing winds. Sedimentation patterns in the 1990 photo (fig. 8) suggest transport to the east. The area from 0 to 1,000 ft (0 to 300 m) east of the jetty (top frame, figs. 8 and 9) is generally one of beach growth and cannot be explained simply from lake level changes (fig. 10). The gains in beach width (fig. 10) are most likely the result of a reversal in longshore drift subsequent to the 1990 photo, augmented by the jetty at the west end of the upper frame. The groin system to the east shows a decrease in beach width (lower frame, figs. 8 and 9); the gains that occurred to the immediate west appear to have happened at the expense of the beach to the east. (In fact, between photo dates, complex changes in sediment deposition between the groins can be seen, especially in accumulation on the down-current side of the groins).

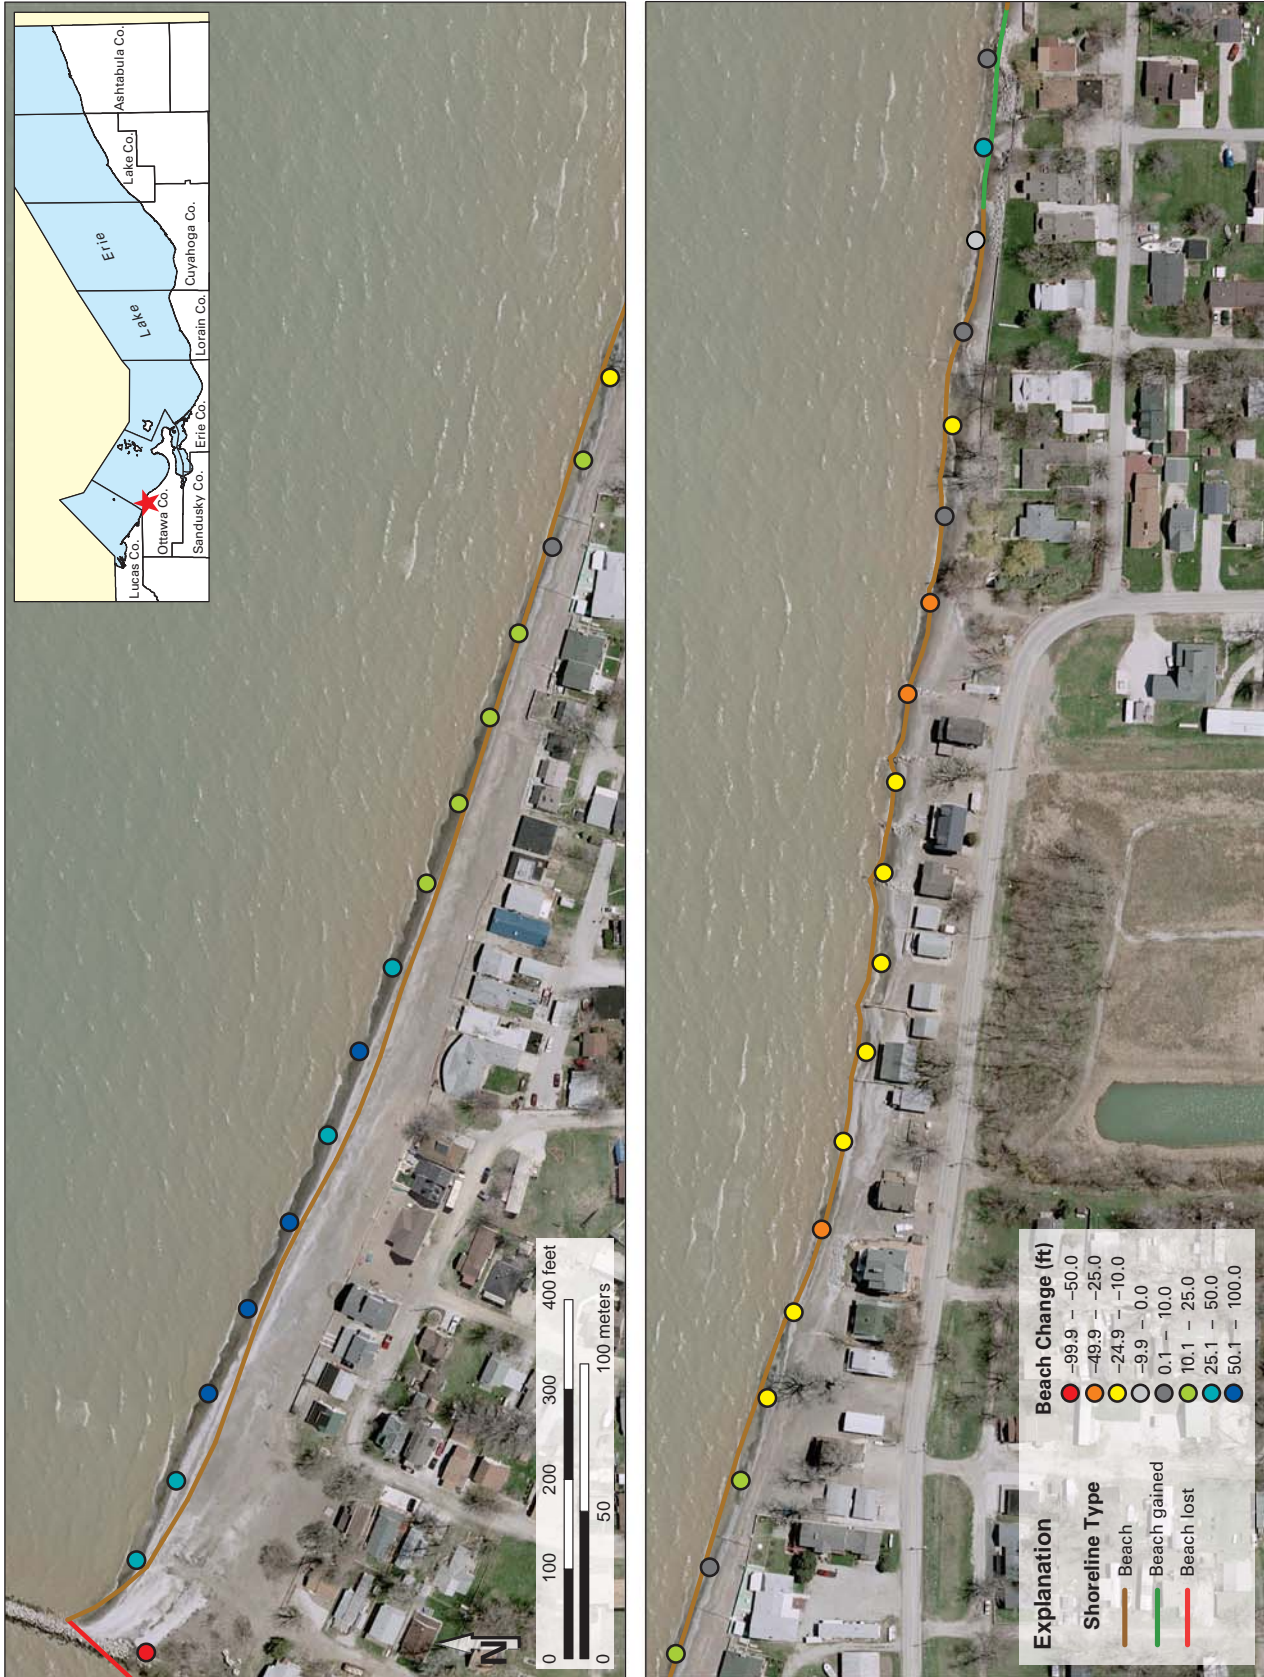
FIGURE 10.—Corrected (for lake level) Lake Erie beach width changes (in feet) and shoreline types superimposed on the 2004 color orthophoto, Ottawa County, Ohio. The panels should be read from left to right beginning with the top panel.

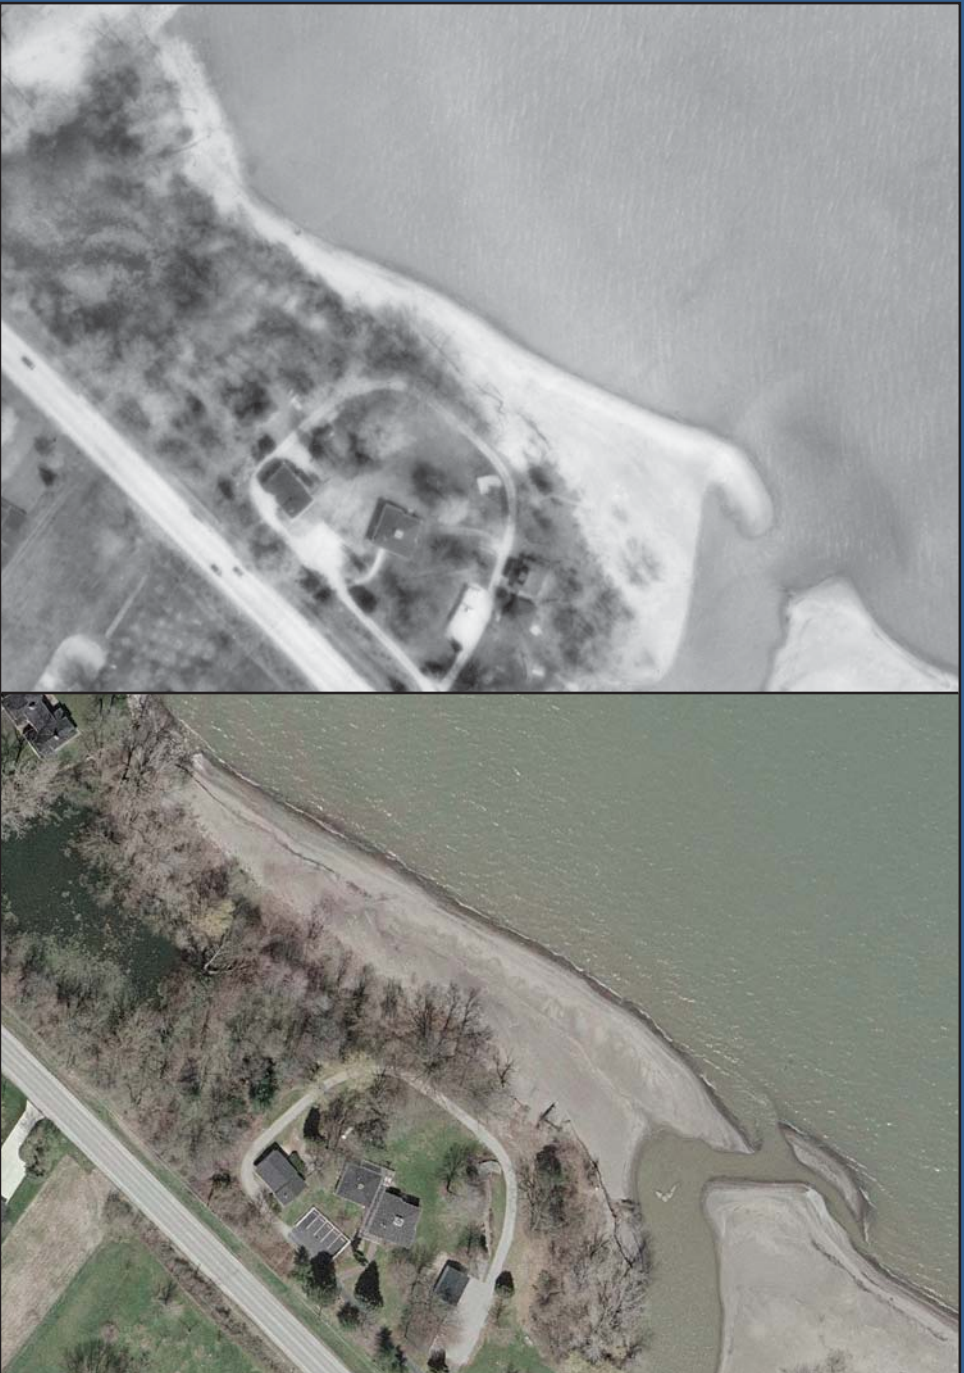
Back cover: Two aerial views of the mouth of Old Woman Creek showing the variability of beach width over time. In 1990 (top image), the beach was narrower, particularly towards its northwest end (upper left), than in 2004 (bottom image). Southeast of the creek's mouth, a barrier beach extends beyond the photograph to a total length of about 800 feet (244 meters; see front cover image).
