GUIDEBOOK NO. 21

GEOLOGIC SETTING AND PROCESSES ALONG LAKE ERIE FROM FAIRPORT HARBOR TO MARBLEHEAD, OHIO

originally prepared for the 2006 North-Central Section meeting of the Geological Society of America

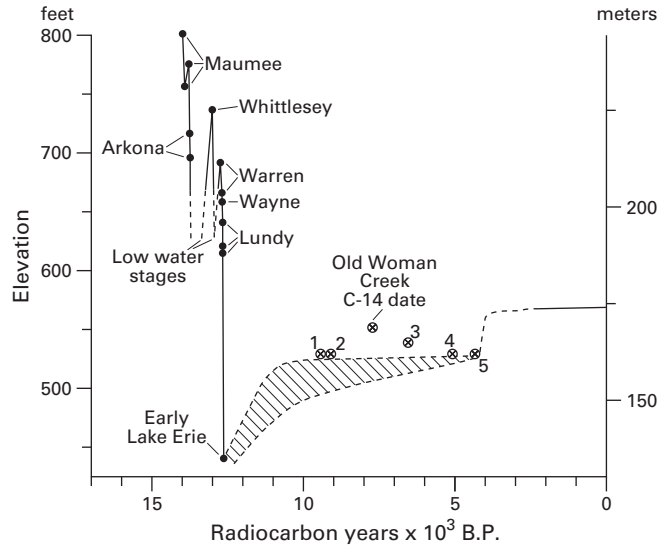
FIGURE 6.— Elevation of proglacial and postglacial lakes in the Lake Erie basin (modified from Forsyth [1959] and Lewis [1969] by Buchanan [1982]). Prominent stages of the proglacial lakes are named (Maumee, Whittlesey, etc.). Elevations of radiocarbon-dated material collected by Buchanan (1982) at Old Woman Creek shown by \circ .

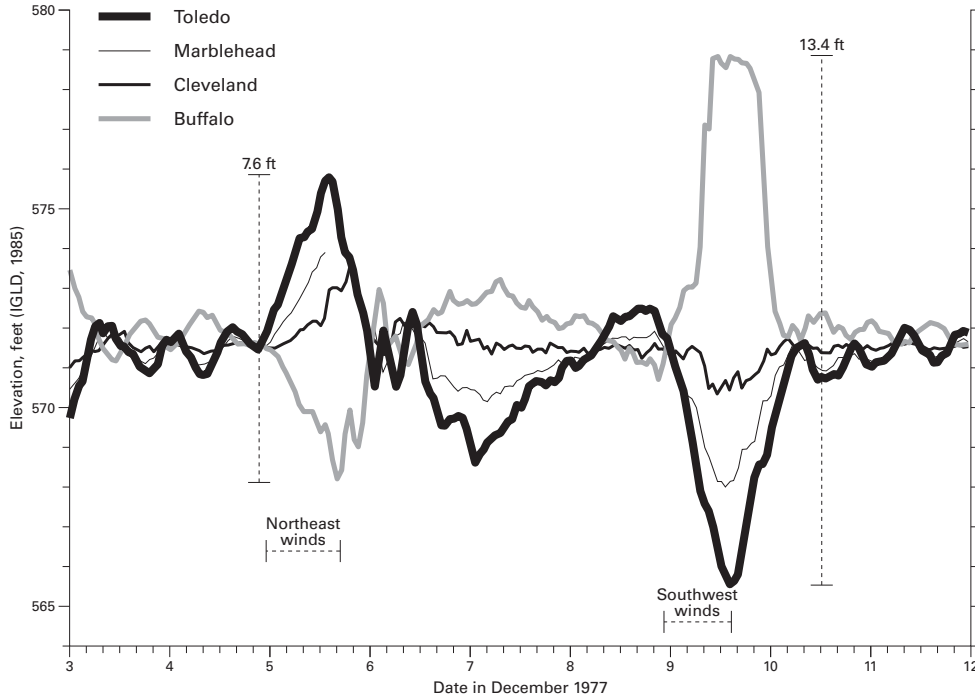
FIGURE 10.—Positive and negative Lake Erie storm surges at Toledo, Ohio, and Buffalo, New York. Smaller oscillations in lake level are inertial seiches with approximately 14-hour periods. Changes in lake level during these events cause flooding, hamper navigation, and promote exchange of water and nutrients in wetlands. Water level data are from NOAA (2006).

Negative storm surges occur at Toledo when strong southwest winds blow across the lake. On April 6, 1979, strong southwest winds lowered the lake at Toledo about 9 ft (2.74 m) and raised the level at Buffalo about 7.5 ft (2.29 m). The difference in lake levels at opposite ends of Lake Erie exceeded 16.5 ft (5.03 m). On December 2, 1985, strong southwest winds lowered the lake 8.5 ft (2.59 m) at Toledo and raised the lake at Buffalo 7.5 ft (2.29 m) to a record-high level (fig. 12). Negative storm surges at Toledo do not create erosion hazards, but they may temporarily hamper ships navigating in the Western Basin. Storm surges along the central part of the lake are less pronounced.

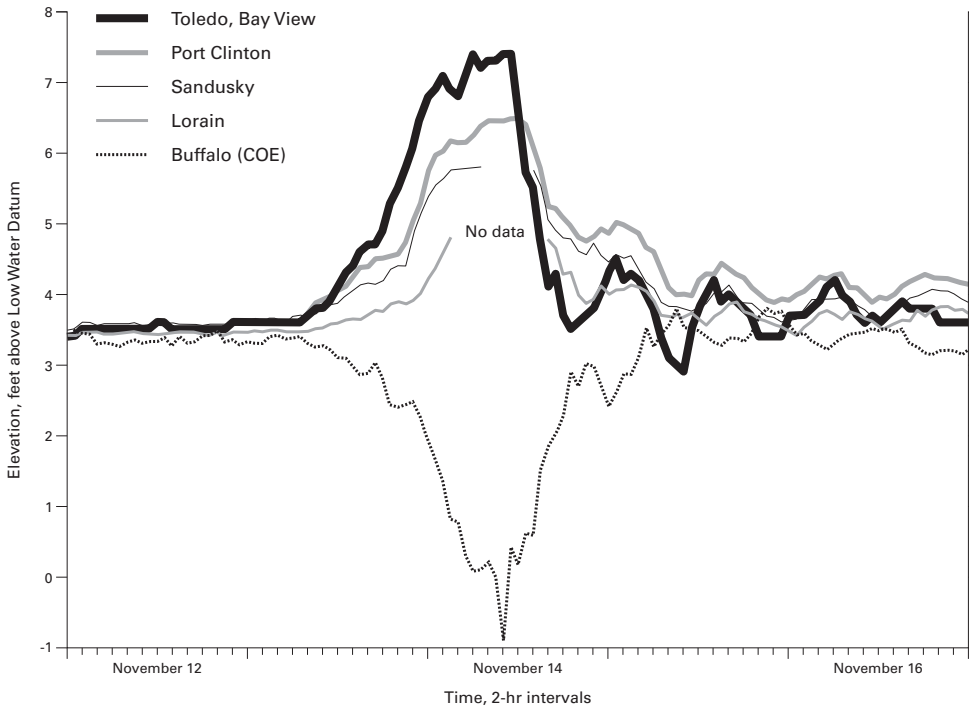
FIGURE 11.—Lake levels during a positive storm surge that breached the barrier beach at Sheldon Marsh (Ohio) on November 14, 1972. This storm caused extensive flooding in low-lying areas along the western shore of Lake Erie (see figure 14). The inertial seiche of water along the axis of Lake Erie can be seen in water levels for two days after the storm. Water level data from gages maintained by the U.S. Army Corps of Engineers and by the Ohio Department of Natural Resources, Division of Geological Survey. Low water datum is 569.2 feet (IGLD, 1985).

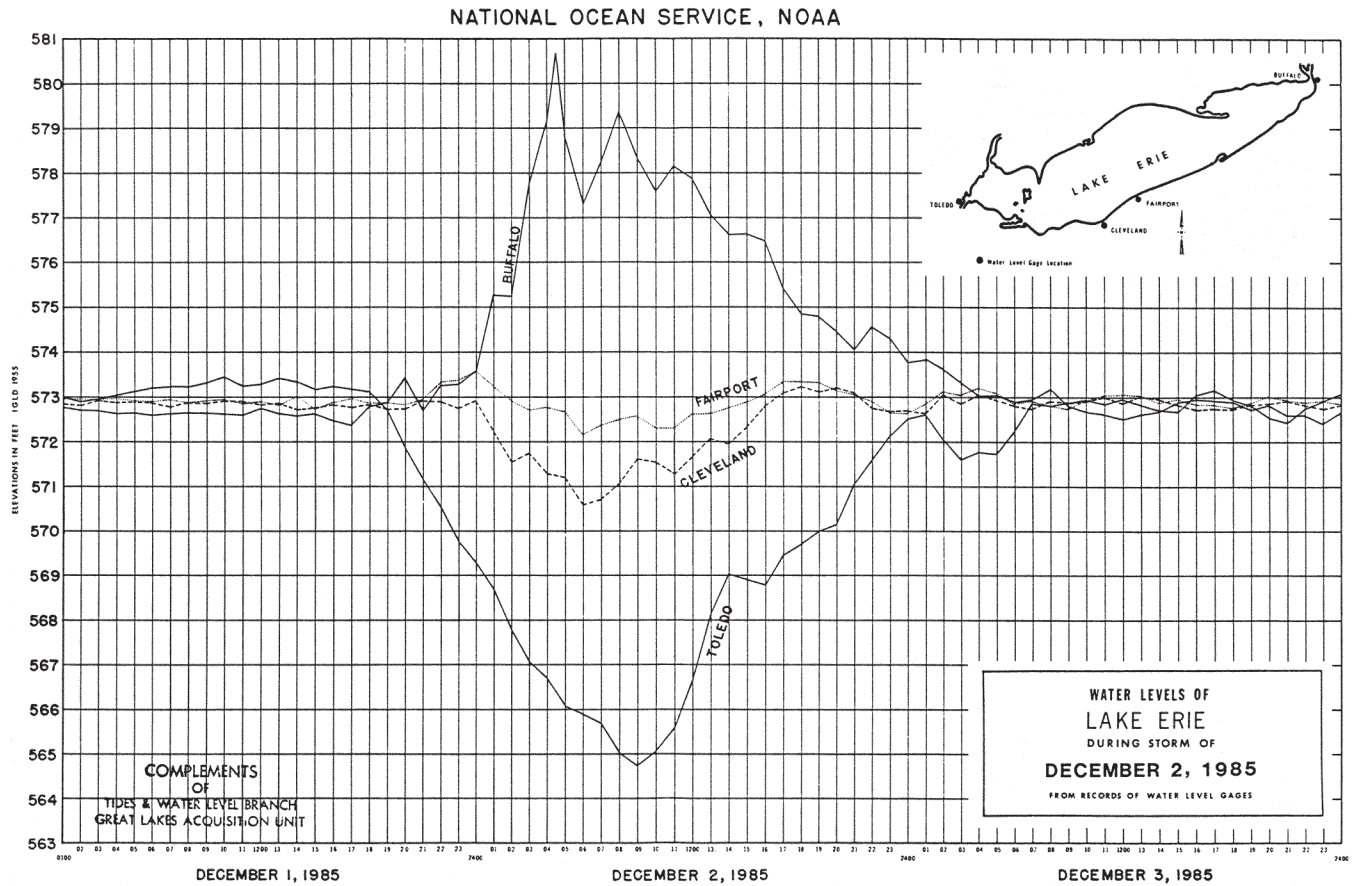
FIGURE 12.—Lake level during a storm on December 2, 1985 (from NOAA, 1985). Extremely strong southwest winds blew water to the east end of the lake, raising lake level at Buffalo, New York, and lowering lake level at Toledo, Ohio.

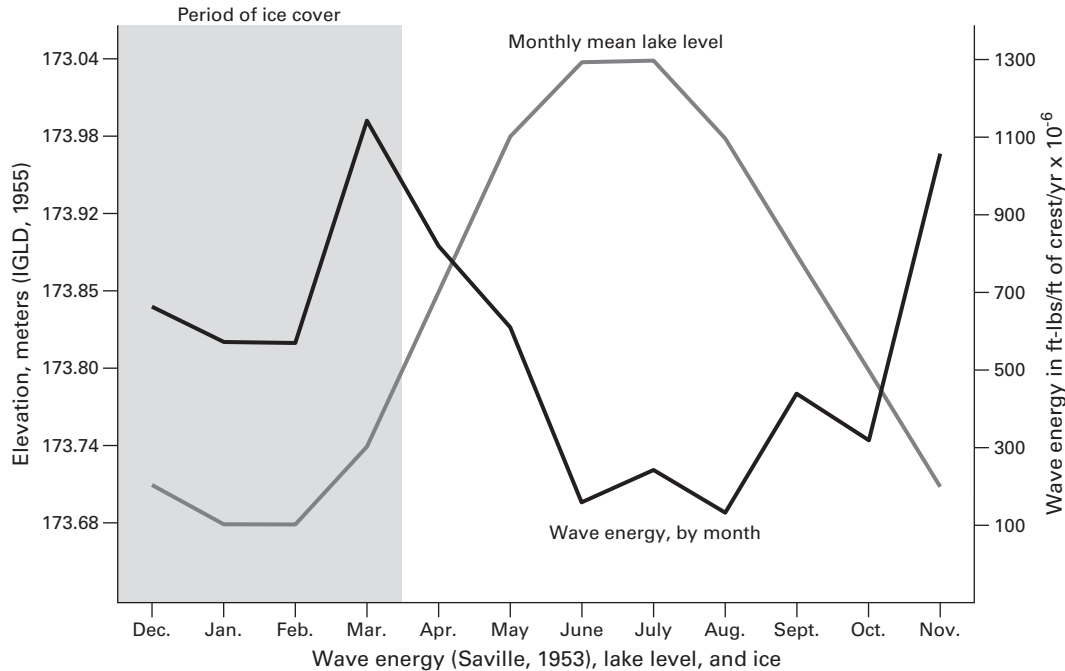
FIGURE 13.—Seasonal wave energy on Lake Erie (modified from Carter, Guy, and Fuller, 1981).

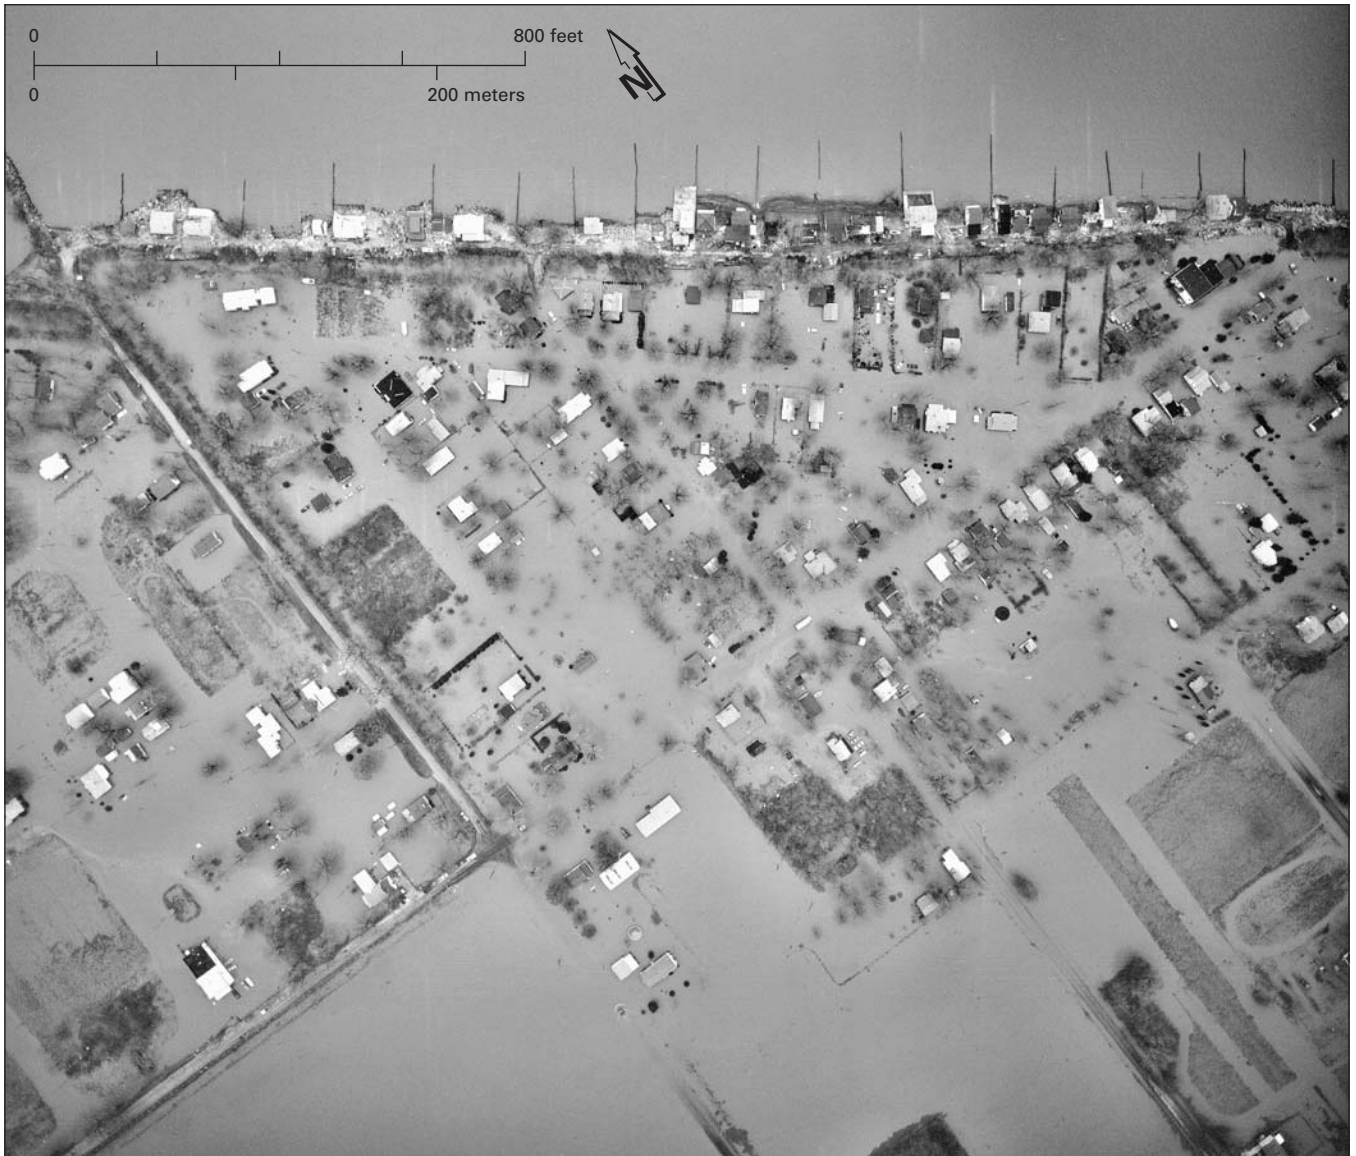
FIGURE 14.—Flooding in Reno Beach along western Lake Erie following storm of November 14–16, 1972. A plot of lake level during the storm is shown in figure 11. Aerial photograph taken November 16, 1972, by the Ohio Department of Transportation.

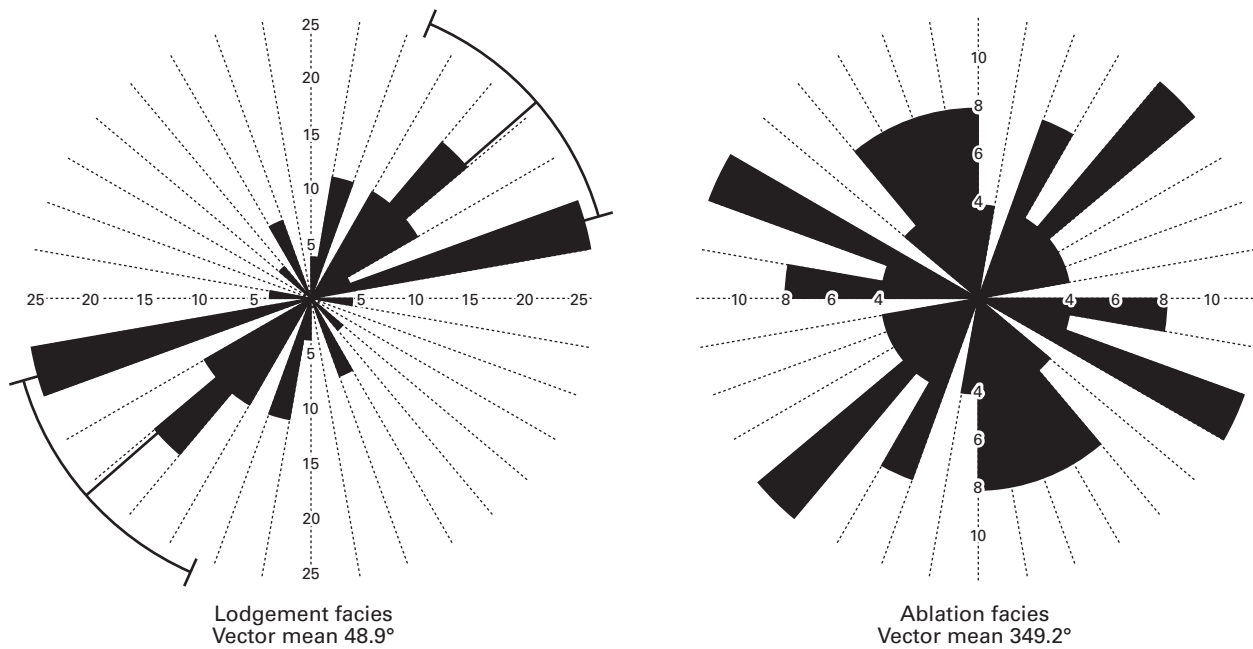
FIGURE 17.—Orientation of clasts in lodgment and ablation till at Painesville, Ohio (modified from Stone, 1994). Units on graphs are percentages.

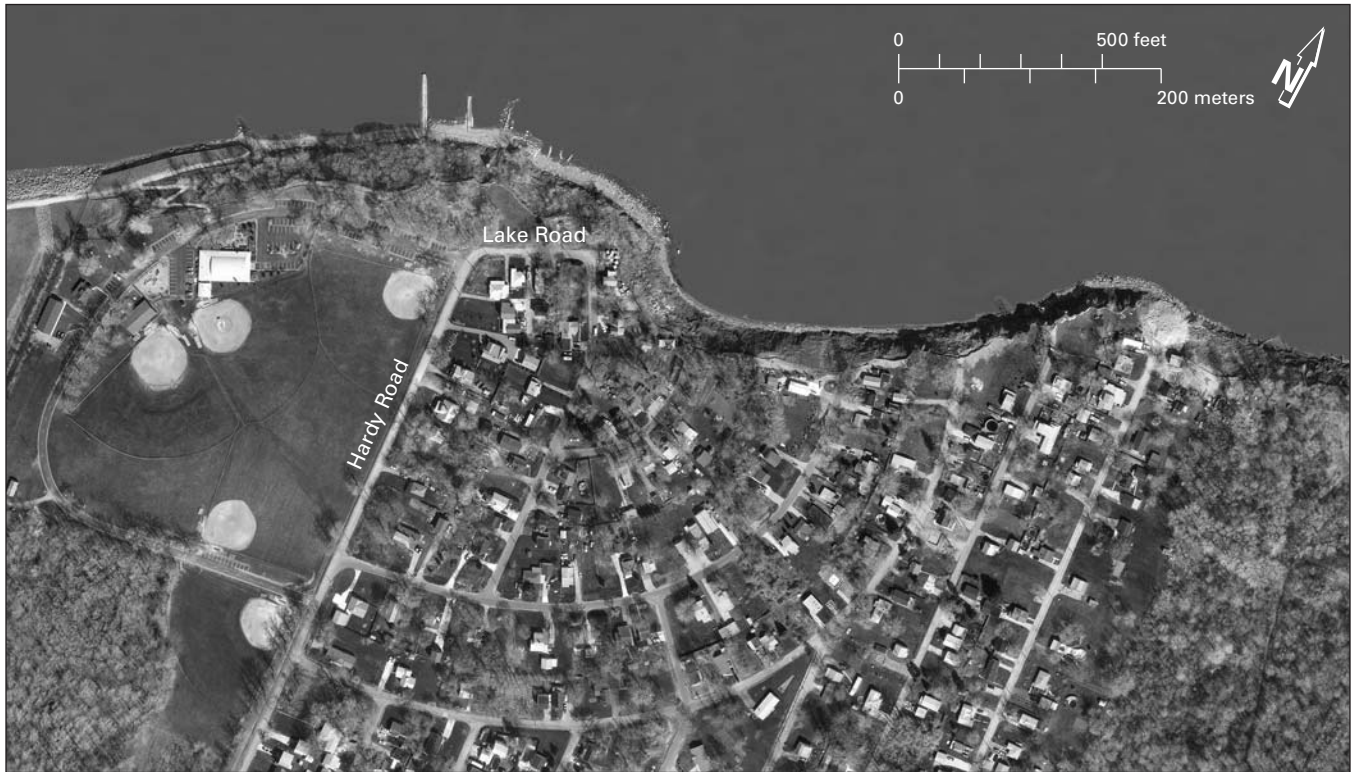
FIGURE 18.—Painesville on-the-Lake, Ohio (west). Aerial photograph taken in 2000 by the Lake County GIS.

Groin-trapped beaches partially protect the park frontage from wave attack (figs. 18, 20). However, the protection has not been adequate, and in the last 5 years, steel bulkheads have been built along the bluff toe at Painesville Township Park. Note the lakeward rotation of the older section of bulkhead. The dissected and hummocky slope at the park is a product of successive slumps and other forms of mass wasting.

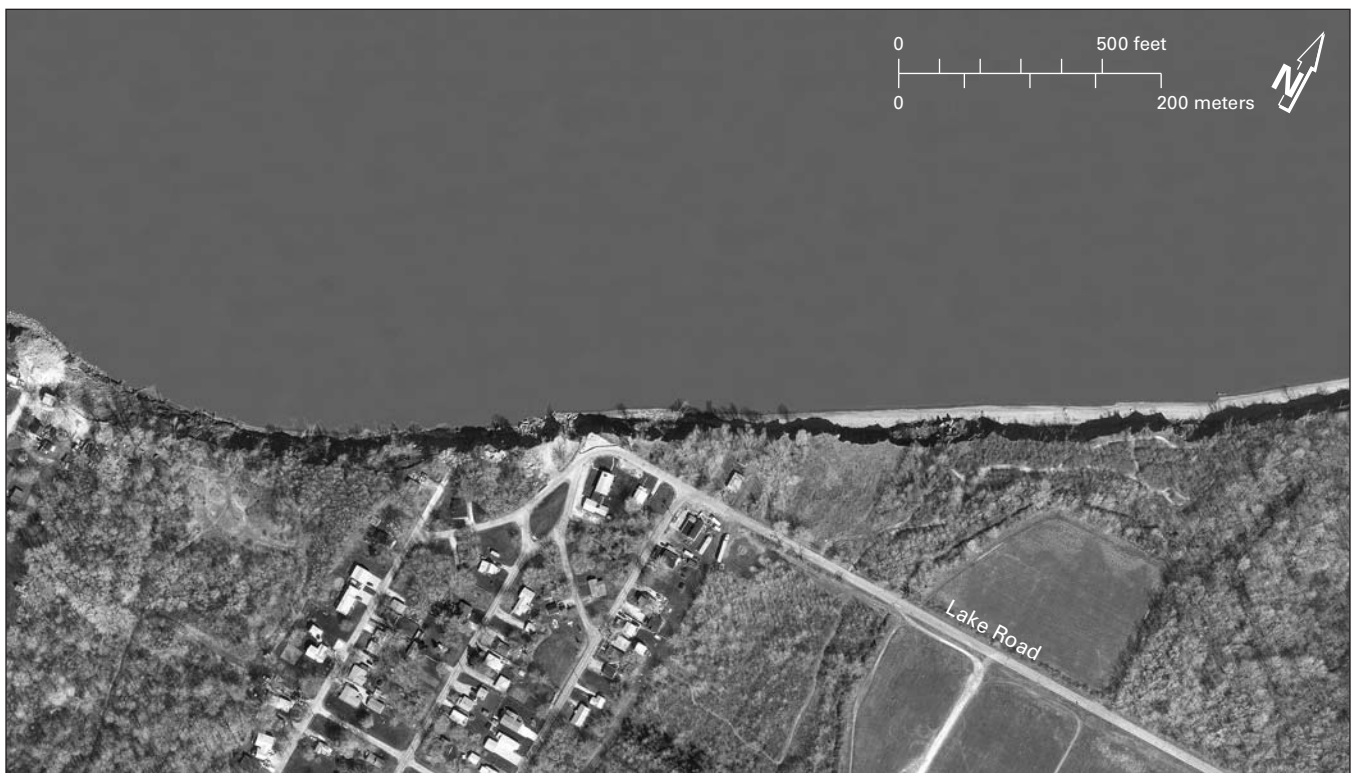
FIGURE 19.— Painesville on-the-Lake, Ohio (east). Aerial photograph taken in 2000 by the Lake County GIS.

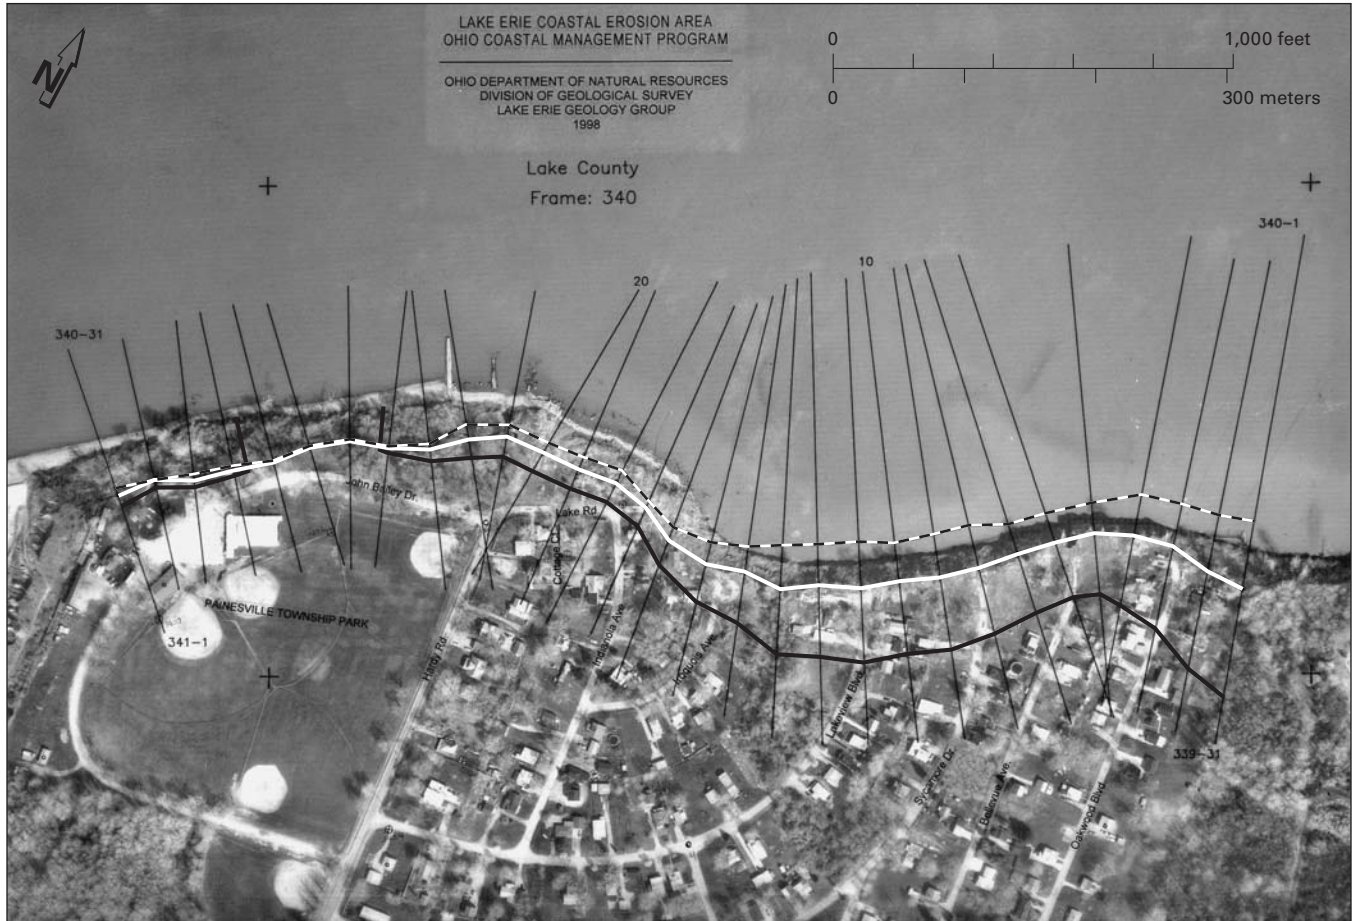
FIGURE 20.—Coastal erosion area map (Ohio Division of Geological Survey, 1998) for Painesville on-the-Lake, Ohio (west). A dashed line marks the 1973 bluff line; a solid white line marks the 1990 bluff line; and a solid black line marks the landward extent of the coastal erosion area. Aerial photograph taken in 1990 by the Ohio Department of Natural Resources.

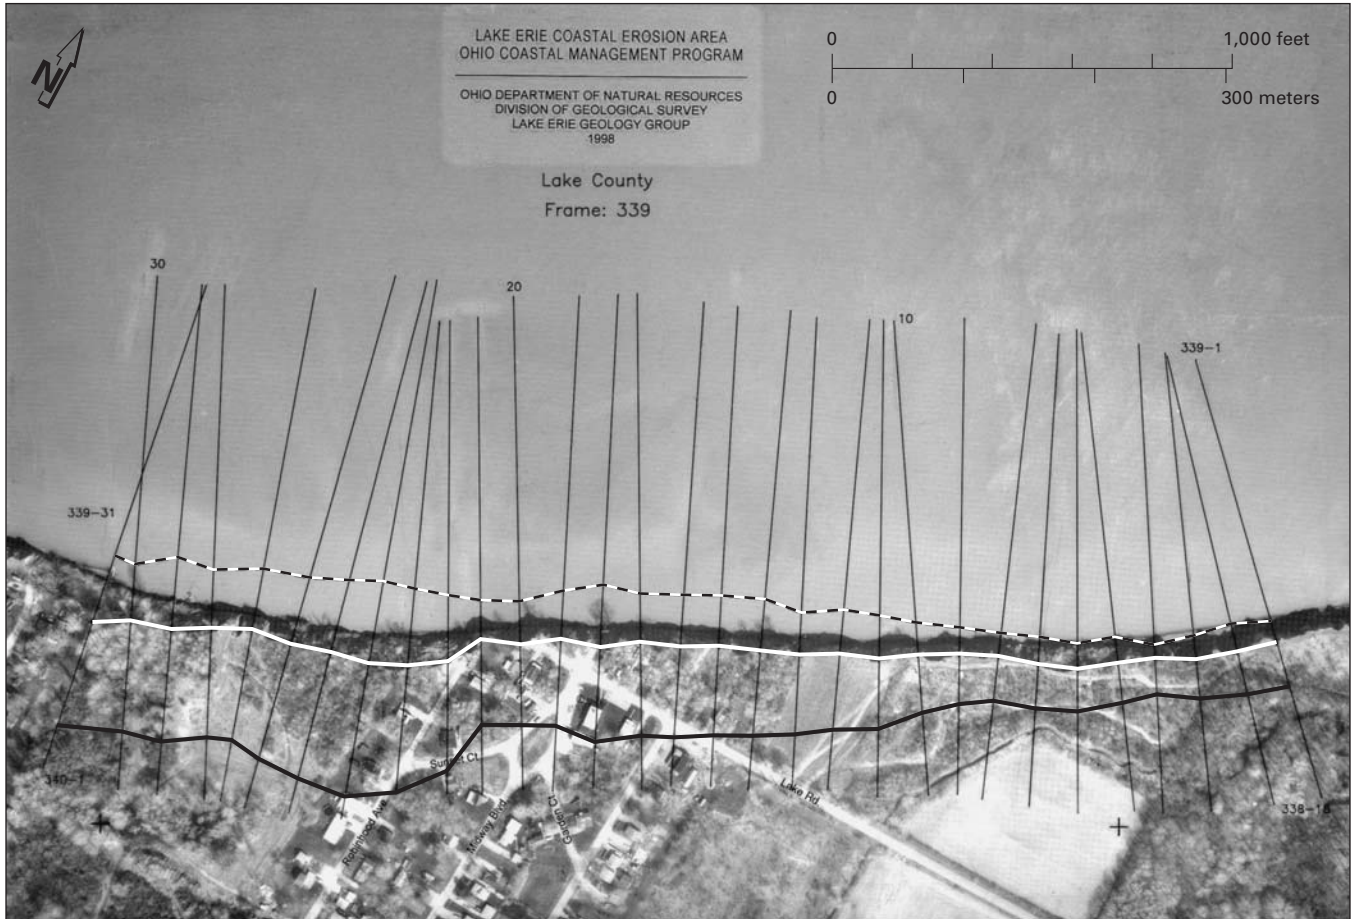
FIGURE 21.—Coastal erosion area map (Ohio Division of Geological Survey, 1998) for Painesville on-the-Lake, Ohio (east). A dashed line marks the 1973 bluff line; a solid white line marks the 1990 bluff line; and a solid black line marks the landward extent of the coastal erosion area. Aerial photograph taken in 1990 by the Ohio Department of Natural Resources.

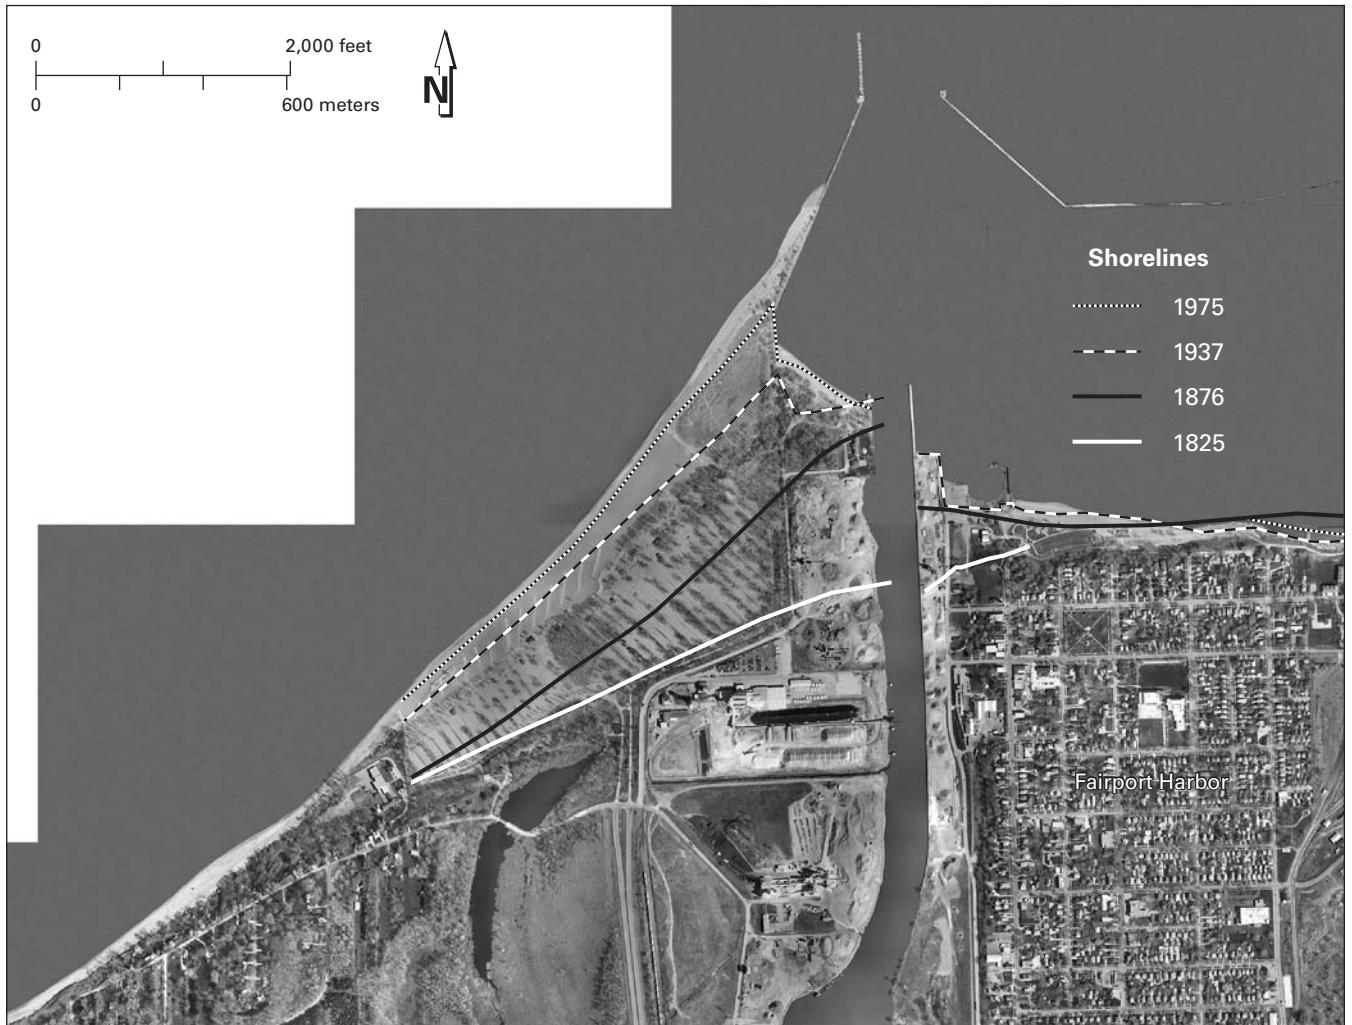
FIGURE 24.—Headlands Beach State Park near Fairport Harbor, Ohio. Historical shorelines adapted from Carter (1978). Aerial photograph taken in 2000 by the Lake County GIS.

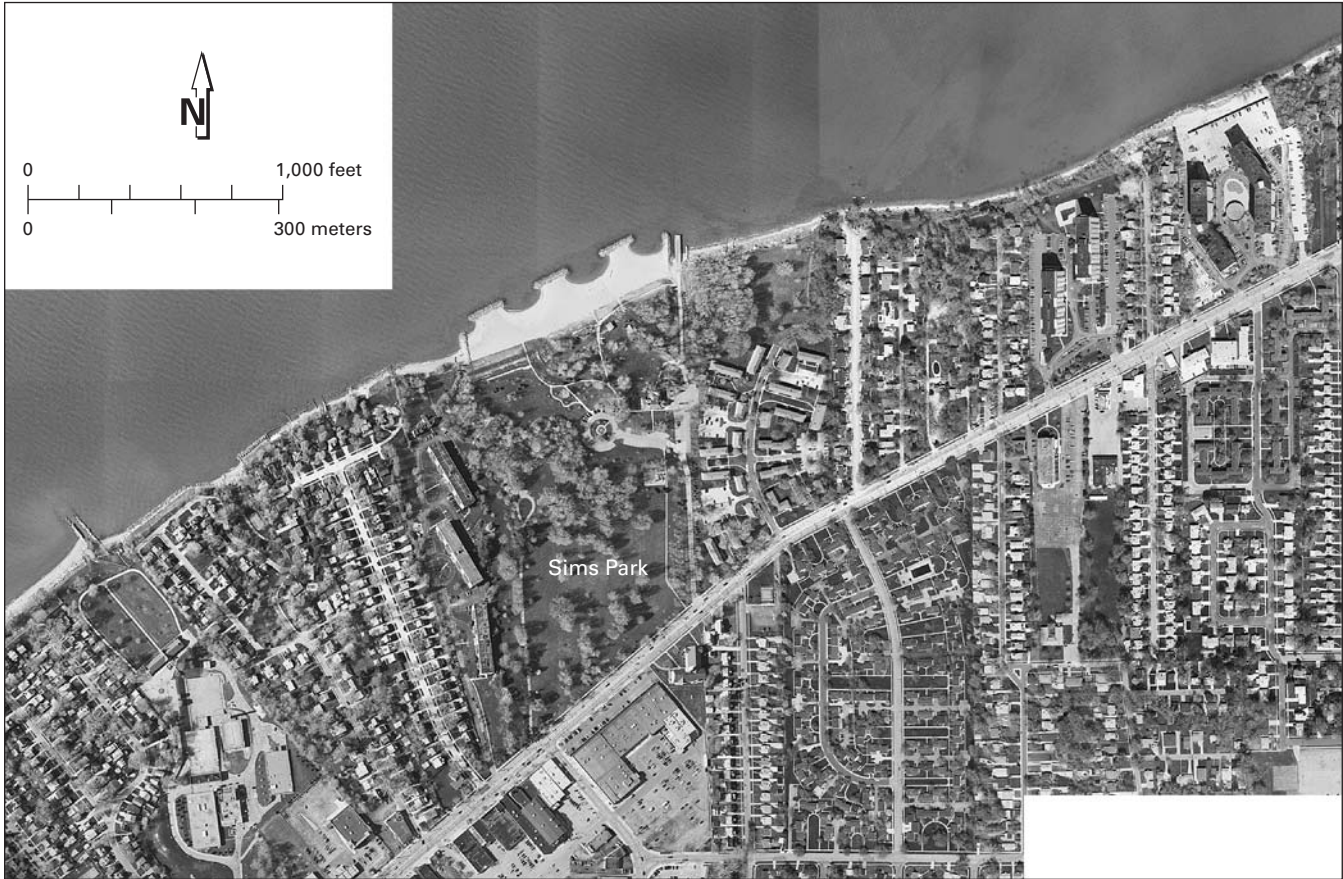
FIGURE 26.—Sims Park in Euclid, Ohio, is located on a broad headland of Devonian shale. Shale crops out in the lower part of the bluff along the western half of the photo but drops below lake level in the eastern part of the photograph. Even though shale is more resistant to erosion than the till found to the east, much of the shale headland is now armored to prevent erosion. To the east, large amounts of fill have been dumped over the bluff edge to reclaim land lost to erosion and to protect the shore. Aerial photograph taken in 2002 by the Cuyahoga County Engineer.

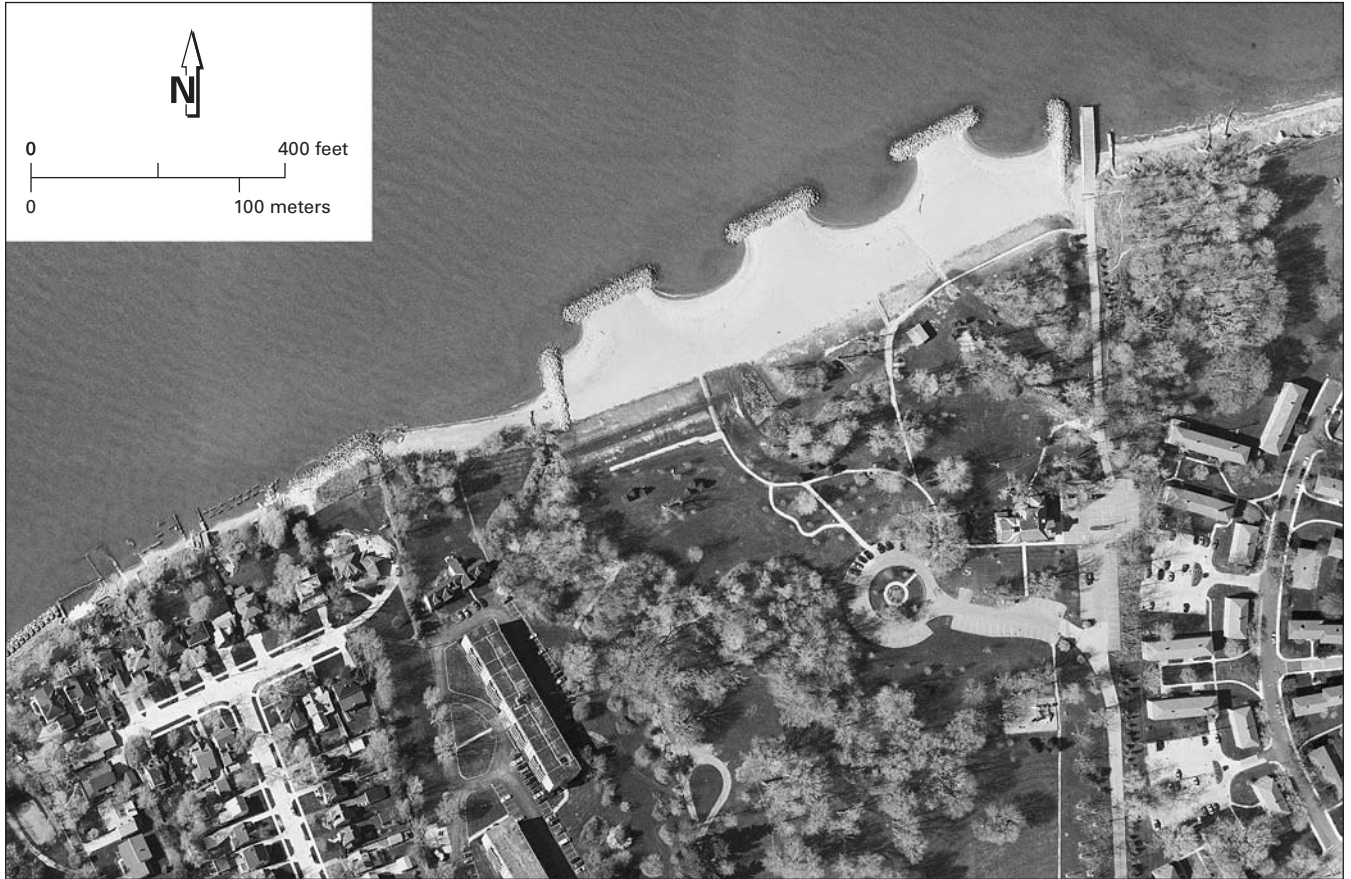
FIGURE 27.—Segmented breakwaters and terminal groins at Sims Park in Euclid, Ohio. The breakwaters are spaced so that tomboles develop. The beach was filled with sand obtained from an upland sand pit. Aerial photograph taken in 2002 by the Cuyahoga County Engineer.

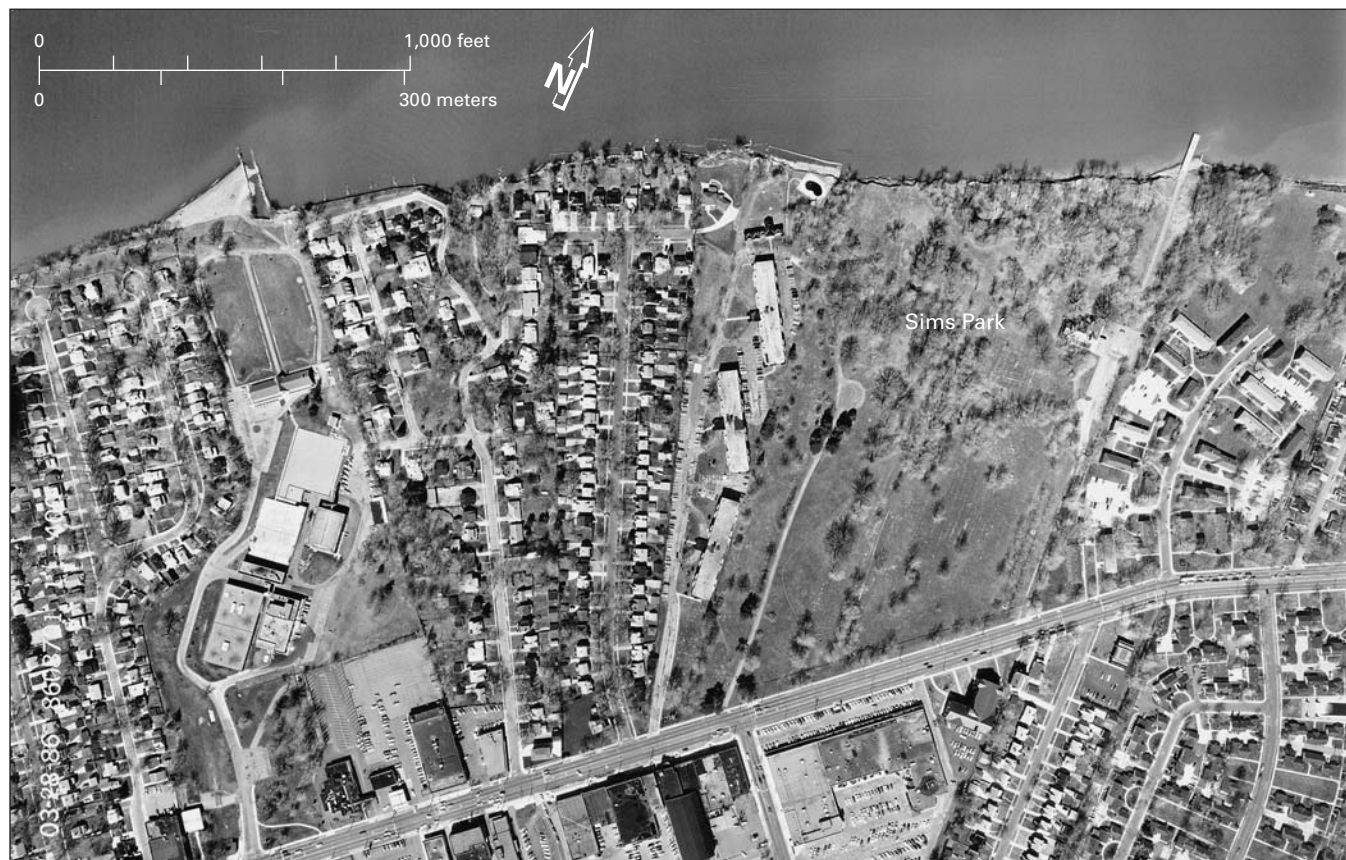
FIGURE 28.—Sims Park in Euclid, Ohio, in 1986, prior to construction of breakwaters and groins. Aerial photograph taken by the Ohio Department of Natural Resources.

In the 1980s three segmented, rubble-mound breakwaters and two terminal groins were built to reduce erosion at Sims Park and to provide a recreational beach (figs. 27, 28). The structures are constructed of Columbus Limestone quarried near Sandusky and are similar to breakwaters built at other Lake Erie parks. To create a beach, about 34,000 yds³ (26,000 m³) of sand from an upland deposit was placed as fill, and an additional 1,700 yds³ (1,300 m³) are added annually to maintain the beach (U.S. Army Corps of Engineers, 1989; Michael Mohr, U.S. Army Corps of Engineers, oral commun., 2006). Further east, large areas of fill stabilize the shore and reclaim land lost to erosion.

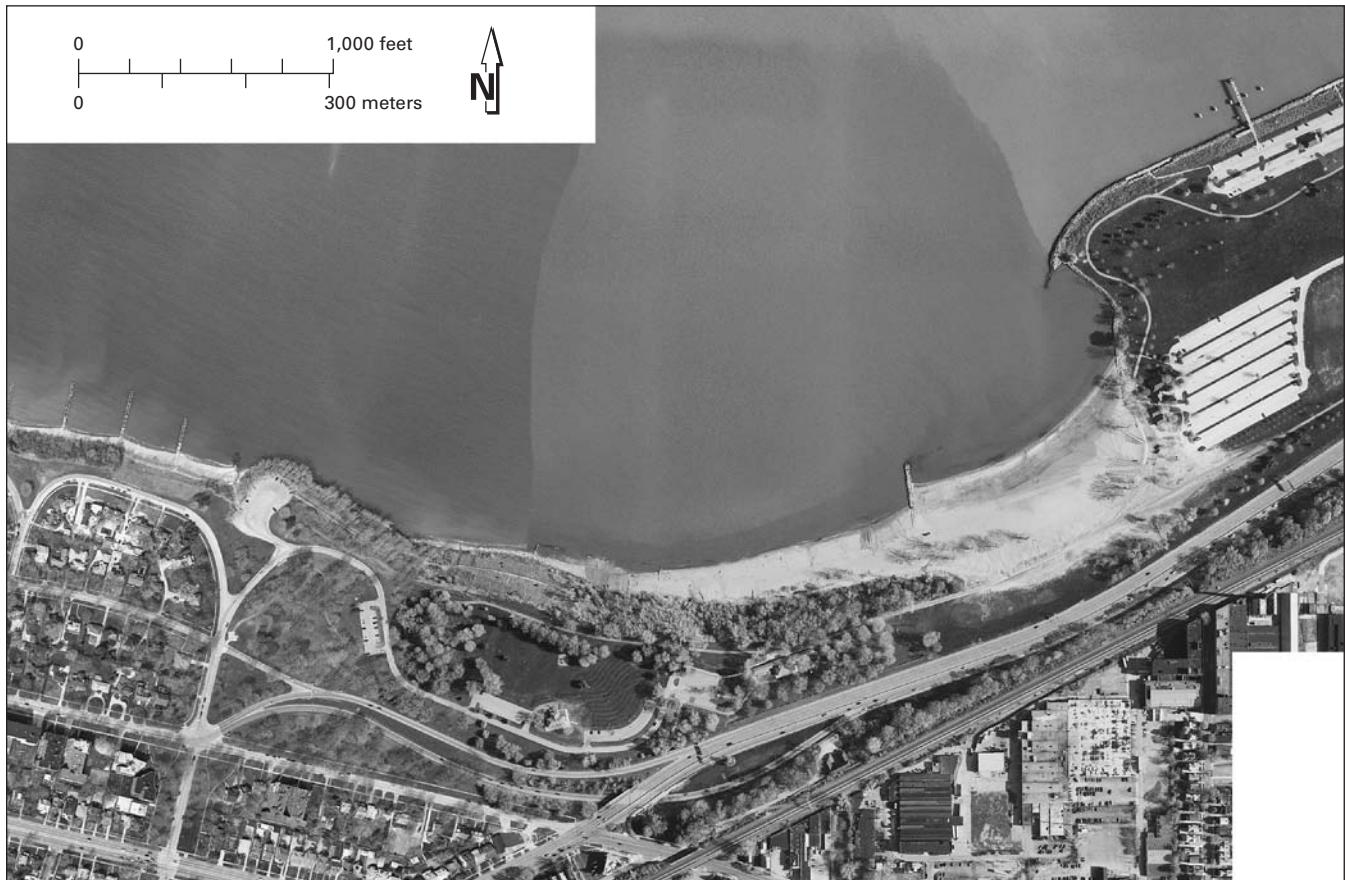
FIGURE 31.—Beach sand at Edgewater Park in Cleveland, Ohio, is trapped by a bulkhead and a groin. Note wind-blown sand near the Shoreway and southwest of the parking lot. The eastern part of the park, shoreward of the stone bulkhead, is all filled land. An oval parking lot at the western end of the park sets atop a small headland composed of Chagrin Shale. West of the headland, groins at Perkins Beach have deteriorated and no longer trap much sand. Aerial photograph taken in 2002 by the Cuyahoga County Engineer.

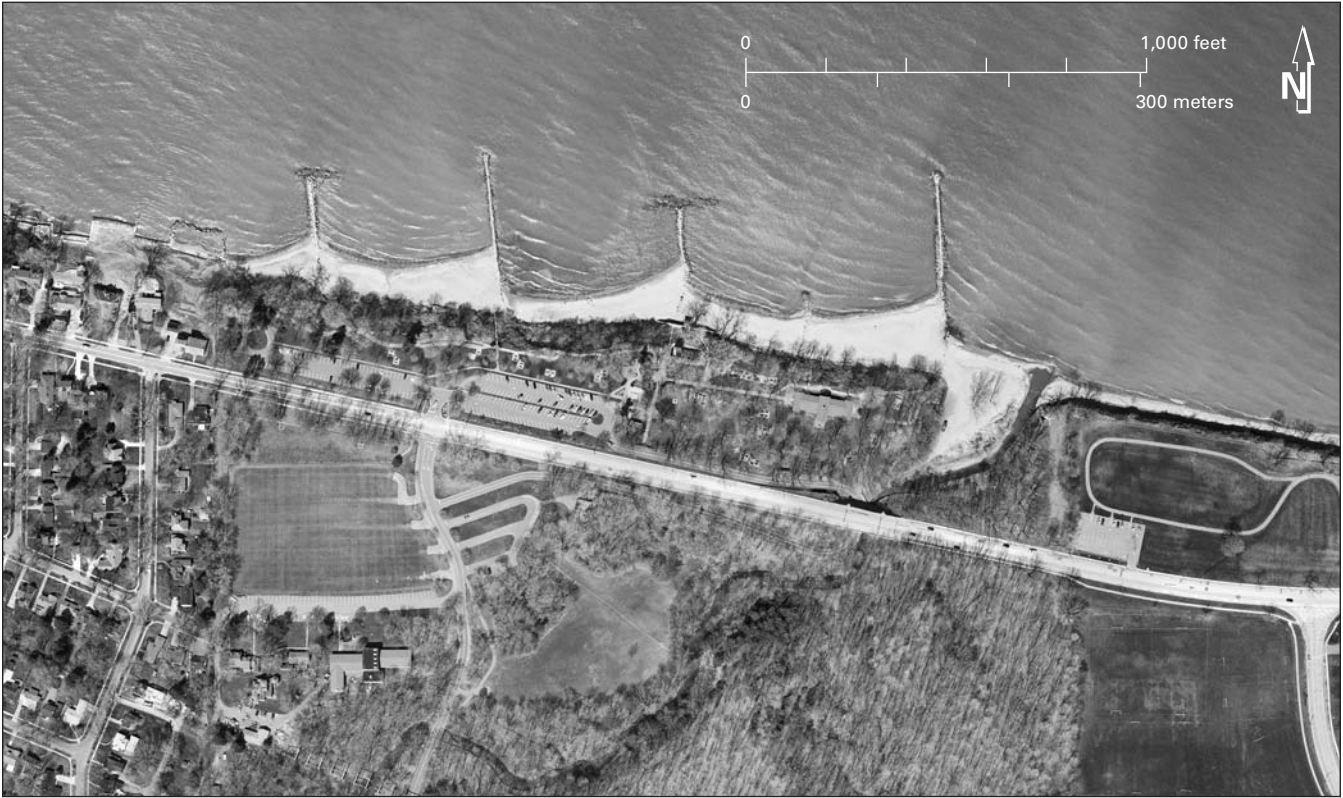
FIGURE 32.—Huntington Reservation in Bay Village, Ohio. Sandstone block groins trap sand to form beach. West of the park, a variety of structures protect the slope of till, glaciolacustrine sediment, and fill. East of the park, the shale cliff is unprotected. Aerial photograph taken in 2002 by the Cuyahoga County Engineer.

The dimension-stone groins were built at the park in 1933 using local Berea Sandstone. These groins, the longest of which extends 500-ft (152-m) offshore, trap sand moving west-to-east alongshore. The resulting beach typically protects the bluff from erosion during storms. However, during the high water of 1985 and 1986, the beach was narrower, allowing storm waves to erode the bluff toe and expose fresh material. The beach was typically narrowest along the section of bluff now subject to mass wasting. Water discharging from the bluff may be ground water or it may be water leaking from water lines. Given the extent and age of infrastructure along the lake, both are possible.

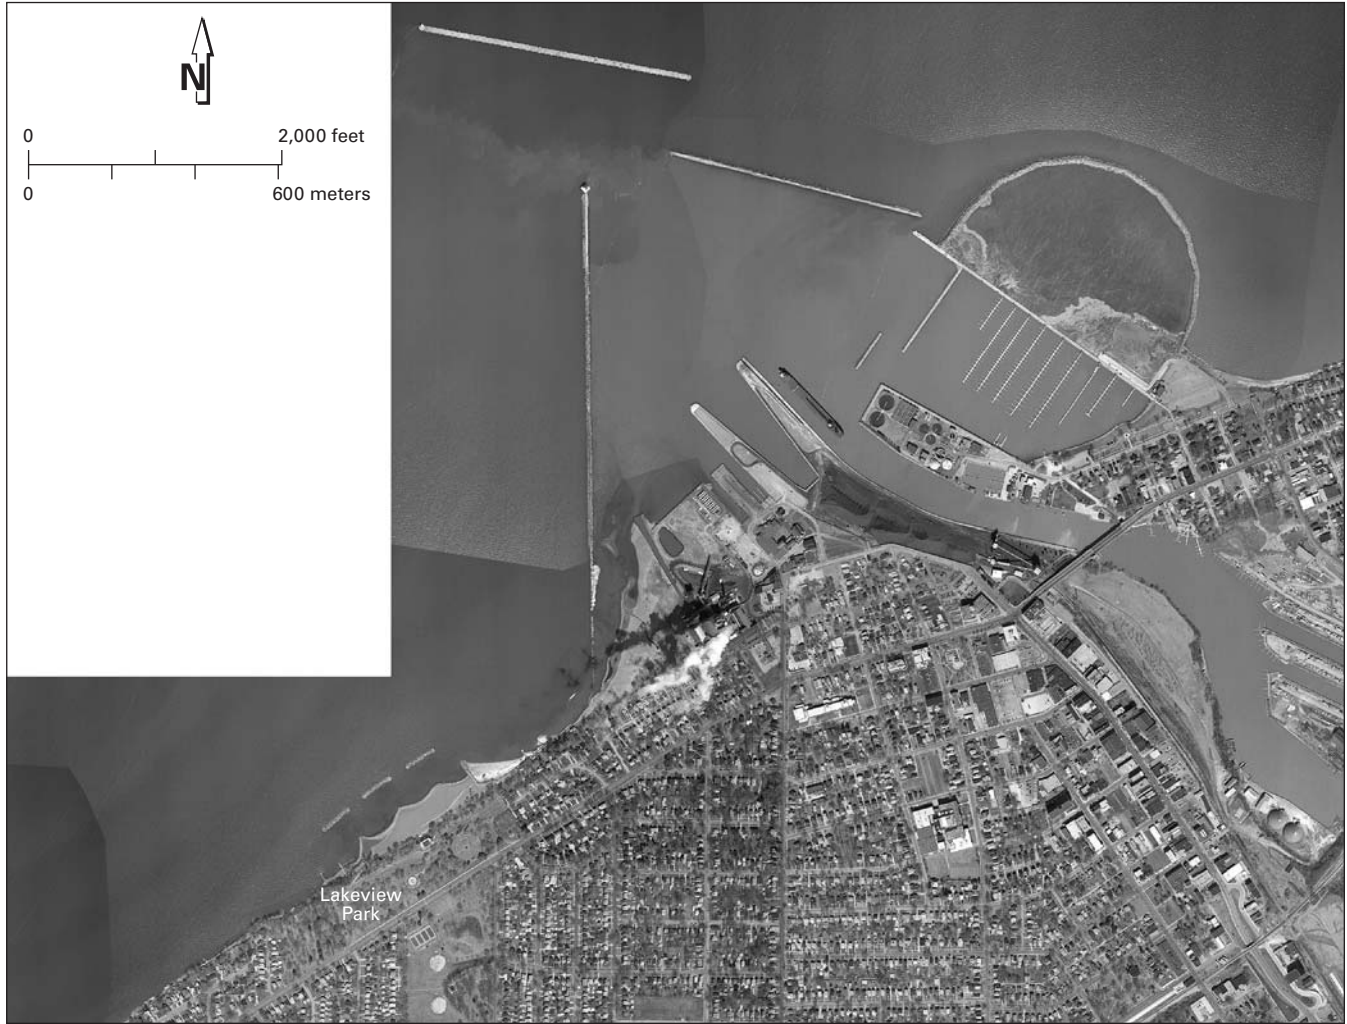
FIGURE 33.—Lorain Harbor and Lakeview Park in Lorain, Ohio. The confined disposal facility (CDF) attached to the east breakwater is nearly filled. Note sand in southwest corner of harbor. Aerial photograph taken in 1999 by the Lorain County Auditor.

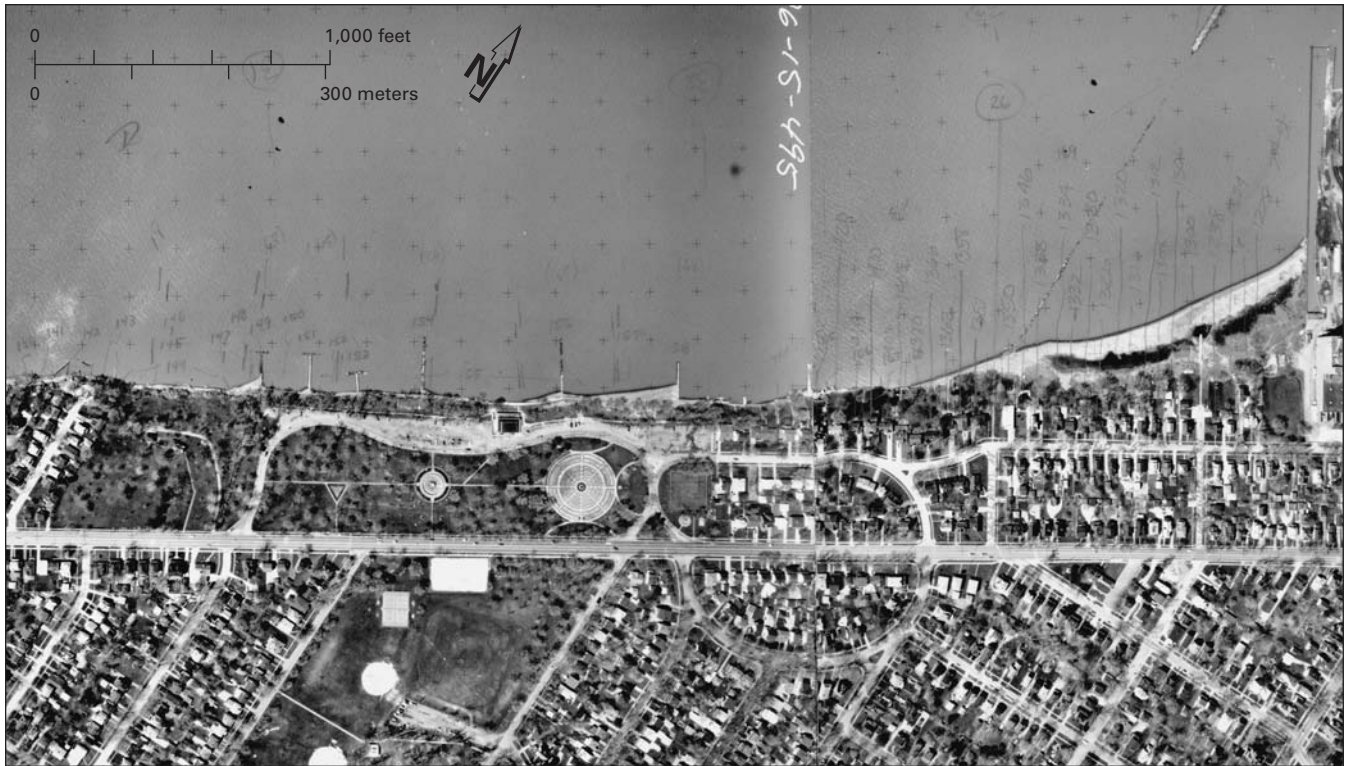
FIGURE 34.—Lakeview Park in Lorain, Ohio, in April 1973. Compare size of beaches at the park and in the harbor with those in 1999 (fig. 35). Aerial photograph taken by the Ohio Department of Transportation.

Lakeview Park is located on the west side of Lorain Harbor (fig. 33). The shore at this site rises 16.4-ft (5-m) above lake level and is composed of till. At one time, six groins and a concrete seawall protected the park (fig. 34). Partial destruction of the seawall, and erosion of the beach in the early 1970s, led to construction in 1977 of a new seawall and three 250-ft (76-m) long breakwaters, modification of two of the groins, and placement of 109,200 yd³ (84,000 m³) of sand (fig. 35; Pope and Rowen, 1983). Sand used to nourish the beach was dredged from a relict Pleistocene deposit located 6-mi (10-km) offshore on the Pelee-Lorain cross-lake moraine (Michael Mohr, U.S. Army Corps of Engineers, written commun., 2005). Rehabilitation of the park was a cooperative project involving the City of Lorain, the Ohio Department of Natural Resources, and the U.S. Army Corps of Engineers.

FIGURE 35.—Lorain Harbor and Lakeview Park in Lorain, Ohio, in 1999. The segmented breakwaters are designed to form salients rather than a tombolos. Compare size and shape of beaches at the park and inside harbor with beaches in 1973 (fig. 34). Aerial photograph taken by the Lorain County Auditor.
