GUIDEBOOK NO. 21

GEOLOGIC SETTING AND PROCESSES ALONG LAKE ERIE FROM FAIRPORT HARBOR TO MARBLEHEAD, OHIO

originally prepared for the 2006 North-Central Section meeting of the Geological Society of America

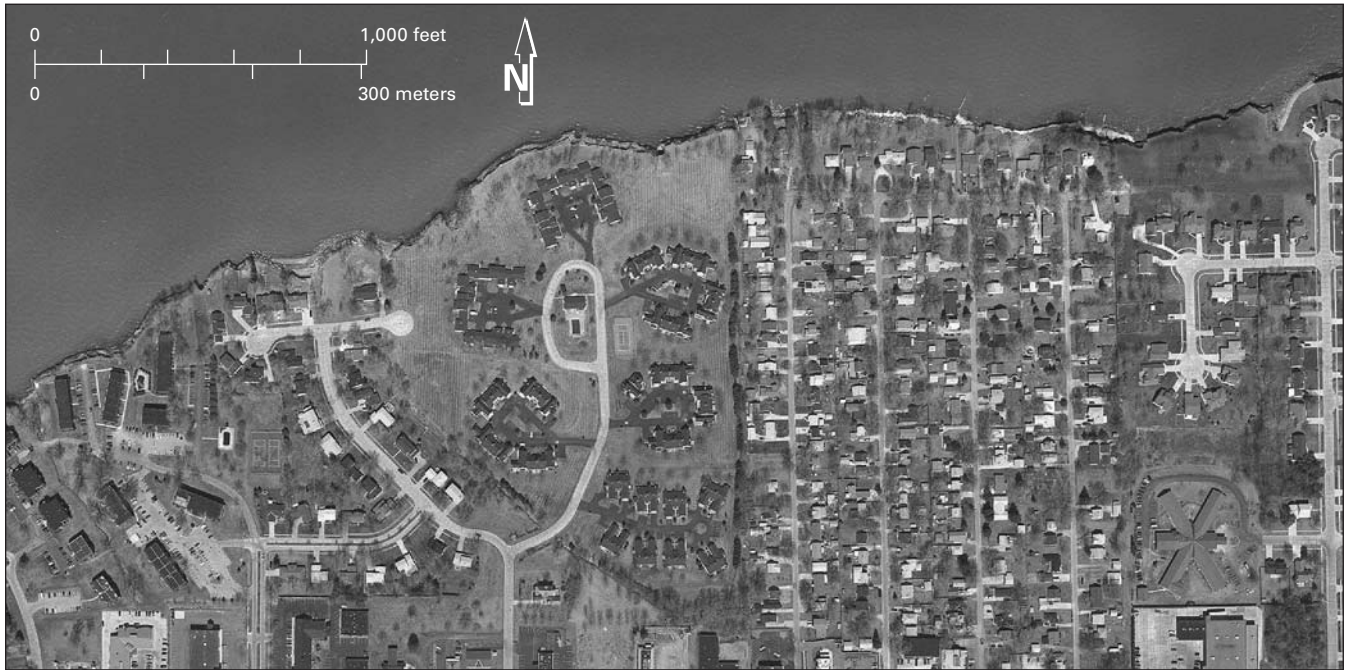
FIGURE 37.—Fault-controlled erosional embayments along the shale-bluffed shore in Vermilion, Ohio (1999). See figure 38 for orientation of faults. Aerial photograph taken in 1999 by the Lorain County Auditor.

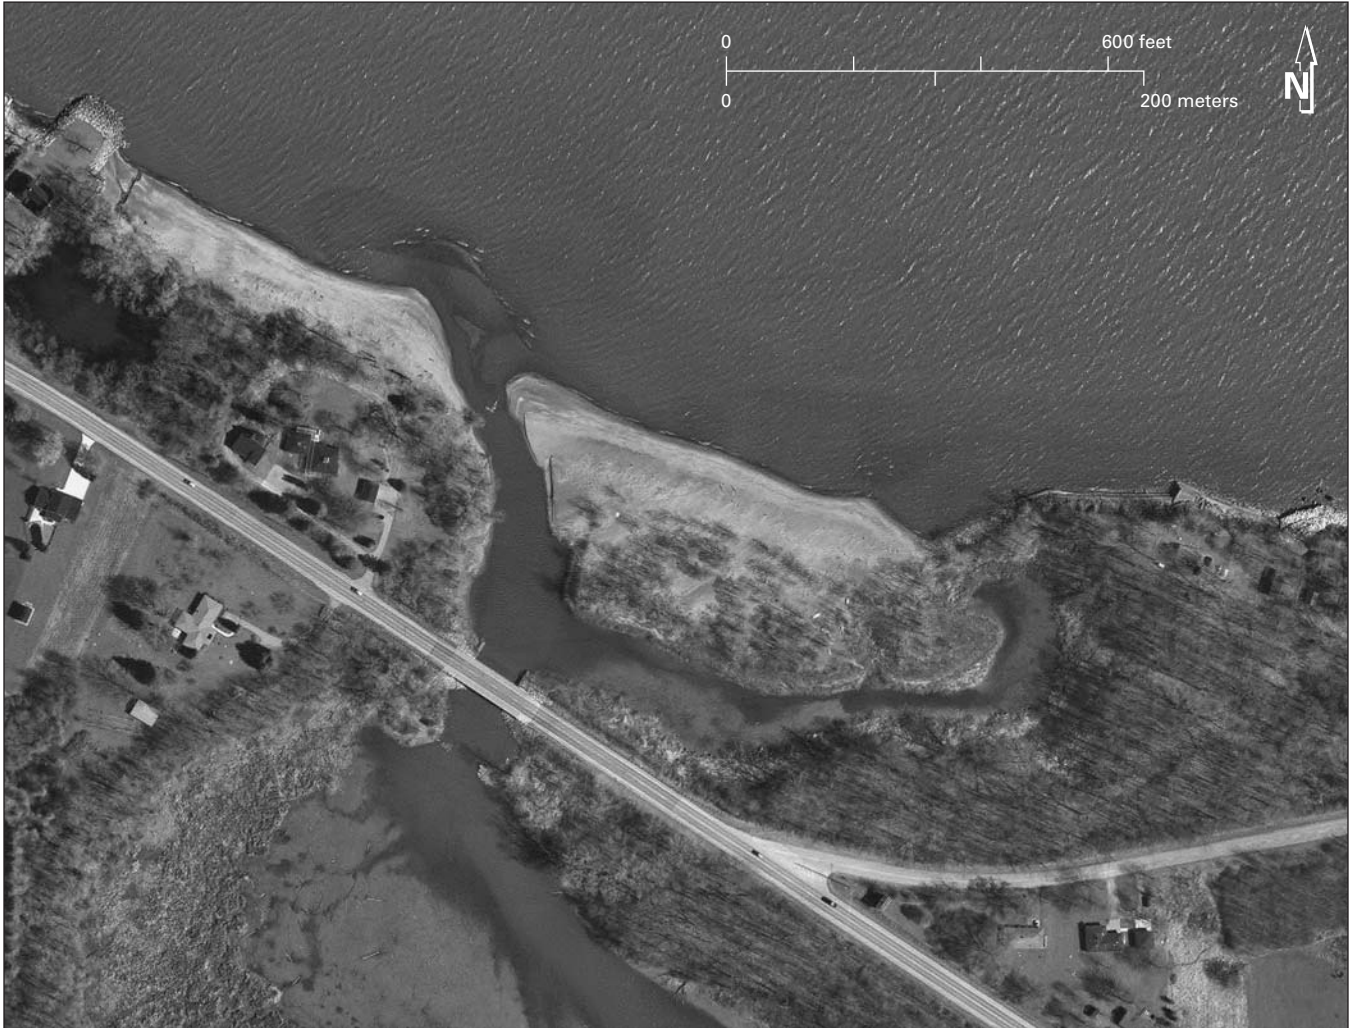
FIGURE 40.—Old Woman Creek in Huron, Ohio. The abandoned stream channel from the 1970s appears on the east side of the floodplain. Westward displacement of the stream mouth suggests a net east-to-west transport of sand along this reach of shore. Aerial photograph taken in 2003 by the Erie County Auditor.

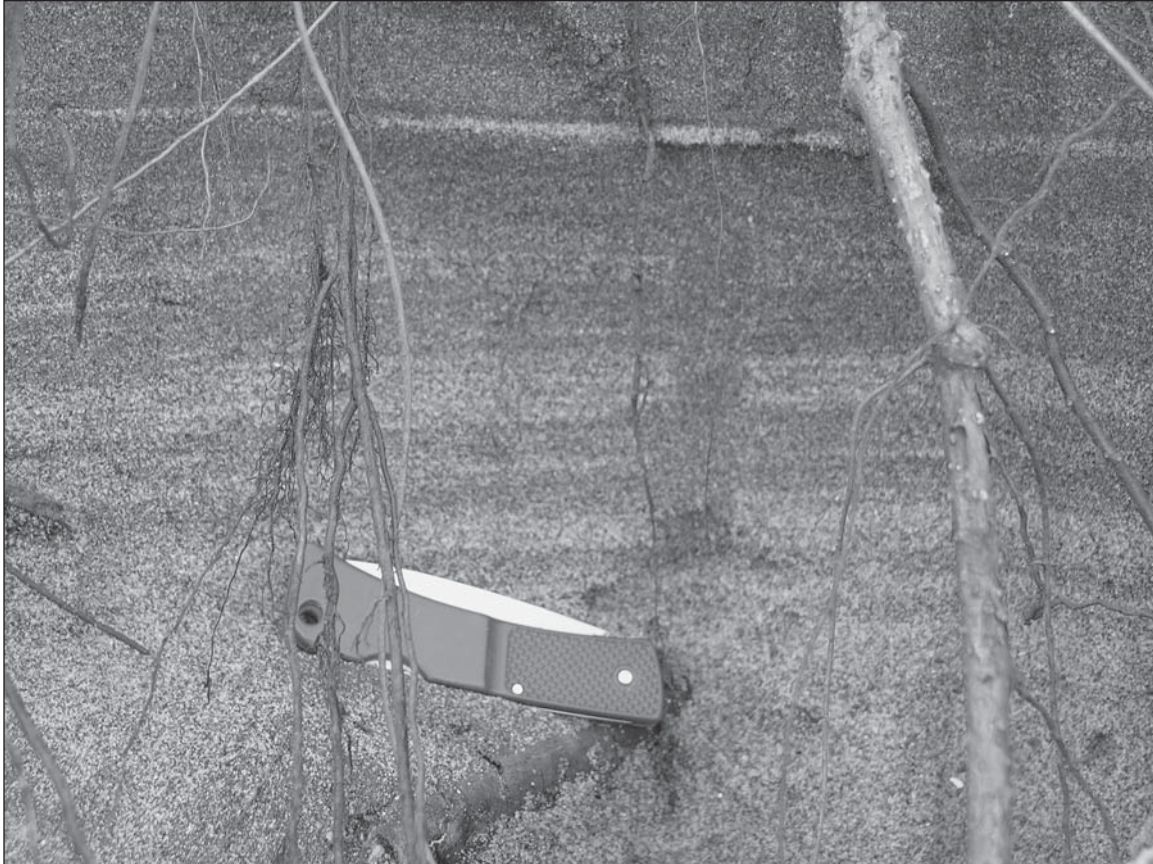
FIGURE 41.—Heavy-mineral sands in the stream-cut bank on the west side of the Old Woman Creek floodplain. Photograph taken by Laura J. Moore.

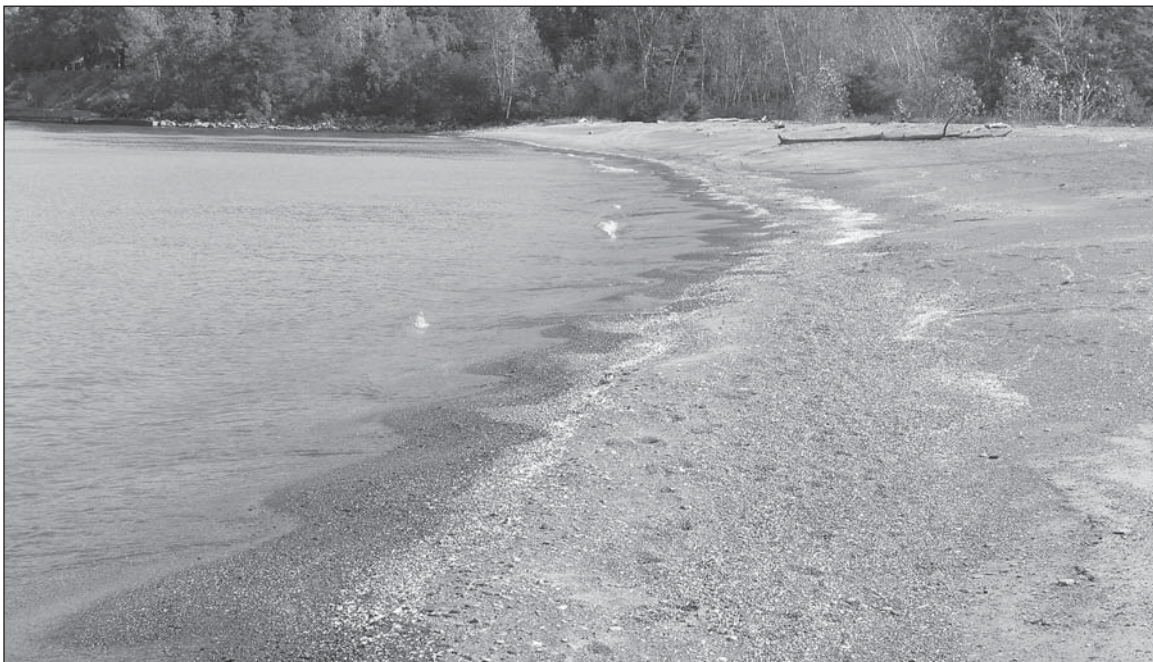
FIGURE 42.—Beach cusps along the beach at Old Woman Creek in Huron, Ohio. Cusp wavelength is about 3 ft (1 m). Photograph taken by Laura J. Moore.

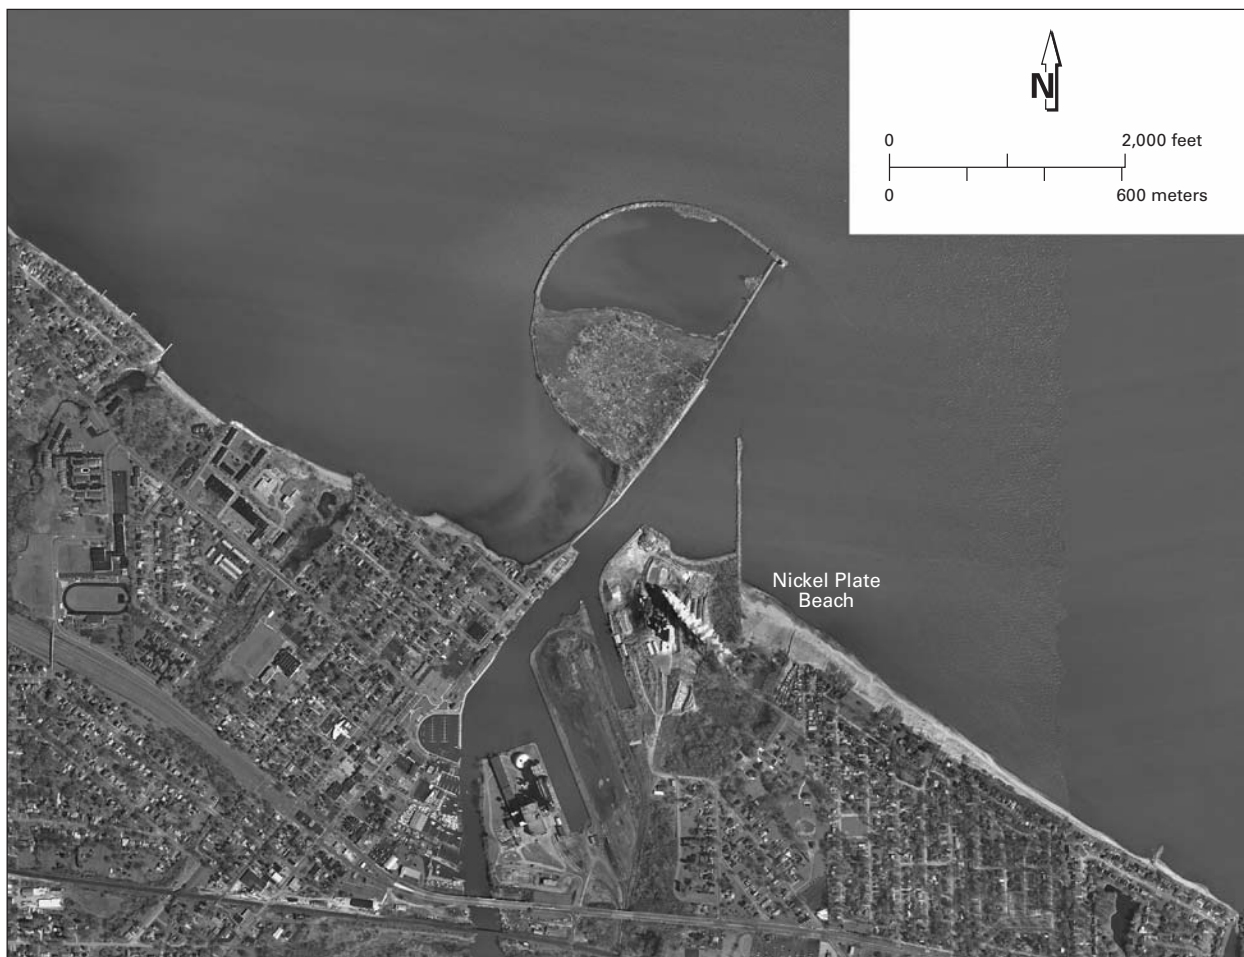
FIGURE 43.—The west jetty at Huron Harbor, Huron, Ohio, extends about 3,410-ft (1,039-m) offshore, blocking littoral transport of sand. A wide beach of sand impounded by the east breakwater extends about 3,300 ft (1,000 m) and is wide enough to support dune development. Beaches west of the harbor tend to be very narrow and seawalls are needed to prevent erosion of the low bank. Aerial photograph taken in 2003 by the Erie County Auditor.

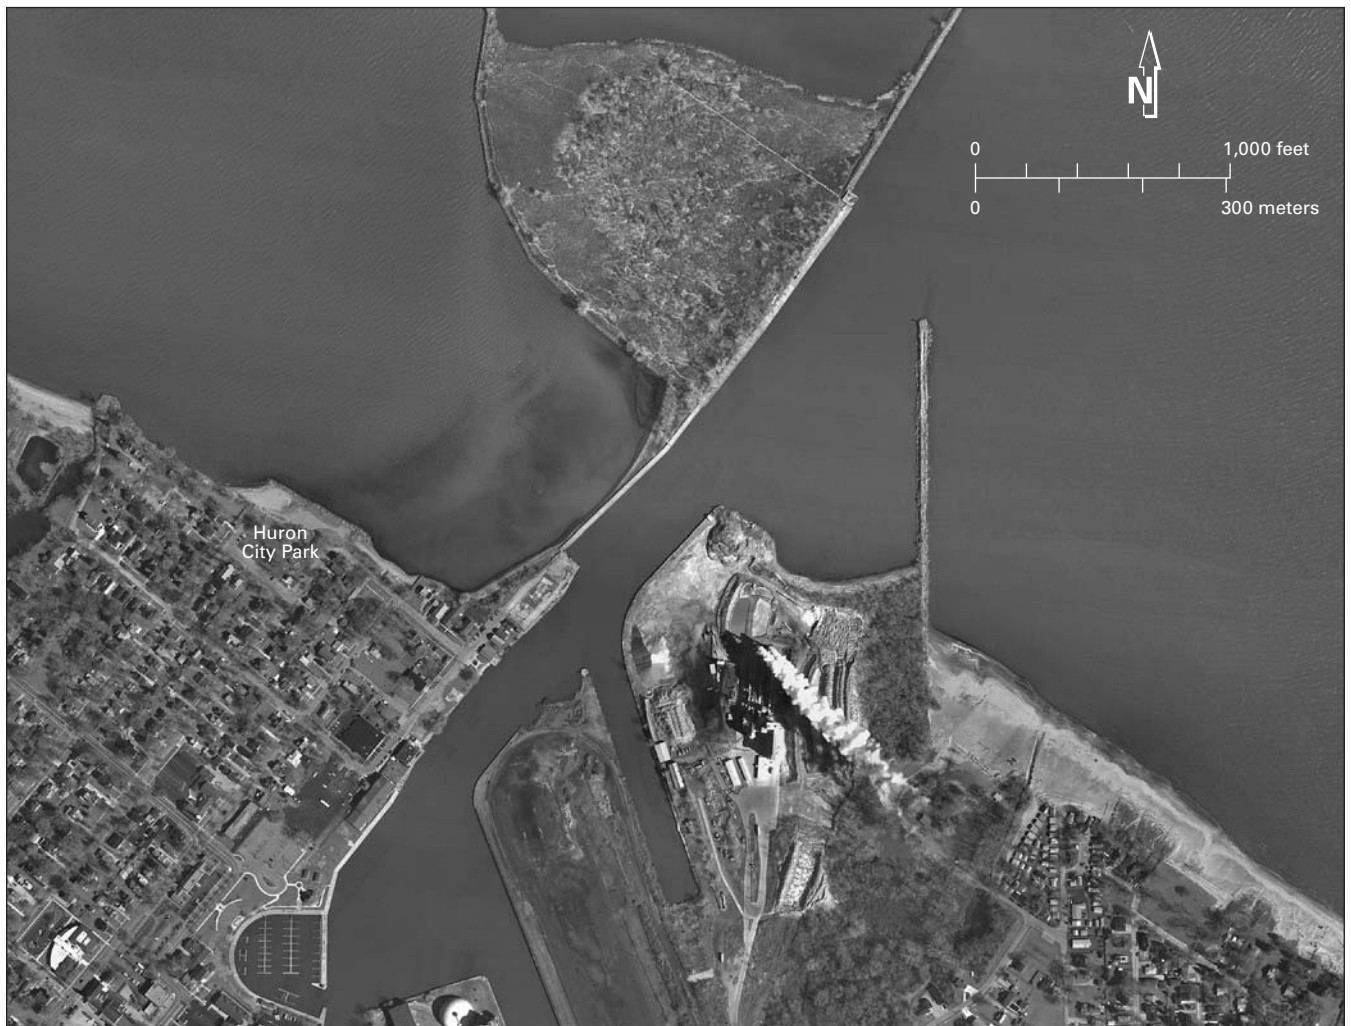
FIGURE 44.—Nickel Plate Beach to the east of Huron Harbor and Huron City Park to the west, in Huron, Ohio. The beach at the city park is protected by a sandstone breakwater. Steam and smoke from the limekiln make a prominent landmark for boaters. Aerial photograph taken in 2003 by the Erie County Auditor.

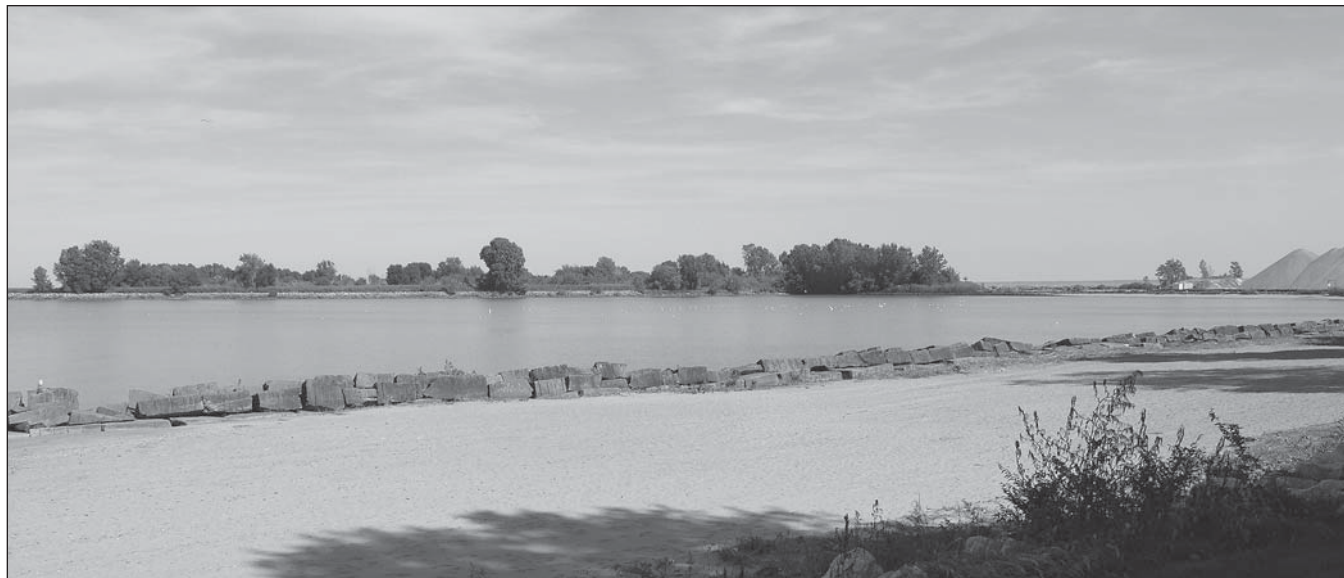
FIGURE 45.—View from Huron City Park, Huron, Ohio, looking lakeward across the beach and a sandstone-block breakwater at a CDF built to contain contaminated sediment dredged from Huron Harbor. Trees are growing on sediment placed in the facility. To the right are piles of limestone brought in by ship for use in a local lime plant. Photograph taken by Laura J. Moore.

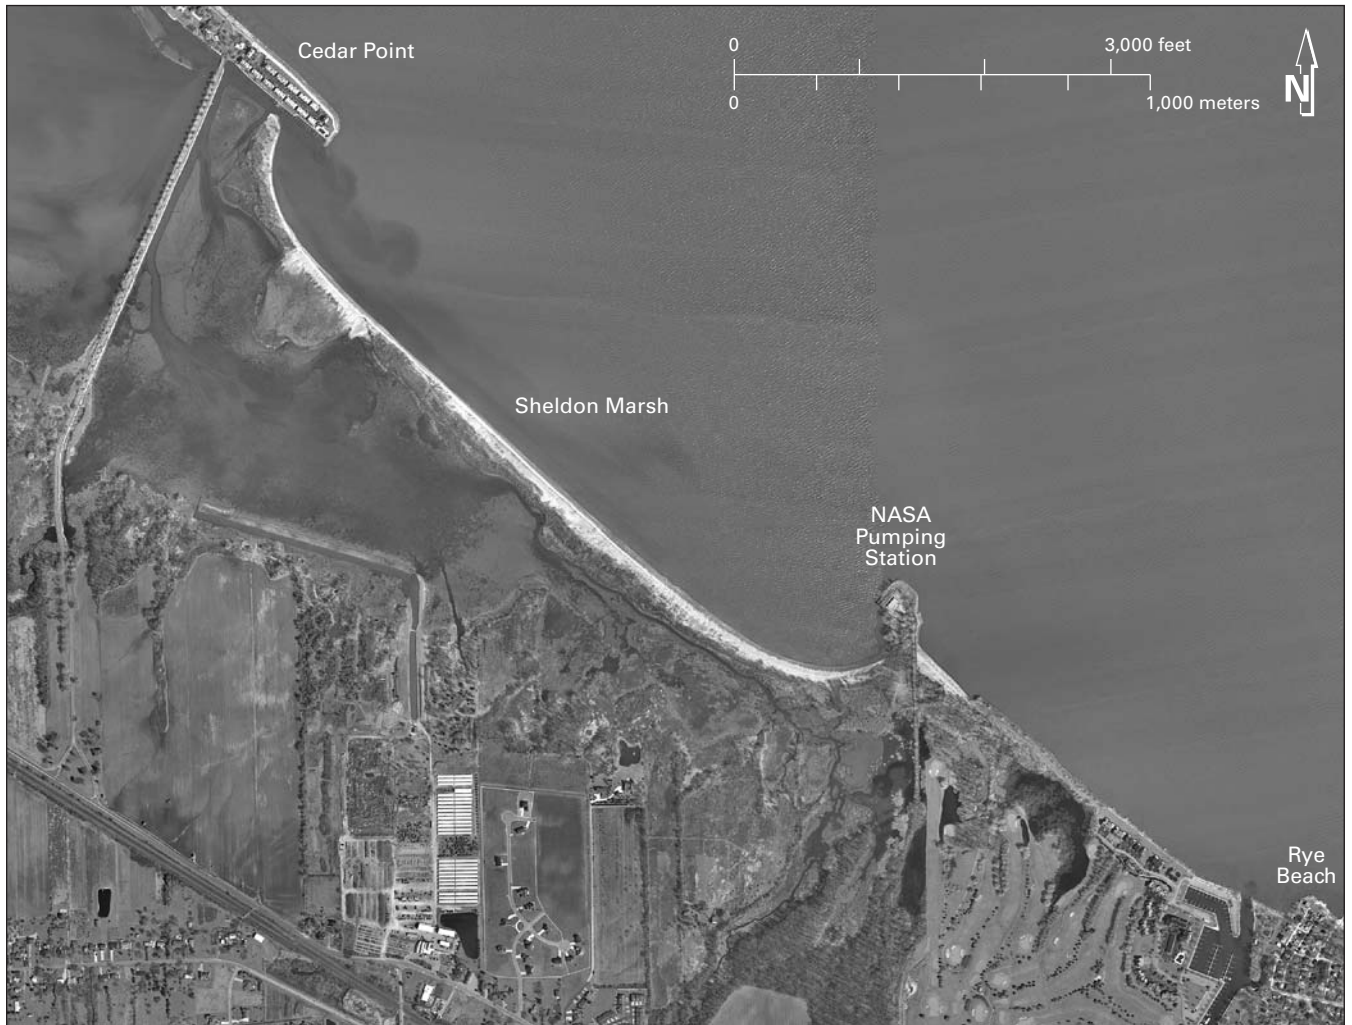
FIGURE 47.—Barrier beach at Sheldon Marsh Nature Preserve in Huron, Ohio. The large washover fan along the western part of the barrier formed during a storm in April 1998. The barrier just east of the washover fan continues to erode more rapidly than other parts of the barrier. Aerial photograph taken in 2001 by the Erie County Auditor.

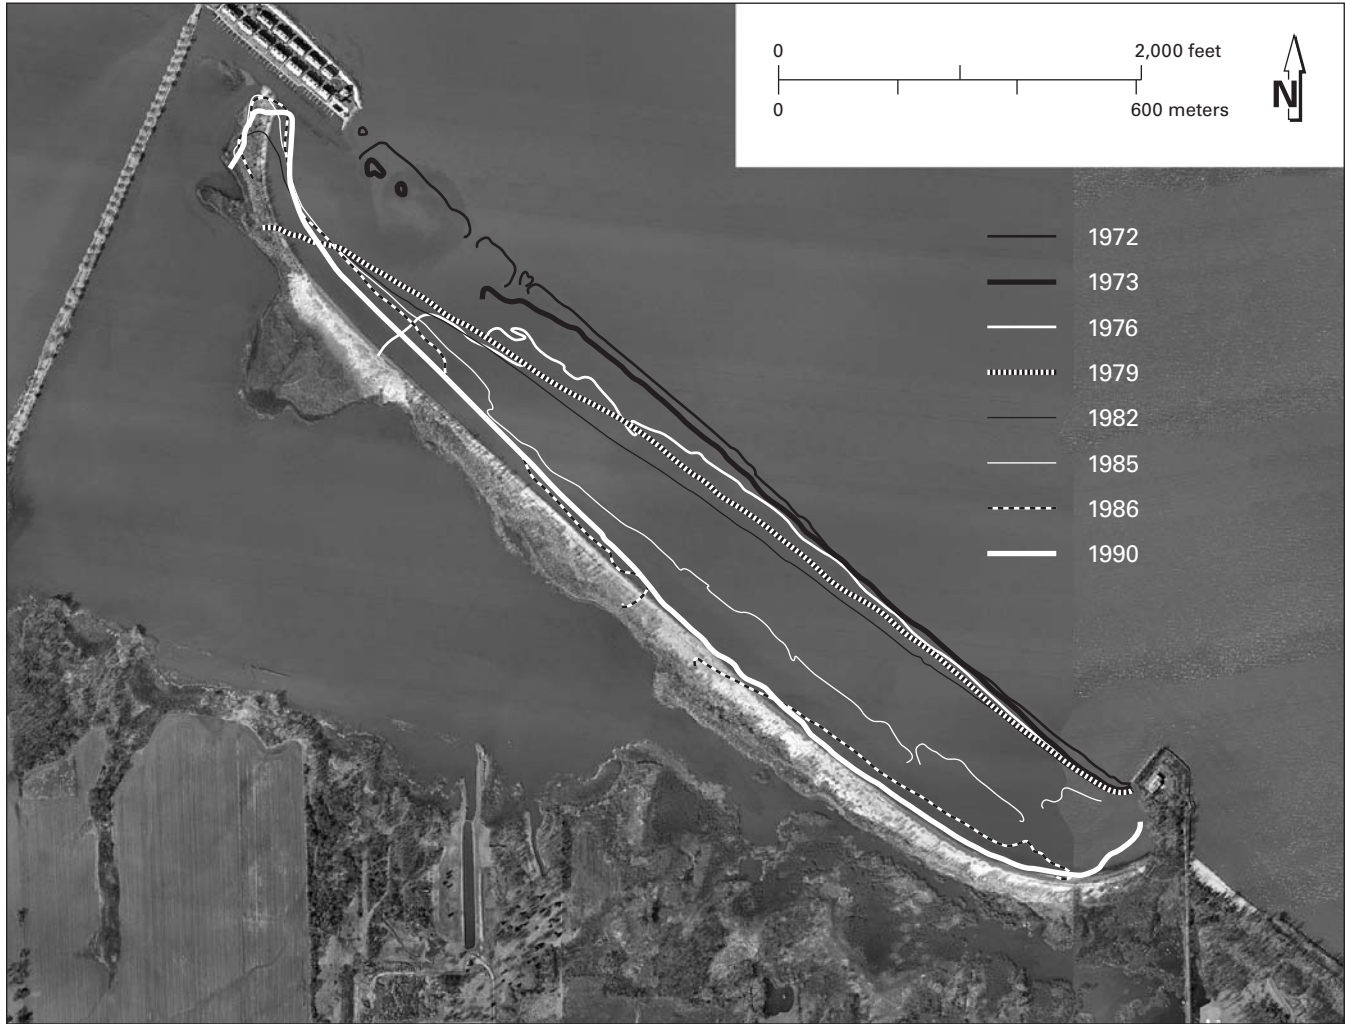
FIGURE 48.—Recession of Sheldon Marsh in Huron, Ohio, since 1972 (modified from Guy, 2002b). Aerial photograph taken in 2005 by the Erie County Auditor.

Since 1934, a long-term rise in lake level has compounded the problem of decreasing sand supply. When vertical aggradation of a barrier cannot keep pace with rising water level because of insufficient sand supply, the barrier retreats (Dillon, 1970). The most recent episode of rapid recession began November 14–16, 1972 (fig. 11), when 60-knot northeast winds caused a storm surge and generated large storm waves that washed over the full length of the barrier. During the storm, the barrier breached at its west end, just east of the Point Retreat Condominiums (fig. 49). The following spring, lake levels rose to record-high levels and remained generally 1–2.5-ft (0.3–0.8-m) above mean lake level for nearly a quarter century. At these high lake levels, even small storm waves easily washed over the barrier beach. Today the barrier is more than 1,310-ft (400-m) landward of its 1972 position (fig. 48). Since 1997, lake levels have been

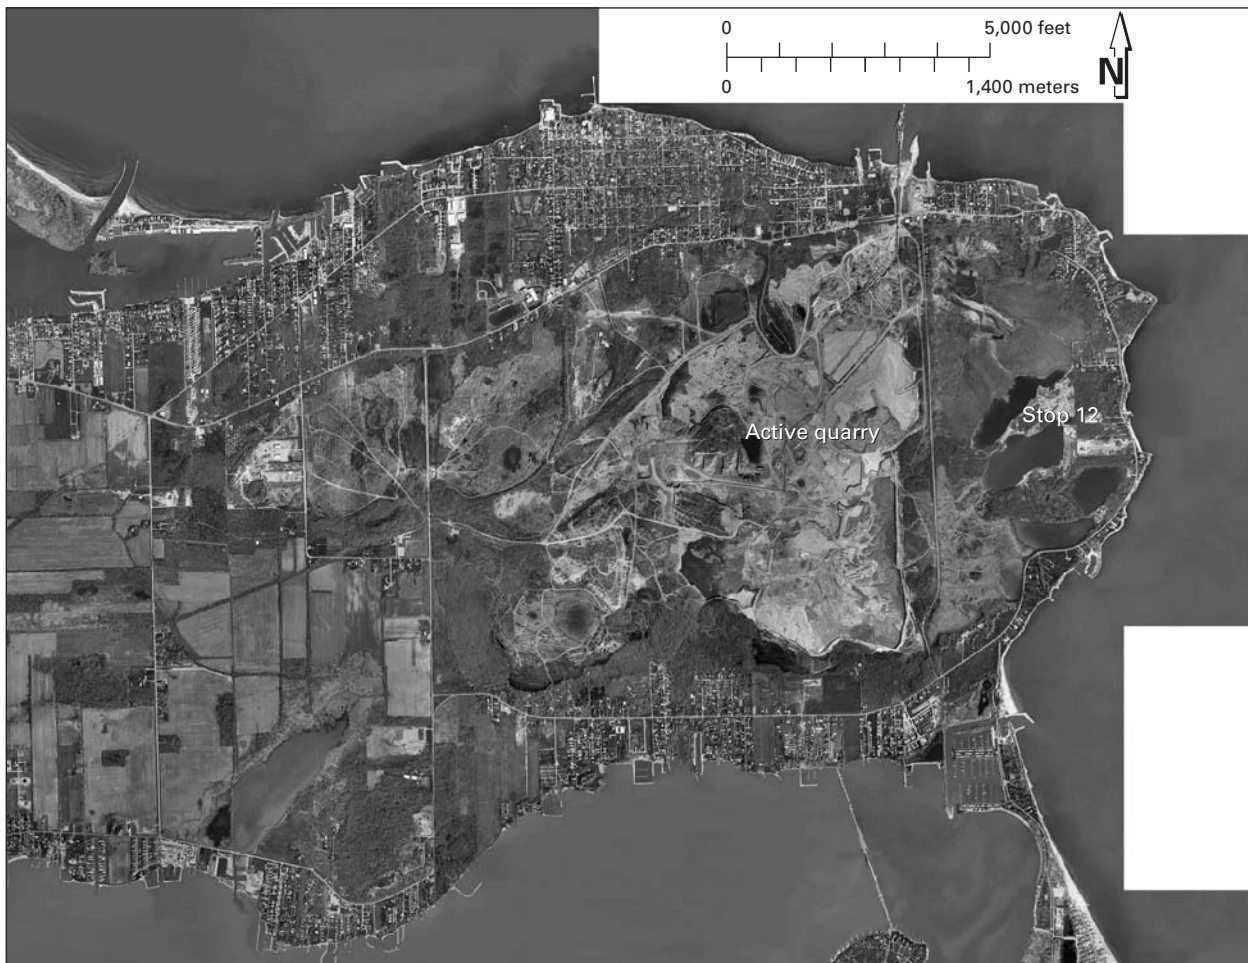
FIGURE 51.—Quarries on Marblehead Peninsula, Ohio. Aerial photograph taken in 2002 by the Ottawa County Auditor.

The Marblehead Quarry, operated by the LaFarge Company, is one of the largest limestone quarries in Ohio (fig. 51). In 2005, 4.2 million tons of crushed Columbus Limestone was removed from the quarry (Wolfe, 2006), and annual production averages about 4 million tons (Mineral Information Institute, 2006). The Columbus Limestone, one of several Lower to Middle Devonian carbonates deposited on the southeastern flank of the Findlay Arch, correlates regionally with the Onondaga Formation of New York and the Detroit River Group of Michigan (Sparling and Rickard, 1985; Oliver, 1976). The limestone was deposited in a subtidal marine environment. The facies exposures are highly fossiliferous, containing solitary rugose corals, colonial corals, encrusting stromatoporoids and corals, planispiral gastropods, and brachiopods (Snow and others, 1991).

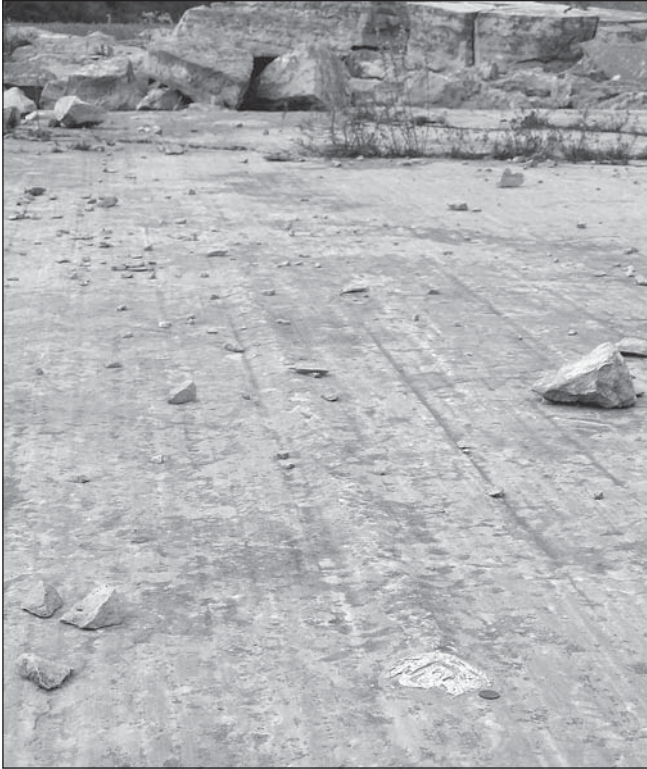
FIGURE 52.—Crag and tail and glacial grooves on Columbus Limestone in Marblehead Quarry, Marblehead, Ohio. Photograph taken by Laura J. Moore.
