# Hydrology, Water Chemistry, and Vegetation Characteristics of a Tamarack Bog in Bath Township, Ohio: Towards Restoration and Enhancement<sup>1</sup>

OHIO J SCI 105 (2):21-30, 2005

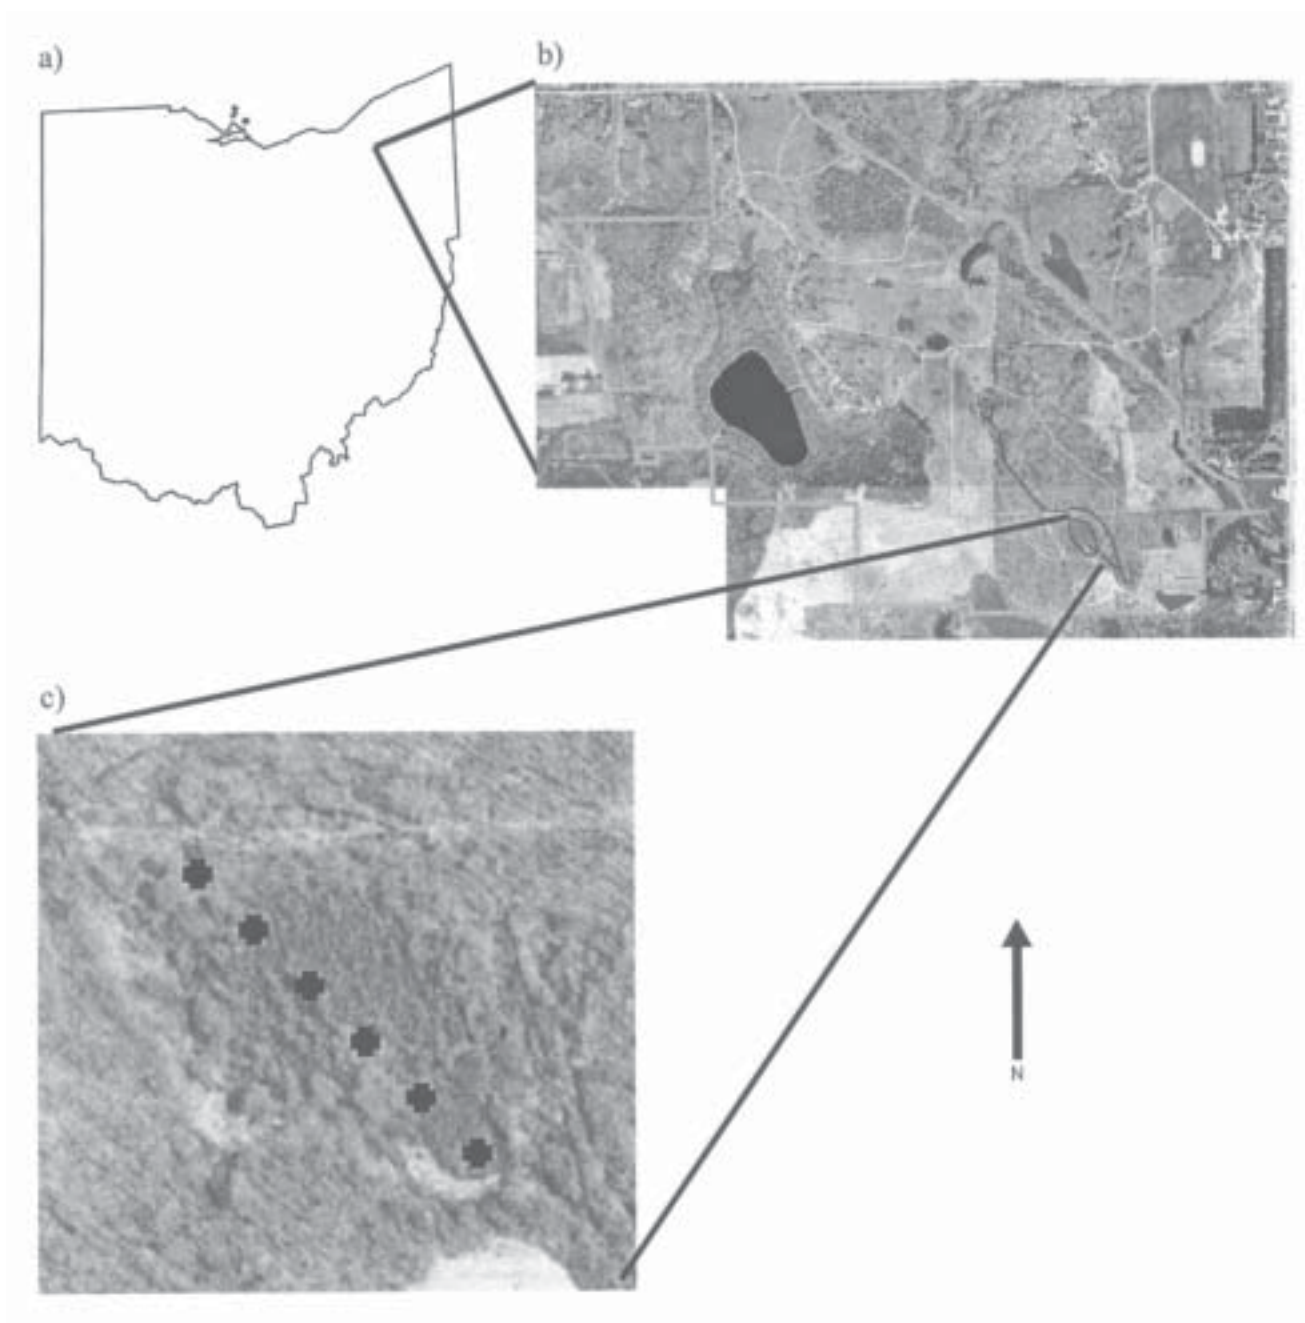
FIGURE 1. Location map of study site; where a) is Ohio, b) is the Bath Nature Preserve, and c) is the Tamarack Bog. The crosses in the Tamarack Bog represent the transect of water level wells located in the bog.

Bath Nature Preserve (BNP) is a 404-acre (163.62 ha) parcel located in the glaciated plateau of northeastern Ohio (Fig. 1a). The property (formerly part of tire manufacturer Raymond Firestone's country estate) is now owned by Bath Township, and preserves healthy examples of habitats such as open grasslands, mature mixed deciduous forests, wetlands, streams, and ponds. Notably, the preserve includes a tamarack bog, located

in the southeast section (Fig. 1b).

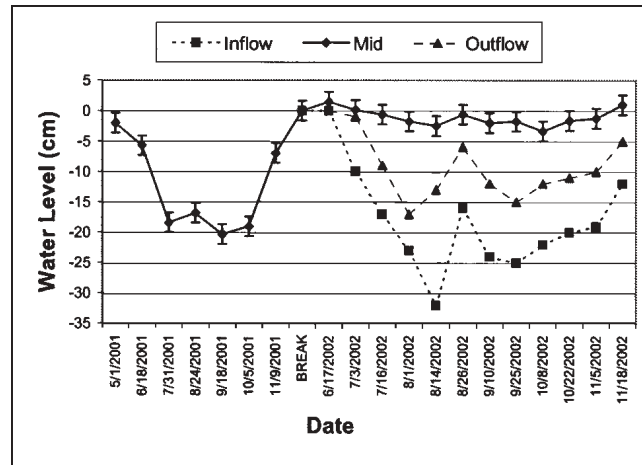
FIGURE 2. Water levels of the Bath Tamarack Bog. There is a break in the data between 9 November 2001 and 17 June 2002. The term "BREAK" on the x-axis refers to the break in data collection with respect to the middle of the bog. Error bars represent  $+1$  standard error.

The hydrology of the bog center demonstrated more variance in the 2001 season than the 2002 season (Fig. 2). In 2001, the water levels of the middle fluctuated from a high of  $-2.0$  cm to a low of  $-20.0$  cm. In 2002, the

hydrology of the bog was more stable, ranging from  $+2.0$  cm to  $-3.0$  cm. The inflow and outflow both demonstrated high variance with the inflow being more severe. Inflow water levels ranged from  $0.0$  cm to  $-32.0$  cm, while outflow levels ranged from  $0.0$  cm to  $-17.0$  cm.

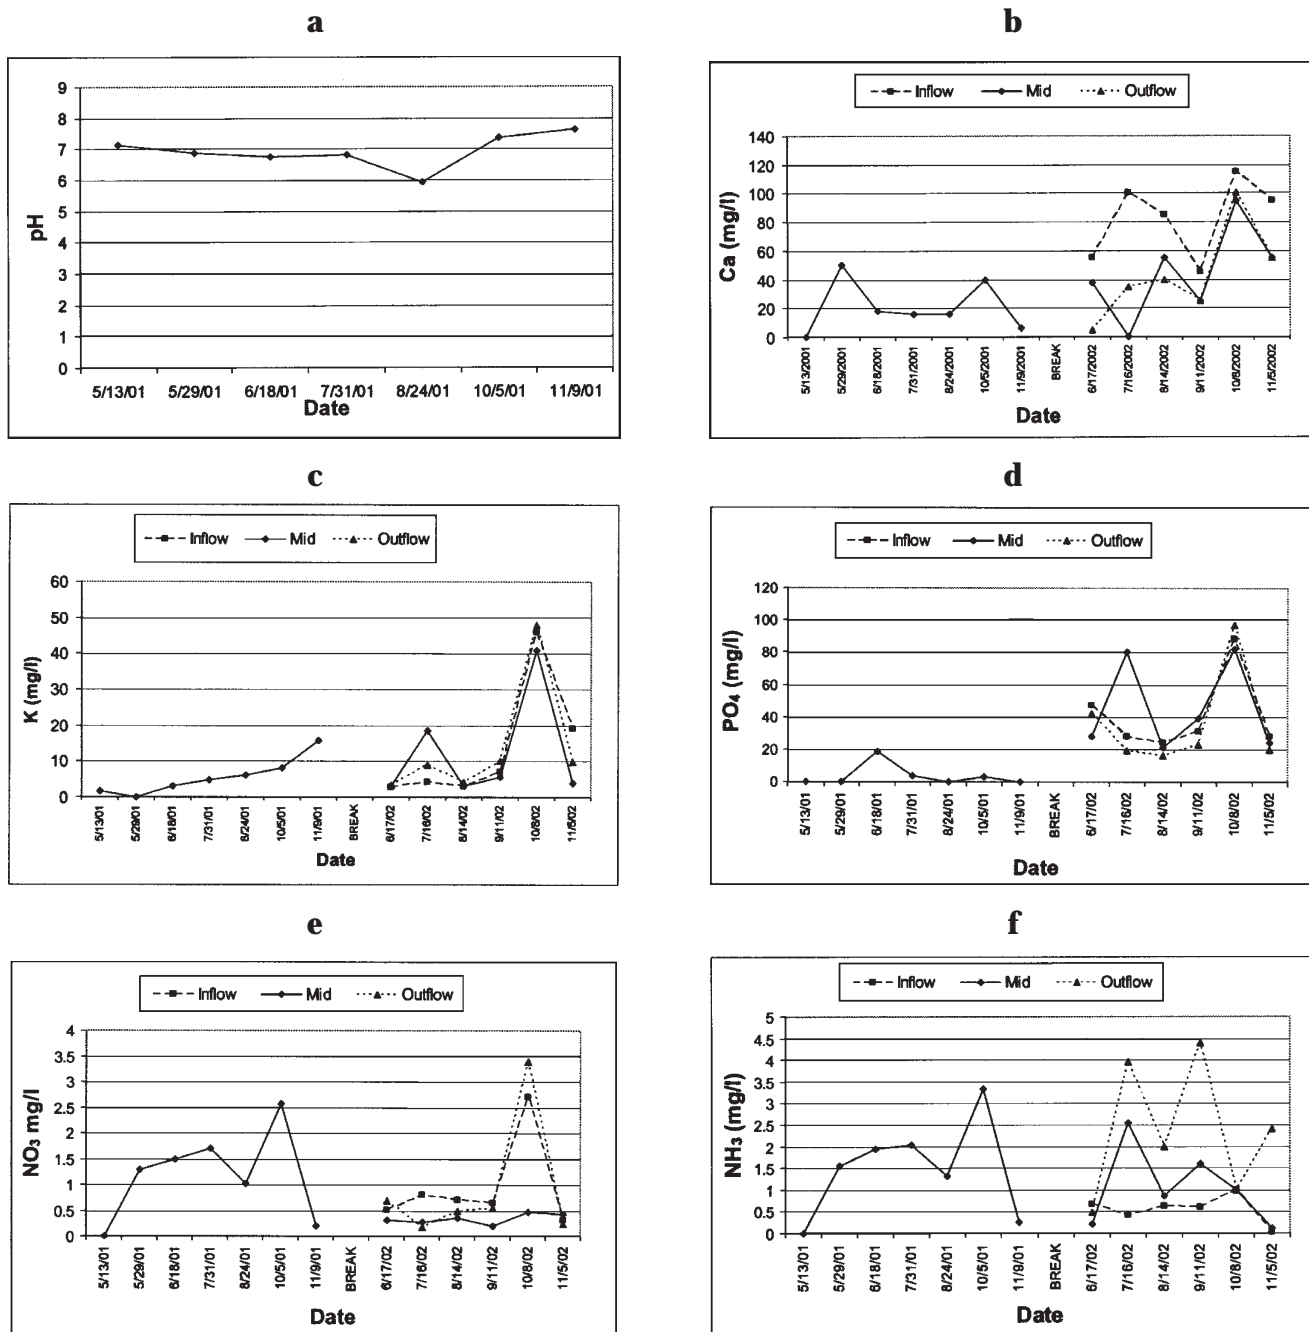
FIGURE 3. Water chemistry measurements; where a) is pH levels from the center of the Bath Tamarack Bog, b) is calcium levels, c) is potassium levels, d) is phosphate levels, e) is nitrate levels of the Bath Tamarack Bog, and f) is ammonia levels of the Bath Tamarack Bog. There is a break in the data between 9 November 2001 and 17 June 2002. The term "BREAK" on the x-axis refers to the break in data collection with respect to the middle of the bog.

The pH, calcium, potassium, phosphate, nitrate, and ammonia levels for 2001 and 2002 are detailed in Figure 3 (a–f). pH (Fig. 3a) shows little variation between May and November of 2001, but quite high values from 6.0 to 7.7. Calcium (Fig. 3b) tended to increase in the fall. Generally the inflow values were greater than mid- and outflow. Similar to calcium, potassium (Fig. 3c), phosphate (Fig. 3d), nitrate (Fig. 3e), and ammonia (Fig. 3f) had high values in October. The highest ammonia values were detected in the outflow (Fig. 3f).

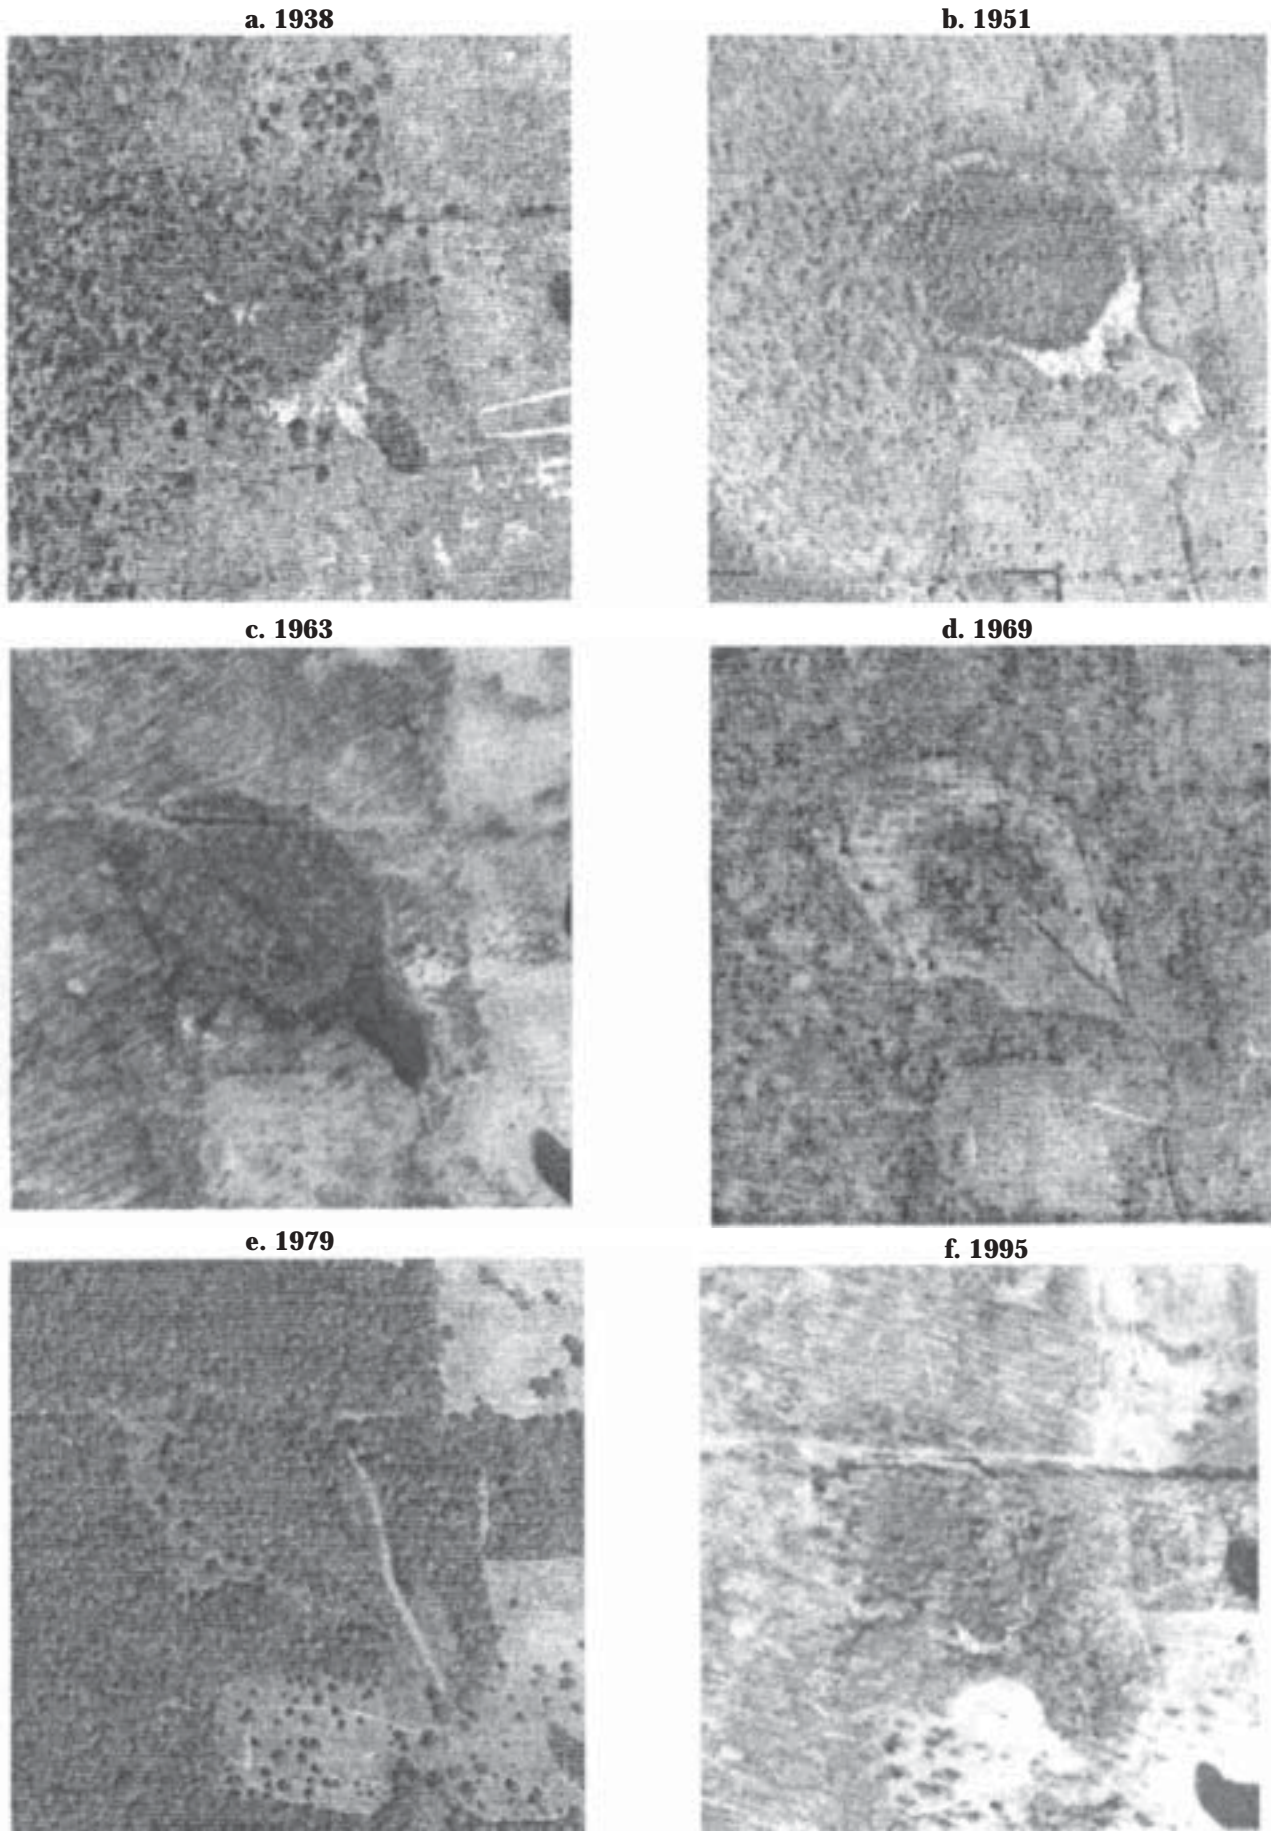
FIGURE 4. Aerial photographs of the Bath Tamarack Bog.

The 1938 aerial photograph of the bog, the oldest available, shows a bog of approximately 5.6 ha and provides evidence for standing water at the southeast end of the bog (Fig. 4a). Standing water is apparent in both the 1951 (Fig. 4b) and 1963 (Fig. 4c) photographs as well. In addition, gas lines appear to have been in-

stalled, crossing through the northern end of the bog in the 1963 photograph. The 1969 aerial photograph (Fig. 4d) shows two ditches present, one through the center of the bog and the other along the east side of the bog. Standing water is not present in this photograph, suggesting that the ditches were constructed between 1963 and 1969. The 1979 aerial photograph (Fig. 4e) shows little change occurring in the area. Lastly, the 1995 (Fig. 4f) photograph is the most recent and is more or less consistent with the current condition of the tamarack bog and surrounding area. The wet area encompassing

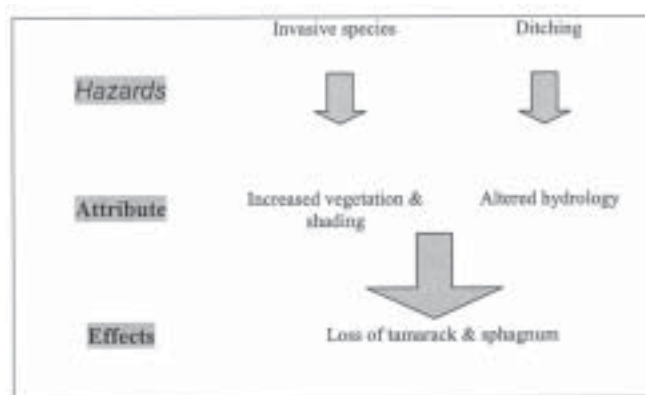
FIGURE 5. Hazards affecting the Bath Tamarack Bog.

Figure 5 shows the effects of the identified hazards on the bog. Invasive species and ditching have both contributed to the loss of tamarack and *Sphagnum* via changes in vegetation and hydrology. The goals of any restoration should be to increase the cover of sphagnum and the number of tamaracks in the bog. Further goals, such as a self-sustaining population of tamaracks may not be practical (NRC 2001).
