CINCINNATI'S GEOLOGIC ENVIRONMENT: A TRIP FOR SECONDARY- SCHOOL SCIENCE TEACHERS

William C. Haneberg,
Mary M. Riestenberg,
Richard E. Pohana,
and
Sharon C. Diekmeyer

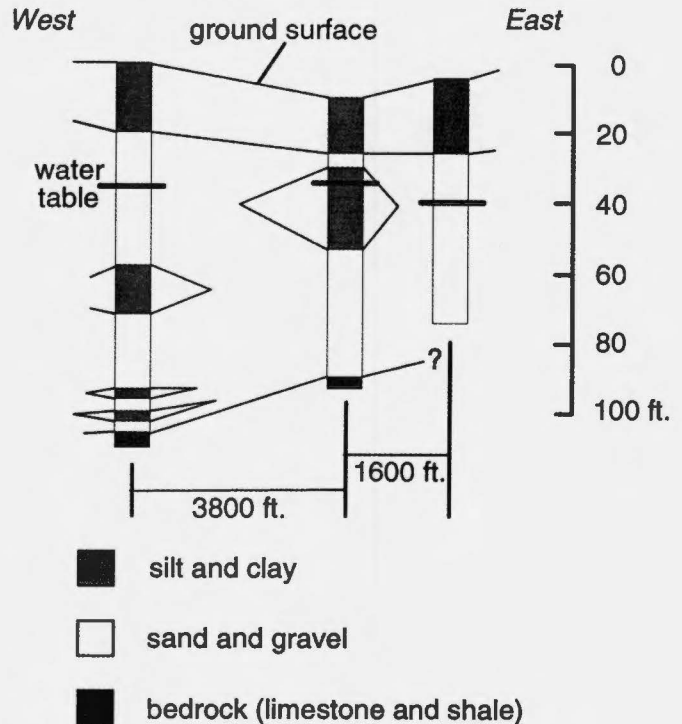
FIGURE 9.—Cross section constructed using drillers' logs from three wells drilled along the Beechmont Levee (U.S. Rte. 50). Vertical exaggeration is approximately 110 times.

Also notice that the lower silt and clay layers in two of the wells are discontinuous. It is difficult, if not impossible, to correlate these layers between wells. Silt and clay layers within an aquifer reduce transmissivity and can also cause problems during well construction.

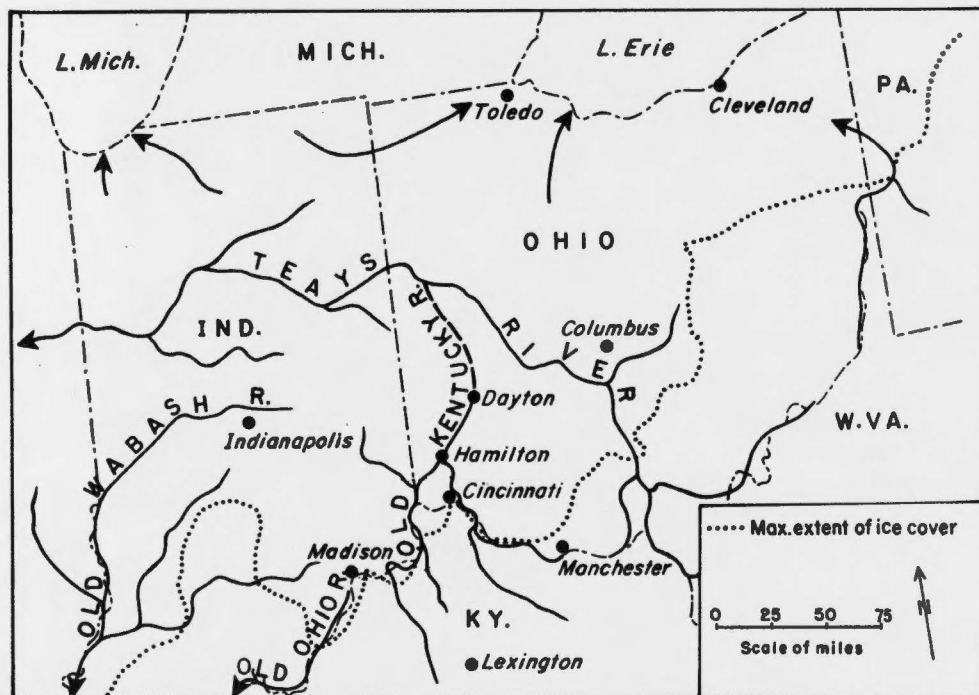
FIGURE 10.—Preglacial (Teays-age) drainage in Ohio, Indiana, and northern Kentucky (from Teller, 1973).

Desjardins (1934) and Durrell (1961) have traced the course of the Teays drainage in southwestern Ohio and northern Kentucky. The main Teays drainages in the Cincinnati area were the Licking River and the Kentucky River, which flowed northward and joined the Teays River in west-central Ohio. The ancient valley system was about 200 feet above the present drainage and was 100 to 200 feet below the uplands.

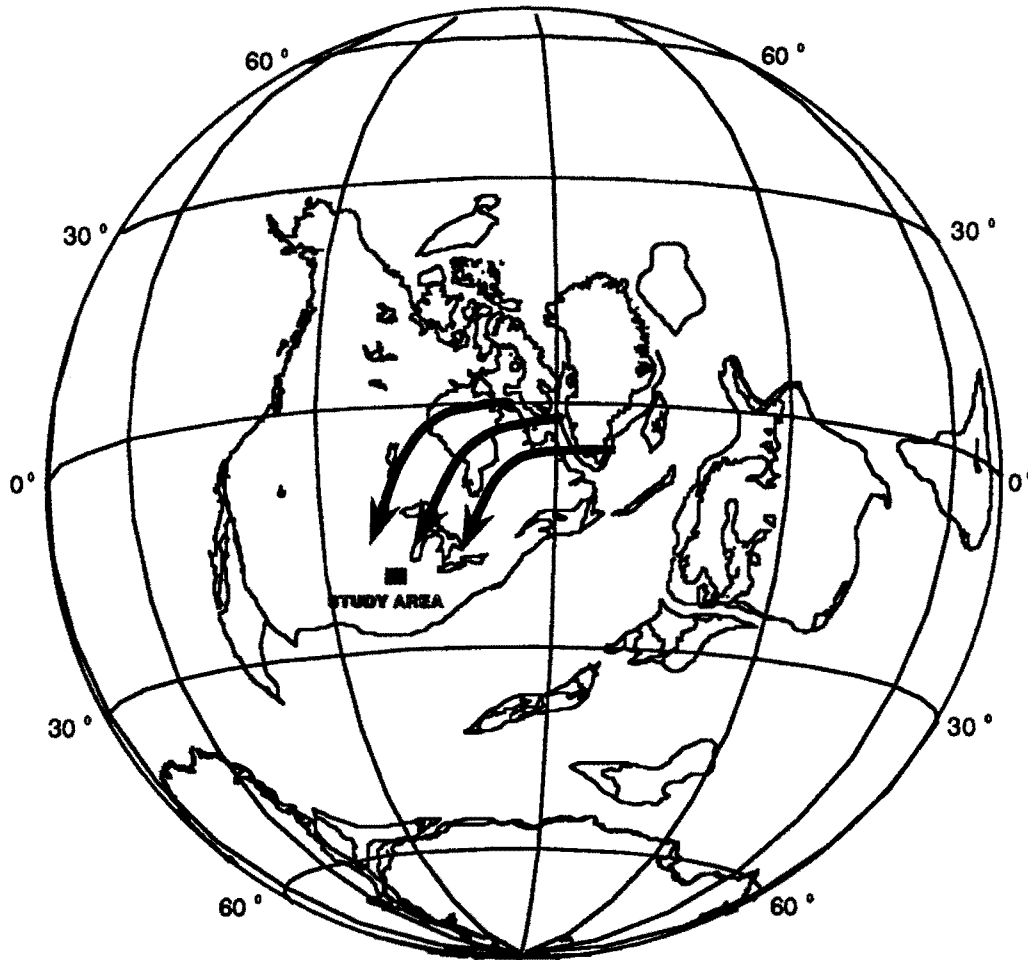
FIGURE 17.—Paleogeographic reconstruction showing the location of the study area during Late Ordovician time, about 438 million years ago (modified from Scotese and Denham, 1988). Arrows indicate the inferred paths of hurricanes and severe storms as they approached the Cincinnatian ramp.

Ordovician ramp (Ziegler, 1981; Tobin, 1982). Figure 17 shows the paleogeographic location of the Cincinnatian ramp and the reconstructed storm tracks.

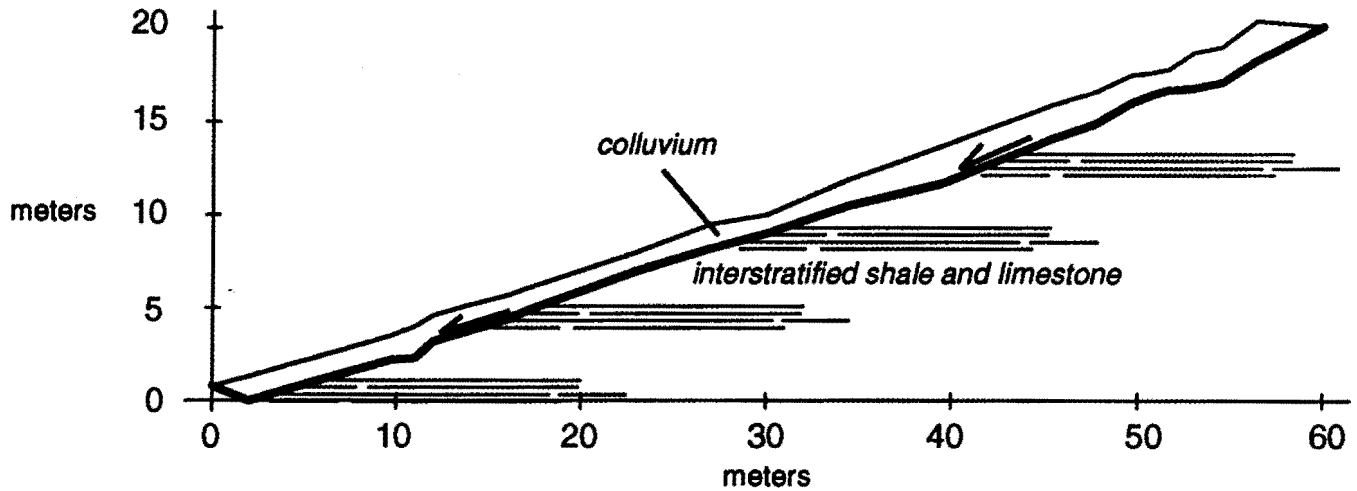
FIGURE 22.—Slope profile along a trench excavated through the thin landslide at Delhi Pike by R. W. Fleming (U.S. Geological Survey) (modified from Haneberg, 1991a).
