An example of Integrated Coastal Management in Punta Candor (Co. Rota, Spain)

G. Gómez-Pina¹, L. Fages¹, J. Román-Sierra¹, M. Navarro², M. Giménez-Cuenca³, J.A. Ruiz³, and J. J. Muñoz-Pérez².

¹Demarcación de Costas Andalucía-Atlántico. Cádiz, Spain.

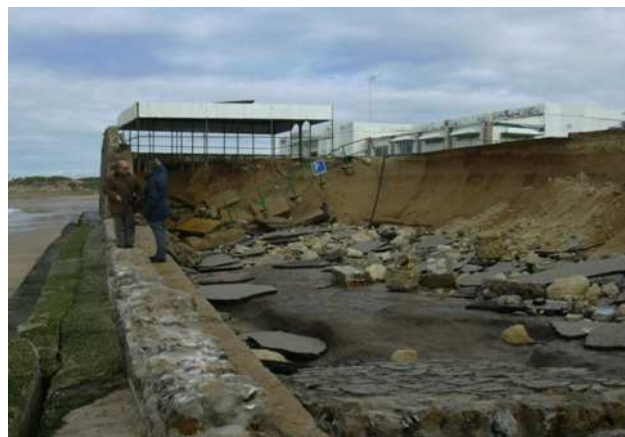
Fig. 5. Destruction of Punta Candor protruding paved area after the storm of December, 2004.

Several projects in this coastline have been successfully performed. One of the most important restoration works were applied in Punta Candor, where erosion destroyed a protruding paved area in 2004 (Fig. 5). Wave processes have been analysed in order to understand local negative effects.

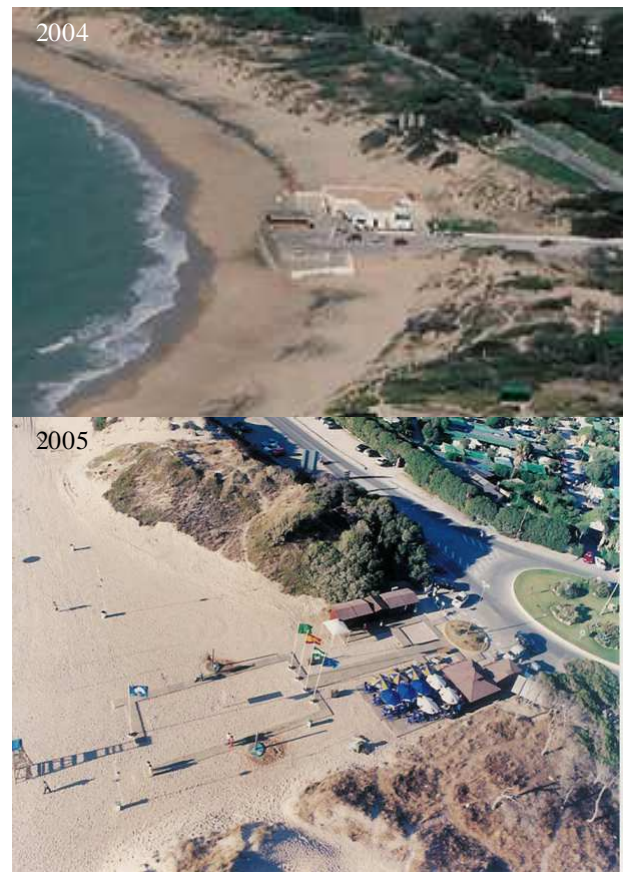
Fig. 7. Comparison between pre (2004) and post-restoration works (2005).

The first phase of Punta Candor restoration was quickly finished in a 6 months period, as there were policy interests due to the closeness of local Town Hall elections (Fig. 7). The new Punta Candor finally achieved the EU blue flag thanks to this restoration project.
